Msenge Emoyeni Powerline Deviation

TERRESTRIAL SPECIALIST REPORT

June 2022

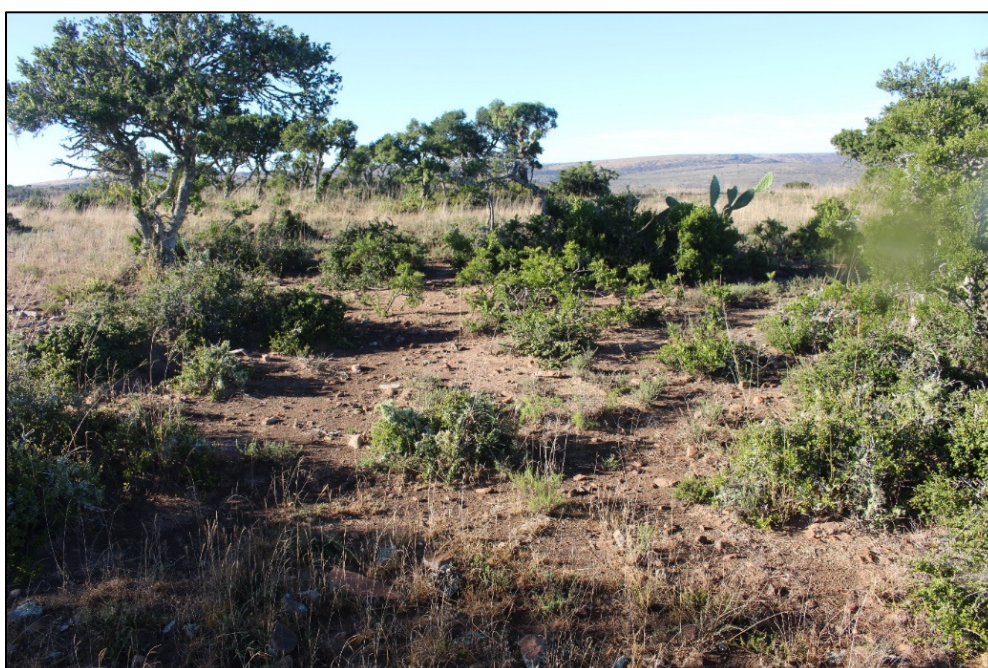
Figure 2.1. The remnants of a large bush clump which would have exhibited a closed canopy, complex architecture and a canopy height of 2-3m

None of the properties investigated showed grasslands, thicket or savanna in good ecological condition (see **Figure 2.1** below), which indicates a steady regime of overgrazing and insufficient resting to allow palatable species to persist in the landscape. At most of the sites visited, the ecological conditions indicated towards rangelands that require significant periods of rest. The bushclumps exhibited the most degree of vegetation structure changes.

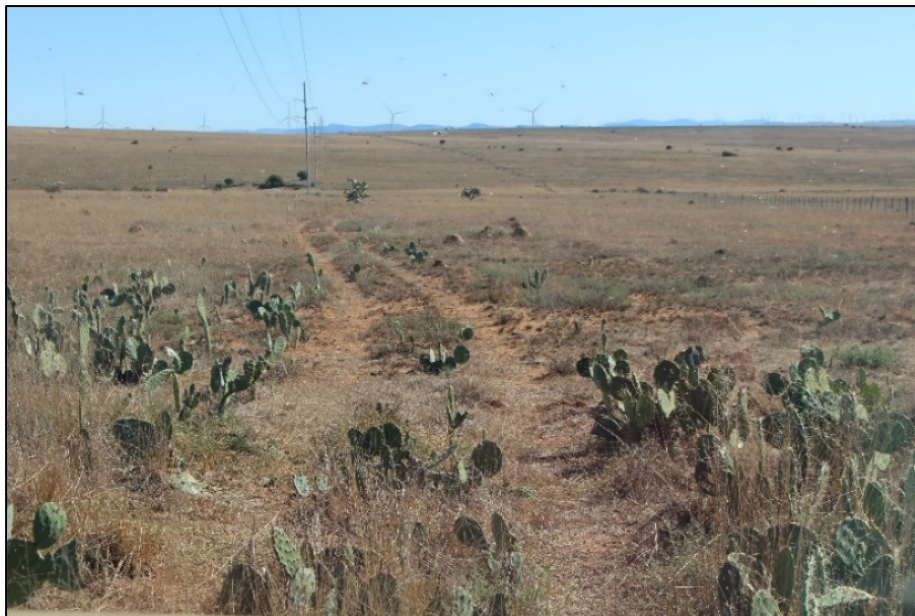
Figure 2.8. *Opuntia megapotamica* populations associated with the existing Eskom infrastructure

The number of declared Alien Invader Plants (AIPs) is limited (*Opuntia ficus-indica*, *Opuntia aurantiaca*, *Opuntia megapotamica* - **Figure 2.8**), but their distributions are widespread and a significant threat to biodiversity and the rural economy. A large population of *Agave americana* is situated on the adjacent property (Farm 225) and poses a threat in the long-term. A small number of naturalized weeds were identified for the area, but these pose little threat and will reduce in number with improved veld management.

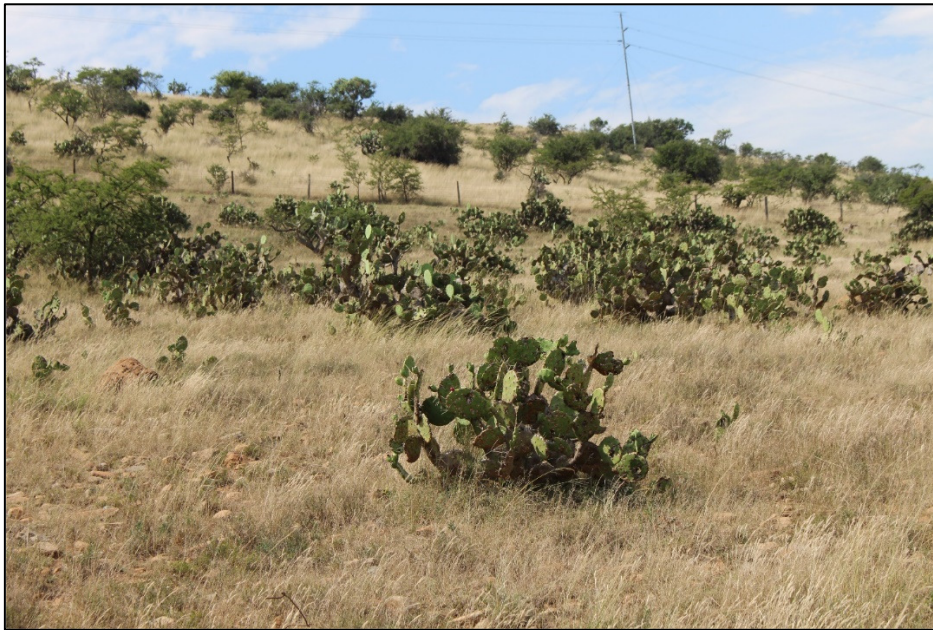
Figure 2.12. High densities of *O. megapotamica* associated with the existing Eskom service road on Farm 242
