Portion 183 of the farm
Zandfontein 317 JR -
Geotechnical Investigation for
Township Establishment Purposes

(Tshwane Metropolitan Municipality)

Report no: K9884-01
Project no: 9884-GB

December 2021

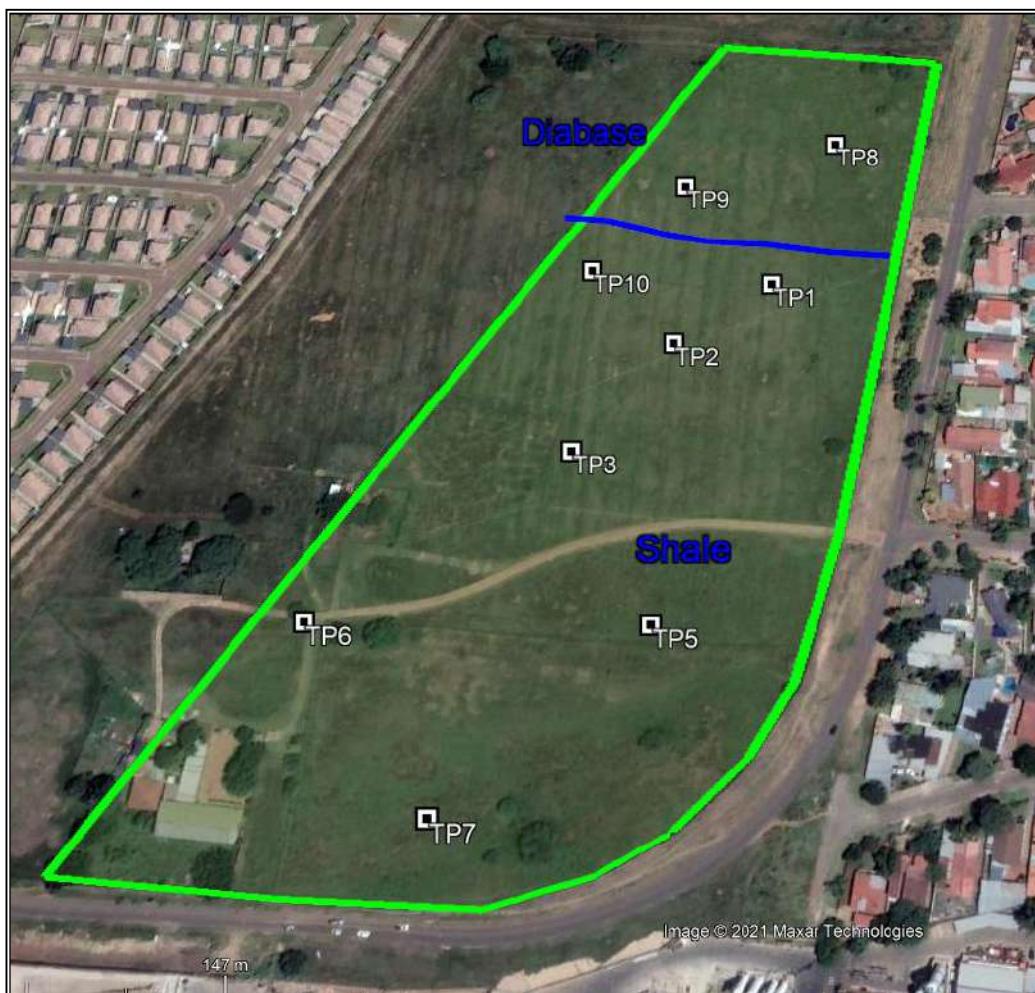
The in situ materials tend to weathered to clayey materials. Most of the materials classified as clayey sand (SC). The regional geology is indicated on 9884-02: Geology Map and the site specific geology on drawing below.

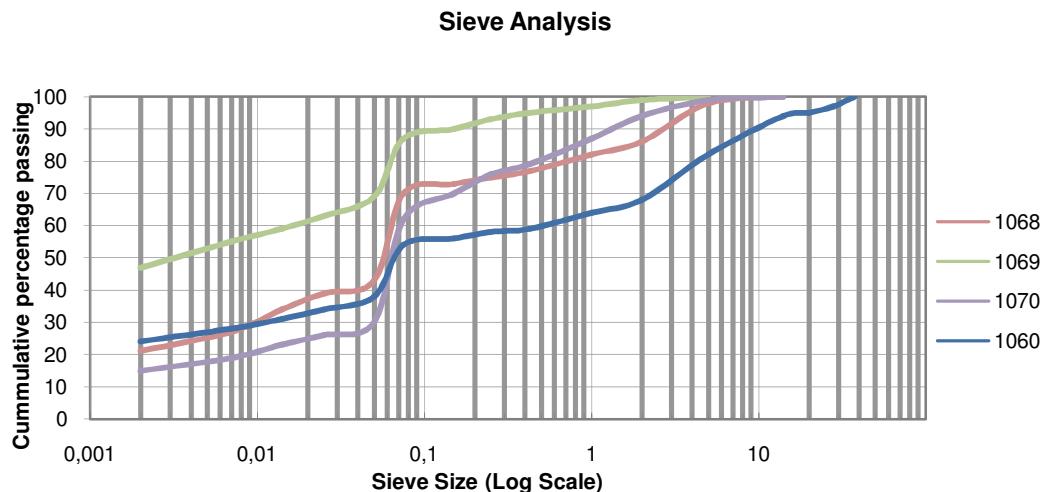
It is evident that the Liquid Limits, Plasticity Indices (PI) and Linear Shrinkage of the samples are generally on the high side.

The following graph shows a summary of the grading analyses.

Using van der Merwe's method to determine the heave potential of material, it is evident that the materials generally classify as having a *Medium expansiveness* potential. The estimated amount of movement due to heave is in the order of 20mm.

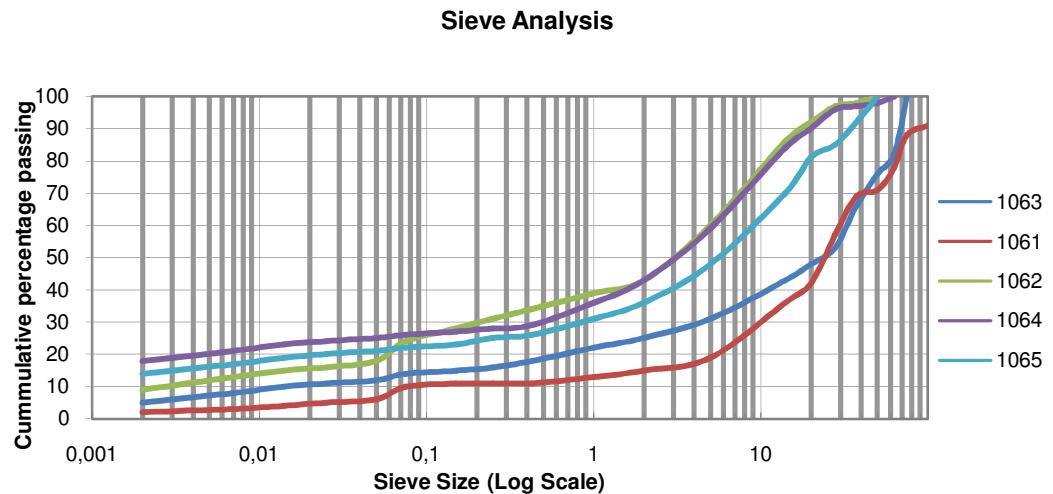
It is evident that the Liquid Limits, Plasticity Indices (PI) and Linear Shrinkage of the samples are generally on the low side, but that the materials show low plasticity values indicating a low heave potential.

The following graph shows a summary of the grading analyses.

Using van der Merwe's method to determine the heave potential of material, it is evident that the materials generally classify as having a *Low* expansiveness potential. The estimated amount of movement due to heave is less than 5mm.

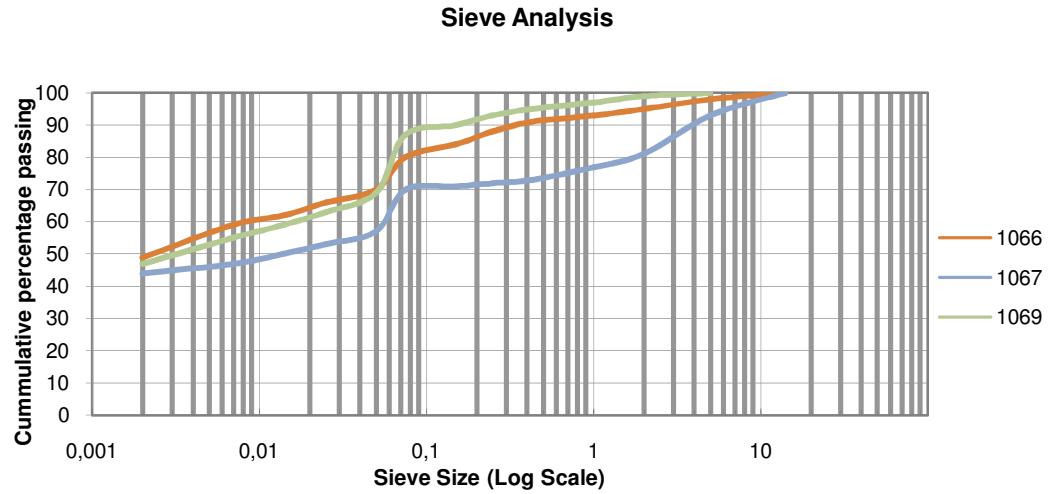
It is evident that the Liquid Limits, Plasticity Indices (PI) and Linear Shrinkage of the samples are high, indicating a high heave potential.

The following graph shows a summary of the grading analyses.

Using van der Merwe's method to determine the heave potential of material, it is evident that the materials classify as having a *High* expansiveness potential. The estimated amount of movement due to heave is in excess of 30mm.

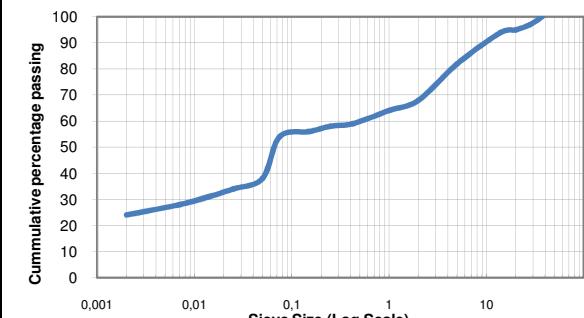
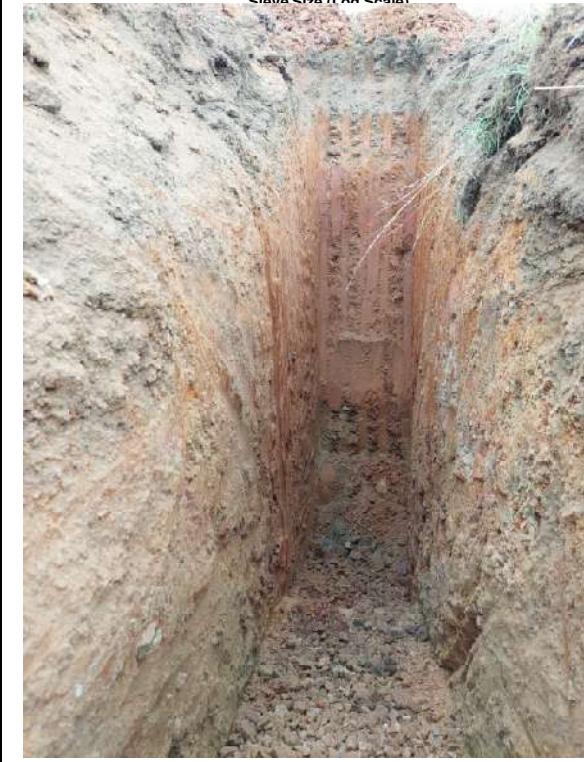
TP NO: 1

0,00 - 0,50: Dry to slightly moist, light grey brown, loose, intact silty gravel with nodular ferricrete; Ferruginised colluvium.

0,50 - 2,20: Slightly moist, dark orange brown to reddish brown with black staining on joints, firm to stiff, relict jointed clayey silt; Residual shale (saprolitic).

2,20 - 2,90: Slightly moist, light grey brown, medium dense to dense, relict jointed silty gravel; Residual shale (saprolitic).

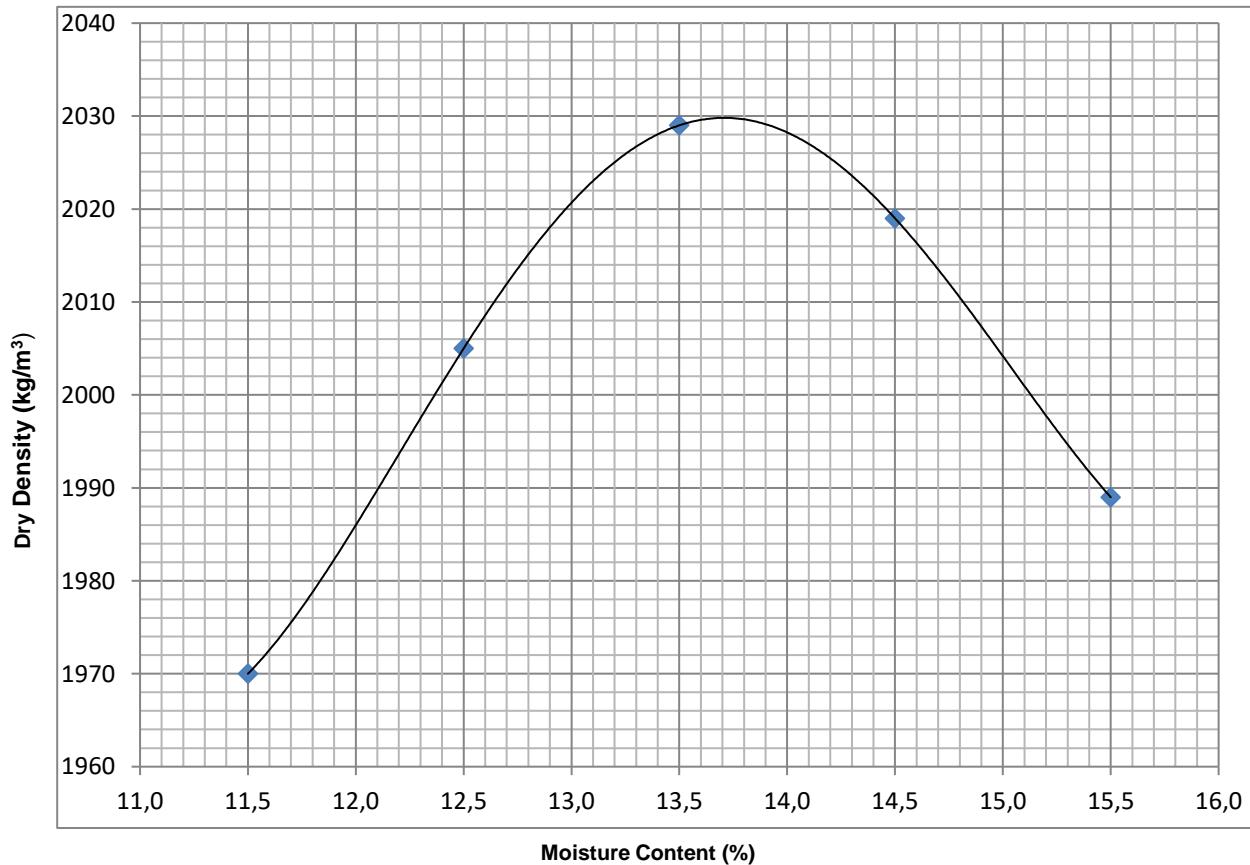
SANS 3001-GR30: Maximum Dry Density and Optimum Moisture Content

Sample Number:	1061		Field Reference:	CBR 2			
Depth (mm):	0,5-2,0						
Description:	CBR 2						
Compaction Effort:	Modified AASHTO						
Dry Density (kg/m ³):	1970	2005	2029	2019	1989		
Moisture Content (%)	11,5	12,5	13,5	14,5	15,5		
Maximum Dry Density (kg/m ³):	2030		Optimum Moisture Content (%):	13,7

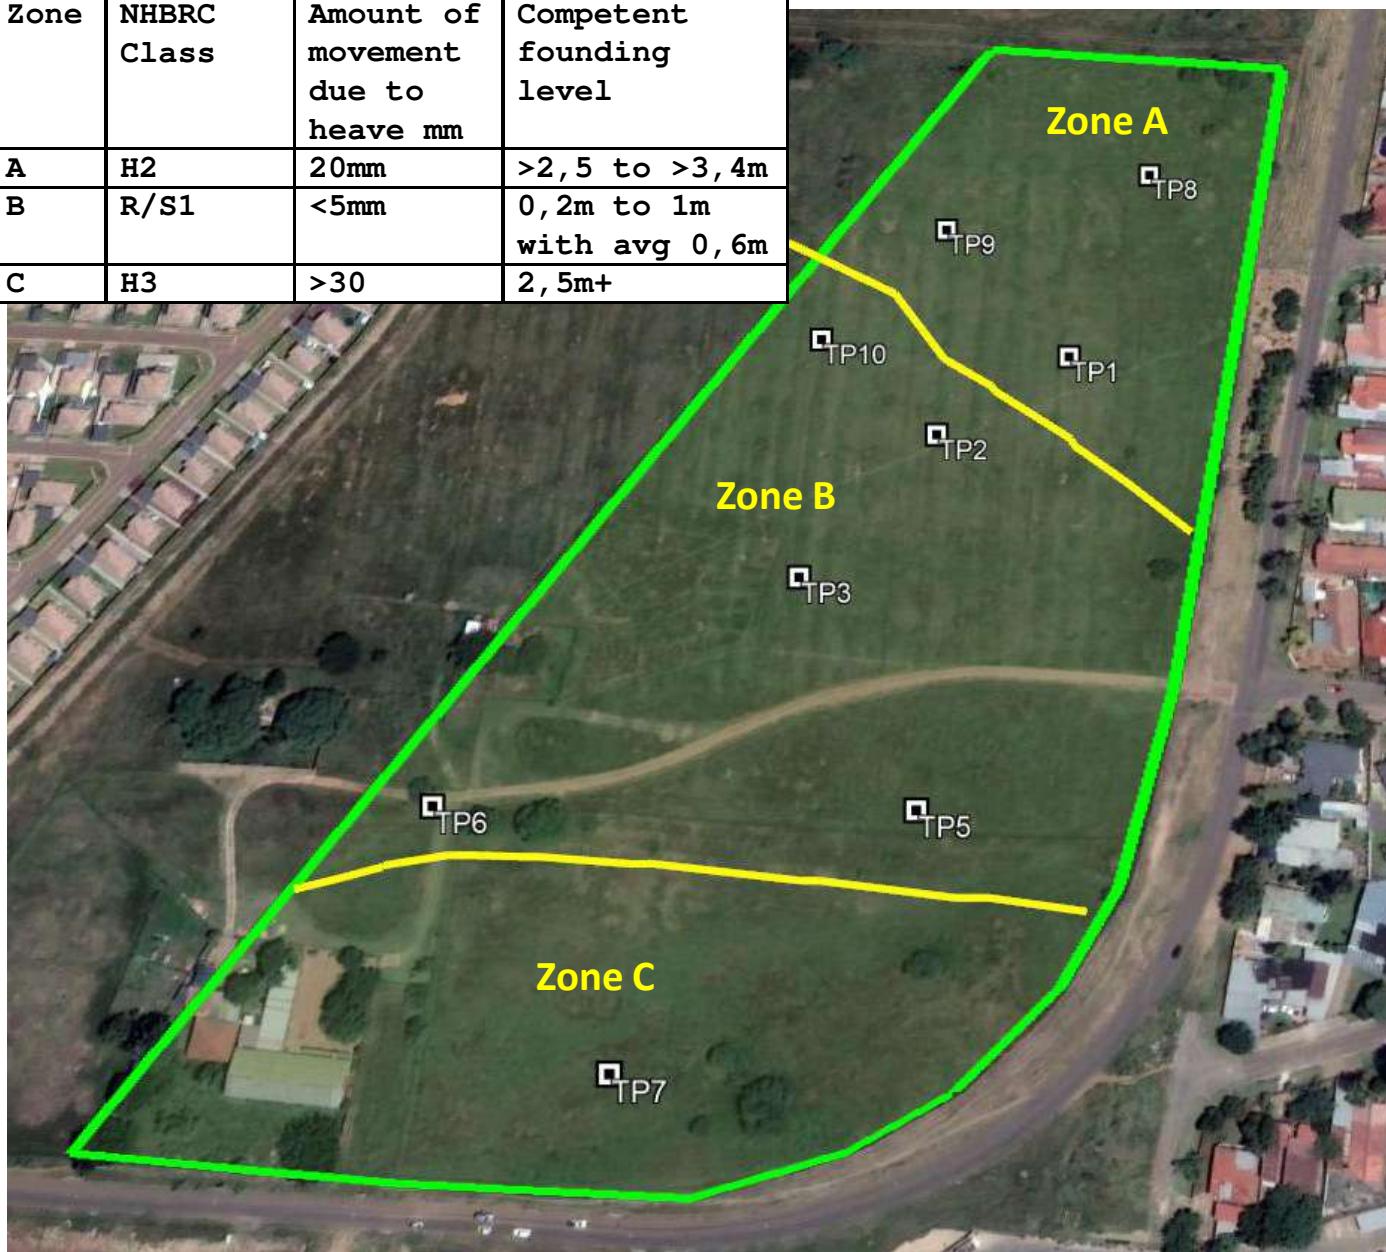
Drawing No.
9884 -02:
Geology Map

Zone	NHBRC Class	Amount of movement due to heave mm	Competent founding level
A	H2	20mm	>2,5 to >3,4m
B	R/S1	<5mm	0,2m to 1m with avg 0,6m
C	H3	>30	2,5m+
