Aggeneys BESS Facility, Portion 1 of the Farm Aroams 57 RD

AQUATIC BIODIVERSITY COMPLIANCE STATEMENT

PREPARED FOR: **WSP SOUTH AFRICA.**

DATE: **March 2023**

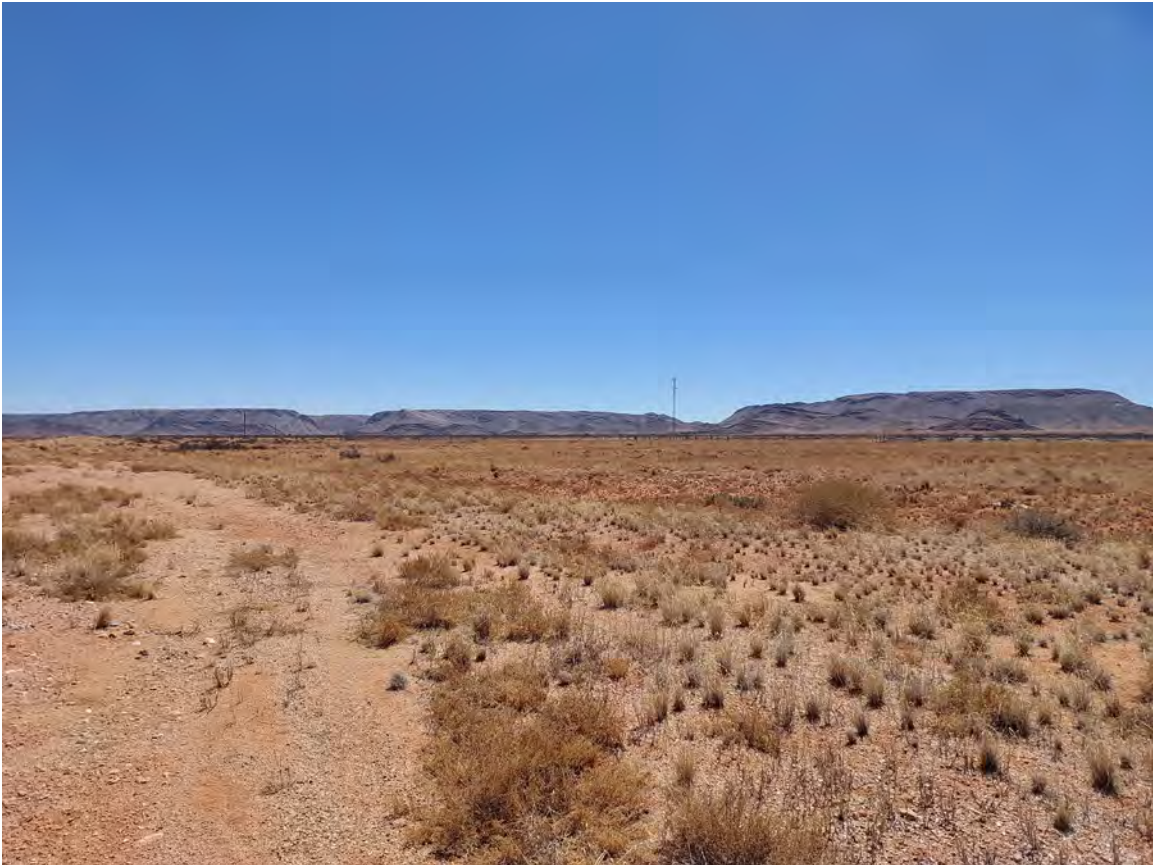
Figure 11: Proposed BESS facility footprint area, with the existing Aggeneys PV facility in the background.

The vegetation within the area consists of Bushmanland Arid Grassland which is of Least Concern (LC), according to the South African National Biodiversity Institute (SANBI) Vegetation Map 2018 (Beta) obtained from CapeFarmMapper ver.2.2.3.1. However, the proposed BESS facility footprint area is currently considered to be in a degraded state consisting of sparse natural vegetation likely due to historic agricultural impacts such as overgrazing (**Figure 11**).

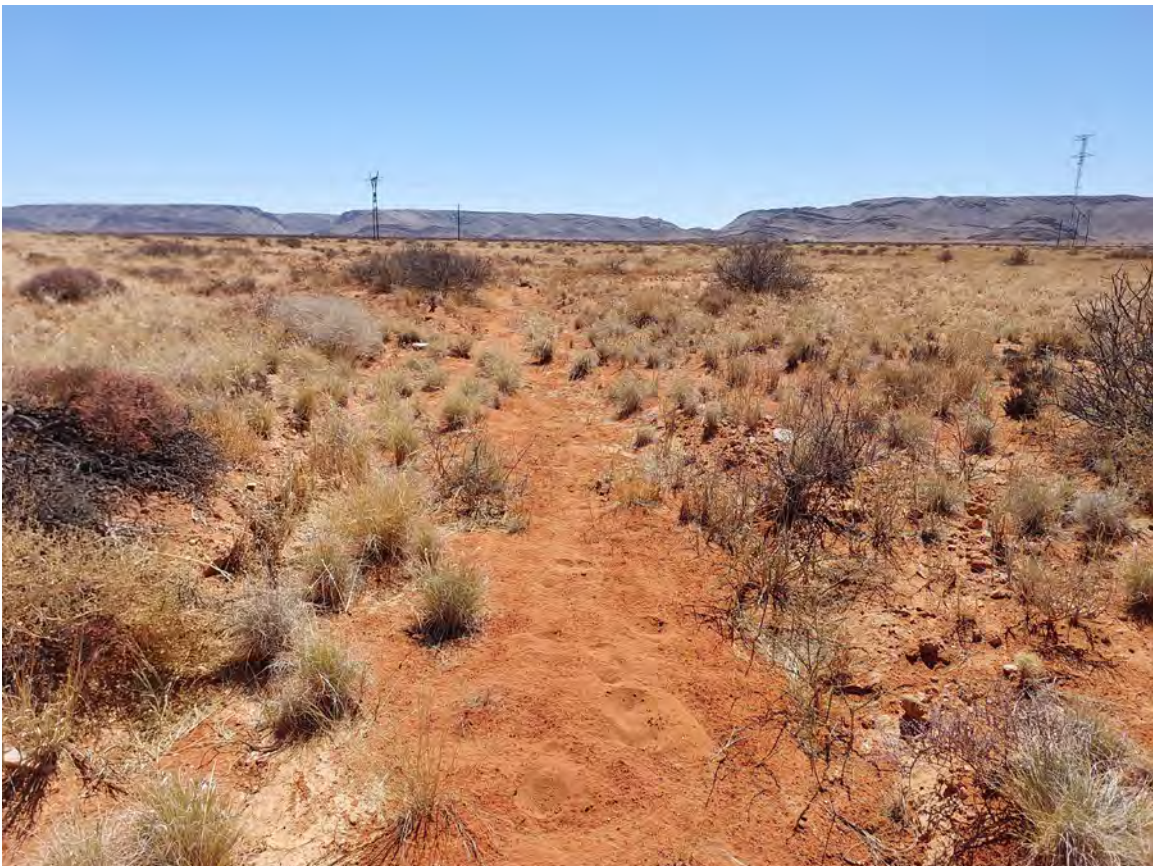
Figure 12: Ephemeral drainage line located between the proposed BESS and layout area; upstream view.

The ephemeral drainage line likely only flows after substantial stormflows and for short periods of time, considering the sandy soils in the region and the flat terrain. These ephemeral watercourse features are considered typical for the Northern Cape (Savannah Environmental, 2019). Sparse riparian vegetation such as *Stipagrostis* spp., *Rhigozum* spp., and *Euphorbia* spp. were observed (**Figure 12, 13 & 14**). Given the limited vegetation cover, sediment is transported from the surrounding catchment into the ephemeral drainage line, and alluvial deposits were observed in the dry streambed. (**Figure 12, 13 & 14**).

- The ephemeral drainage line should be avoided as far as practically possible during the construction and operation of the facility.
- Vehicles should remain on the existing dirt track with no new access roads/tracks constructed within the delineated drainage line.

- No vegetation should be removed from the ephemeral drainage line.
- The outer areas of the cleared BESS facility and lay-down area, within 100 m of the ephemeral drainage line should make use of sedimentation preventative measures such as the use of silt nets and/or sandbags to prevent sedimentation entering the watercourse via surface water run-off during construction activities.

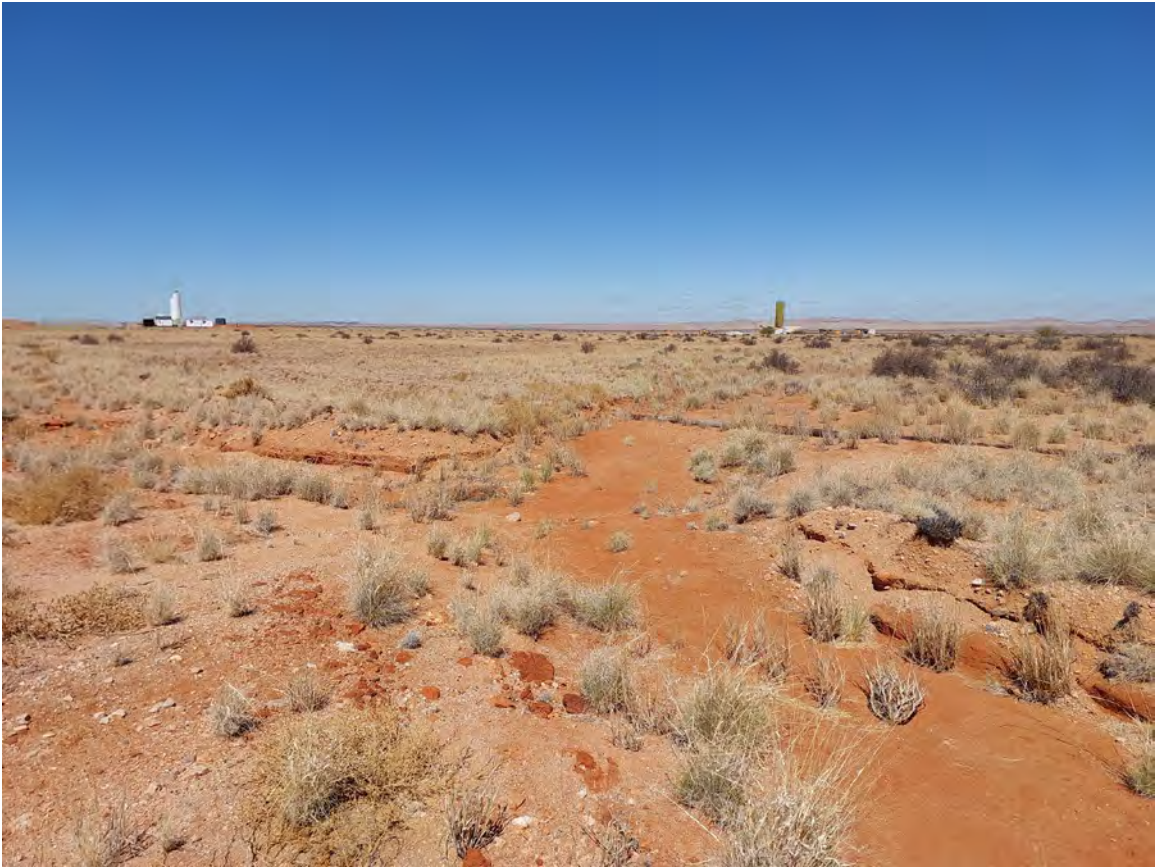
Figure 13: Ephemeral drainage line and erosion; downstream view.

The topography of the proposed BESS facilities footprint area is relatively flat. In general, the area slopes gently (<3%) from a small ridgeline in the north/northeast (approximately 903 masl) to the south/southwest plains (880 masl). The geology is described as bedrock comprising of ancient basement rocks of the Bushmanland Terrance of the Namaqua Province overlain by Quaternary sand cover. This sand cover is a combination of alluvium in the drainage lines and colluvium closer to the bedrock outcrops. The soils in the proposed BESS facility and surrounds are sandy red soils, partly infested with coarse fragments, indicating susceptibility to water and wind erosion as observed on site (**Figure 13**).

- During construction activities, cover cleared areas with straw to minimize sedimentation by wind.
- Any soil stockpiles within 100 m of the watercourse should be bunded using an appropriate structure (silt nets, sandbags, etc.).

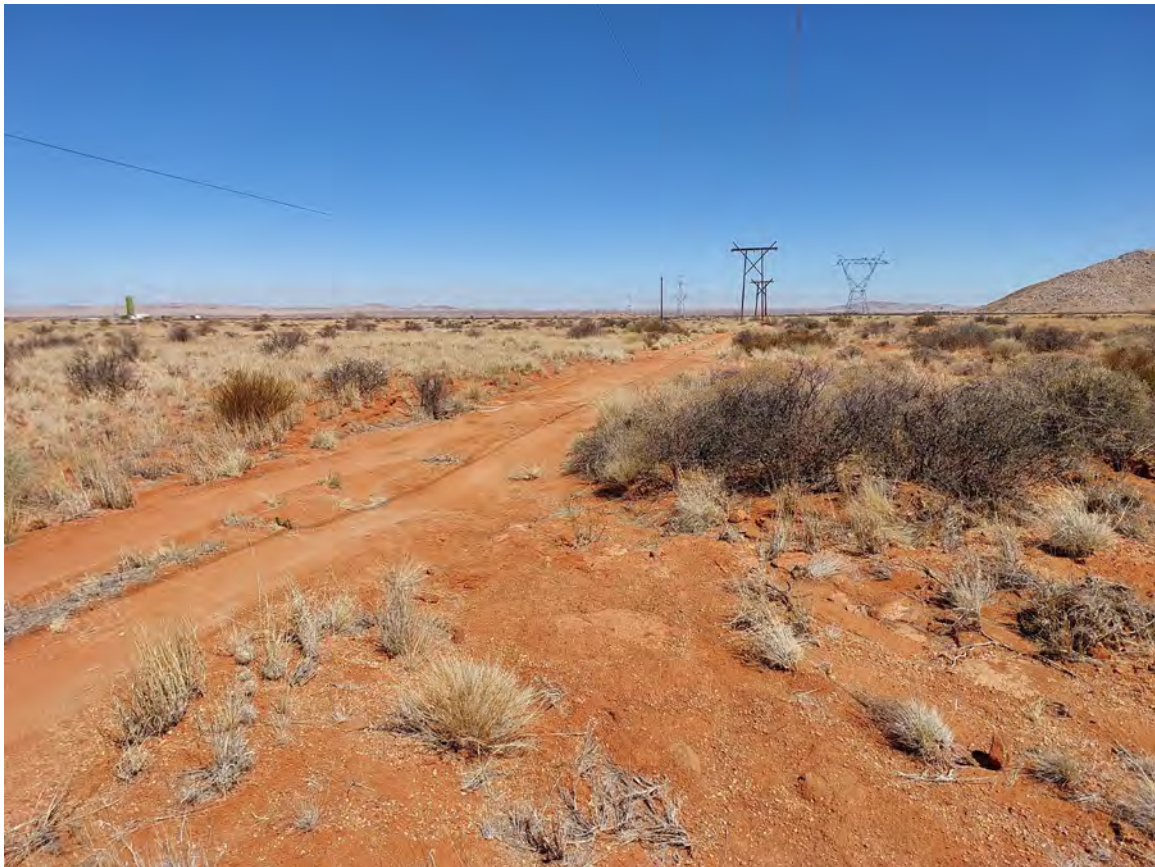
Figure 15: Dirt tracks and power lines present in the drainage line.

The habitat integrity of the ephemeral drainage line was assessed using the Kleynhans *et al* (2008) Index of Habitat Integrity assessment methodology. The assessment produced an instream habitat integrity score within category E (seriously modified), and a riparian habitat integrity score within category F (critically modified). The assessment results for the instream and riparian habitat are presented in **Table 1** and **Table 2** respectively. Impacts to the drainage line include vegetation removal and flow modification as a result of previous agricultural activities, and the upstream PV facility and associated access roads. The downstream farm road likely results in periodic inundation within the drainage line during stormwater flows, resulting in channel and bed modification, as well as erosion. Additionally, considering the previous agricultural land use, surrounding industrial land uses and dirt tracks through the drainage line, there has likely been physio-chemical modifications to the drainage line.
