# GAS TRANSMISSION PIPELINE, AND ASSOCIATED INFRASTRUCTURE, NIGEL

## Ecological Impact Assessment Report

May 2019

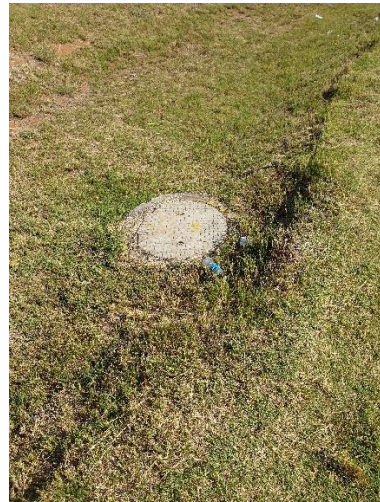
Maintenance hole for existing buried pipeline within the development corridor

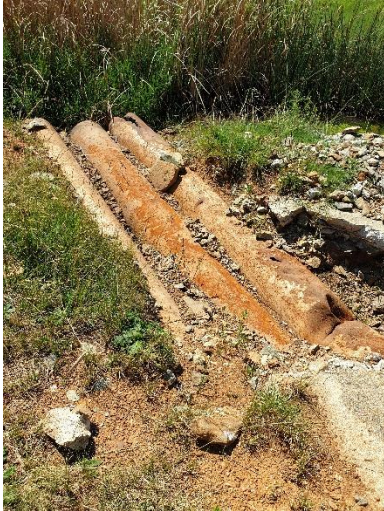
Old pipelines running through the surface water feature at the northern portion of the development corridor

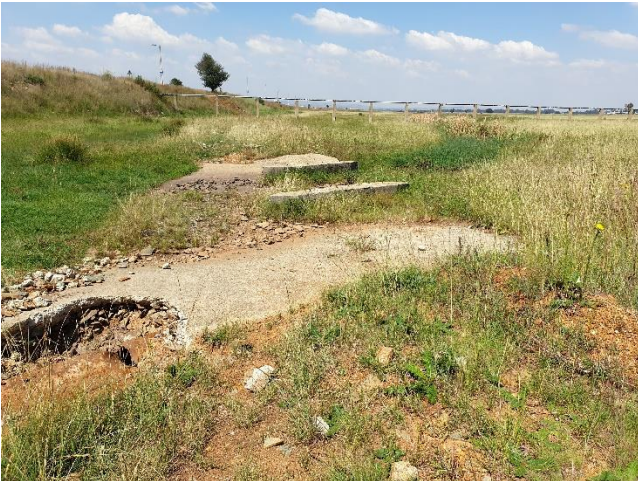
Old infrastructure foundations near the northern portion of the development corridor
