RICHBAY CHEMICAL (PTY) LTD

**PROPOSED NEW CHEMICAL PLANT:
VOSLOORUS, EKURHULENI**

**FEASIBILITY DOLOMITE STABILITY AND
GEOTECHNICAL INVESTIGATION**

Report No:KP2689

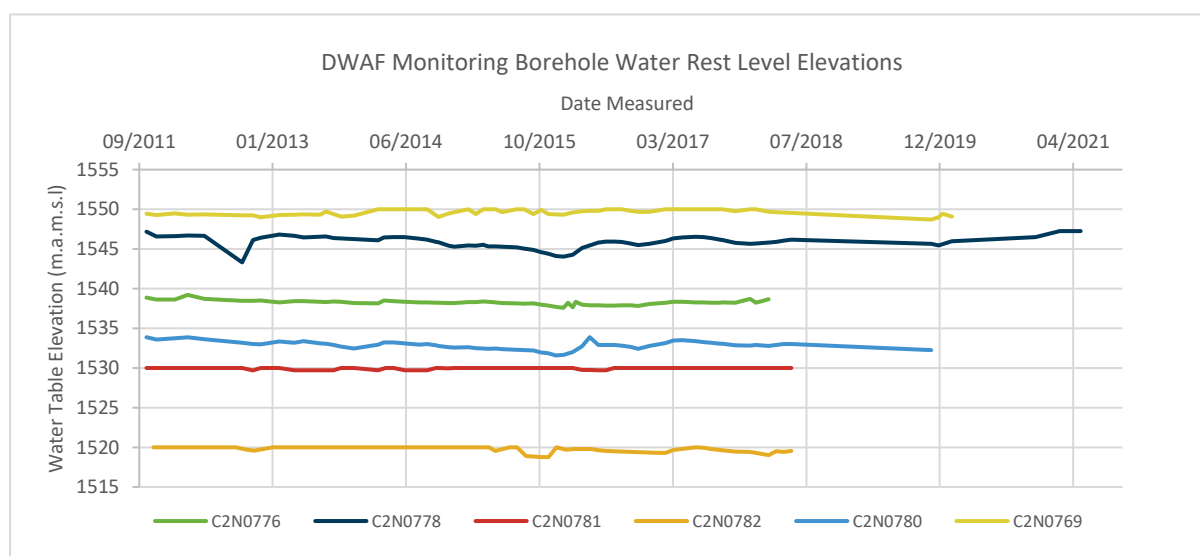
The site forms part of the Natspruit East dolomite groundwater compartment with many ground water monitoring boreholes, as indicated in Figure 3. The median groundwater level in the compartment is recorded as 15,2 m with the minimum and maximum ad-hoc measurements varying between 12,3 m and 21,4 m below surface [7]. Water rest elevations from the DWAF monitoring boreholes surrounding the site are indicated below.

Water rest levels recorded in monitoring boreholes operated by the Department of Water Affairs (DWAF), indicate that regional water level for boreholes near the site over the last 10-year period is relatively stable. However, slight fluctuations (<1m) do occur, which can possibly be attributed to seasonal drought and possibly nearby abstraction of water for industrial and/or agricultural use.

The static water level (SWL) for this site has been taken as the regional median of 15 m below surface and used in the stability analysis in Section 8 of this report. The investigation was conducted at the turn of seasons from dry to wet. No significant water sources of consequence or in excess of seasonal rainfall, were noted near the site. A summary of the water rest levels as encountered in the boreholes is presented in TABLE 1 and the descriptive statistics of the water rest levels are shown in TABLE 2.

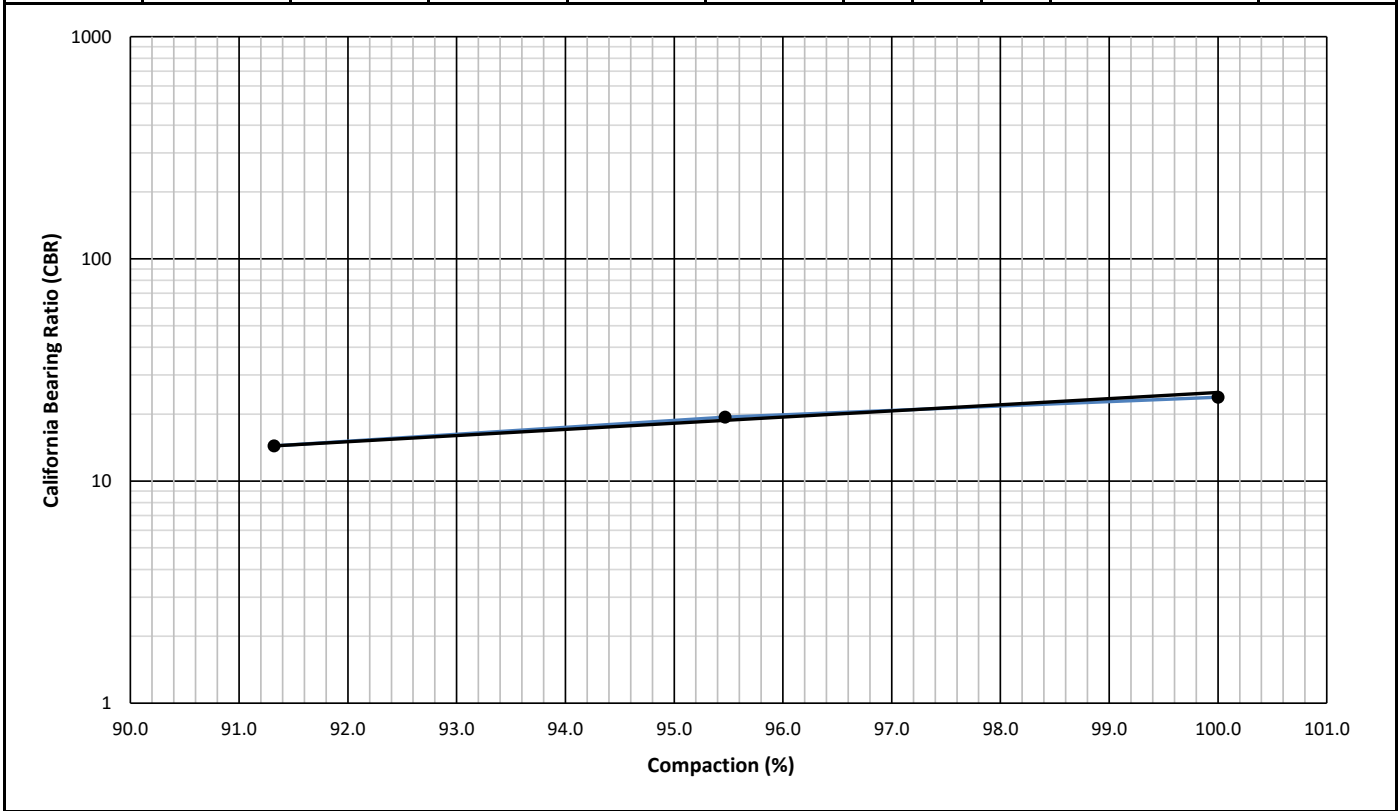
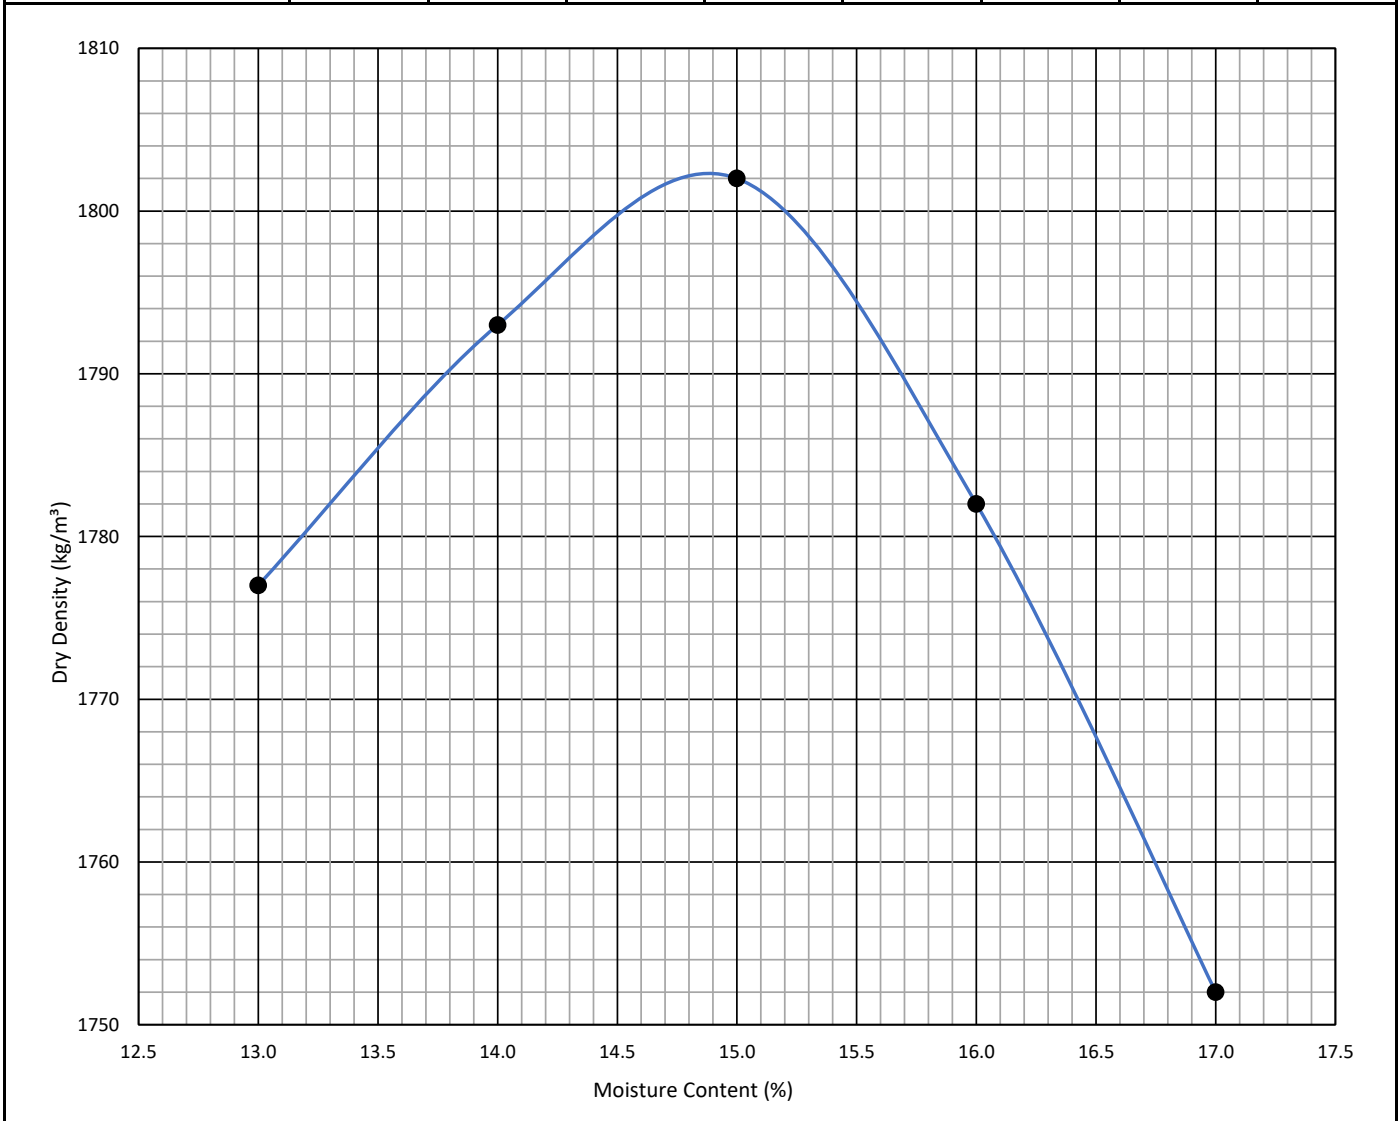
Mod. AASHTO Values		Compaction Data: CBR			Swell	CBR at (mm)			CBR Values	
MDD (kg/m ³)	OMC (%)	Dry Dens. (kg/m ³)	MC (%)	Comp. (%)		2.5	5.0	7.5	Compaction (%)	CBR
1805	14.9	1809	15.6	100.0	0.1	24	26	24	100	24
1805	14.9	1727	15.6	95.5	0.1	19	20	20	98	22
1805	14.9	1652	15.6	91.3	0.2	14	13	12	97	21
									95	19
									93	16
									90	13

Moisture Content (%)	13.0	14.0	15.0	16.0	17.0			
Dry Density (kg/m ³)	1777	1793	1802	1782	1752

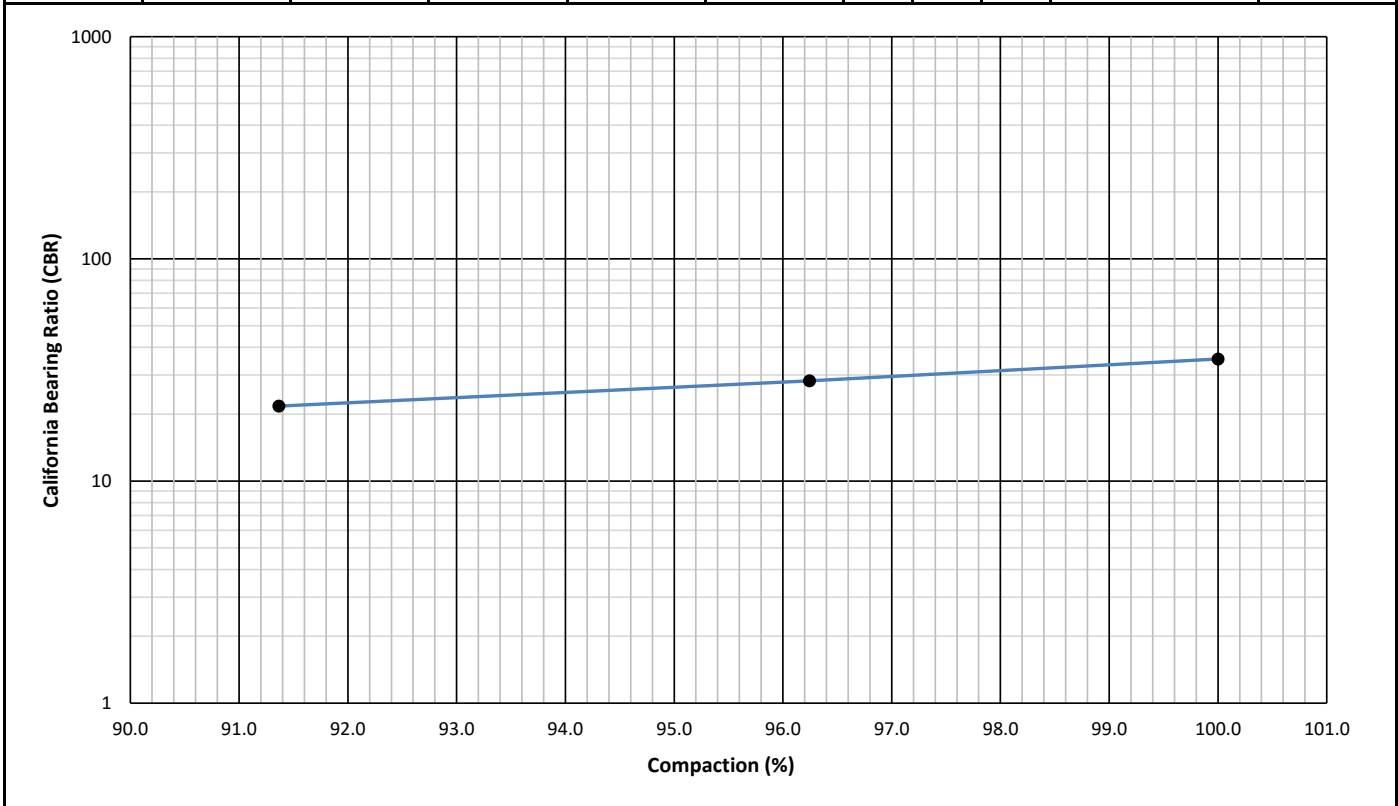
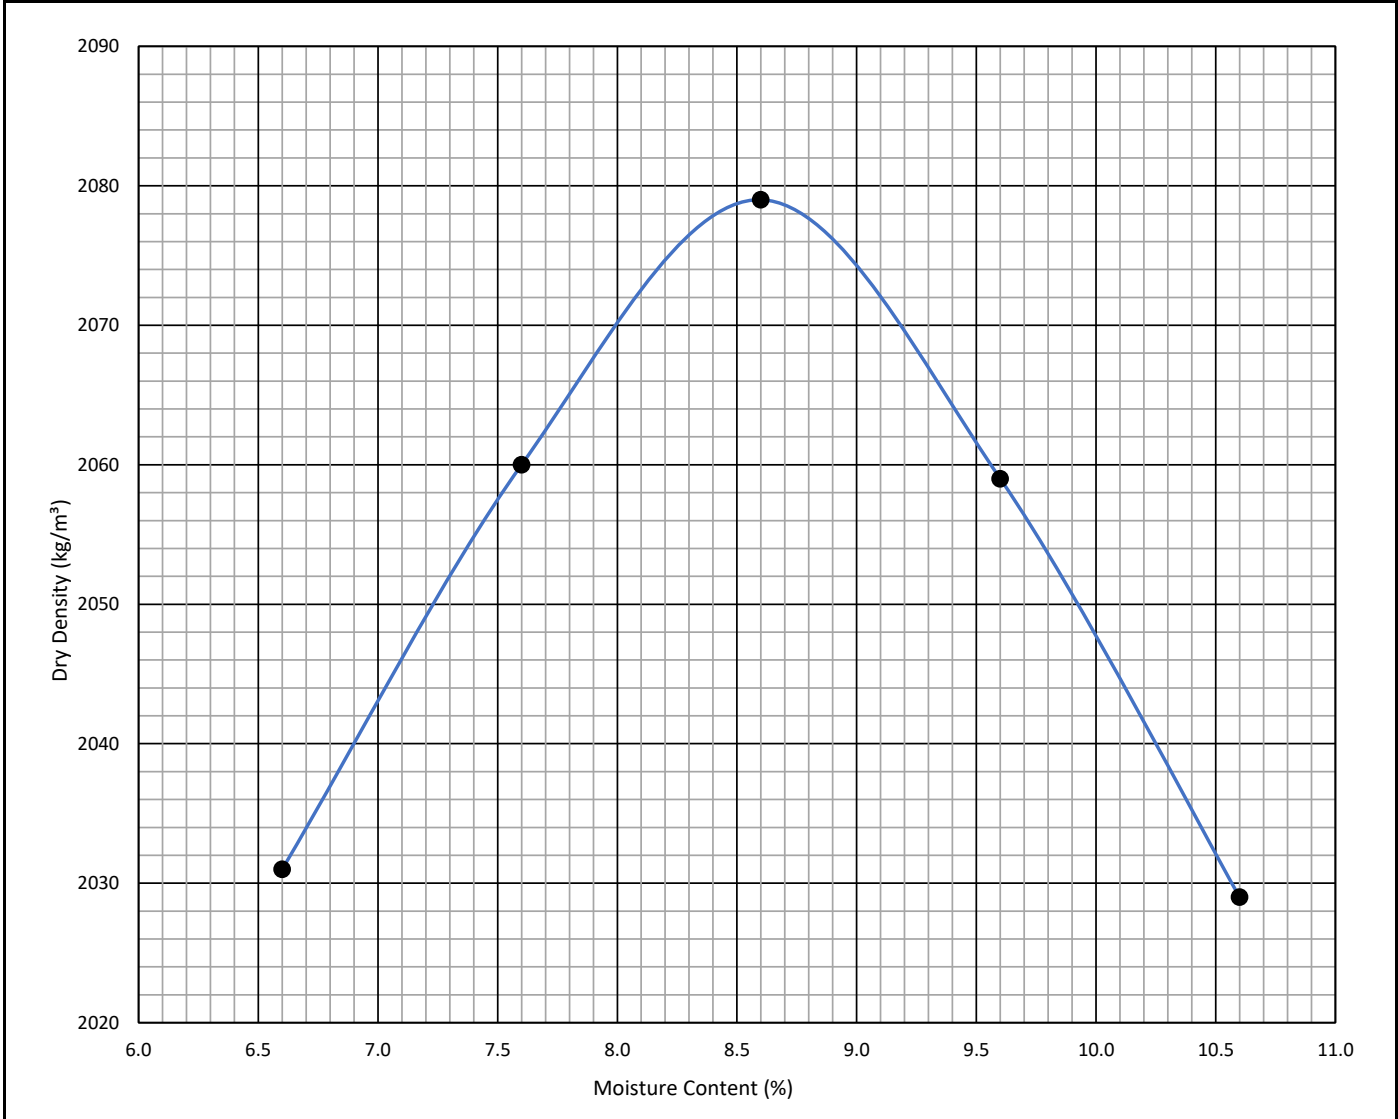
Mod. AASHTO Values		Compaction Data: CBR			Swell	CBR at (mm)			CBR Values	
MDD	OMC	Dry Dens.	MC	Comp.		2.5	5.0	7.5	Compaction (%)	CBR
(kg/m ³)	(%)	(kg/m ³)	(%)	(%)	(%)					
2079	8.6	2050	9.3	100.0	0.0	35	41	42	100	35
2079	8.6	1973	9.3	96.2	0.0	28	34	35	98	31
2079	8.6	1873	9.3	91.4	0.0	22	22	20	97	30
									95	26
									93	24
									90	20

Moisture Content (%)	6.6	7.6	8.6	9.6	10.6			
Dry Density (kg/m ³)	2031	2060	2079	2059	2029

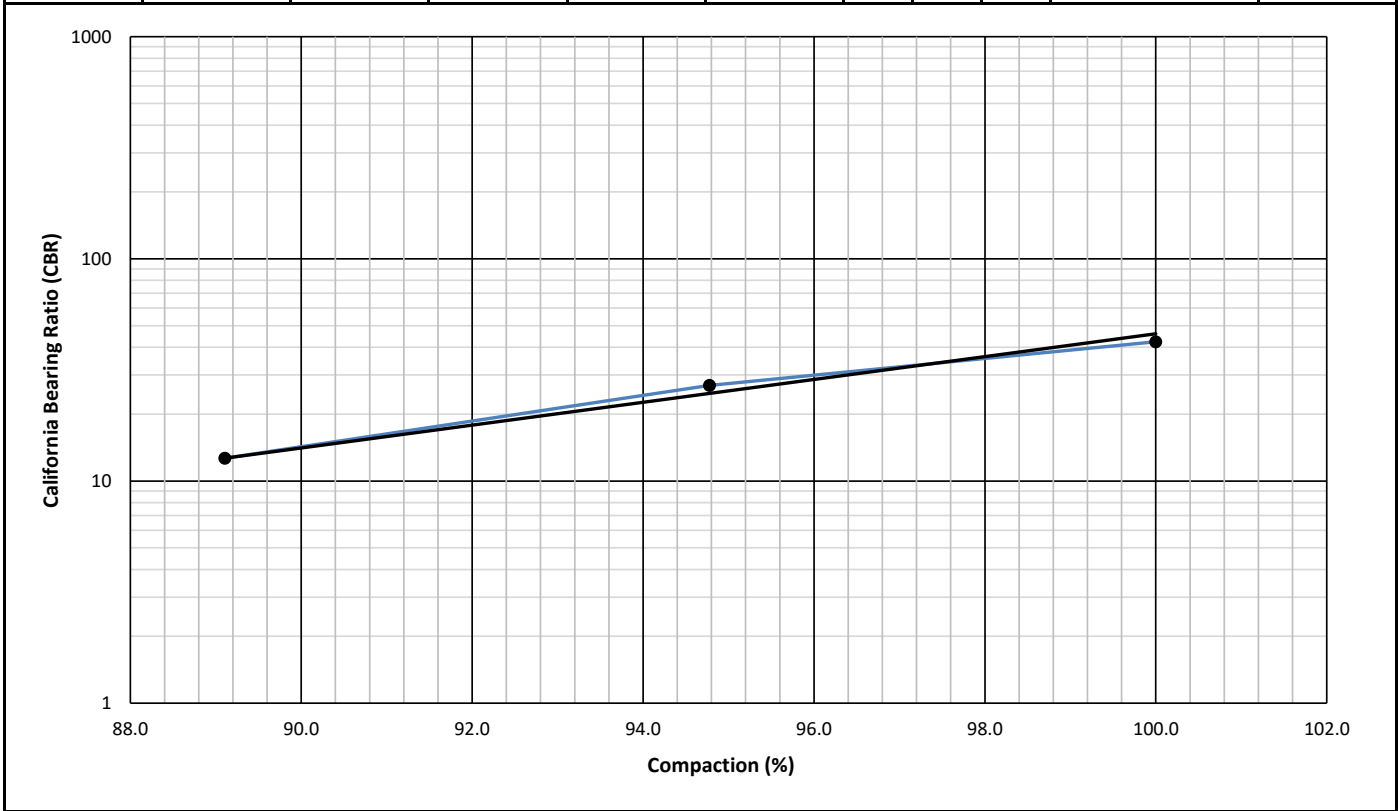
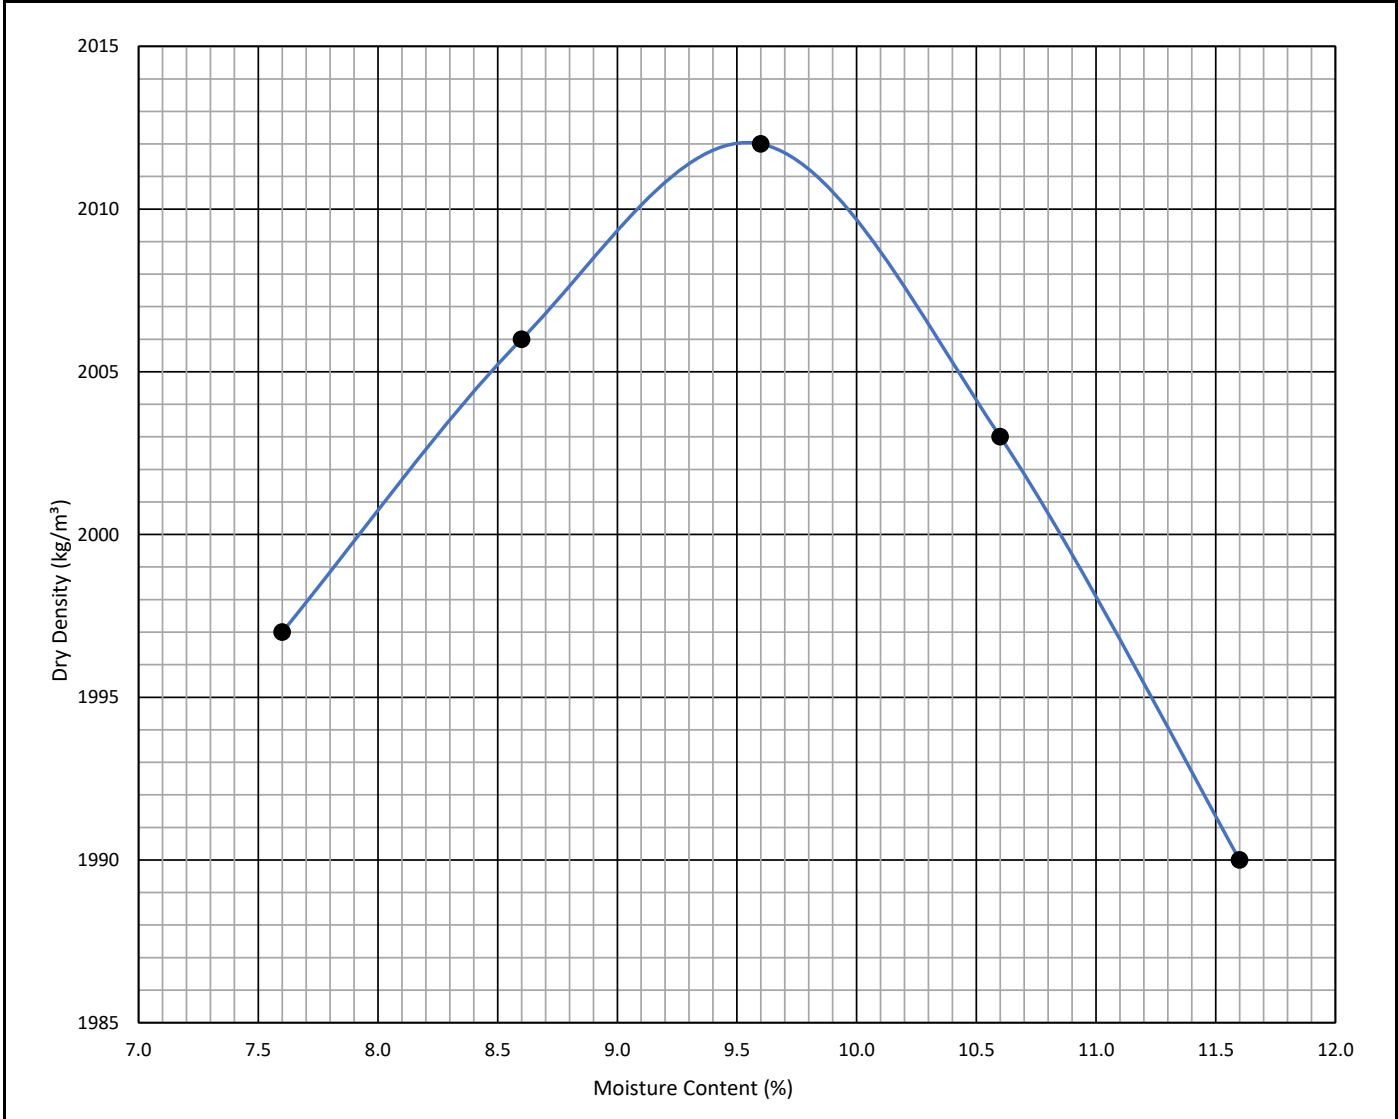
Mod. AASHTO Values		Compaction Data: CBR			Swell	CBR at (mm)			CBR Values	
MDD (kg/m ³)	OMC (%)	Dry Dens. (kg/m ³)	MC (%)	Comp. (%)		2.5	5.0	7.5	Compaction (%)	CBR
2012	9.6	2010	9.3	100.0	0.1	42	48	47	100	42
2012	9.6	1905	9.3	94.8	0.1	27	24	22	98	36
2012	9.6	1791	9.3	89.1	0.2	13	10	8	97	33
									95	27
									93	21
									90	14

Moisture Content (%)	7.6	8.6	9.6	10.6	11.6			
Dry Density (kg/m ³)	1997	2006	2012	2003	1990
