**Anglo American Platinum
Rustenburg Process Division**

Annual Integrated Surface and
Groundwater Quality, Biomonitoring
and Toxicity Testing Assessment
Report, Vol I

September 2018 to August 2019

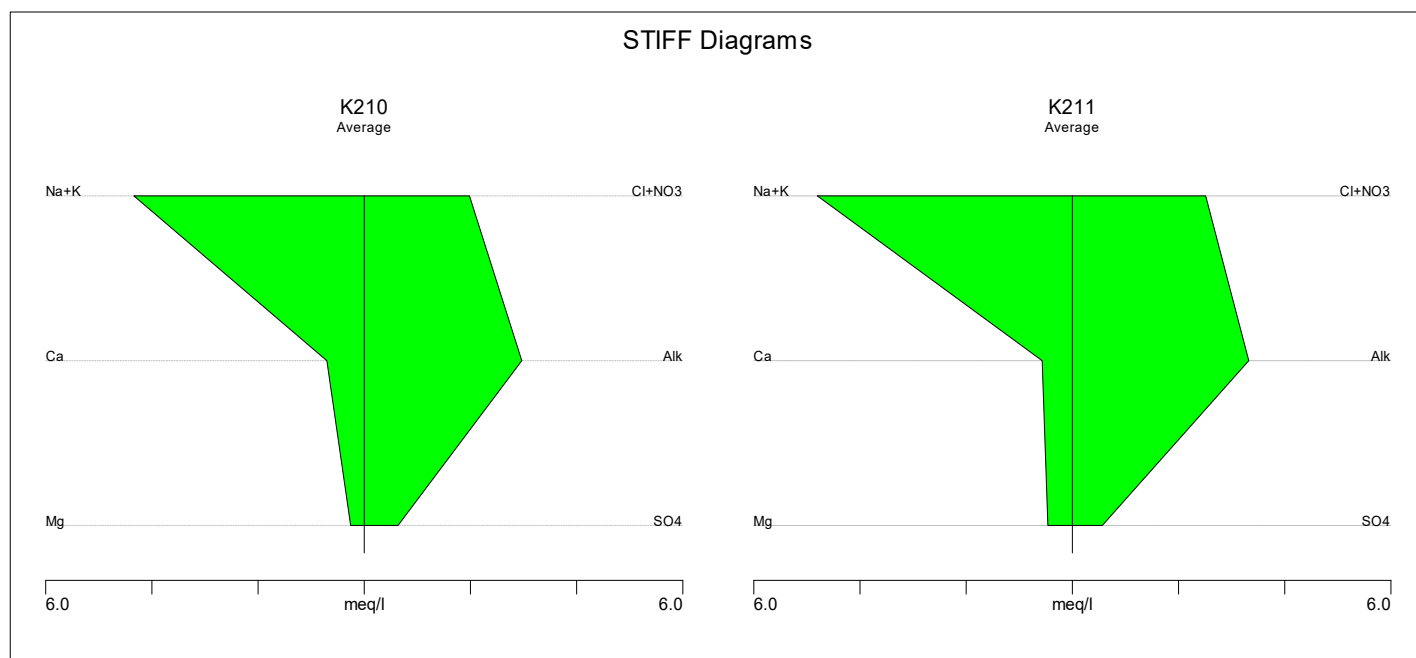
Figure 9: STIFF diagrams representing the water quality profile of the PMR Pollution control dams (K210 and K211)

K210 exceeded the General Authorisation limit guidelines in terms of average pH and copper concentrations while K211 exceeded in terms of average copper concentrations.

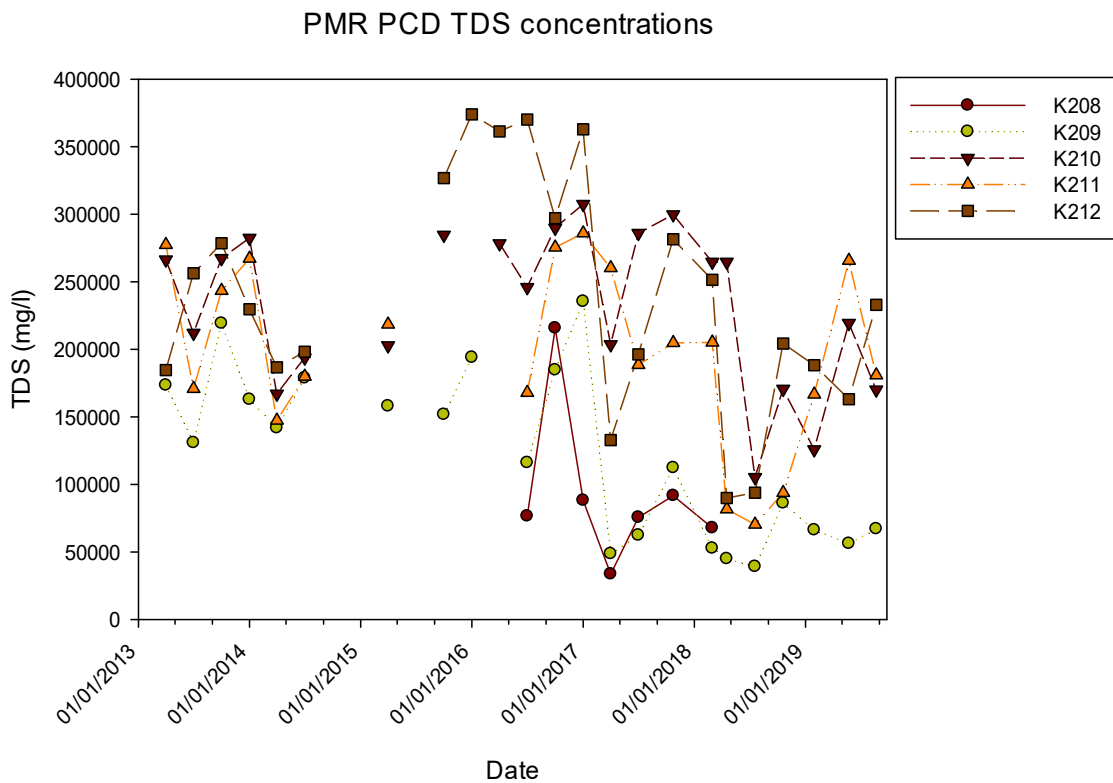
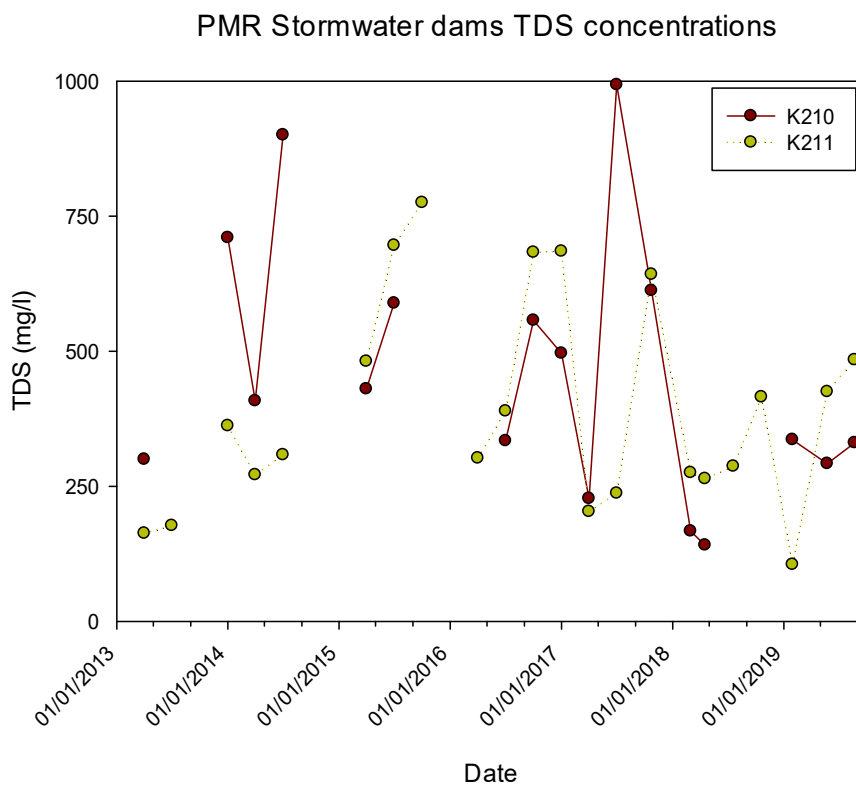
Figure 10: PMR pollution control dams and stormwater dams timeline graph

The time-line graph Figure 10 indicates quarterly variances in terms of TDS (salinity) concentrations. A decrease over the indicated time period was noted at the pollution control dams and stormwater dams in relation to overall salinity concentrations. That being said, the average salinity of the pollution control dams remained high.

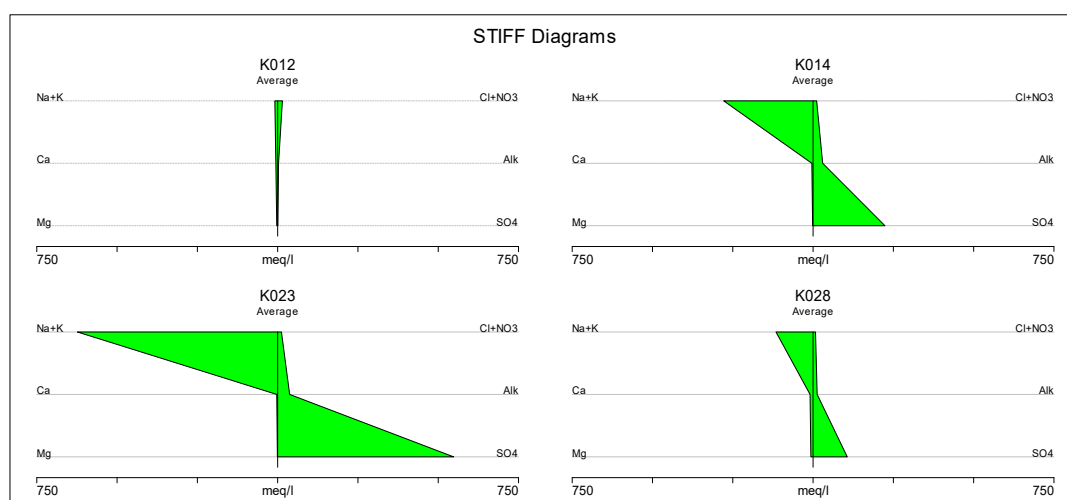
Figure 14: STIFF diagrams showing the water quality profiles of the Klipfonteinspruit, up-, mid- and downstream of RBMR.

Figure 14 shows the average water quality profiles of localities upstream (K012), midstream (K014 and K023) and downstream (K028) of RBMR in the Klipfonteinspruit. These water quality profiles may be compared with those in Figure 12 for the RBMR process water dams.

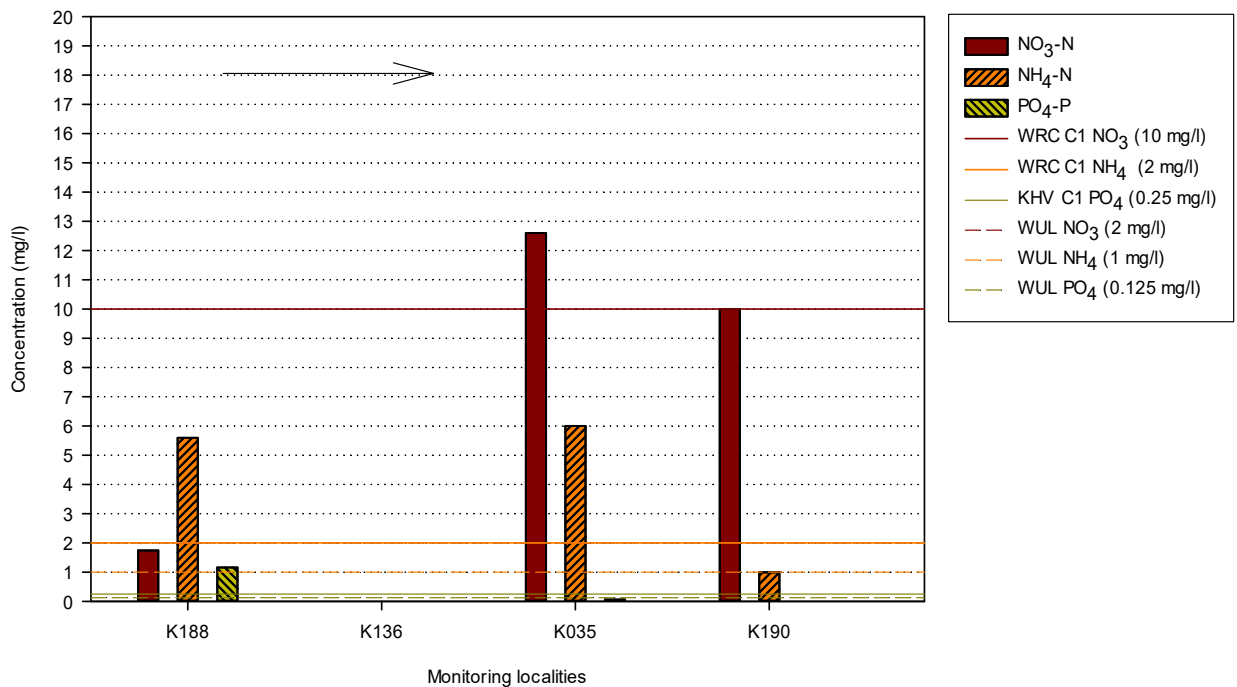
Figure 20: Average data for in-stream localities in the Klipgatspruit for the annual period September 2018 to August 2019

Upstream from the Waterval tailings storage facilities, the Klipgatspruit water quality is seen to be fairly un-impacted; samples were also indicative of stormwater run-off. Downstream from the Waterval tailings storage facilities (including the Klipgat dam) water quality is seen to change significantly. As may be seen from Figure 20 water quality from Klipgat dam is the main contributor to the noted change. During high-flow events water flowing in the Klipgatspruit will eventually end up in the Hex River. Although no overflow was recorded at the Klipgat dam, it is evident that some seepage occurs, either from Klipgat dam or the tailings storage facility.

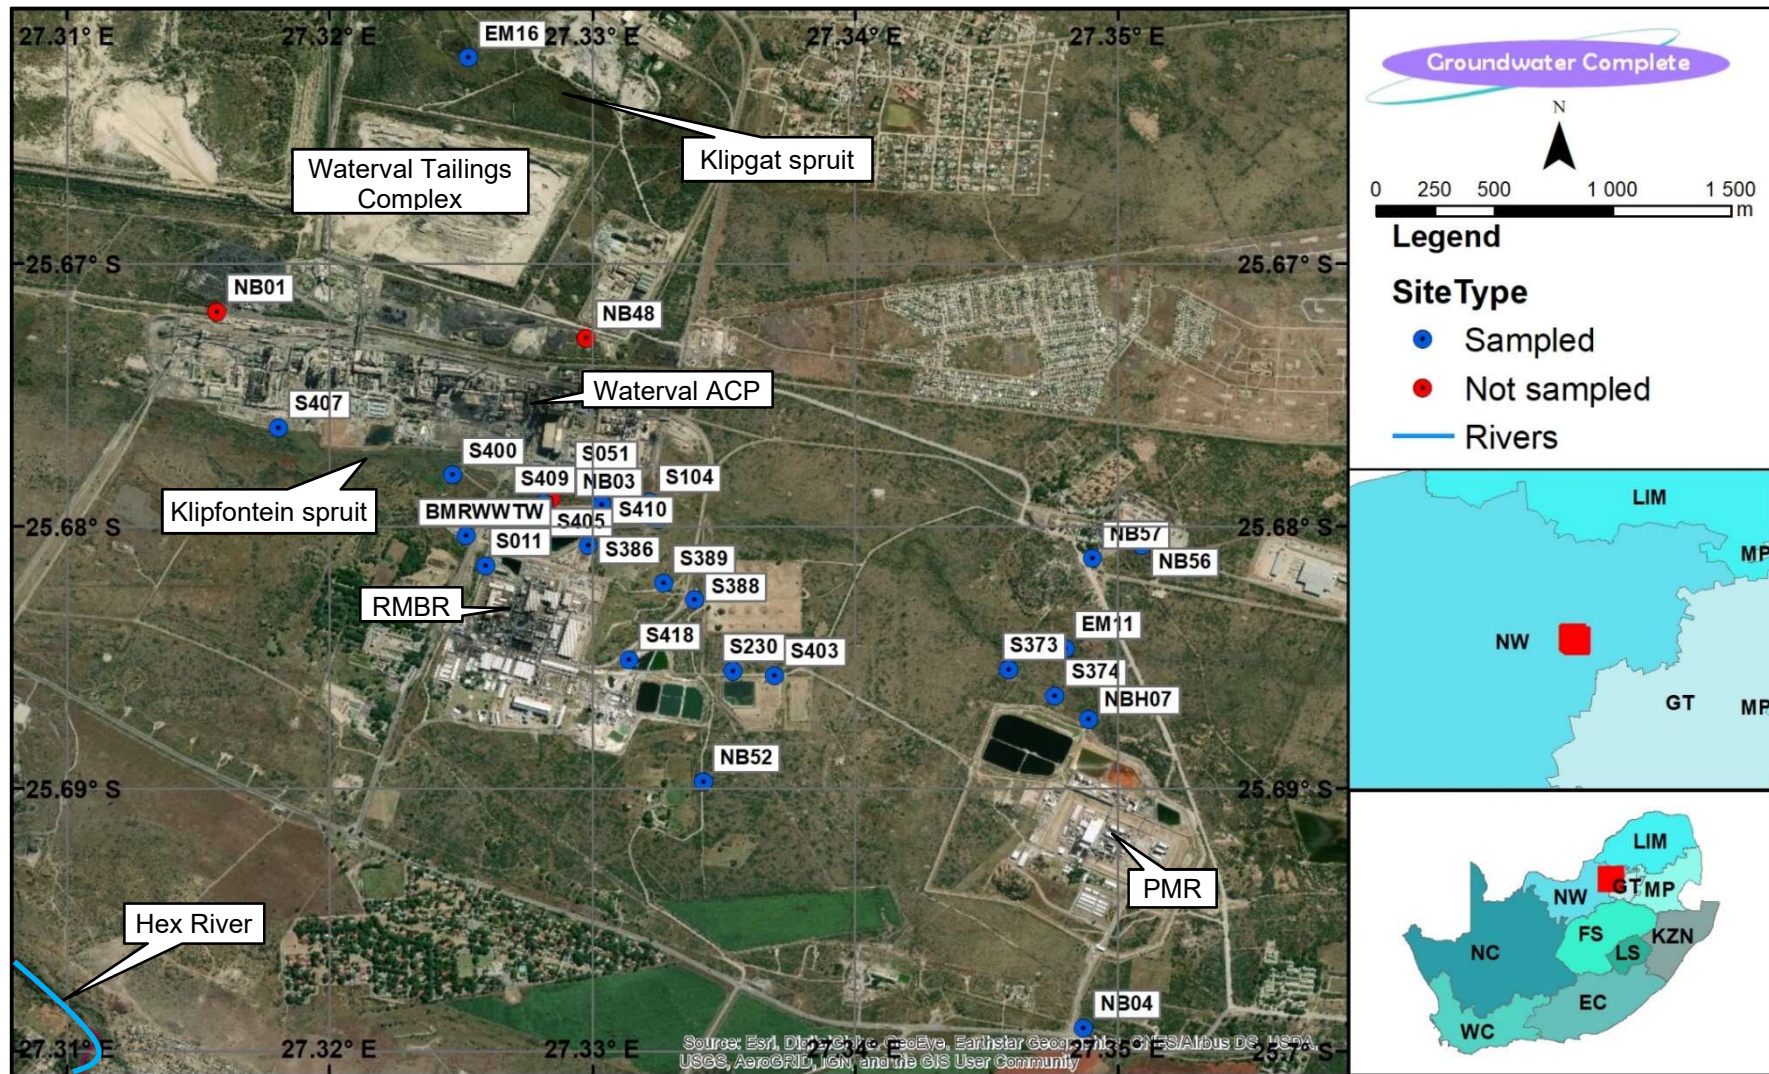
Figure 1: Map of the RPM area with distribution of groundwater monitoring points during 2018/2019

The distribution of all the groundwater monitoring points that were actively sampled during the past year is presented on a regional map of the RPM operations area in **Figure 1. More detailed site maps on a larger scale are provided in each section with the discussion of the water quality properties in each area and are orientated with north at the top of all maps and figures.** The regional groundwater seepage directions (flow lines) are also indicated as blue arrows on each of the maps in the source areas.

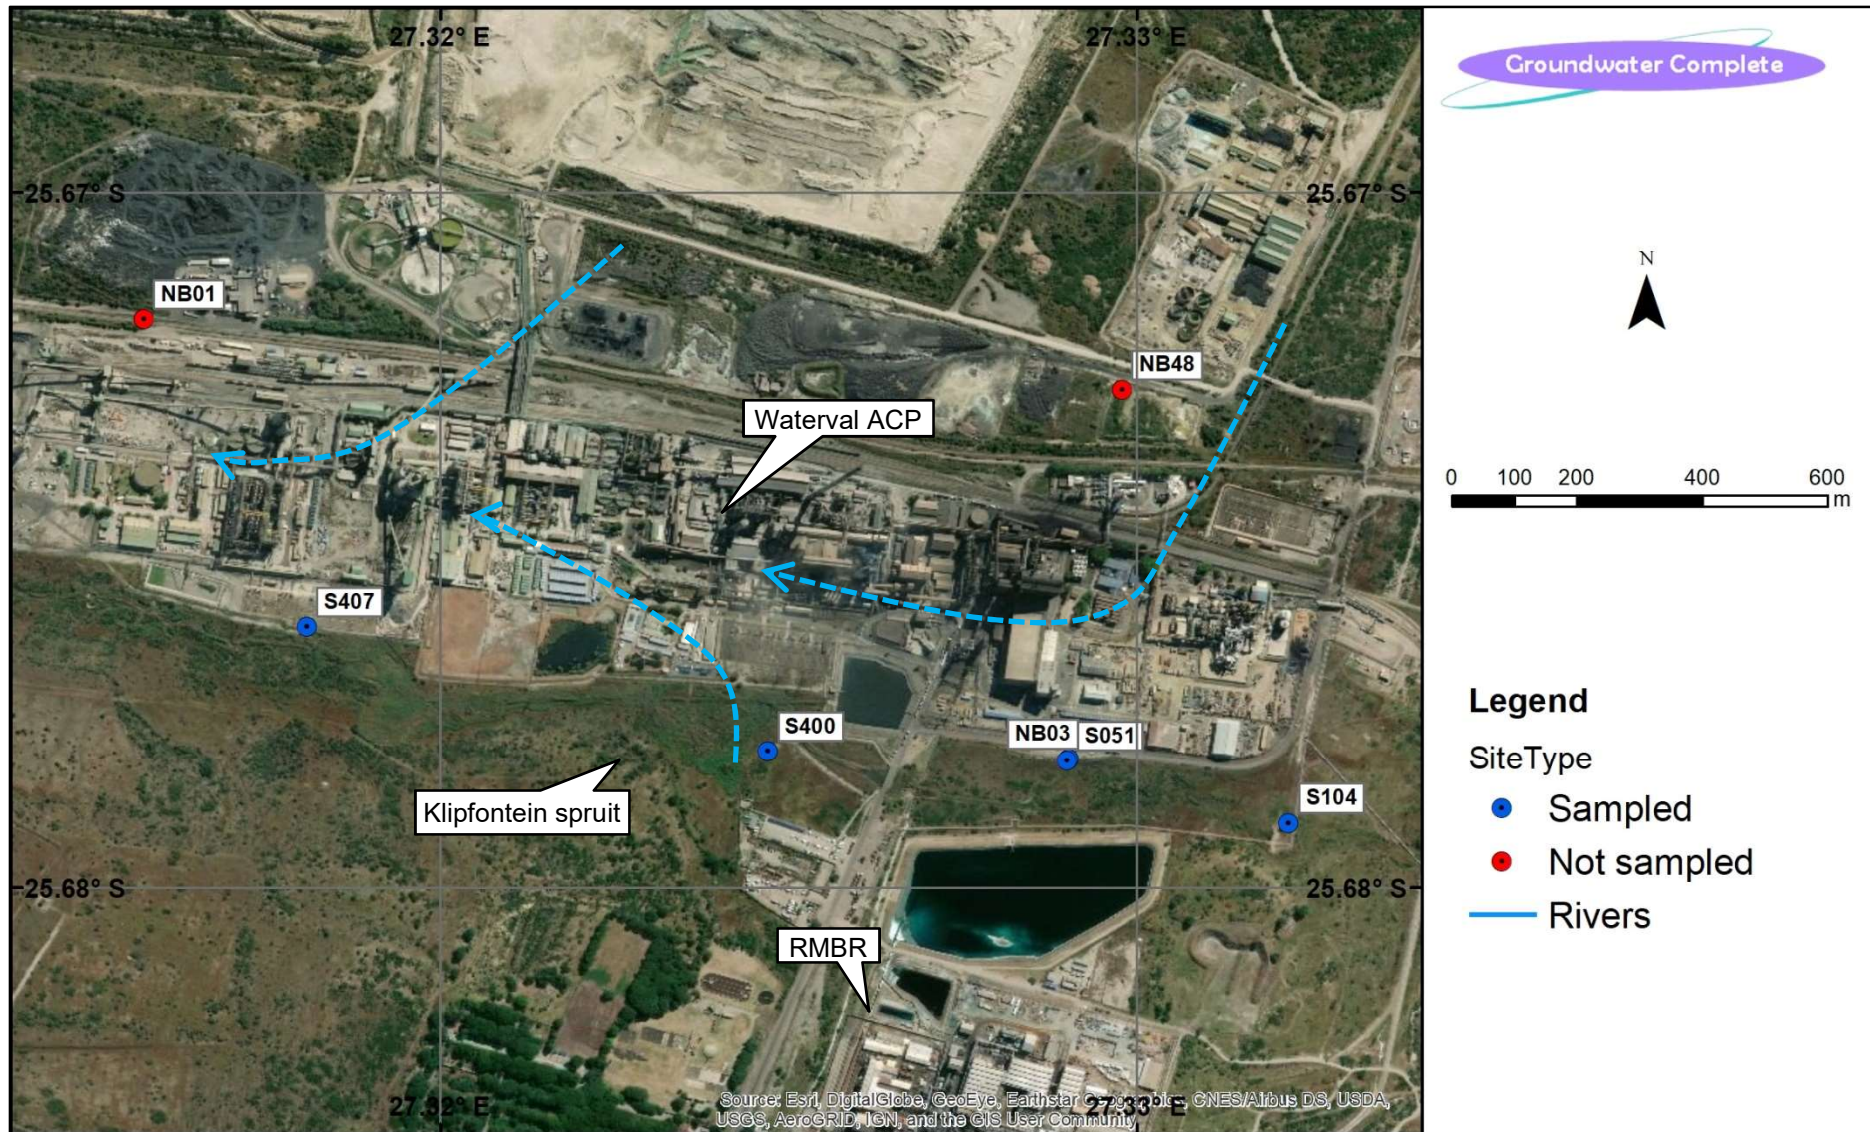
Figure 3: Positions of monitoring boreholes in the Waterval Processing area

This processing complex consists of a number of processing modules including the Waterval Concentrator, Waterval Smelter, UG2 Concentrator and the Acid Plant. The larger part of the surface area underlying the Waterval Processing area is lined by concrete surfaces and effluent dams like storm water control, settling and return water dams are lined with synthetic or clay liners. Seepage and leachate formation however still emanates from the Waterval Processing area.

The Waterval Processing area is situated to the south of an east-west trending surface water divide and groundwater flow will be in the same direction as surface flow, namely southwards. Groundwater seepage and mass transport will thus also occur southwards and then west in the direction of flow of the Klipfontein Spruit.

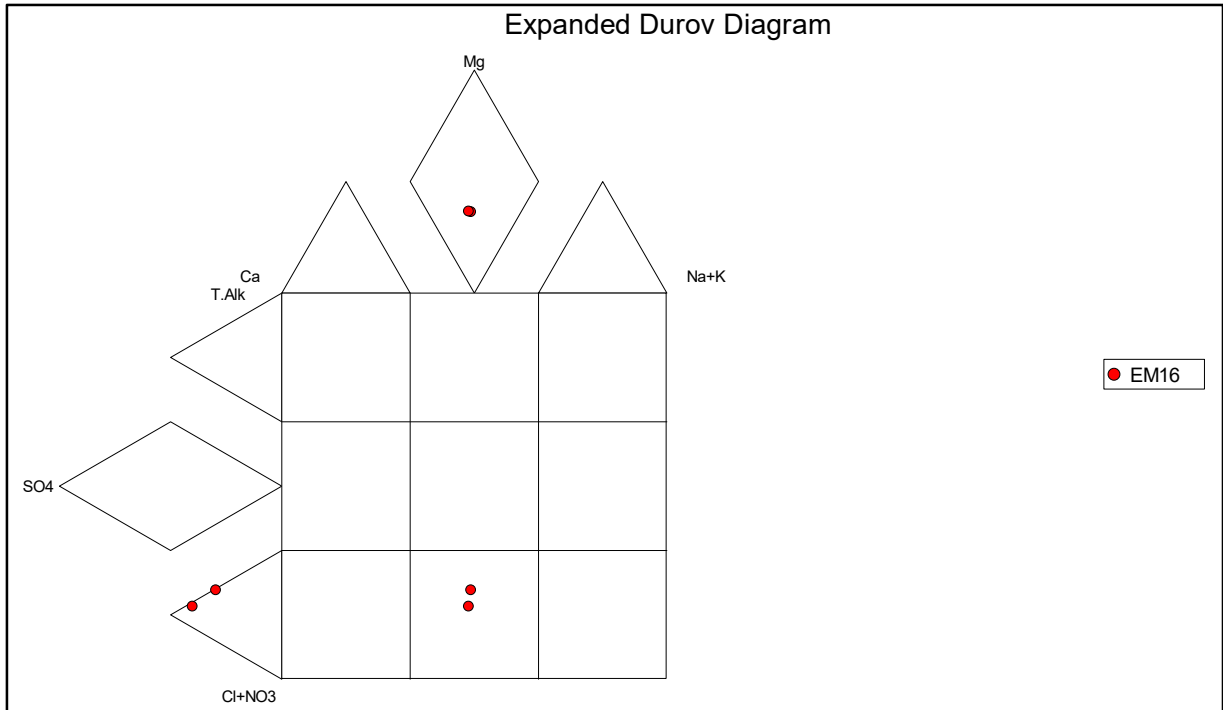
Figure 22: EDD of groundwater chemistry in the Waterval Tailings Complex area

- Significant groundwater pollution occurs in the down gradient direction with magnesium and sulphate/chloride being the dominant contaminants.
- Its is recommended that more boreholes be drilled to supplement the monitoring of the tailings complex.
- **The majority of indicator chemical parameters do not comply with the water quality objectives stated in the RPM Water Use License.**

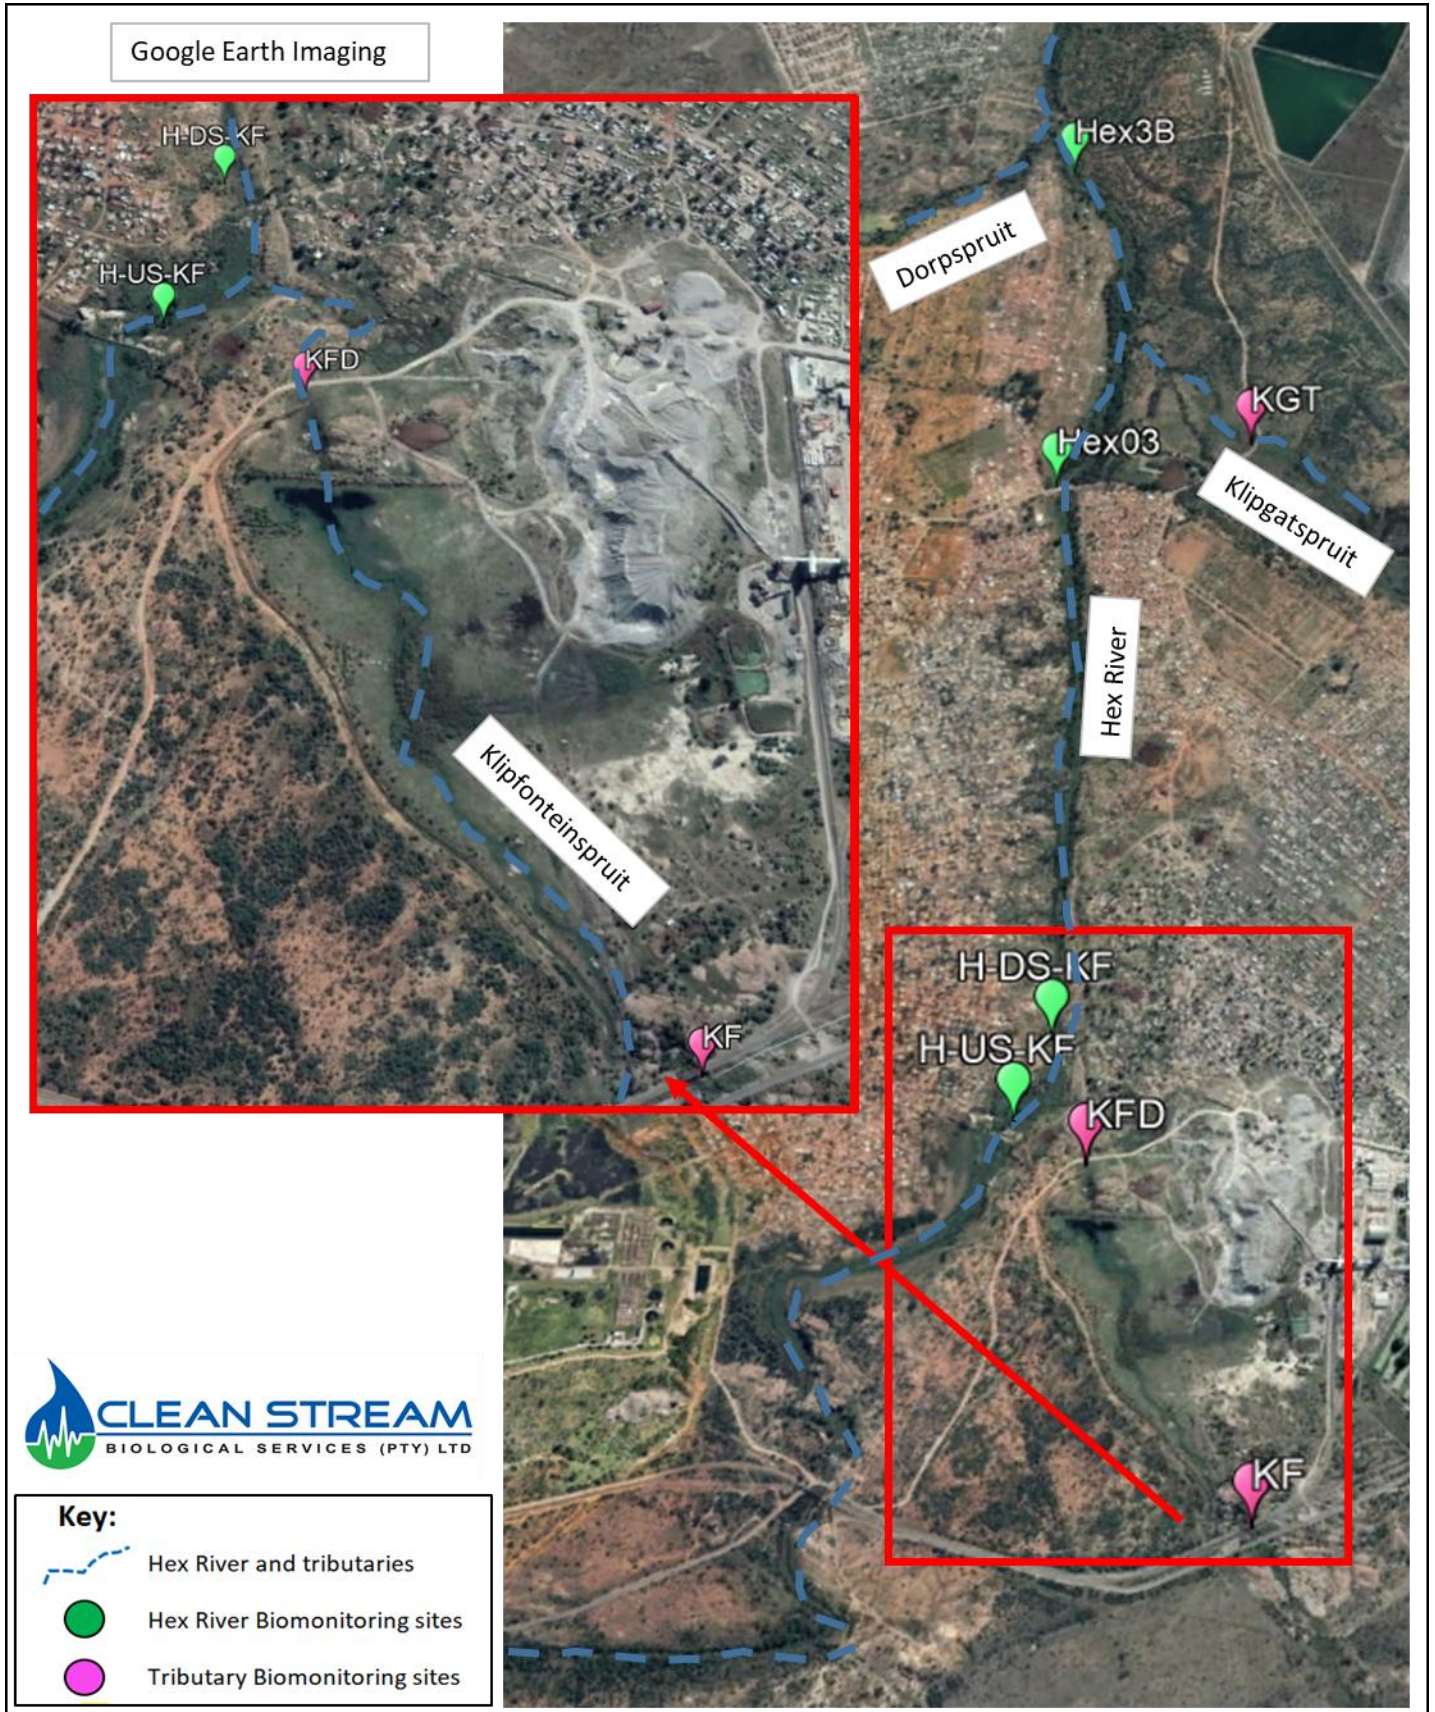
Figure 1: Google Earth image of study area, indicating Hex River and tributary biomonitoring sites.

Site name shaded green = Hex River mainstem	Site name shaded blue = Tributary of Hex River	Site name shaded red = Toxicity testing
Impact shaded gray = Potential RPM and non-RPM impacts (directly upstream)	Impact shaded pink = Potentially impacted by RPM/AAPL (directly upstream)	Impact shaded yellow = No RPM/AAPL impacts (directly upstream)
Site name shaded Orange = Discontinued from Clean Stream Biological Services scope
