Rehabilitation of the Orlando Dam, Soweto City of Johannesburg

Vegetation Assessment

Date: January 2020

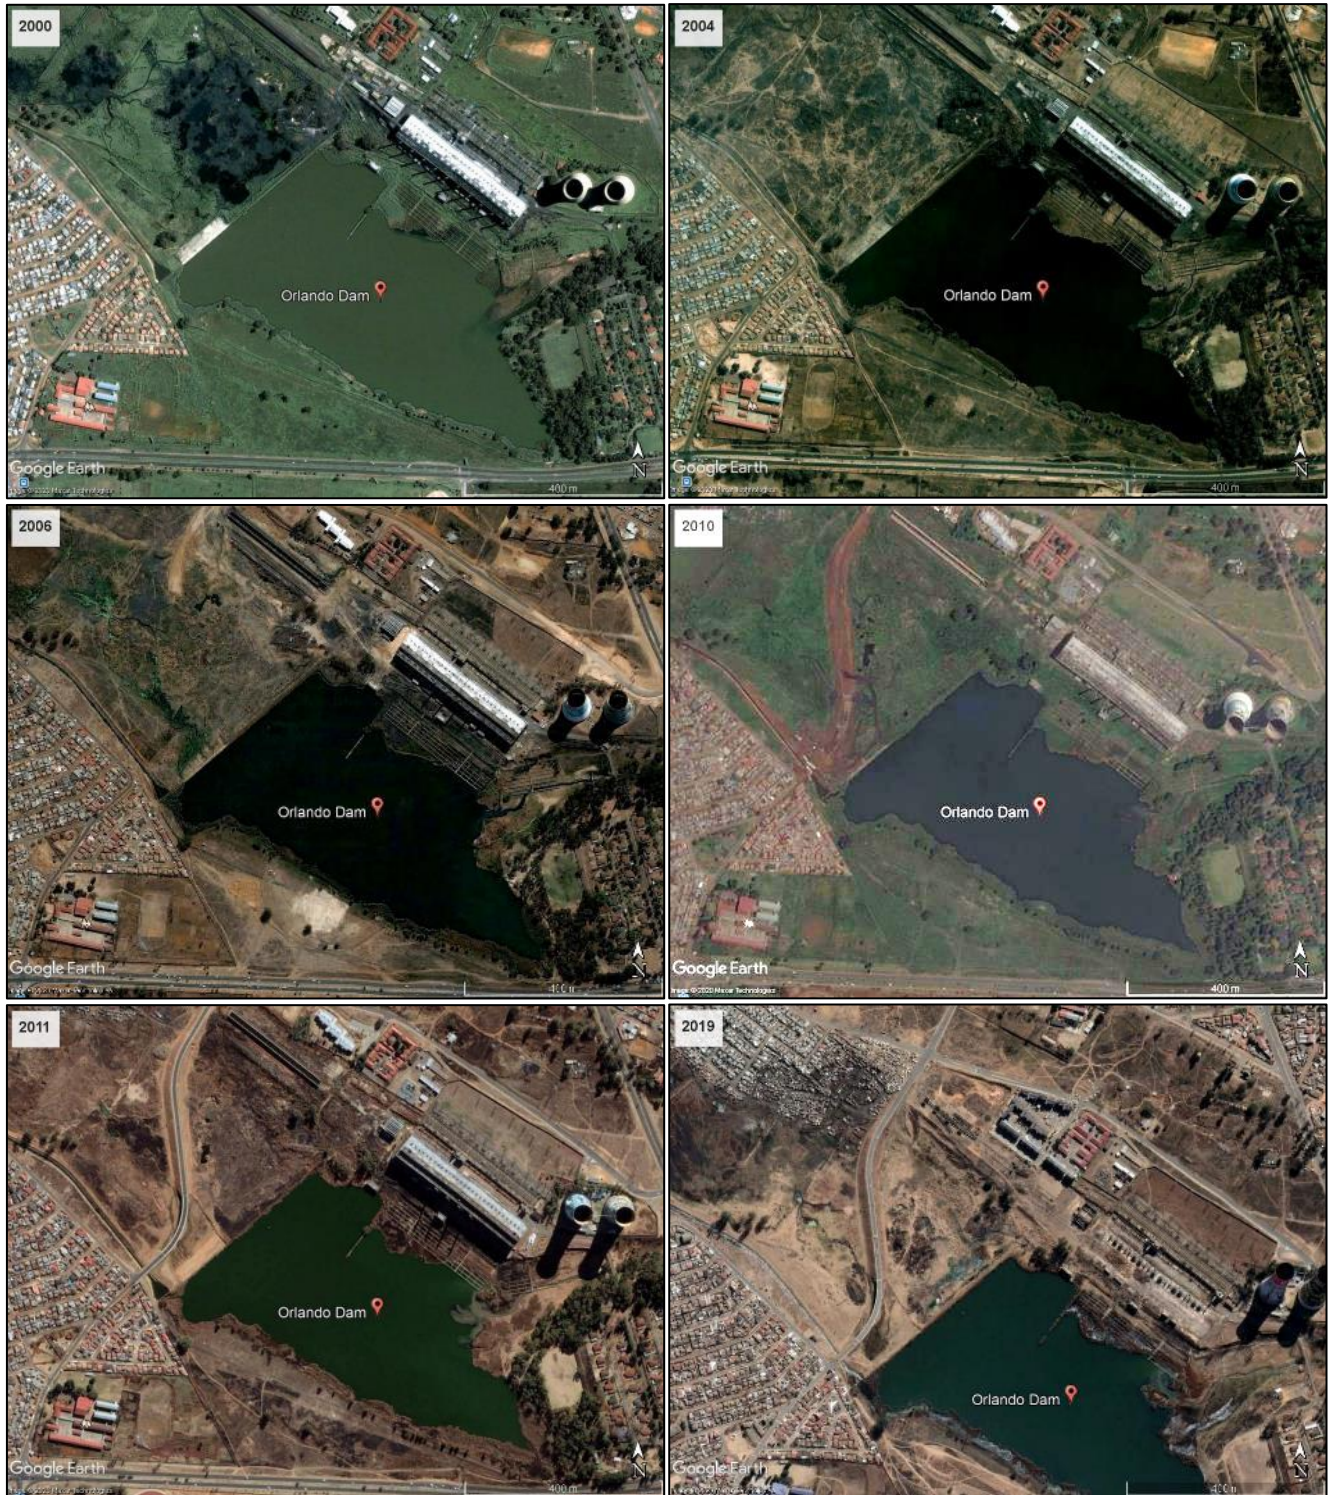
Figure 6: Google Earth aerial imagery of the dam and surrounding vegetation from 2000, 2004, 2006, 2010, 2011 and 2019 show the continuous soil disturbances around the dam over time

Historical Google Earth aerial imagery show that the vegetation around the dam has been disturbed continuously over time (Figure 6). Other than the construction, operation and decommissioning of the Orlando Power Station, various other impacts can be noted.

The spillway to the west of the dam has been in use prior to the year 2000. The area north of the dam wall was inundated in 2000 and later dried up. At the time of the site visit, this area also received sewerage from a leaking system which likely also caused the inundation in 2000. By 2004 the vegetation had a low basal cover and was likely already dominated by weedy species as was noted at the time of this assessment. Construction of Mbambisa Road commenced in 2006 and was only completed by late 2010 or early 2011. This could have caused several impacts to adjacent vegetation. In addition, activities south of the dam also resulted in vegetation clearance over time, which was later colonised by grasses and weedy species.

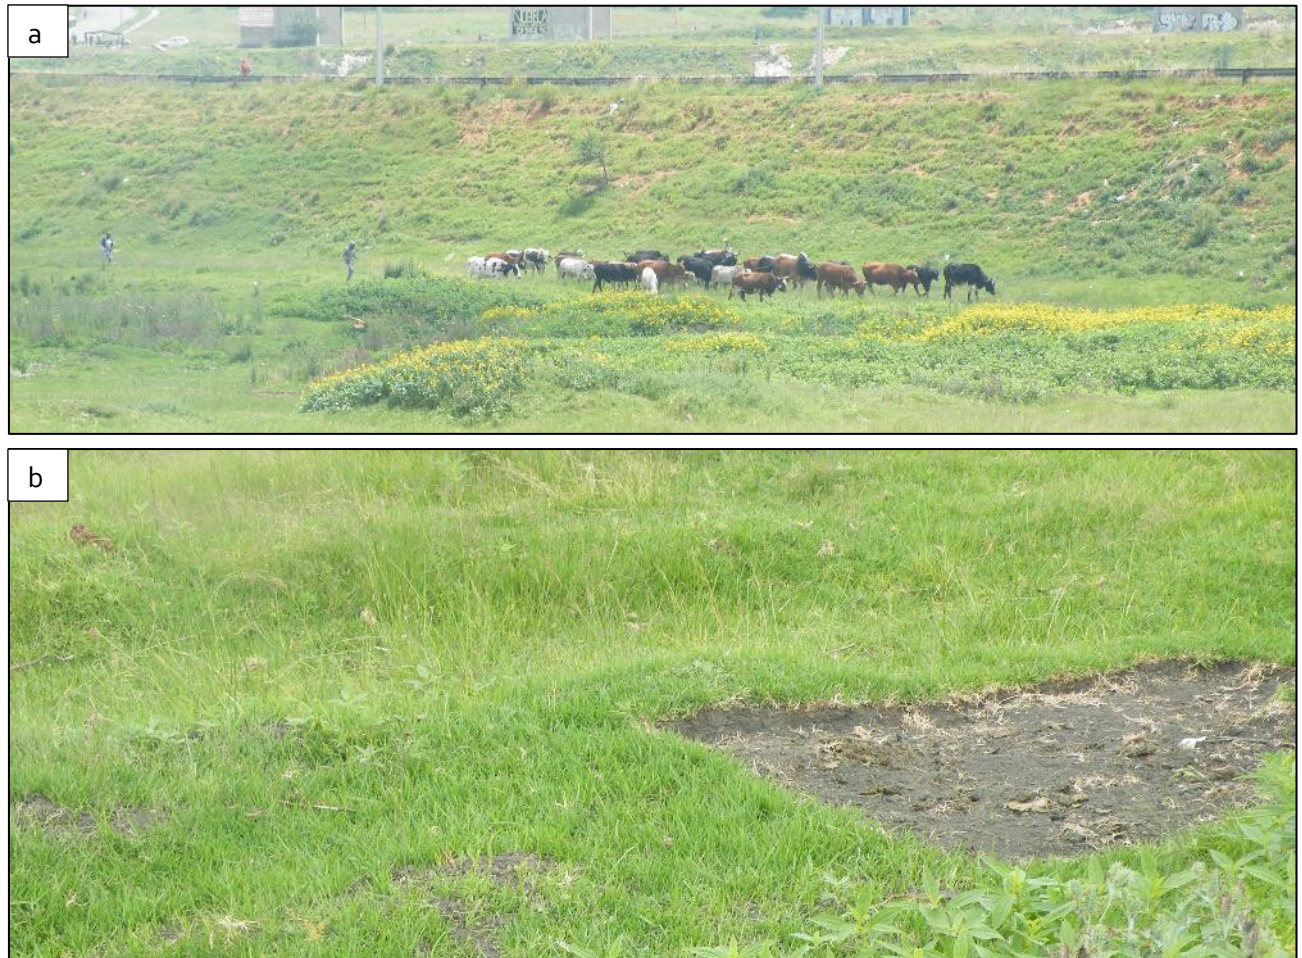
Photograph 1: a) Cattle grazing the vegetation north of the dam wall and b) kikuyu sods harvested from site

At the time of the site visit, cattle, goats and sheep grazed the site (Photograph 1a). The invasive lawn, *Pennisetum clandestinum* (kikuyu) invaded the moist soils north of the dam wall. The community harvest sods of this species for use on gardens (Photograph 1b). Most of the vegetation north of the dam wall comprised weedy exotic and invasive plant species (Photograph 2). The soil on the dam wall was destabilised and several ditches and dumping noted downstream of the wall.

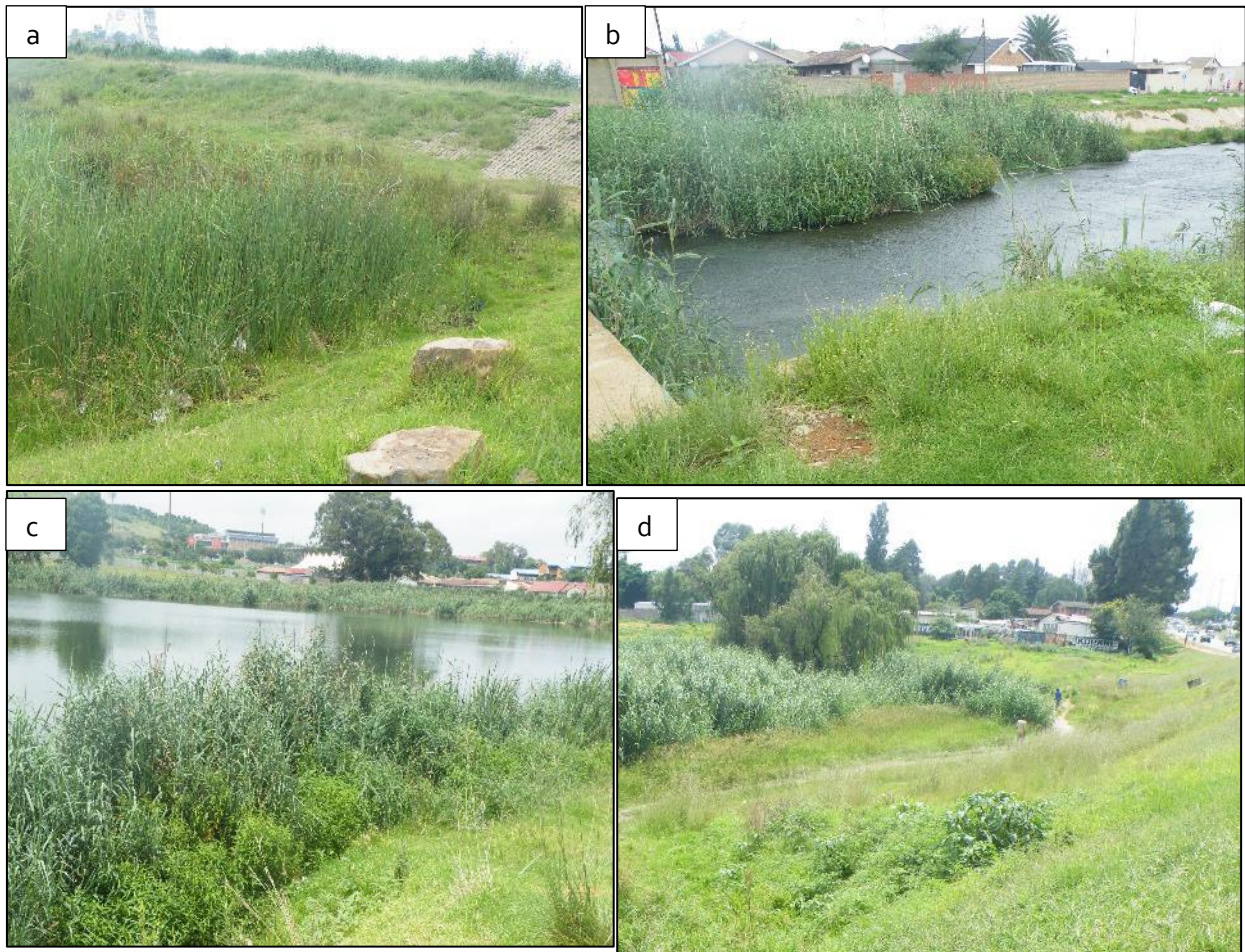
Photograph 3: a) *P australis* in the pond underneath the dam overflow north of the dam wall, b) *P australis* in the spillway, c) around the edge of the dam and d) at the inflow of the Diepkloofspruit at Chris Hani Road.

The *P. australis* vegetation is in a natural state as this species tends to form dense stands allowing little if any forb species to grow.

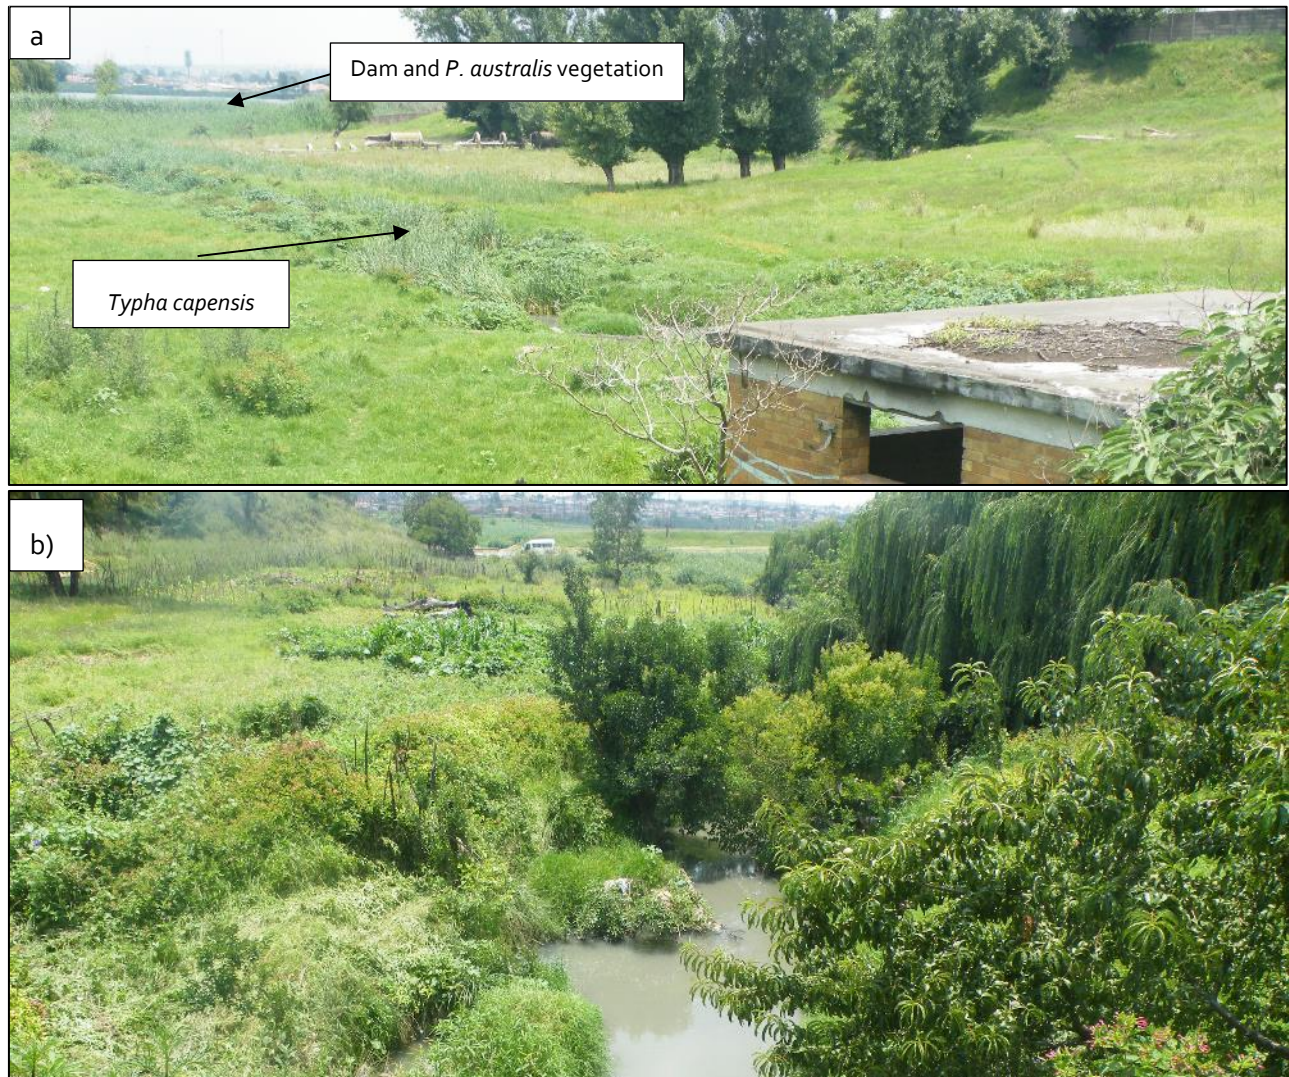
Photograph 4: a) *Typha capensis* patches west of Sheffield Road and b) invasive species dominated vegetation east of the Sheffield Road

The non-perennial river draining into the Orland Dam from the east were dominated by the indigenous reed *Typha capensis* (bulrush) in the permanently wet areas (Photograph 4a). However, the vegetation was invaded by numerous alien and invasive plant species, with the category 1b invasive shrub *Mirabilis jalapa* (four-o'clocks), being the most dominant on either side of Sheffield Road that traverses the watercourse (Photograph 4b). This invasive species was not noted during the historic vegetation assessments of the site (SEF, 2004 & 2009) and has since emerged as the dominant species in the area.

The species composition of this vegetation is modified from typical highveld wetland vegetation. However, the degraded vegetation plays a role in flood attenuation and soil stabilisation.

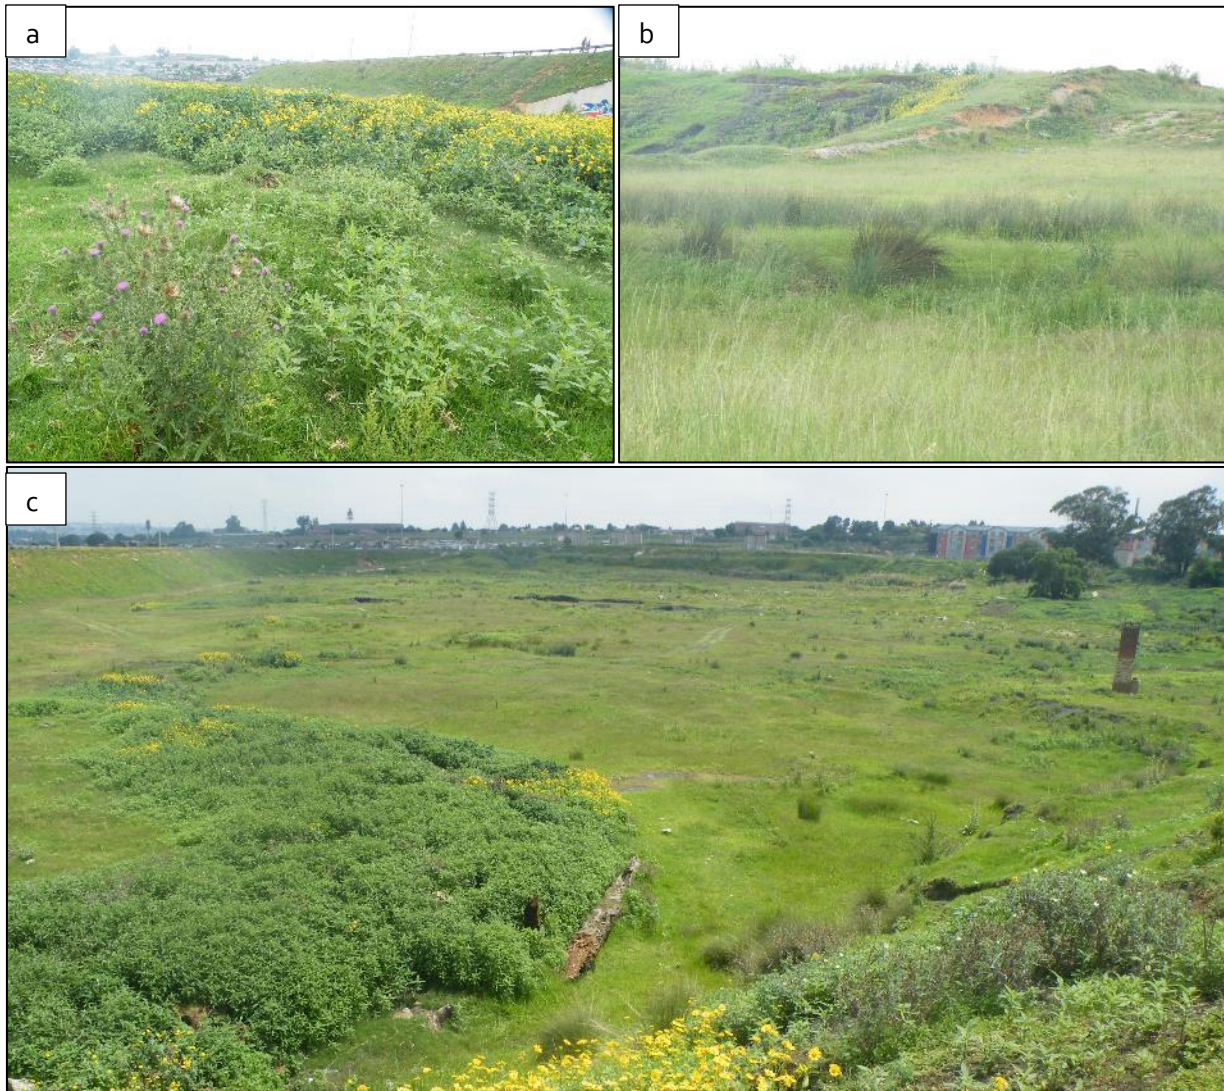
Photograph 5: Alien invasive species dominate the moist grassland a) west of Mbambisa Road, b) and c) along the dam wall and north-west thereof

The moist grassland north of the dam wall is grazed and subsequently dominated by *Cynodon dactylon* (Photograph 5). Other indigenous grasses include *Hyparrhenia hirta* (common thatch grass and *Eragrostis plana* (tough love grass). Much of the vegetation was dominated by alien invasive plant species. The dominant spreading grass was the invasive *Pennisetum clandestinum* (kikuyu). Forbs were also weedy in nature e.g. *Plantago lanceolata*, *Centella asiatica* (marsh pennywort) and the category 1b invasive species *Cirsium vulgare* (Scotch thistle), *Verbena bonariensis*, *Flavernia bidentis* (smelters bush) and a dominance of the emergent weed *Verbesina encelioides* var *encelioides* (wild sunflower).

The moist grassland is modified from natural wetland vegetation in the Highveld. However, the vegetation is the typical result of increased stormwater or sewerage, soil disturbances, erosion and colonisation by invasive plant species in an urban environment. No plant species of conservation concern are expected to be present due to the historical disturbances in the area (see section 4.3). Even though parts of the moist grassland north of the dam wall is classified as a CBA: Important, it is not in a primary state.

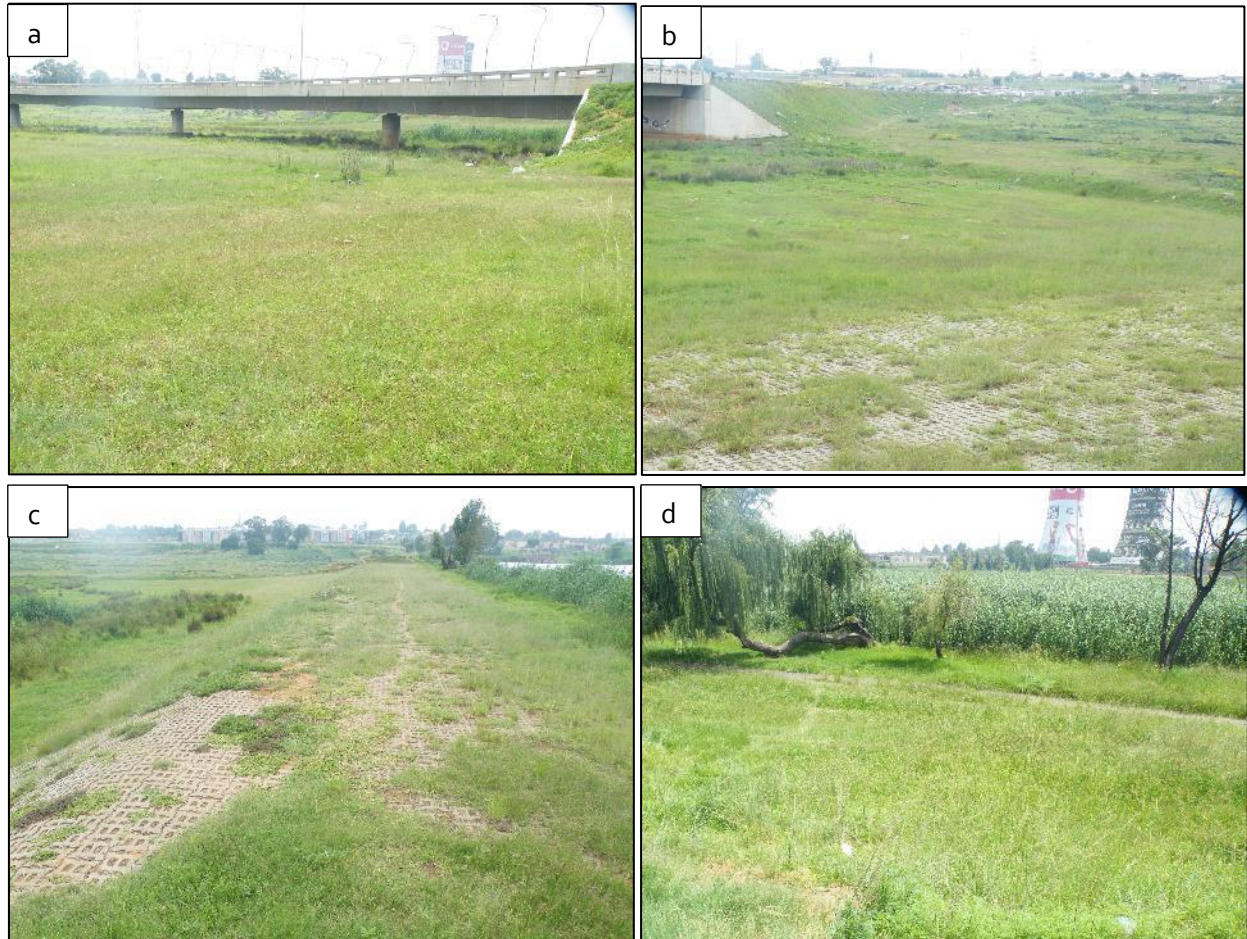
Photograph 6: Modified grassland downstream of the dam wall a) west of Mbambisa Road, b) east of the road c) on top of the dam wall (dominated by *Cynodon dactylon*) and d) modified grassland just north of Chris Hani Road.

The grass layer was dominated by the indigenous pioneer grass *Cynodon dactylon* (couch grass) and *C. nlemfuensis* (star grass), which were likely planted as part of the post construction rehabilitation of Mbambisa Road. Other indigenous grasses include *Hyparrhenia hirta* (common thatch grass), *Eragrostis curvula* (love grass), *Panicum repens* and limited *Digitaria eriantha* (finger grass) and *Eragrostis plana* (tough love grass). The forb layer was dominated by the weedy *Plantago lanceolata* and patches of *Conyza podocephala*. Other species include *Cleome gynandra* (African cabbage), *Tribulus terrestris* (common devil's thorn), *Lactuca inermis* (wild lettuce), *Gomphocarpus fruticosus* (milk weed) and *Nidorella hottentottica* (Appendix B).
