PIETERMARITZBURG CHEMICAL STORAGE WAREHOUSE

Geotechnical Desktop Study

FINAL REPORT REV 0: CONFIDENTIAL

PROJECT NO. 41103633

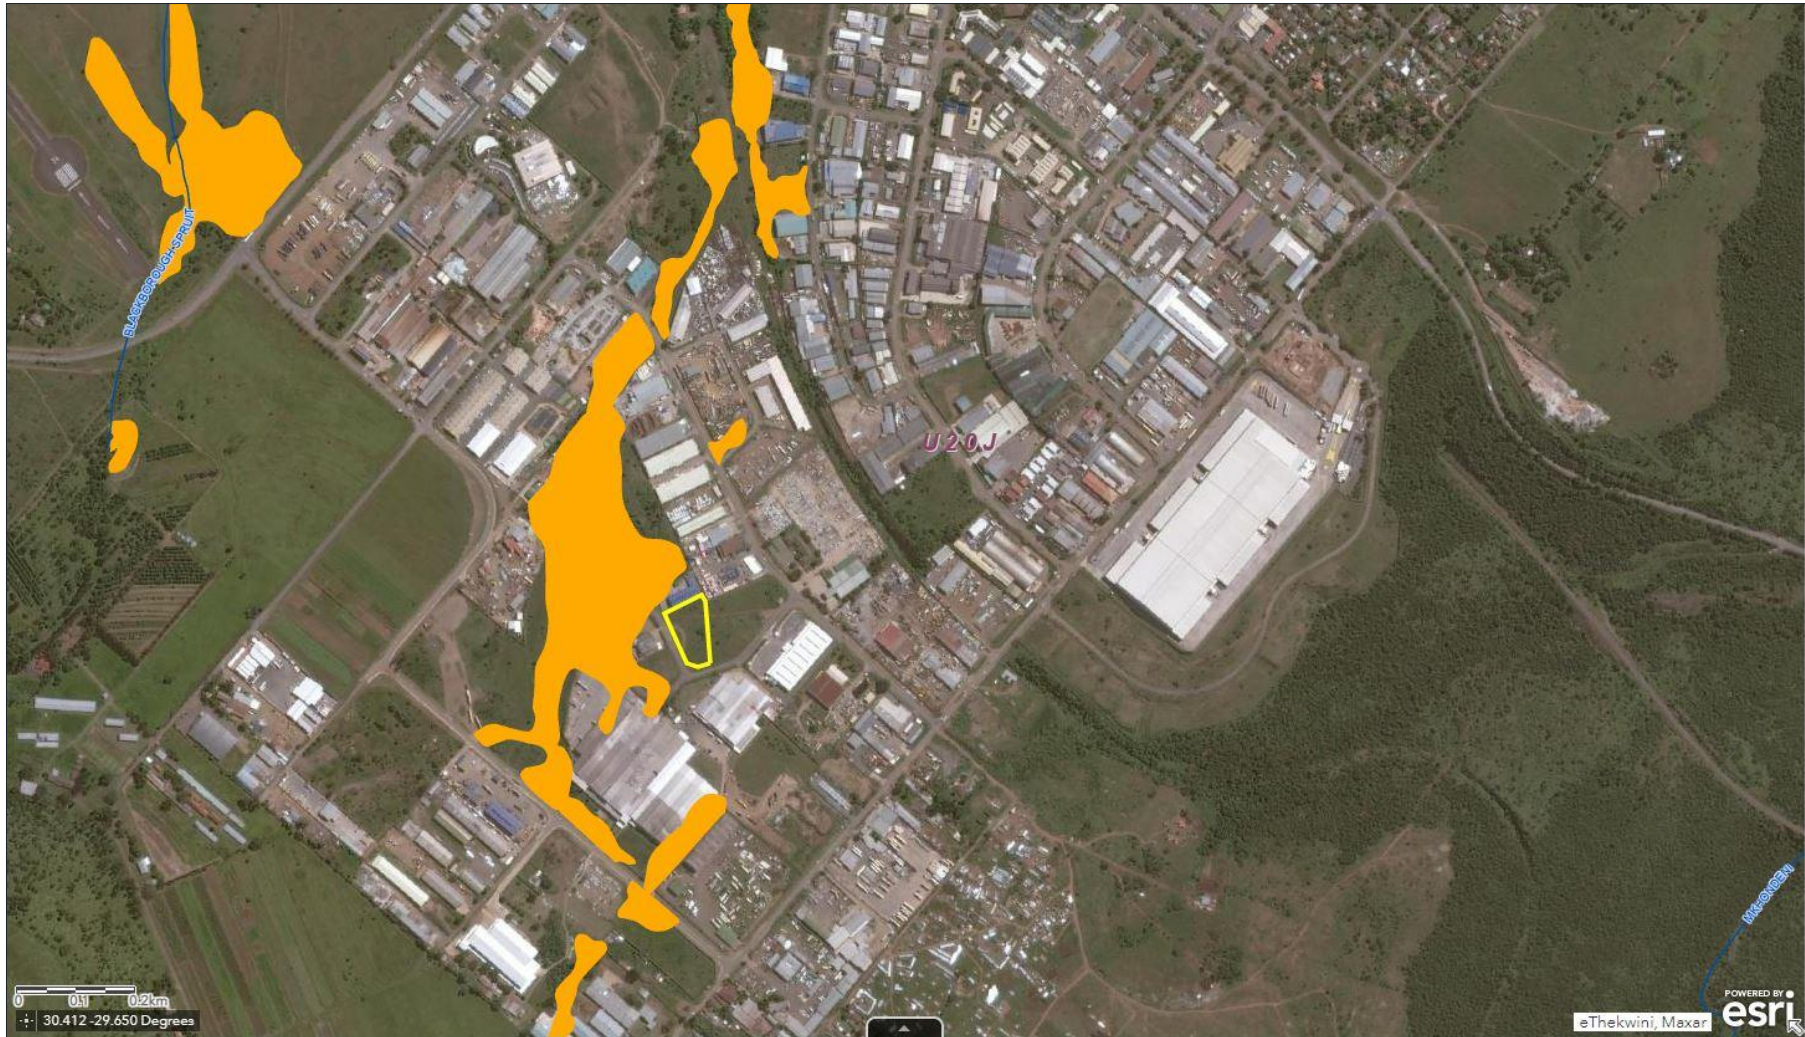
Figure 2-3 - Watercourses in the area

No drainage features were observed throughout the site. However, a drainage feature is evident to the west of the site with no development in the vicinity of this features.

Figure 2-3 indicates the drainage features around the site.

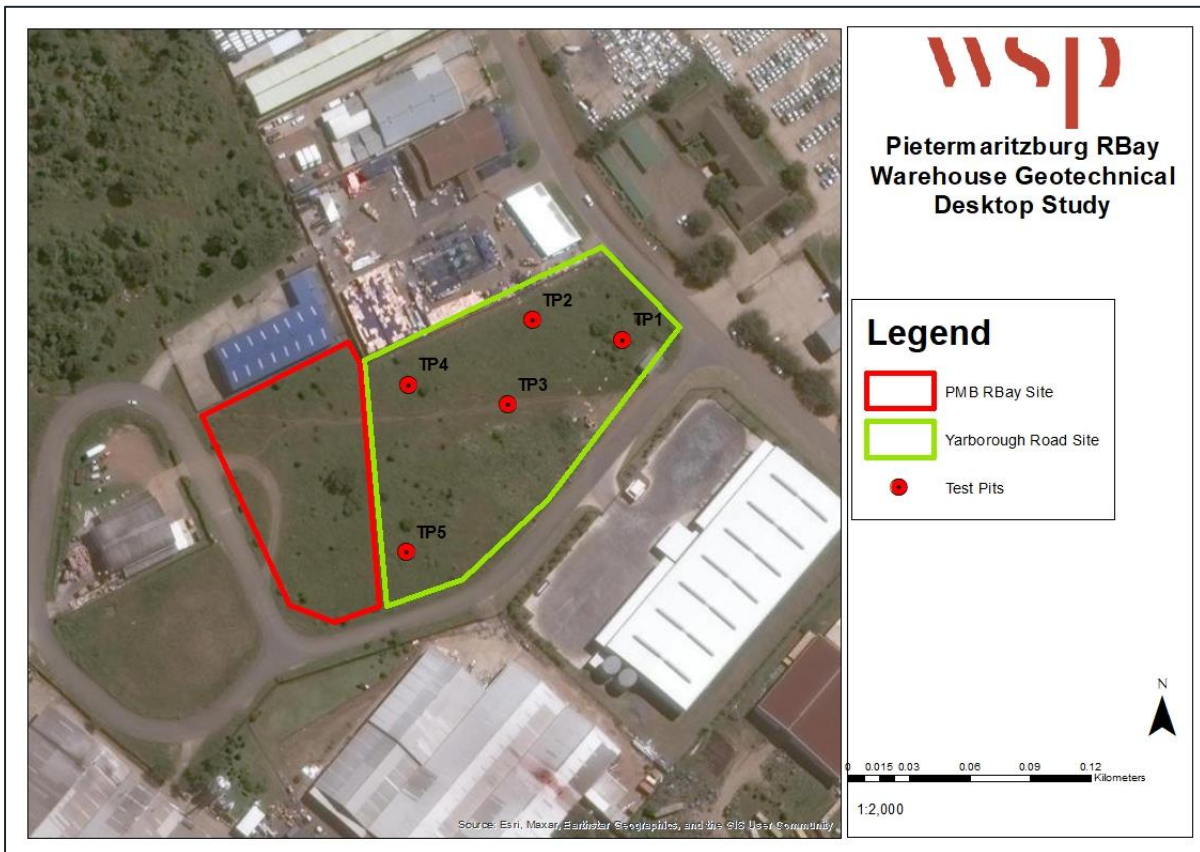
Figure 4-1 - Position of the test pits on the adjacent site

The report is reproduced herein as APPENDIX A. During the investigation, five test pits were excavated and Dynamic Cone Penetration (DCP or DPL) test were conducted adjacent to the test pits. The position of the test pits is indicated in Figure 4-1.

The profile, as encountered in the test pits is summarised in Table 4-1 along with an assessment of the consistency of the material from the results of the DCP tests. The profile is consistent across the site and, generally, comprises residual shale and shale rock. Fill and colluvium were also encountered. TLB refusal was encountered in shale rock.

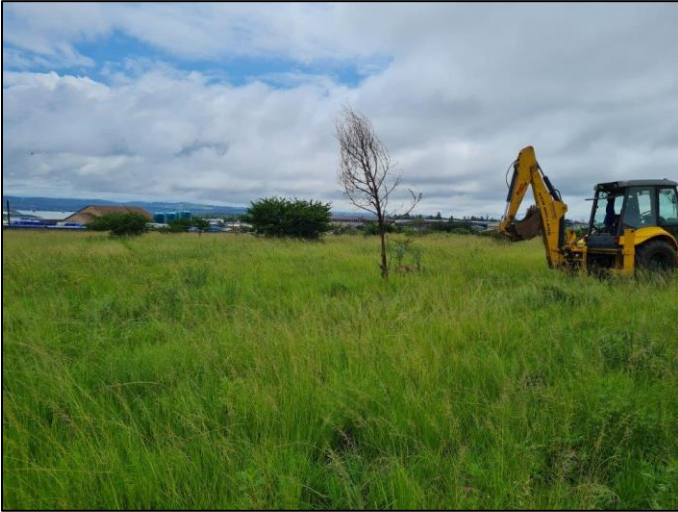
Fig. 1: General north easterly view across the site

No natural drainage features were observed on the site itself.

Figure 1 below shows the north easterly view of the site.

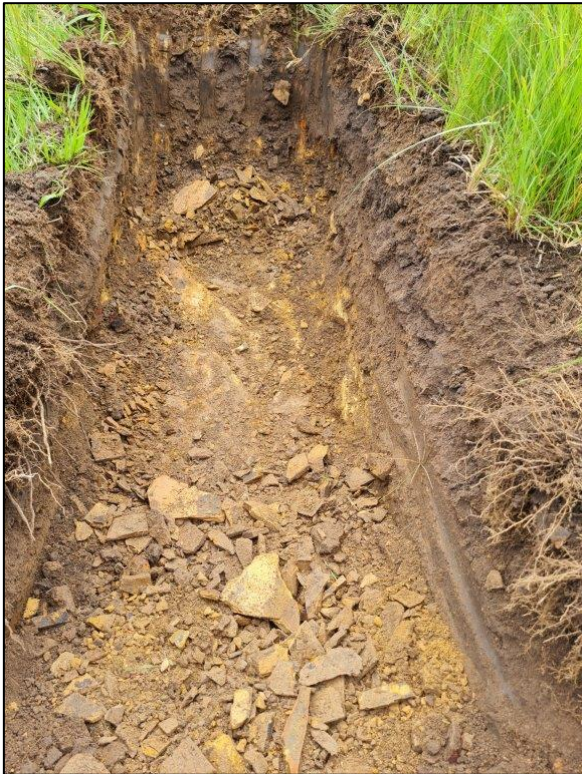
Fig. 2: General view of test pit 2

Figures 2, 3 4 and 5 below depict the general soil profiles encountered within the test pits.

- Refusal: TLB refusal was encountered at 0.680.
- Groundwater: No water seepage observed.
- Bedrock: Shale bedrock was encountered in the test pit at 0.440m.
- Sidewall Collapse: No sidewall collapse was observed.
- Samples: No samples taken.

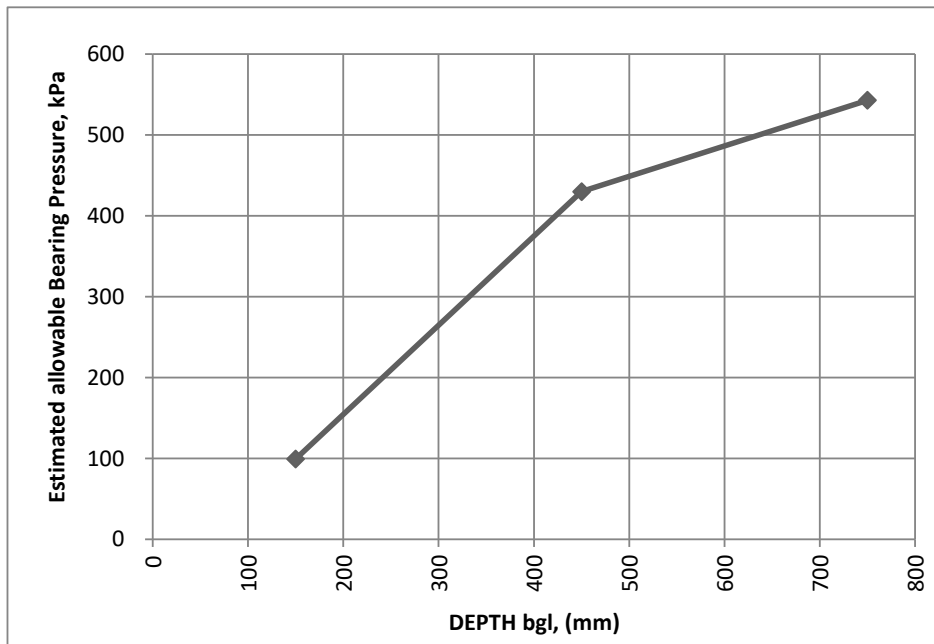
DPL NO. 5

DYNAMIC CONE PENETROMETER TEST RESULTS

Non - Cohesive Penetration Guide		
SPT mm/blow	DCP DN	Consistency
< 5	132-210	Very Dense
5 - 10	78-132	Dense
10 - 30	25-78	Med Dense
30 - 75	10 - 25	Loose
75 - 100	<10	Very Loose
