MARINE ENVIRONMENTAL IMPACT ASSESSMENT FOR THE PROPOSED PEDESTRIAN PATH TO CONNECT THE TWO PARTS OF THE HERMANUS CLIFF PATH VIA POOLE'S BAY, SOUTH AFRICA

October 2021

Anchor Environmental Consultants Pty (Ltd)

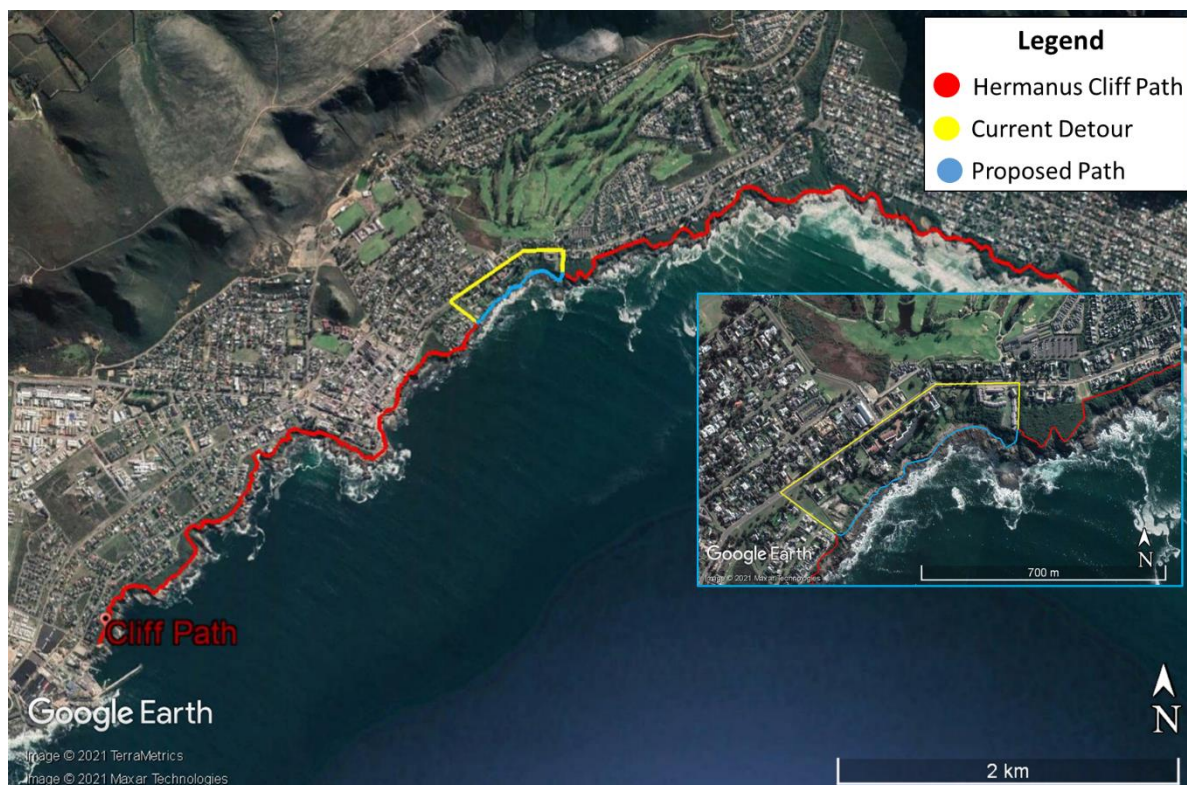
Figure 2 The position of the Hermanus Cliff Path (red), current detour (yellow) and the proposed path (blue).

This path is, however, interrupted halfway where it takes an approximate 1 km detour along the R43 (Main Road; Figure 2). The section of the path that extends along the Main Road is located between the Western Entry Promontory in the west and Mickey in the east. The Cliff Path Action Group, a private and voluntary community group, is wanting to connect the two parts of the current Hermanus Cliff Path by the construction of a walkway via the coastline in Poole's Bay.

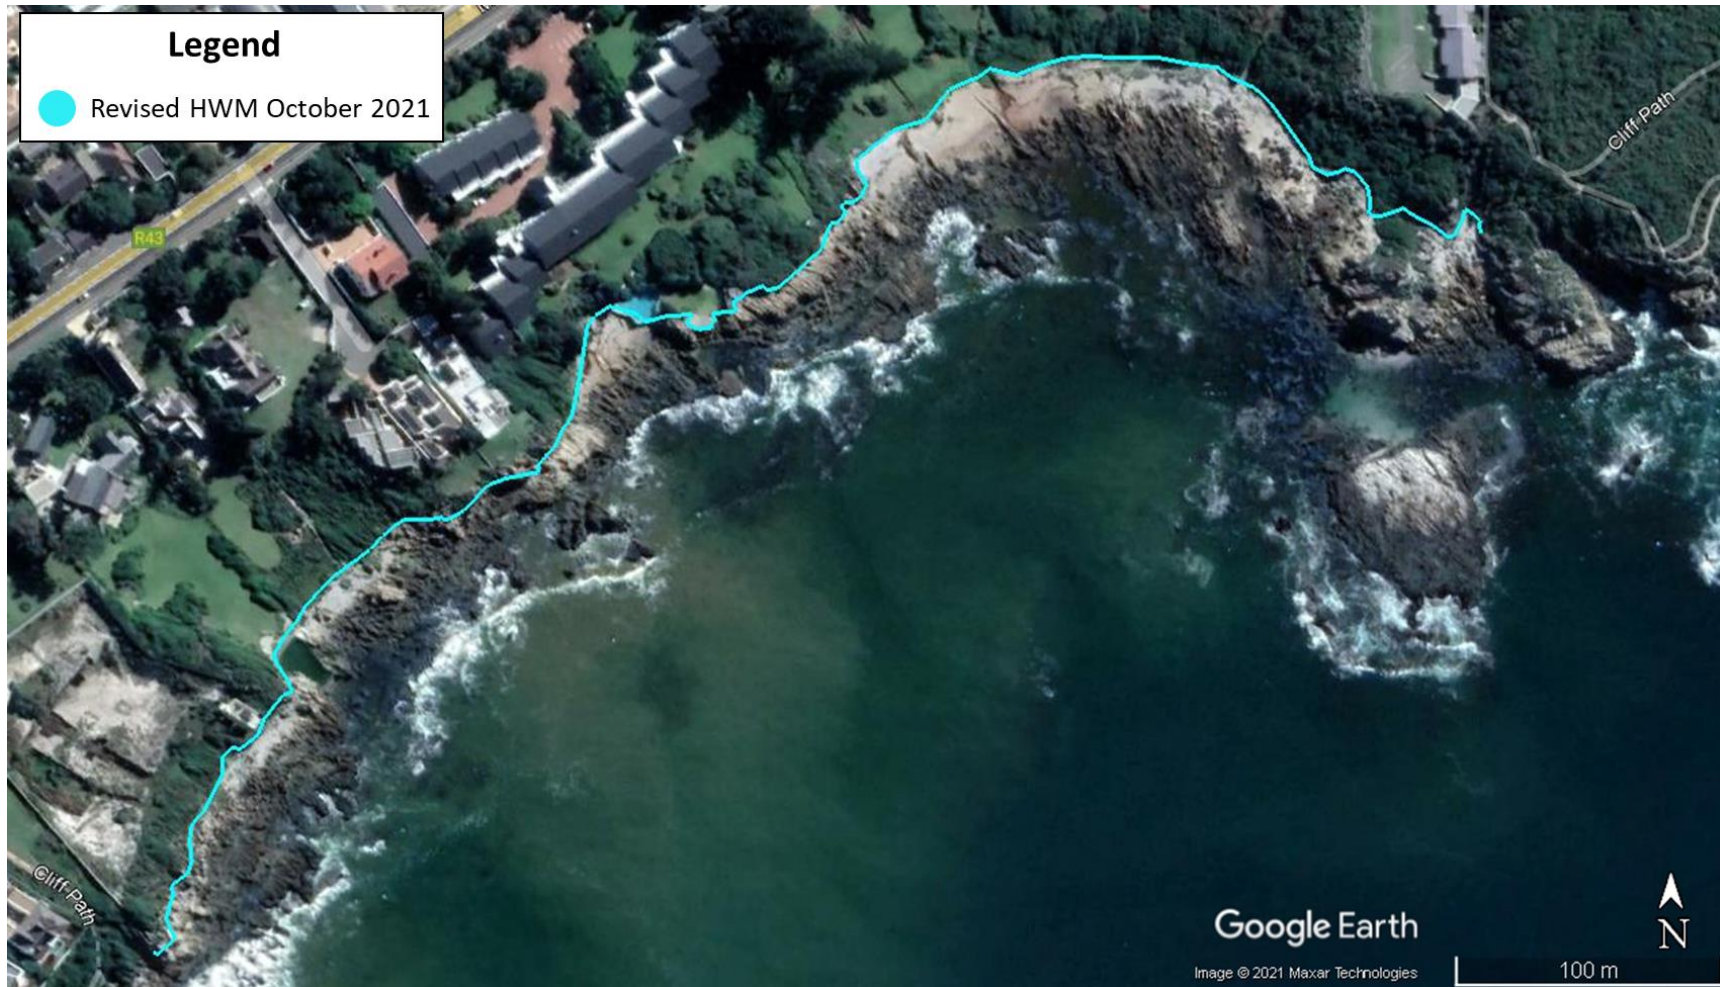
Figure 3 The current position of the high-water mark (in blue) as revised in October 2021 within the Poole's Bay area where the proposed pathway will be located.

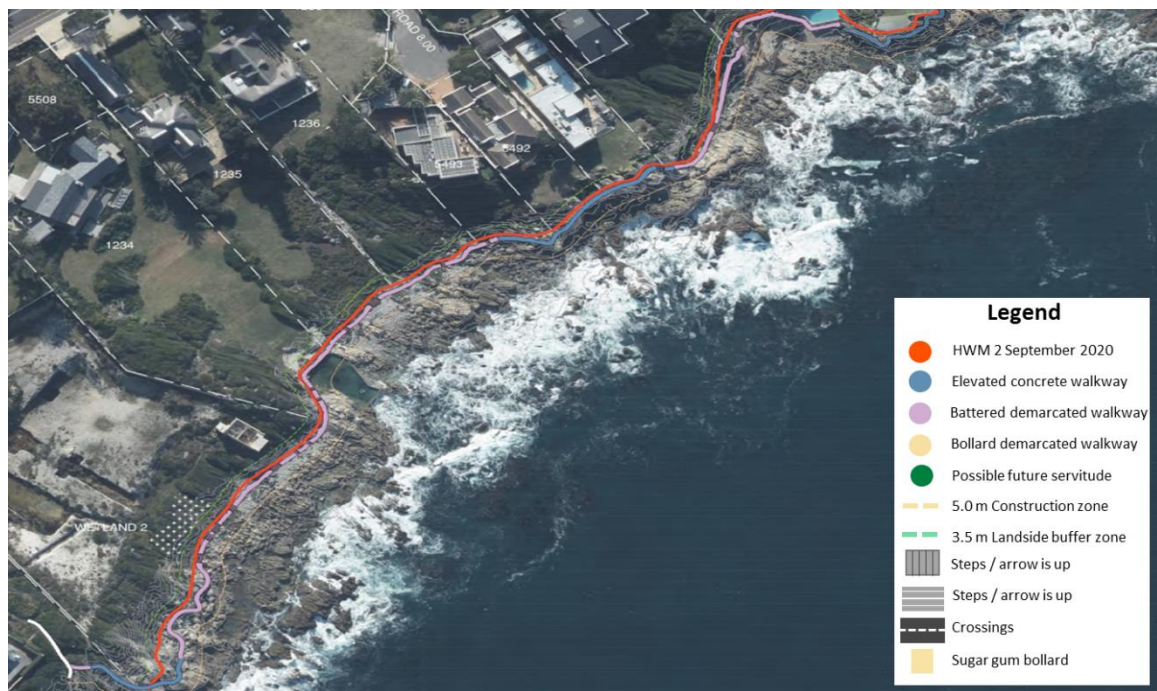
Figure 5 The western most section of the proposed walkway (blue and purple) relative to the high-water mark (indicated in red) for Alternative one. Note that the map illustrates the HWM as it was recorded prior to its revision in October 2021. The map was extracted from the Pre-Application Draft Basic Assessment Report (Ecosense 2020).

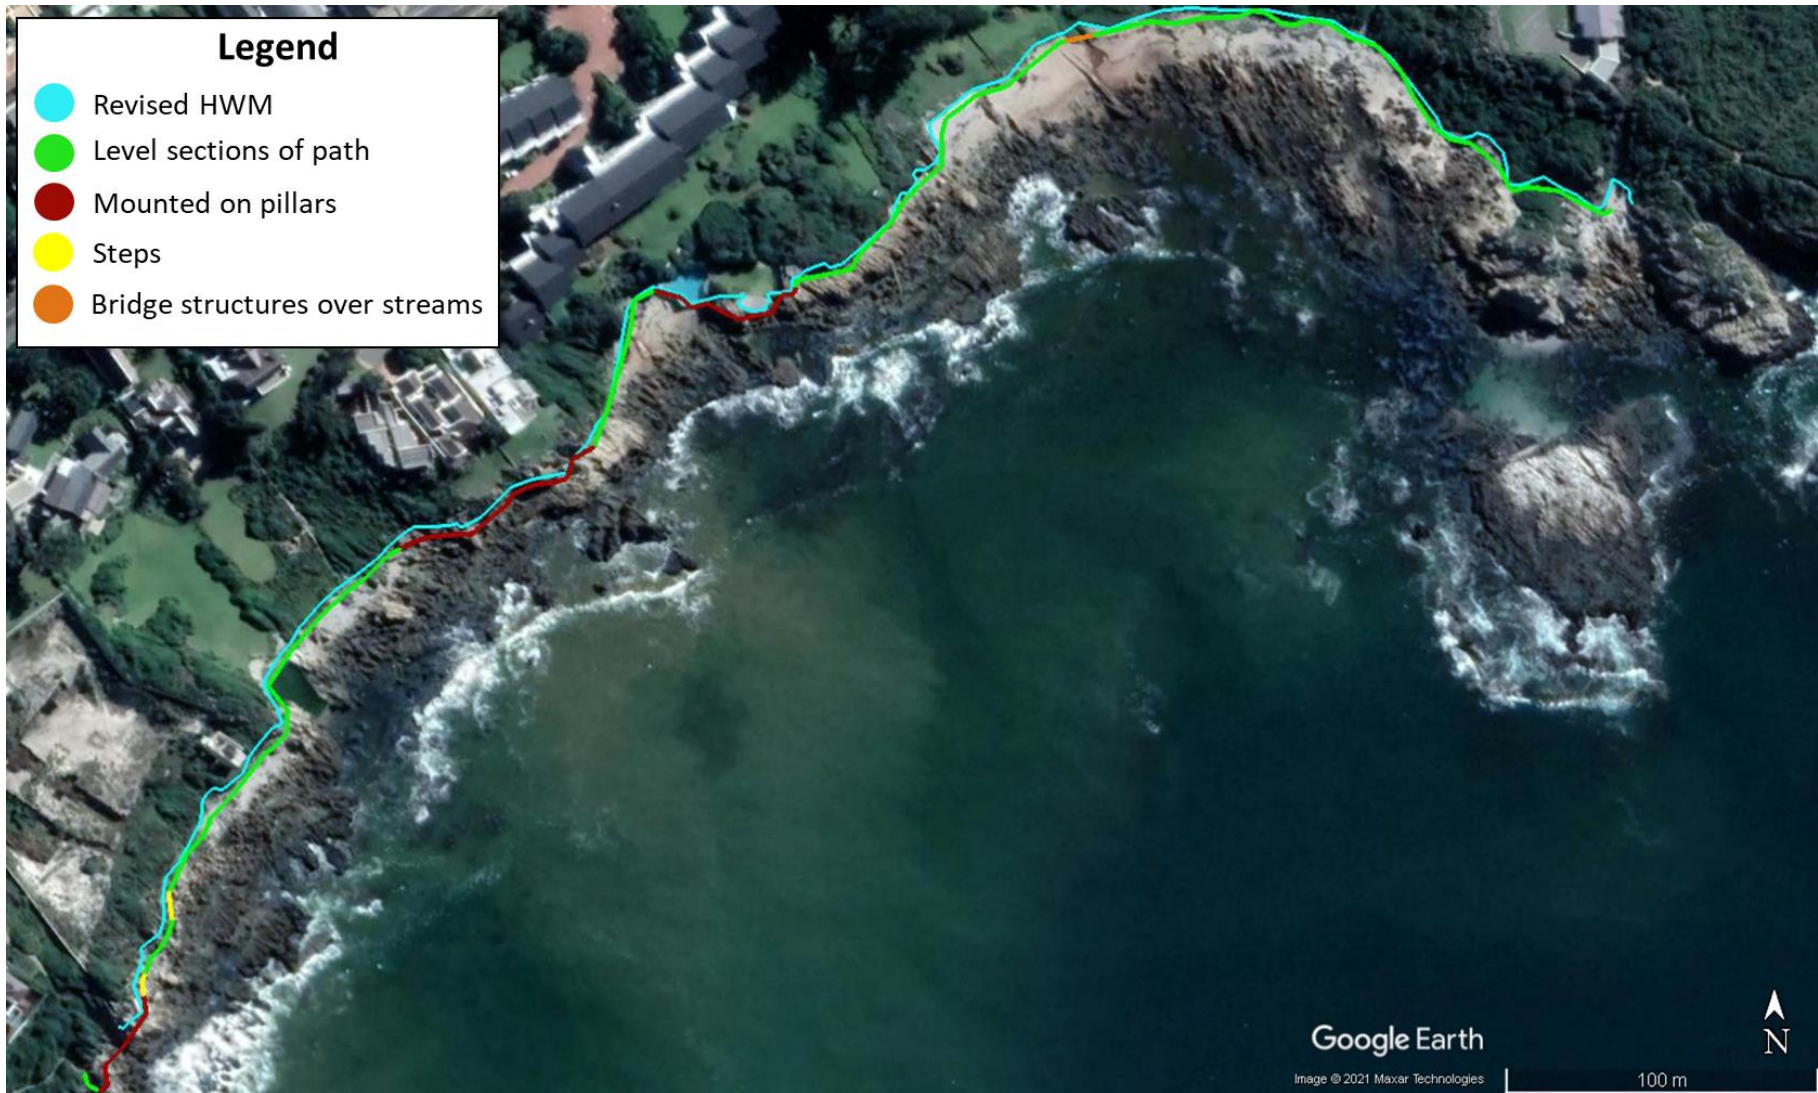
Figure 6 The proposed walkway (green, maroon, yellow and orange) within the Poole's Bay area relative to the position of the revised high-water mark (blue) for the second Alternative.

The second alternative proposes a formal, continuous walkway along the entire length of the path, even across easily accessible areas such as the pebble beaches. The walkway will be constructed of similar materials along the length of the path and include steps and bridges. This design will provide continuity and a refined appearance. The section on the western side of the path will, instead of being mounted against the wall using buttresses, be mounted on pillars to form a bridge. The pillars will be anchored to the base of the cliffs and be tall enough to ensure that the walkway will not be submerged during high tide. This will allow safer crossing during high tide and ensure that the path is always accessible. In areas where the walkway is elevated more than 500 mm, railings will be installed. The entry point on the western side will not extend through the gully, but rather through an alternative connection point that is more easily accessible.

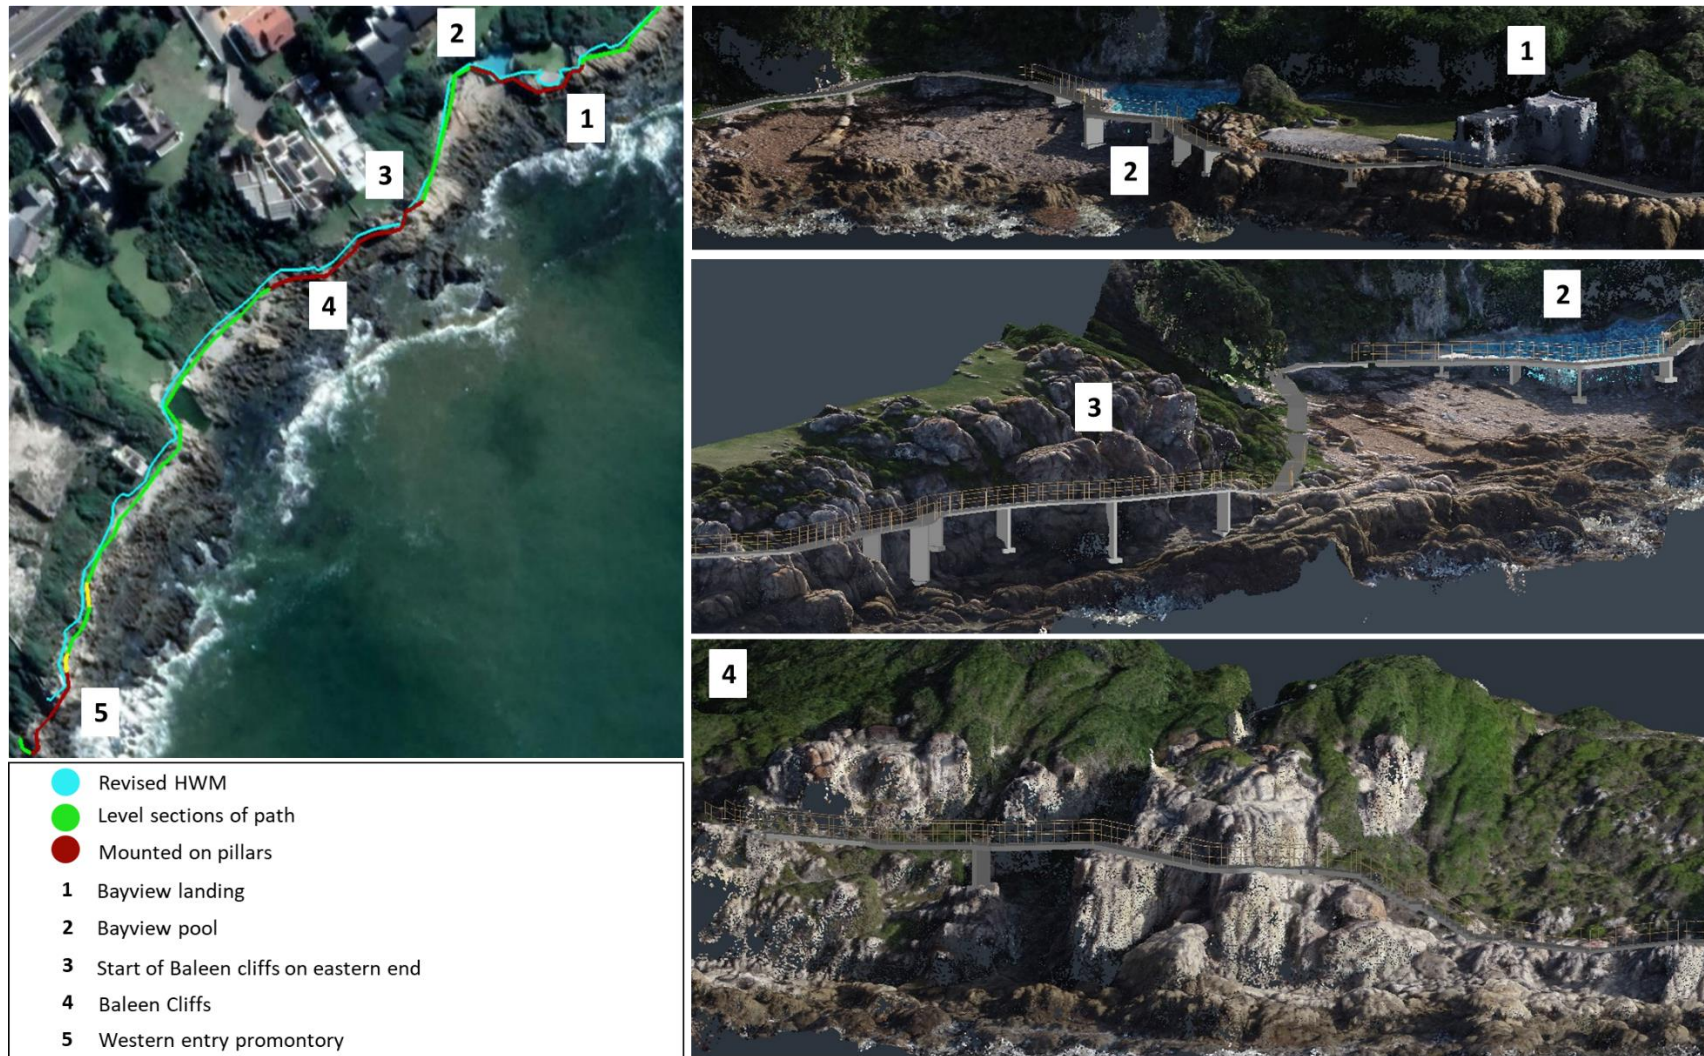
Figure 12 In some sections, the cliffs and therefore the proposed path, extend into the intertidal zone. For this reason, the proposed path will be raised and mounted either against the cliff wall or on pillars. These elevated sections will occur at the (1) Bayview landing; (2) Bayview pool; (3&4) Baleen cliffs; and (5) Western Entry Promontory.

As the cliffs extend into the intertidal zone, the proposed path runs narrowly between the cliff and shoreline over very rocky terrain within the upper intertidal zone. In these sections, the path will be elevated and either mounted against the cliff wall or on pillars to allow safer crossing and to avoid the path being submerged during high tide (Figure 12). In some sections, the cliffs and therefore the proposed path, extend into the intertidal zone. For this reason, the proposed path will be raised and mounted either against the cliff wall or on pillars as illustrated in the figures above. These elevated sections include the (1) Bayview landing; (2) Bayview pool; (3&4) Baleen cliffs; and (5) Western Entry Promontory.

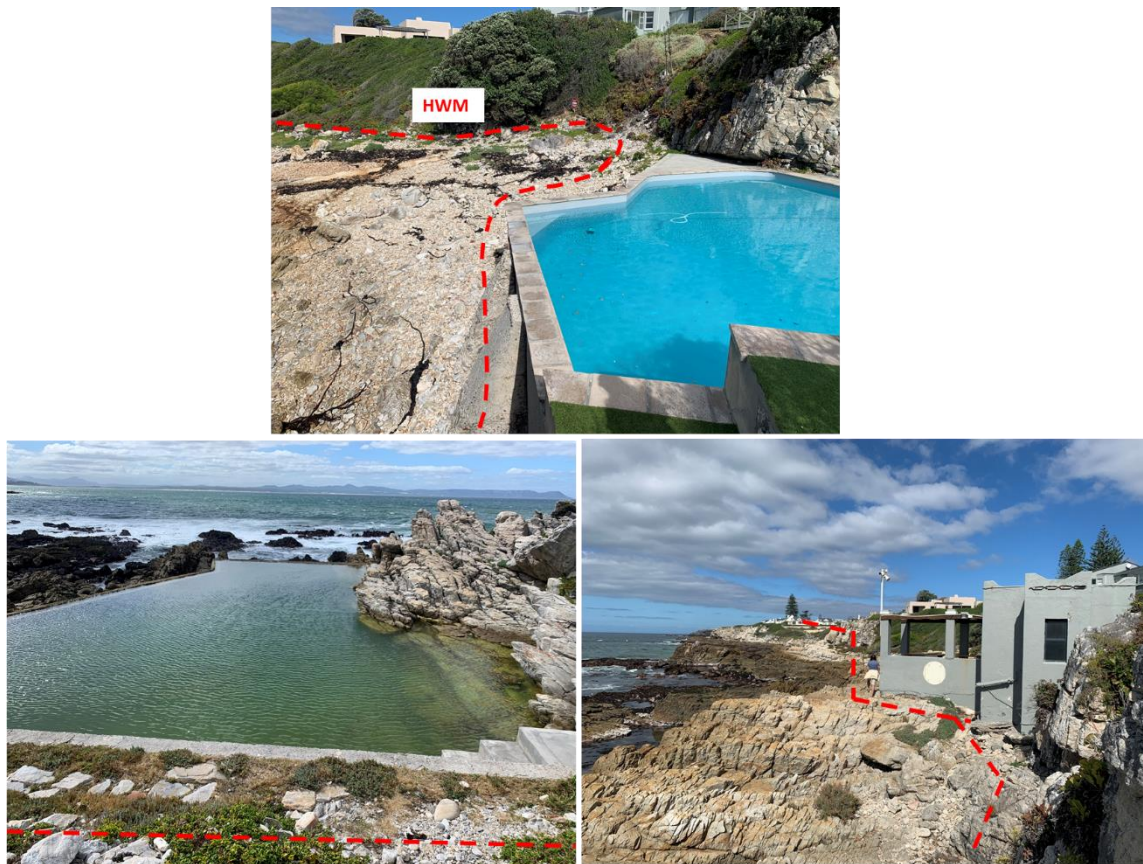
Figure 19 Photos taken along the route of the study area showing how the study area is already disturbed and transformed due to the presence of various structures either below or bordering the high-water mark (HWM — indicated in red).
