FINAL GEOTECHNICAL INVESTIGATION REPORT

GEOTECHNICAL INVESTIGATION FOR TOWNSHIP ESTABLISHMENT ON PORTION
22 OF THE FARM MOOIFONTEIN NO. 14 – IR, EKURHULENI METROPOLITAN
MUNICIPALITY, GAUTENG PROVINCE.

February 2018

Ruvimbo Consulting (Pty) Ltd

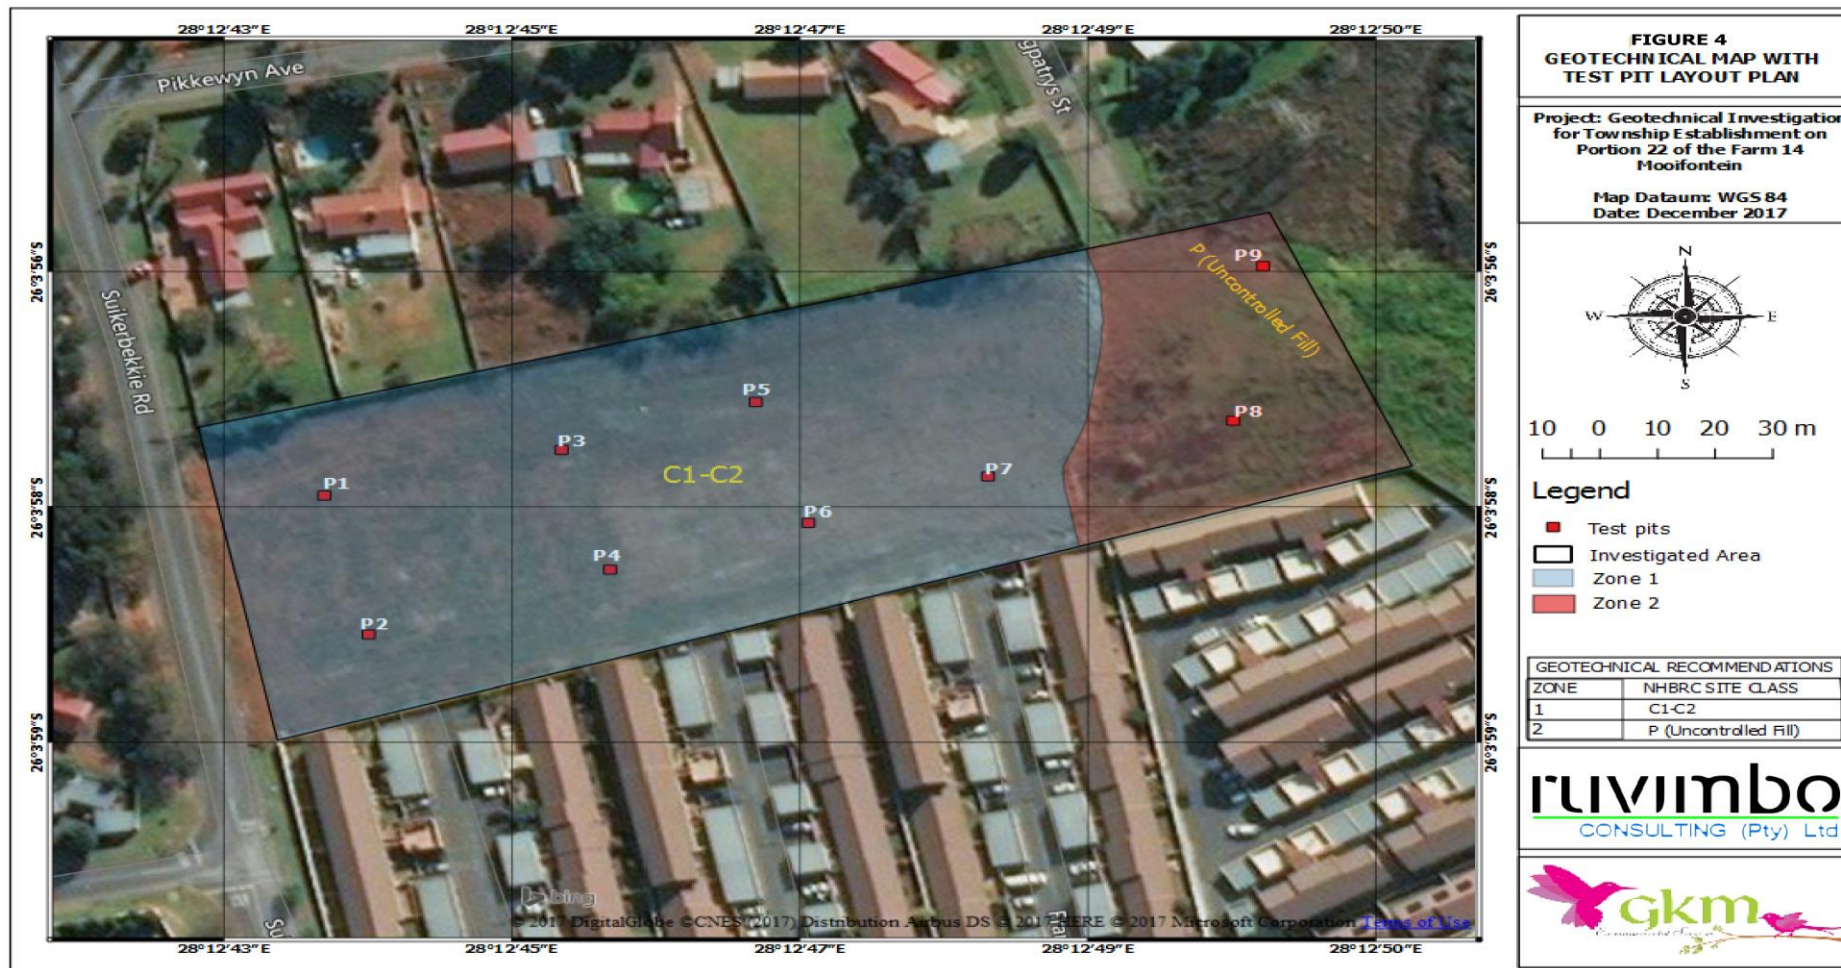
Figure 4: Test Pits Position and Geotechnical Zonation

The geotechnical investigation comprised the excavation of nine test pits (TP1 to TP9) on the 19th of November 2017, using Tractor Loader Backhoes (TLB's). **Figure 4** shows the position of the test pits and geotechnical zonation of the site. The test pits were excavated to refusal depth or to the maximum reach of the machine. The test pits were logged by geologist according to standard practice [5]. The soil profiles are presented and attached as **Appendix A**.

The site is defined by two broad zones (Zone 1 and Zone 2), based on the materials encountered and typical soil profile as follows:

5.1 Zone 1 (TP1 - TP7)

5.2 Zone 2 (P8 – P9)
