REPORT ON THE GEOTECHNICAL INVESTIGATION OF THE PROPOSED NEW LANDFILL SITE, MALUTI-APHOFONG

Prepared by: JB Consult

Project No. JBC076

Date: December 2013

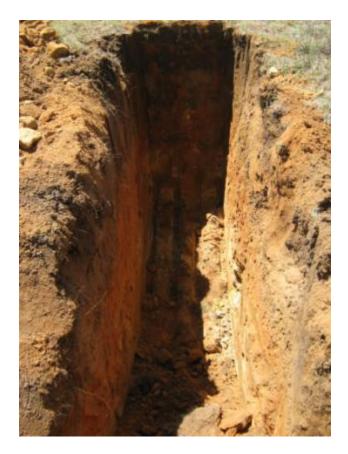
MAP TP 1

Moist, light brown, MEDIUM DENSE, intact, SILTY SAND with abundant

Moist, yellow and red, DENCE, intact, slightly CLAYEY SILTY SAND. Residual Sandstone.

Refusal of Machine on soft rock SANDSTONE.

- 1) No Groundwater seepage.
- 2) Refusal at 1.8m.
- 3) Disturbed Sample at 0.1--0.5m.
- 4) Disturbed Sample at 0.5--0.8m.
- 5) Disturbed Sample at 0.8--1.8m.

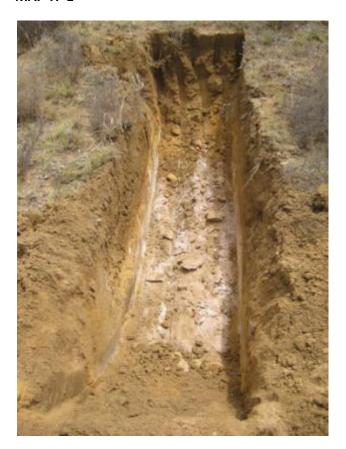
MAP TP 2

2) Refusal at 0.9m.

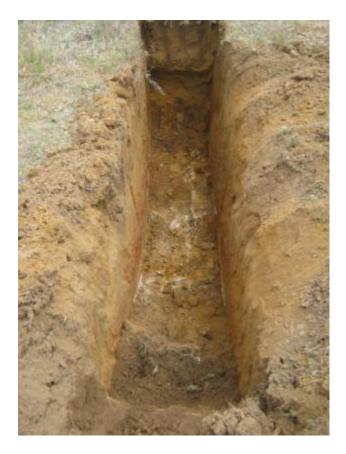
MAP TP 3

Moist, light brown, MEDIUM DENSE, intact, SILTY SAND with abundant

Moist, yellow and red, DENCE, intact, slightly CLAYEY SILTY SAND.

Refusal of Machine on soft rock SANDSTONE.

- 1) No Groundwater seepage.
- 2) Refusal at 1.5m.

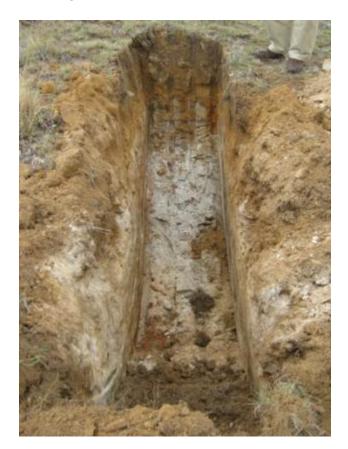
MAP TP 4

Moist, light brown, MEDIUM DENSE, intact, SILTY SAND with abundant roots.

Moist, yellow and red, DENCE, intact, slightly CLAYEY SILTY SAND becoming Highly weathered Sandstone.

Refusal of Machine on soft rock SANDSTONE.

- 1) No Groundwater seepage.
- 2) Refusal at 1.3m.

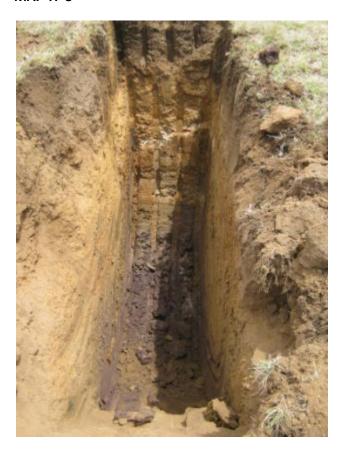
MAP TP 6

Moist, light brown, MEDIUM DENSE, intact, SILTY SAND with abundant roots.

Moist, yellow and red, DENCE, intact, slightly CLAYEY SILTY SAND.

Moist, olive brown and purple, FIRM, friable, CLAYEY SILT.

1) No Groundwater seepage.

2) No Refusal.

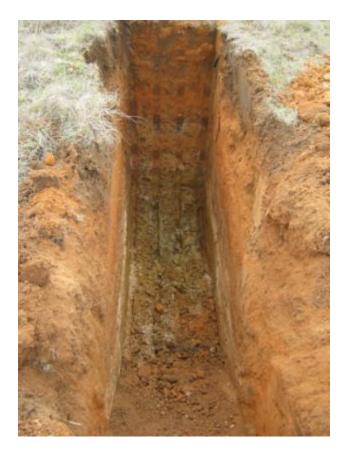
MAP TP 7

Moist, light brown, MEDIUM DENSE, intact, SILTY SAND with abundant roots.

Moist, yellow and red, DENCE, intact, slightly CLAYEY SILTY SAND becoming Highly weathered Sandstone.

Refusal of Machine.

- 1) No Groundwater seepage.
- 2) Refusal at 1.8m.

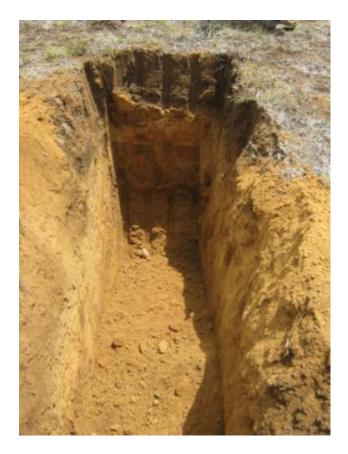
MAP TP 11

Moist, light brown, MEDIUM DENSE, intact, SILTY SAND with abundant roots.

Moist, yellow and red, DENCE, intact, slightly CLAYEY SILTY SAND.

Moist, olive brown and purple, FIRM, friable, CLAYEY SILT.

Partial Refusal of machine on soft rock Mudstone.

- 1) No Groundwater seepage.
- 2) Partial Refusal at 1.8m.

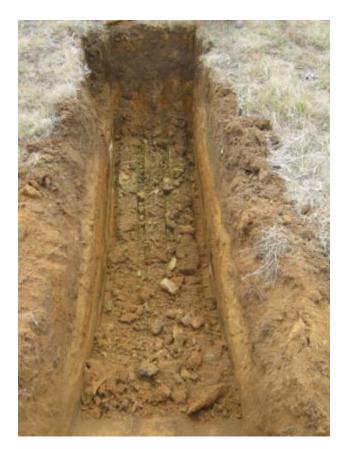
MAP TP 12

Moist, light brown, MEDIUM DENSE, intact, SILTY SAND with abundant roots.

Moist, yellow and red, DENCE, ferruginised, slightly CLAYEY SILTY SAND with ferricrete nodules.

Refusal of Machine on HARDPAN FERRICRETE.

- 1) No Groundwater seepage.
- 2) Refusal at 0.7m.
