**Phase 1 Heritage Impact Assessment for the
proposed development of a new Taxi Rank in
Mahikeng, NW Province.**

Report prepared by
Paleo Field Services
PO Box 38806
Langenhovenpark 9330
June 2021

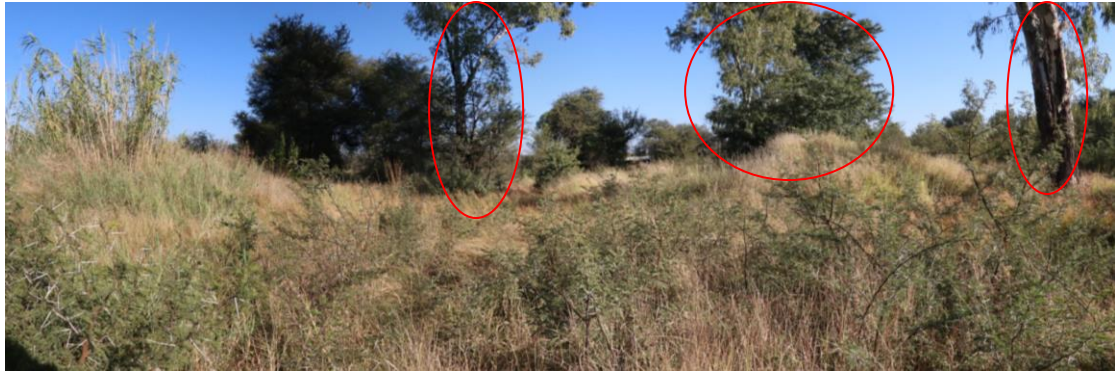
Figure 1: General view of the site. Note a dominant grass layer with scattered trees, though the majority of these are exotic invasive species (red). Note also the general modification of the surface topography.

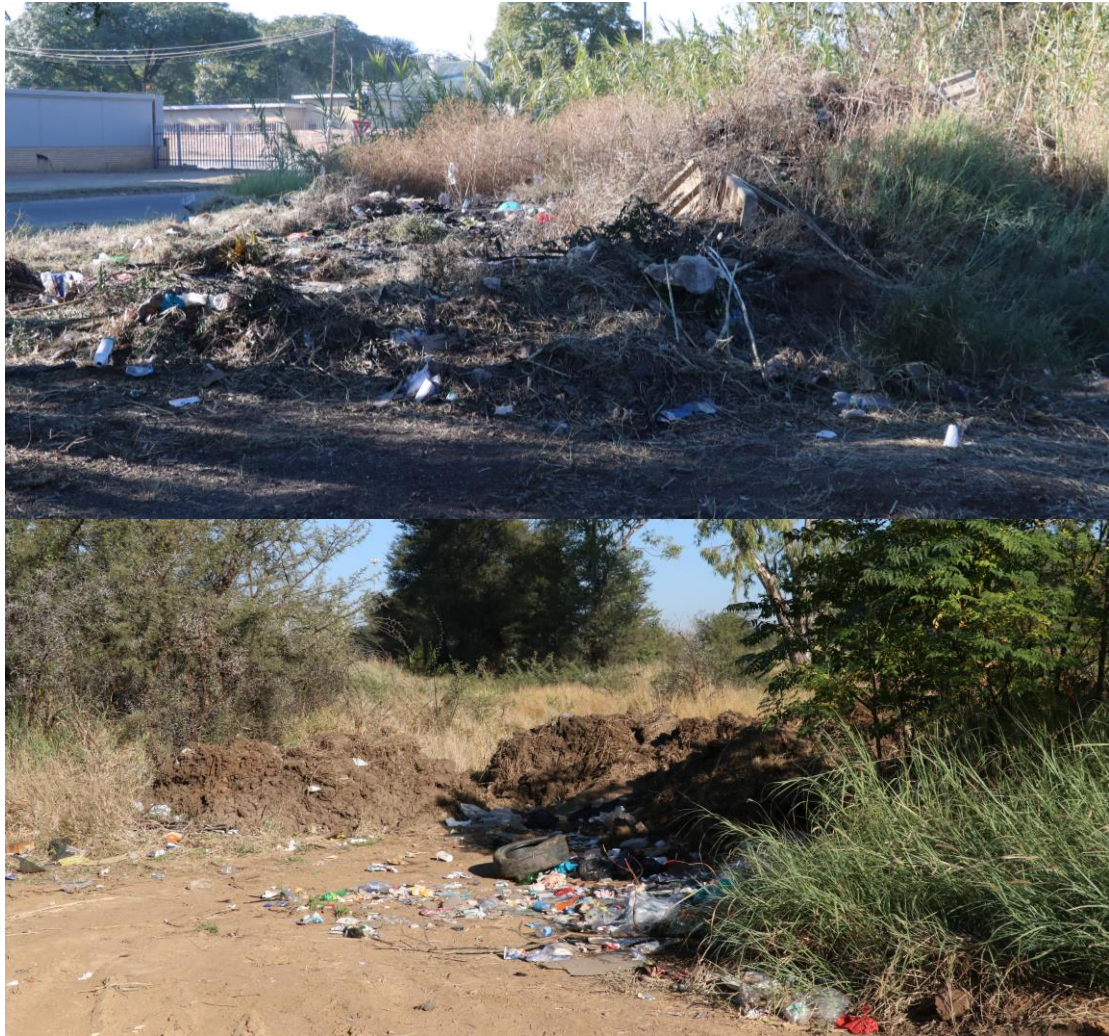
Figure 2: Rubbish and rubble dumping is abundant on the site and cause extensive degradation.

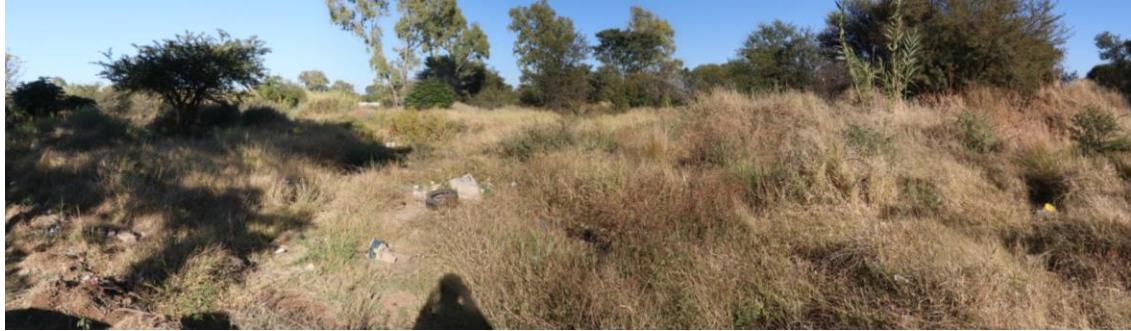
Figure 3: The natural surface topography of the site has clearly been modified.

The topography of the site is relatively uniform but is also clearly modified, at least in terms of the surface topography. Rubble dumping and shallow excavations as well as general surface disturbances have all contributed to a modified surface topography. The site is almost completely flat, without any discernible slope. A linear storm water channel is also situated along the southern portion of the site (Appendix A: Map 1). This is considered a completely artificial system although it does feed into the storm water system of Mahikeng and does eventually discharge into the Molopo River, approximately 2.5 km to the south west of the site. The elevation on the site is 1283 m without any discernible changes and also confirm the largely flat topography of it.

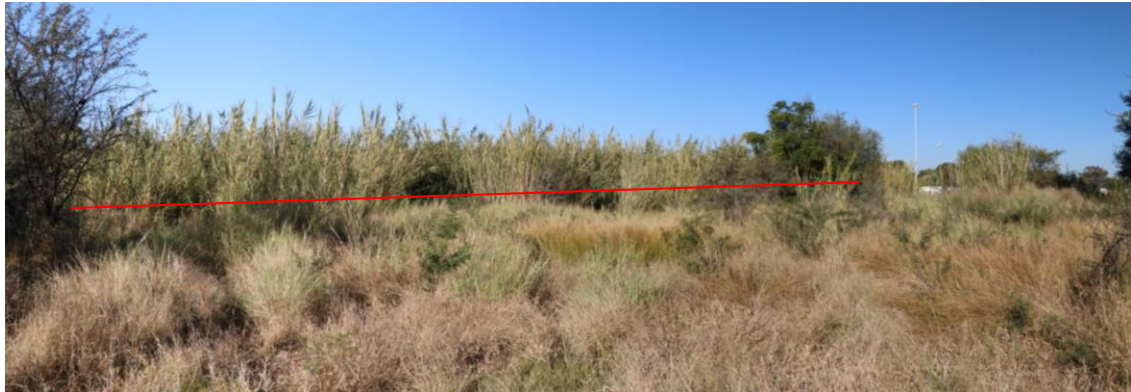
Figure 4: The artificial storm water channel on the site is clearly completely artificial and dominated by the invasive Spanish Reed (*Arundo donax*).

Soil samples collected along the storm channel show clear indications of wetland conditions and is a consequence of prolonged saturation of the soils (Appendix C). The channel is however completely dominated by the invasive Spanish Reed (*Arundo donax*) and consequently obligate wetland plants are absent and do not confirm the presence of wetland conditions, a consequence of the artificial nature of the storm water system. Although soils still indicate the presence of wetland conditions, it should be kept in mind that these wetland conditions are an artificial manifestation caused by the storm water system.

The wetland conditions which has formed as a result of the storm water channel is completely artificial. However, historical aerial imagery seem to indicate that a small drainage line may have been present in this area though it would already have been modified by as early as 1958 (National Geo-Spatial Information). Whichever the case may be, at the present the channel is

completely artificial and does not contain any riparian habitat. The wetland conditions do resemble to some degree a channel wetland system, though due to its current artificial nature it differs in several important instances (SANBI 2009).

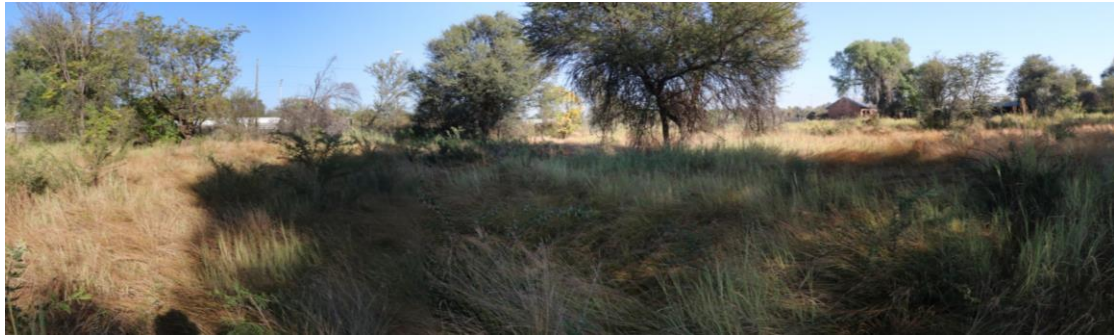
Figure 5: Though also heavily degraded, remnants of the natural vegetation type do still occur on the site.

The site still contains dense stands of the grasses *Cenchrus ciliaris* and *Heteropogon contortus*. These are semi-climax species which are considered to be remnants of the remaining natural vegetation type on the site. However, an abundance of other pioneer grass species also indicate degradation of this grass layer. These include *Cynodon dactylon*, *Melinis repens*, *Urochloa panicoides*, *Eragrostis echinochloidea*, *Enneapogon cenchroides*, *Hyparrhenia tamba* and *Eragrostis lehmanniana*. This species assemblage is a clear indication of a degraded natural grass layer. In addition, the shade loving grass, *Setaria verticillata* occurs underneath some of the trees on the site and the moisture loving grass, *Panicum coloratum* is present in depressions where moisture may collect. The tree layer contains scattered specimens of the indigenous *Vachellia karroo*, *Ziziphus mucronata* and *Vachellia tortillis* var. *heteracantha*. These are also considered as remnants of the natural vegetation type. A single small specimen of *Vachellia sieberana* var. *woodii* was also noted near the roadway but is considered planted since this species does not naturally occur in this region and is considered highly unlikely to be a natural range extension. Underneath some of the trees the climber, *Pergularia daemia* was also noted, an indigenous species, also considered a remnant of the natural vegetation. The above description is however the full extent to which natural vegetation still remains on the site, with the remaining proportion consisting only of exotic weeds and invasive plant species. Exotic weeds are prominent and dominate significant portions of the site. These include *Sphaeralcea bonariensis*, *Bidens pillosa*, *Flaveria bidentis*, *Amaranthus hybridis*, *Datura stramonium*, *Sonchus oleraceus* and *Euhorbia heterophylla*. The invasive climber *Ipomoea purpurea* is also abundant in the undergrowth and in shrubs. The shrub and tree layer also contains an abundance of invasive species of which a few are also regarded as serious invaders. These include *Tipuana tipu*, *Parkinsonia aculeata*, *Caesalpinia gilliesii*, *Robinia pseudoacacia*, *Prosopis glandulosa*, *Morus alba*, *Melia azedarach* and *Schinus molle*. The artificial storm water channel on the site is also dominated by the highly invasive Spanish Reed, *Arundo donax*, to the exclusion of all other vegetation which this invasive plant is known for. The above should clearly indicate the abundance of exotic and invasive plants which cause extensive degradation and contributes to the largely transformed condition of the site. The site also does not contain any protected, rare or endangered species and given the severe degradation of the site it is highly unlikely that any such species would still remain.

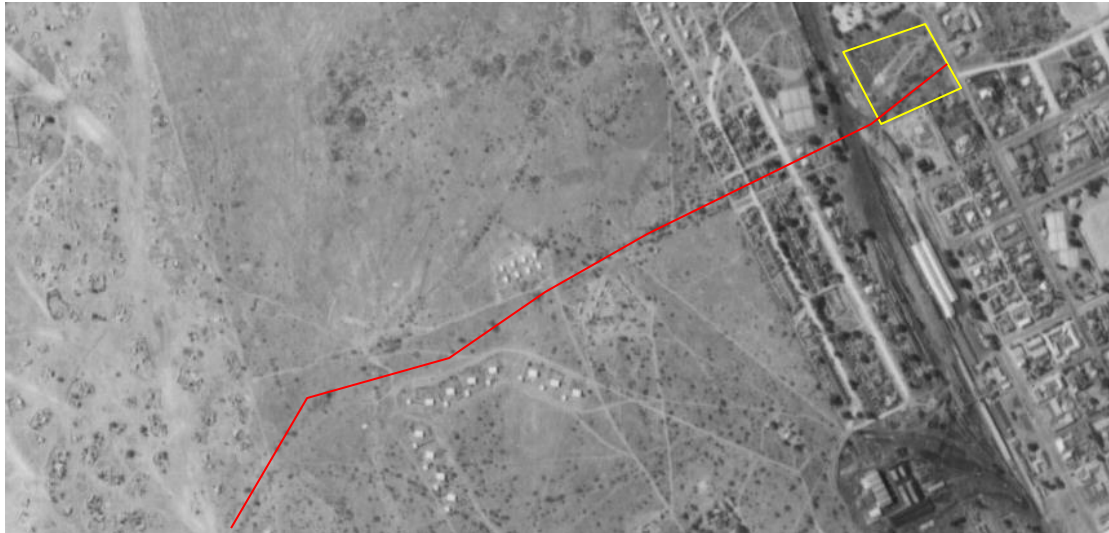
Figure 6: Historical images indicate that a small natural drainage line may have been present in this area though it would have been very small and already modified by as early as 1958 (National Geo-Spatial Information).

Currently the storm water channel seems to be completely artificial, without any natural connection. However, when looking at historical images it is probable that a small natural drainage line may have been present in this area. It was however already heavily modified by as early as 1958 (National Geo-Spatial Information). By 1976 the drainage line had already been integrated into the storm water system of the urban area of Mahikeng. Currently the channel is completely artificial and though it does not seem to have a downstream connection it is simply being covered by the adjacent railway network. It is connected to a downstream channel which is situated within a dense urban area which eventually (approximately 2.5 km) flows into the Molopo River to the south west of the site.

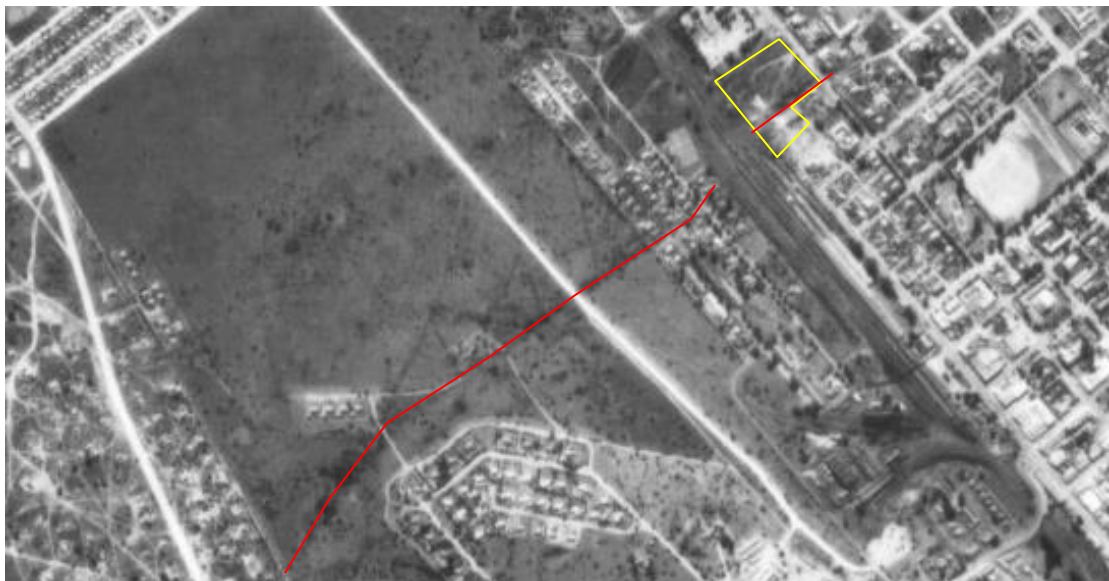
Figure 7: By 1976 the area is already highly urbanised and any natural drainage line completely removed and now largely canalised to manage storm water generated by the urban area (National Geo-Spatial Information).

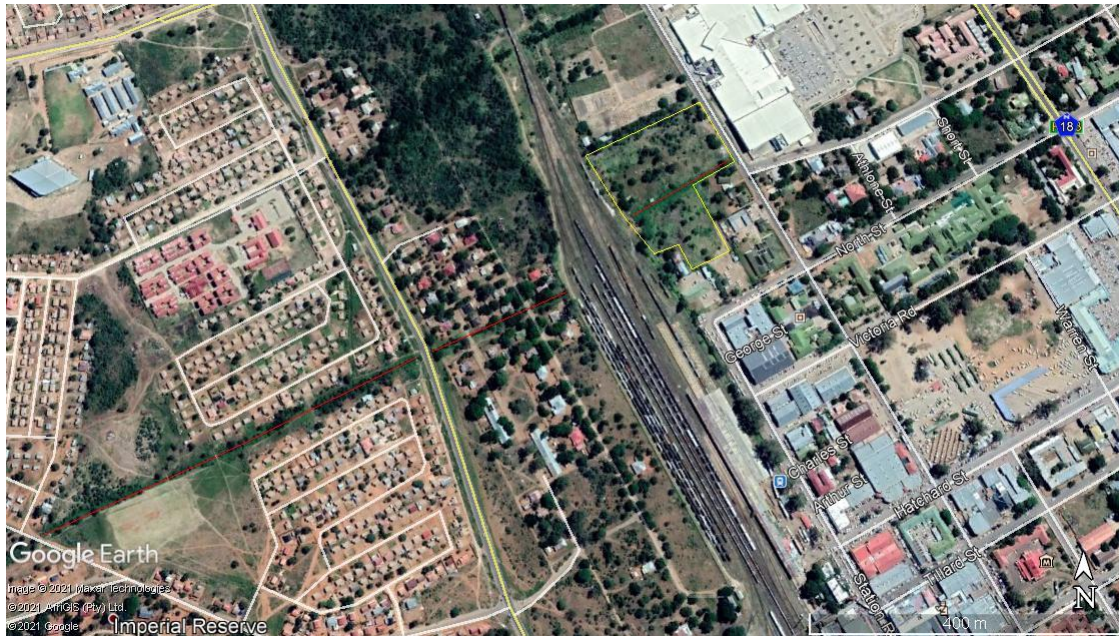
Figure 8: Currently the storm channel is quite obscured but careful observation may indicate that it still forms part of the downstream storm water system.

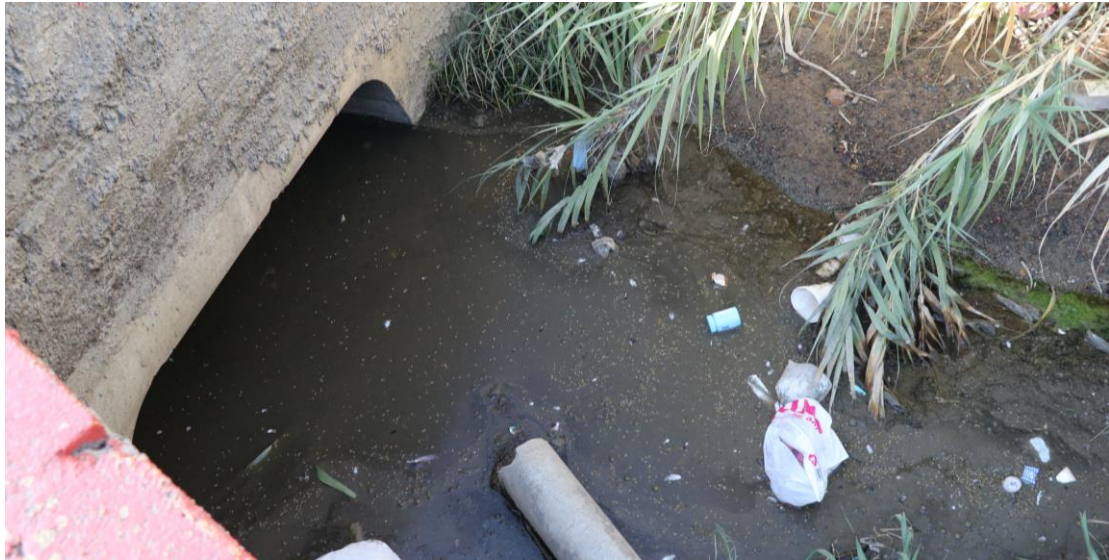
Figure 9: Where the storm water channel enters the site, it emerges from an underground section. Water quality is quite clearly very poor.

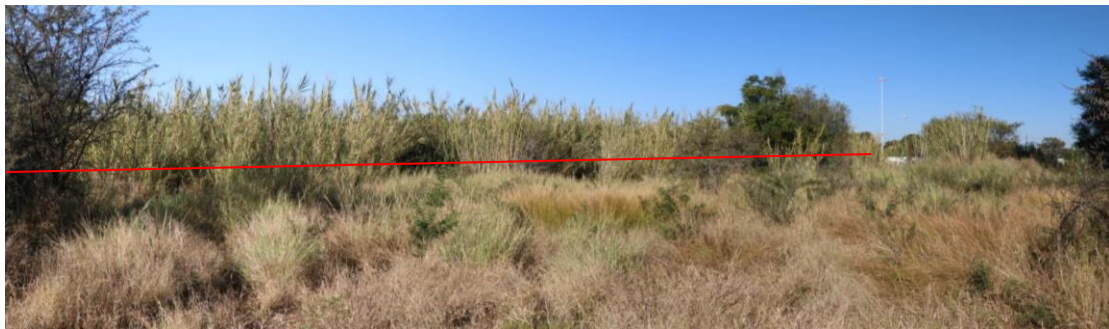
Figure 10: View of the storm water channel section located on the site.

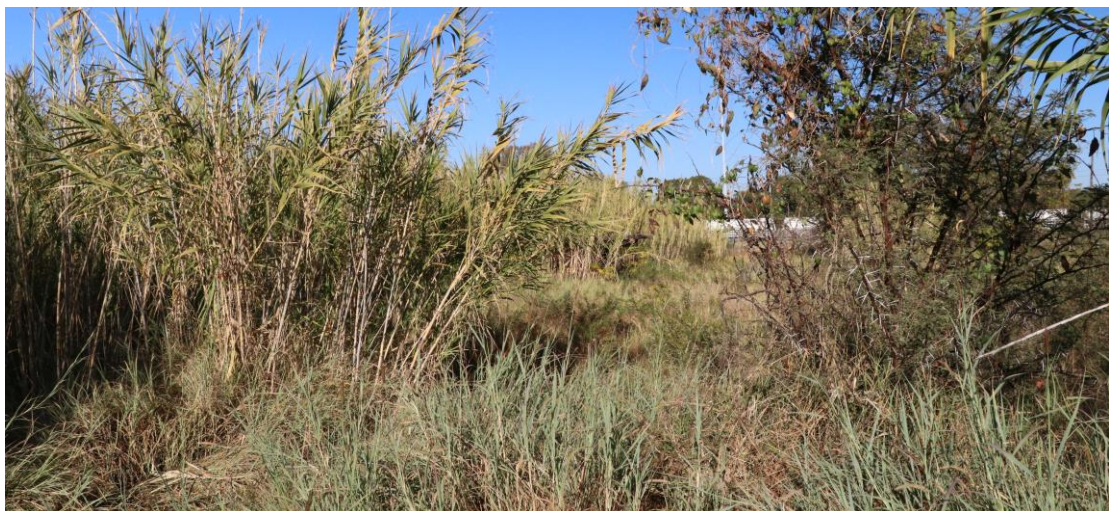
Figure 11: The section of the storm water channel on the site consists exclusively of a dense infestation of the exotic *Arundo donax* (Spanish Reed) and riparian vegetation and habitat is absent.

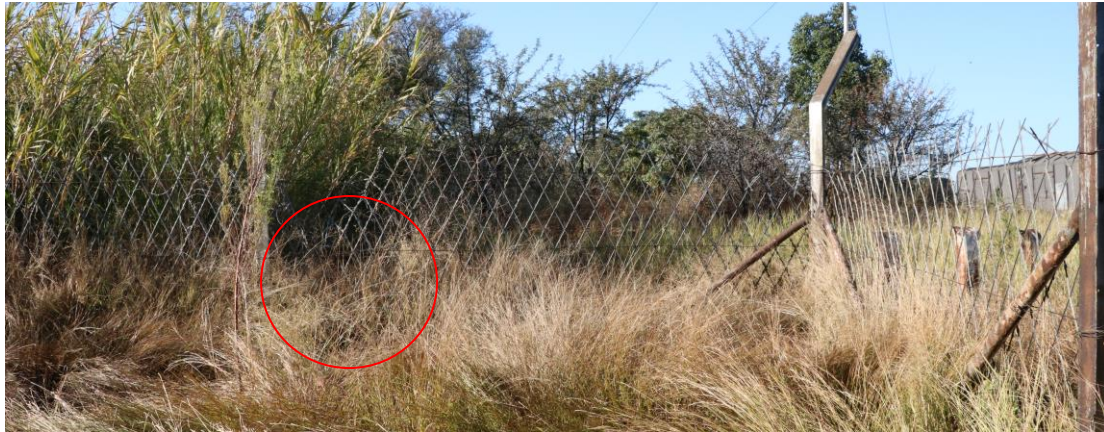
Figure 12: Where the storm water channel exits the site it is again situated underground.

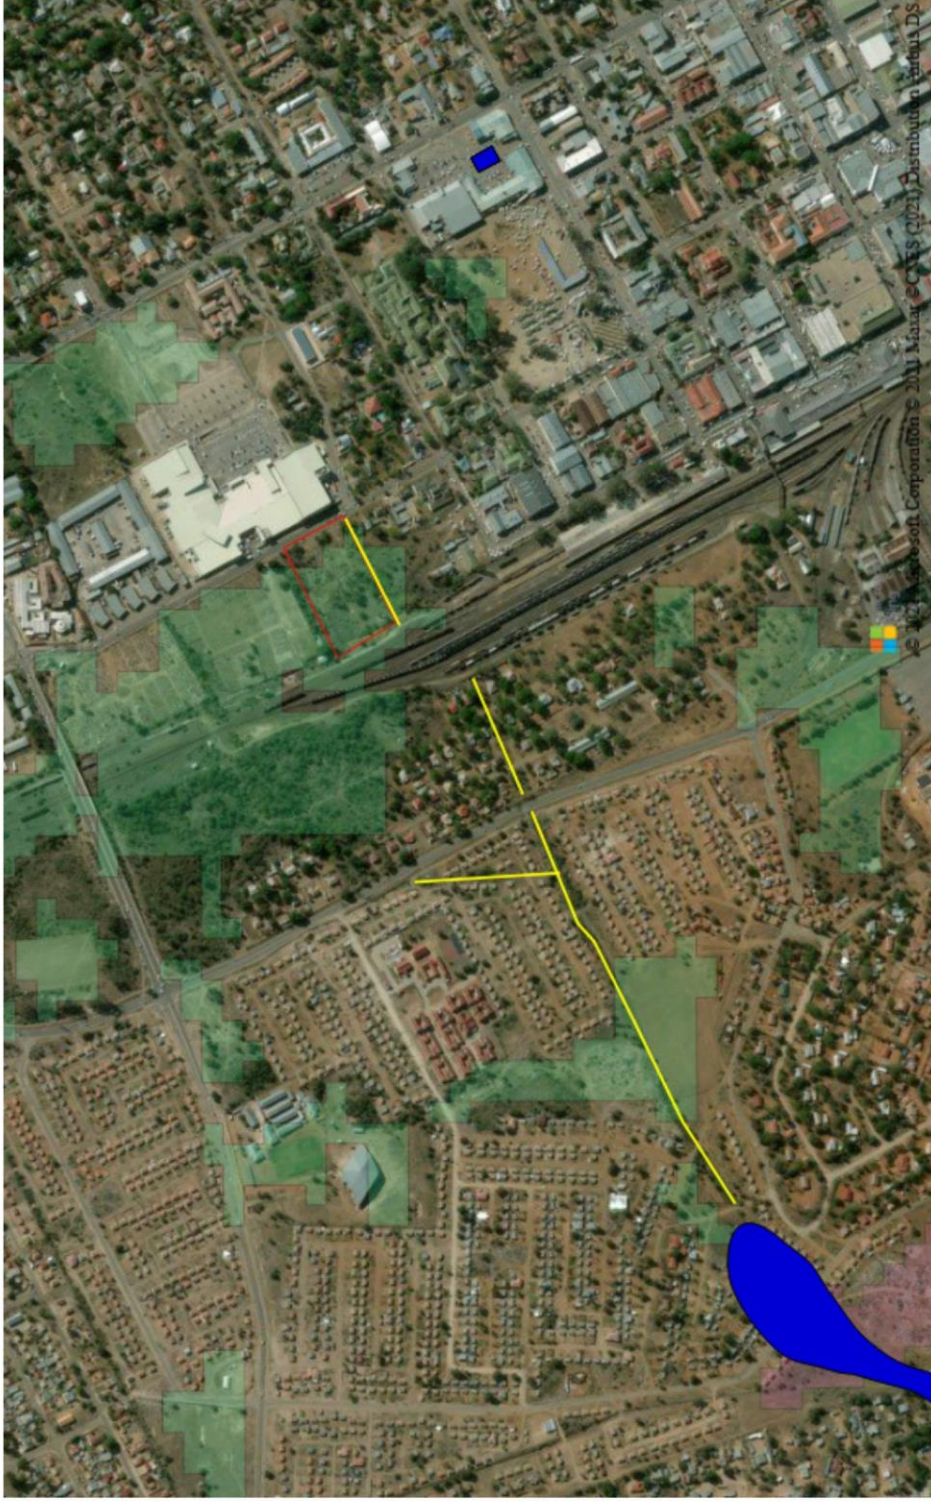
Map 1: Locality map of the proposed taxi rank development in Mahikeng. The National Biodiversity Assessment 2018 indicates the remnants of Klerksdorp Thornveld in the area though from the aerial perspective it is already evident that these areas are degraded and isolated by urban surroundings. The location of the artificial storm water channel on the site and downstream is also indicated. Note that it flows into natural wetland areas to the west of the site.

The majority of the site has been transformed from the natural condition by several impacts and land uses (Appendix A: Map 1). The level of degradation is to such an extent that the vegetation on the site is no longer regarded as representative of the natural vegetation type and is considered transformed. Large volumes of rubble and refuse is being dumped on the site. Historically, the site was also affected by dumping and shallow excavations and the survey indicated clearly that the surface topography has largely been modified, where it should consist of a relatively flat plain it now has an irregular surface of small mounds and shallow excavations.

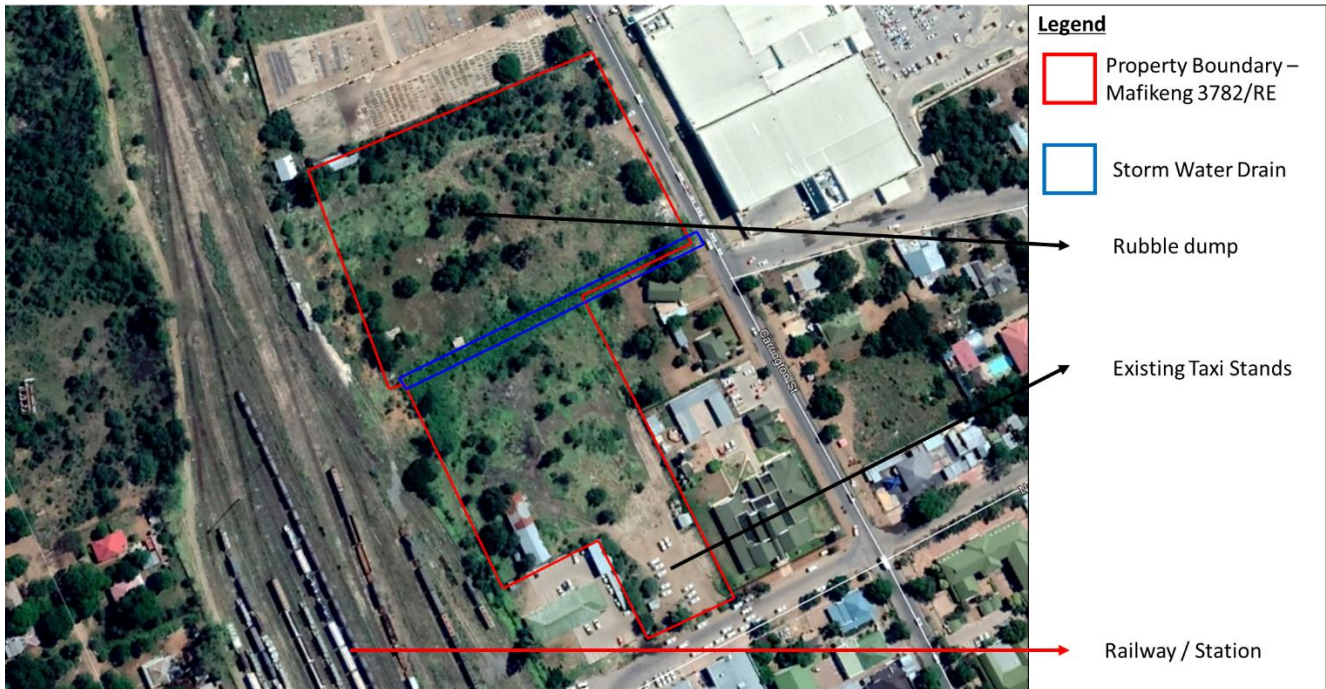
Figure 1: Site Layout

The proposed development on property Mafikeng 3782/RE, is situated in the middle of the town Mafikeng and surrounded by the Industrial Area to the North, a railway system to the West and Commercial/Residential areas to the East. The site is highly degraded and was confirmed during the site visit that the whole area was used to dump rubble. The centre of the site contains a large open storm water drain which contains water that seem to be highly polluted. Only the south section of the site is currently used as a taxi stand/ holding area.

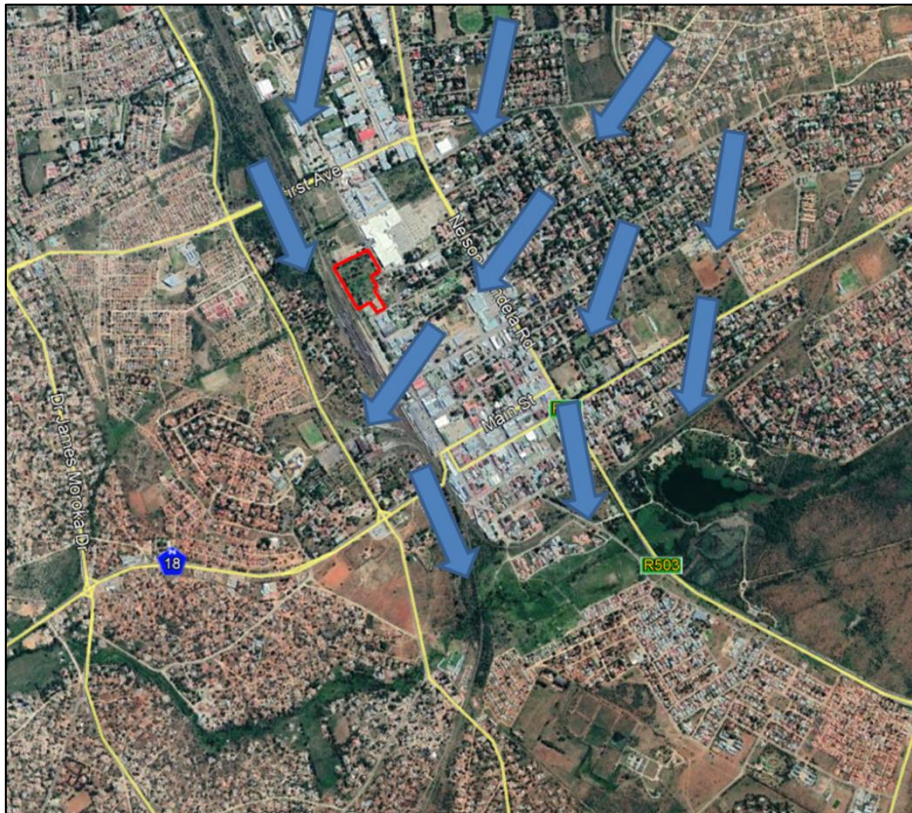
Figure 3: The red polygon indicates the proposed site and the blue arrows indicated inferred flow direction.

The proposed site is situated in the middle of Mahikeng next to a major railway section. The site itself is fairly flat (due to the small size), but slightly slopes in a South West direction towards the railway. The site is also very uneven as a result of past construction rubble dumping that took place. **Figure 2** shows a cross-sectional profile view from a North – South and West – East direction. These elevation profile shows that the whole area of Mahikeng slopes towards the Molopo River, South of the proposed site and seen in **Figure 3** which shows the general drainage direction. The general slope is ranges between 0 – 2% but increases to 2 – 6% when approaching the Molopo River.

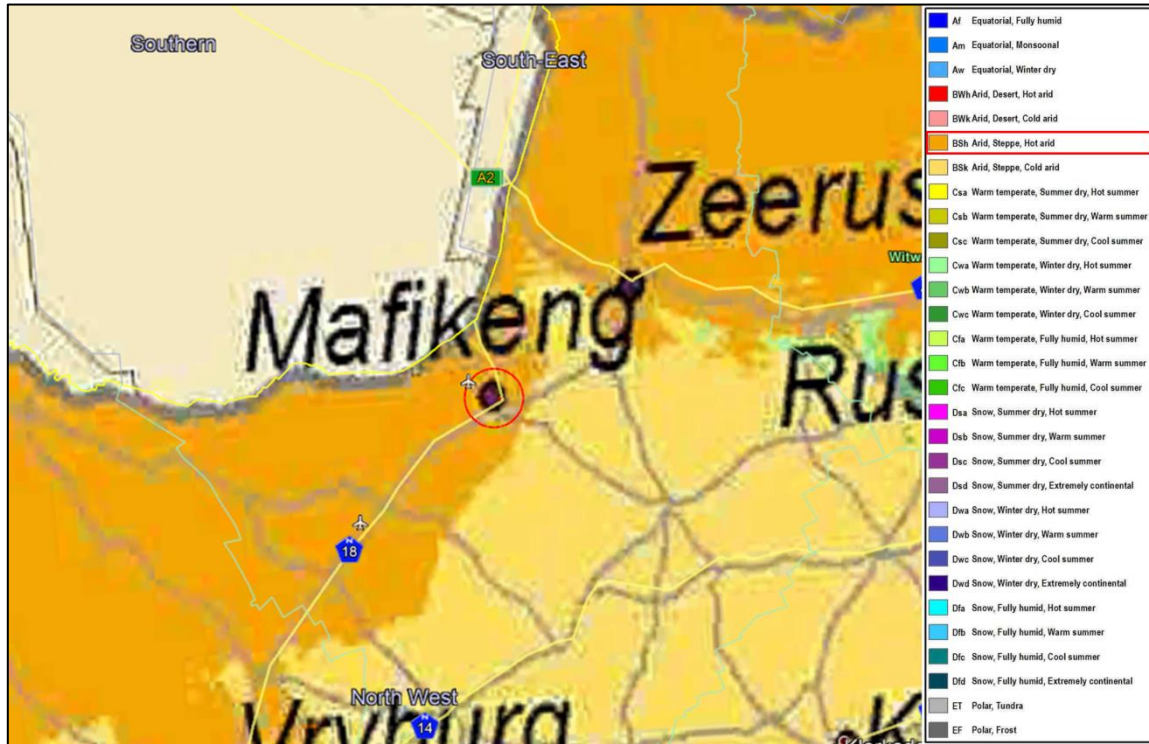
“The Koppen Climate Classification subtype for this climate is "Bsh". (Mid-Latitude Steppe and Desert Climate). (*Weatherbase.com*) (Figure 4).

Figure 4: Figure showing the locality of the site and its Koppen Geiger classification zone.

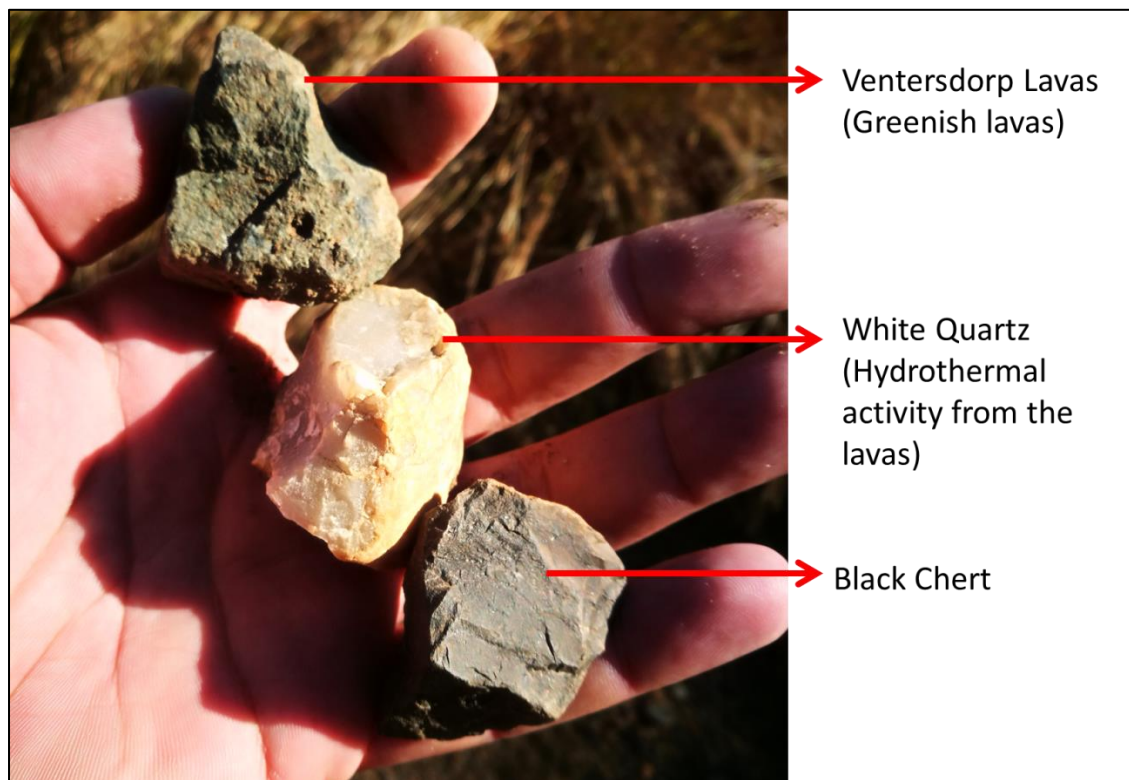
Figure 7: Rock types on site

It can be said with a fair amount of certainty that the underlying geology consists of Green Ventersdorp lavas, and due to the hard and resistant nature of the rock, the aquifer will most likely be a fracture aquifer.

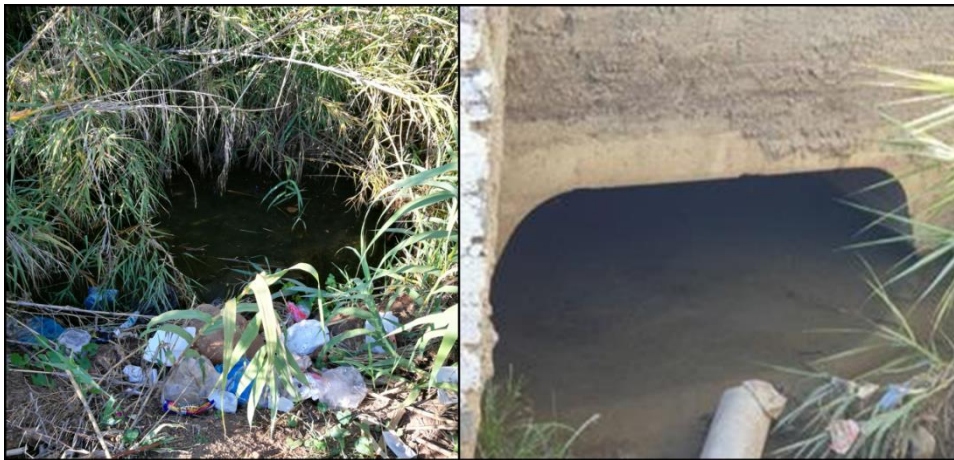
Figure 9: Photographic evidence during the site visit of the storm water drain on site.

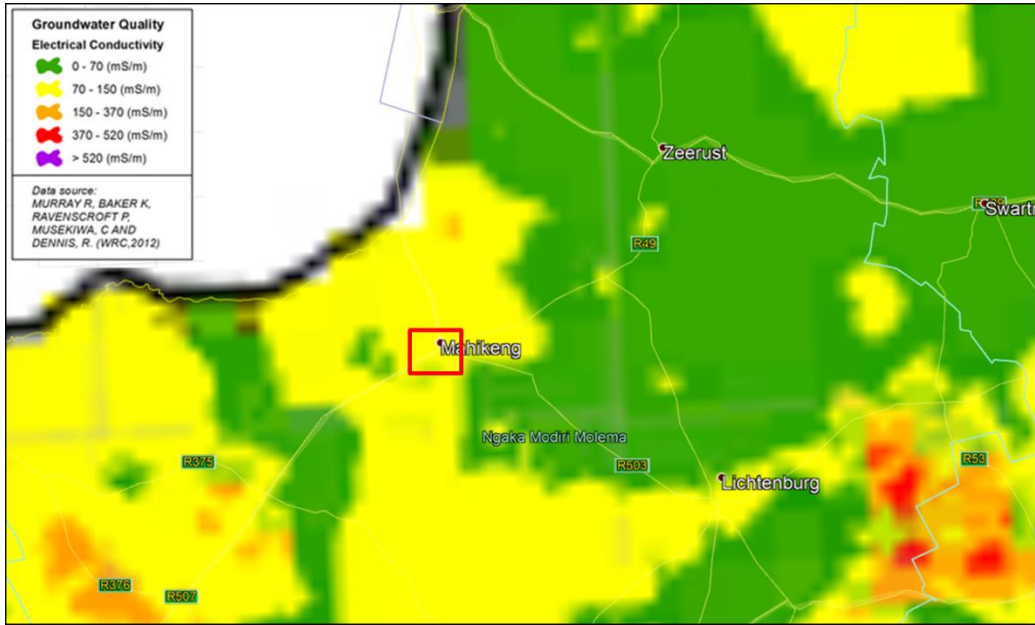
Figure 10: Map indicating average quality of ground water resources in Mahikeng.

The desktop study (**Figure 10**) indicates that the electrical conductivity ("salts indicator") is between 70 -150 mS/m, which is classified as being the standard for groundwater. However the site is situated in the centre of a highly populated Mahikeng and right next to a working train yard/ railway. It is thus expected that the quality of water will be poor and not suitable for human use.
