GEOLOGICAL REPORT

SPECIALIST INPUT FOR THE SCOPING PHASE OF THE ENVIRONMENTAL IMPACT ASSESSMENT

PROPOSED OYSTER BAY WIND ENERGY FACILITY ON A SITE NEAR OYSTER BAY, EASTERN CAPE PROVINCE

Technical Report No: OGS2010-11-11-1

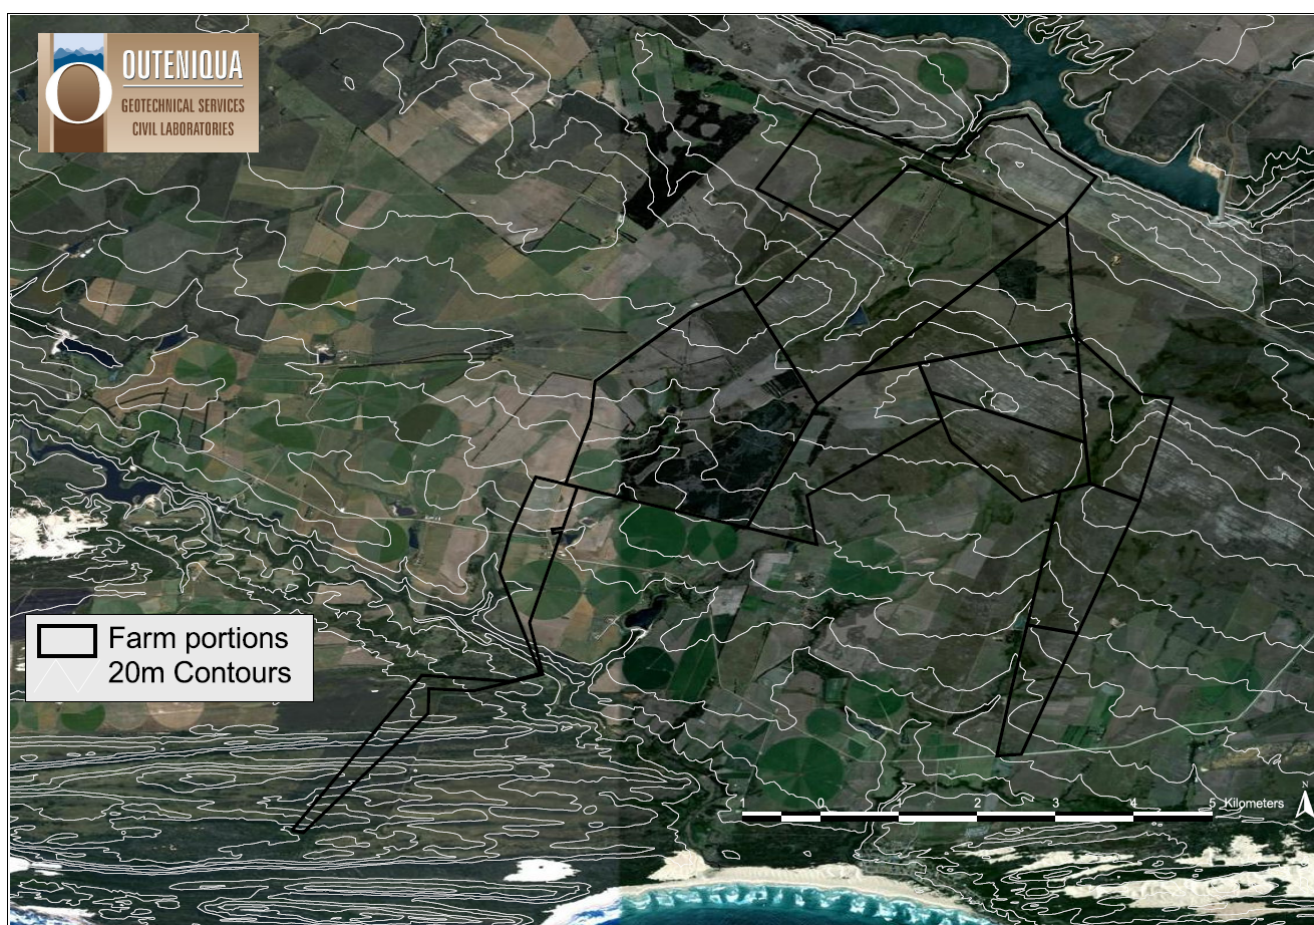
Figure 2: Aerial photo of the study area (black lines) with 20m contours (white)

The study area is located on hilly terrain ranging in altitude from 60 to 190m AMSL. The majority of the study area lies between the Krom River and Klipdrif Rivers with only a small portion extending south-westwards across the Klipdrif River (See **Figure 2**).
