**BRIEF GEOTECHNICAL STUDY
FOR PROPOSED TSHEPO SOLAR POWER PLANT
NEAR HOTAZEL
NORTHERN CAPE PROVINCE**

**Report by
Johann Lanz**

June 2016

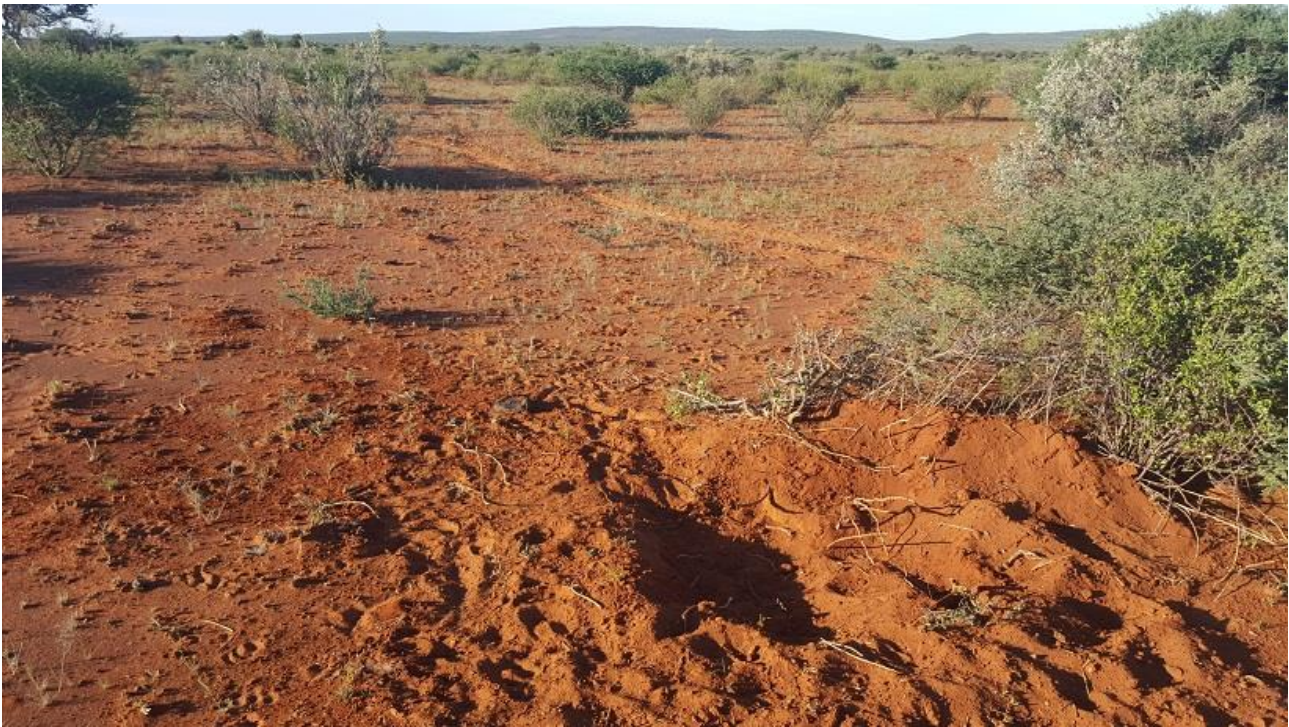
Figure 5. View of typical conditions across the site, showing the predominant deep, red sands.

The proposed development is located on a terrain unit of level plains at an altitude of around 1,100 meters. Slope is less than 1% across the site. A satellite image map of the site is shown in Figure 3. Access roads and grid connections are shown in Figure 4. Photographs of site conditions are shown in Figures 5 and 6.

The site predominantly comprises deep, largely unconsolidated, red sands, but there is evidence of hard, shallow underlying rock and outcrops in places. The depth of the rock below surface across most of the site is unknown, but from the land type data it can be estimated to be between 60 and 150cm across much of the site.

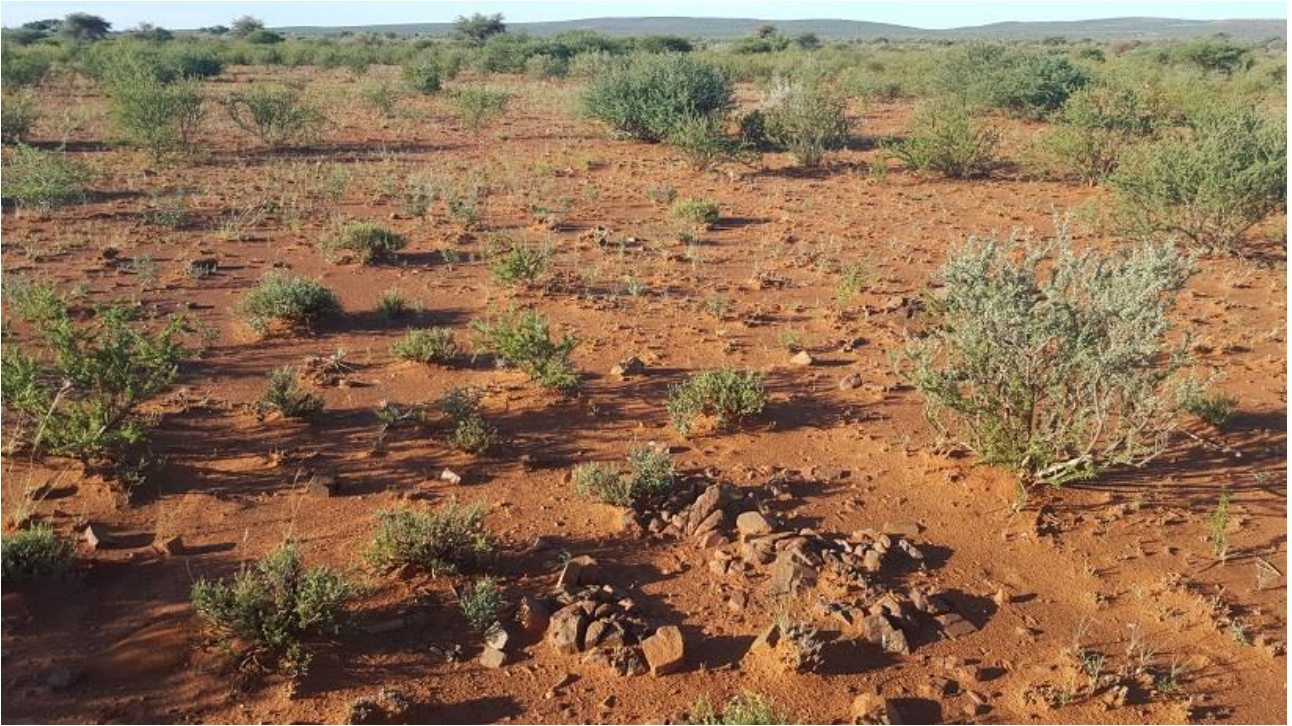
Figure 6. View of typical conditions across the site, showing overlying red sands with rock outcrops.

The land type classification is a nationwide survey that groups areas of similar soil, terrain and climate conditions into different land types. There are two land types across the site, namely Ah9 in the west and Ae1 in the east. Soils of both land types are very similar and are predominantly deep, well-drained, very sandy red and yellow soils of the Hutton and Clovelly soil forms, although some shallower soils on underlying rock and hardpan occur in land type Ae1. The soils fall into the Oxidic soil group according to the classification of Fey (2010). A summary detailing soil data for the land type is provided in Appendix 1, Table A1. The field investigation confirmed that the site comprises predominantly red sands, but there is evidence of shallow underlying rock and outcrops in places (see Figure 5).

The foundations for mounting structures will need to be erected in sand, but may also need to go into hard underlying rock in places.
