ZITHOLELE CONSULTING ON BEHALF OF ESKOM HOLDINGS

**D615 - SOLAR INTEGRATION PROJECT
ENVIRONMENTAL IMPACT ASSESSMENT
DRAFT BIOPHYSICAL REPORT**

Report No.: JW194/12/D615

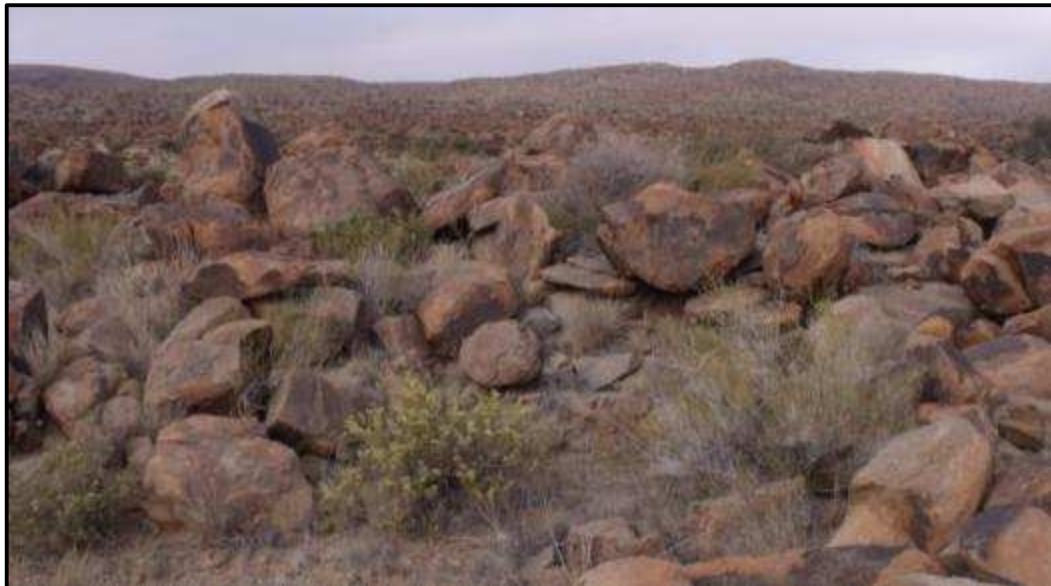
As shown on the Soils map for the study area there are two rocky soil types. The first is rocky areas with miscellaneous soils and the second is hard rock areas. In both cases the rock originates from shallow geology found throughout the study area. In the east of the study area the hard rock areas originate from the Langeberge and some isolated outcrops en corridor to Upington. The first unit of miscellaneous soils with rocky areas are found closer to the Orange River and is associated with the Inselbergs that can be found throughout the area. The soil forms that are found in these areas are illustrated below. These include the Mispah and Glenrosa soil forms and both are characterised by their shallow nature overlying a hard layer.

Figure 4-7: Rocky areas on site, just south of the Orange River.

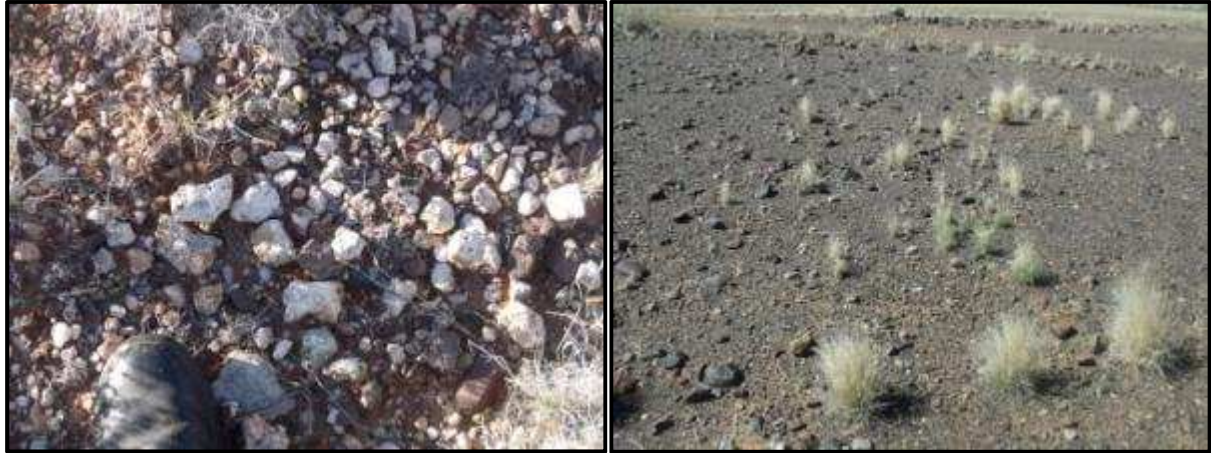
As the red sands of the Kalahari recede the soils begin to become more diverse. These areas have a variety of soils including shallow calcrete, gravel plains and red or brown soils. Below are photos of the soils found in these areas.

Figure 4-11: Mixed shallow soils on site.

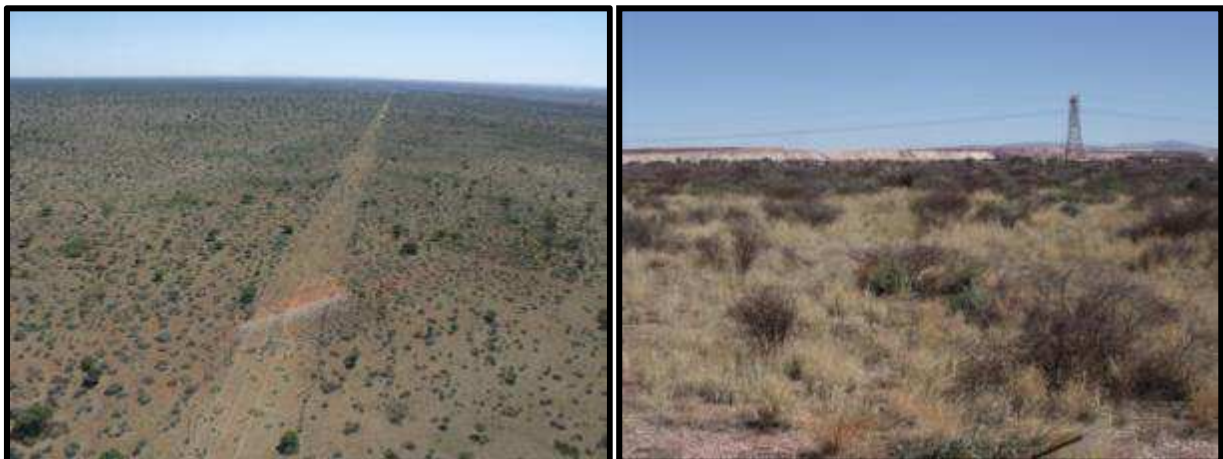
Figure 4-23: Kathu Bushveld showing the vegetation as well as the impact of an existing power line.

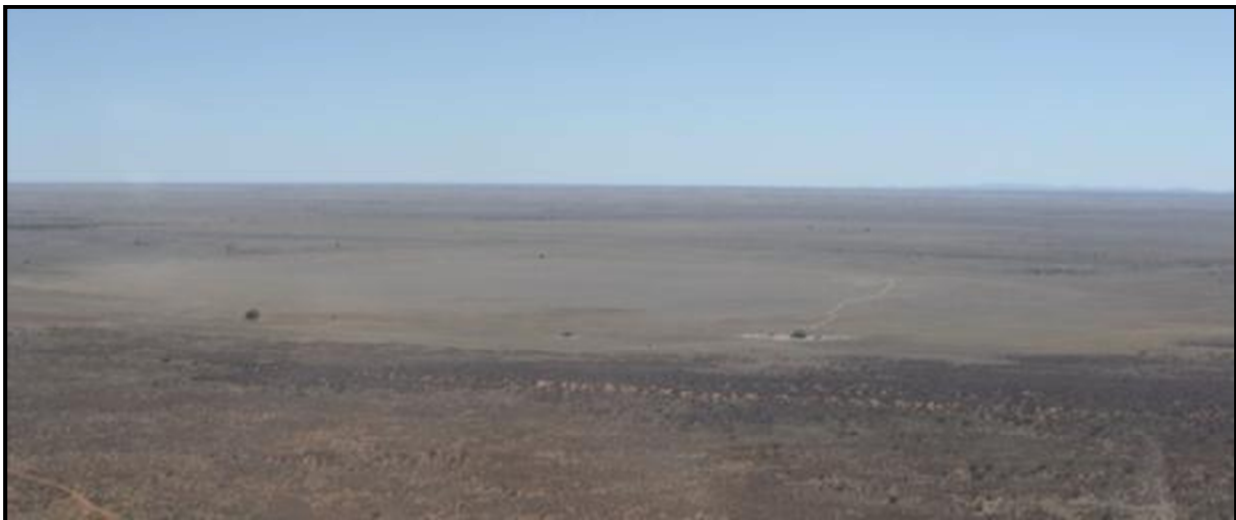
Figure 4-27: The salt pan found along the Ferrum-Solar 1 Corridor

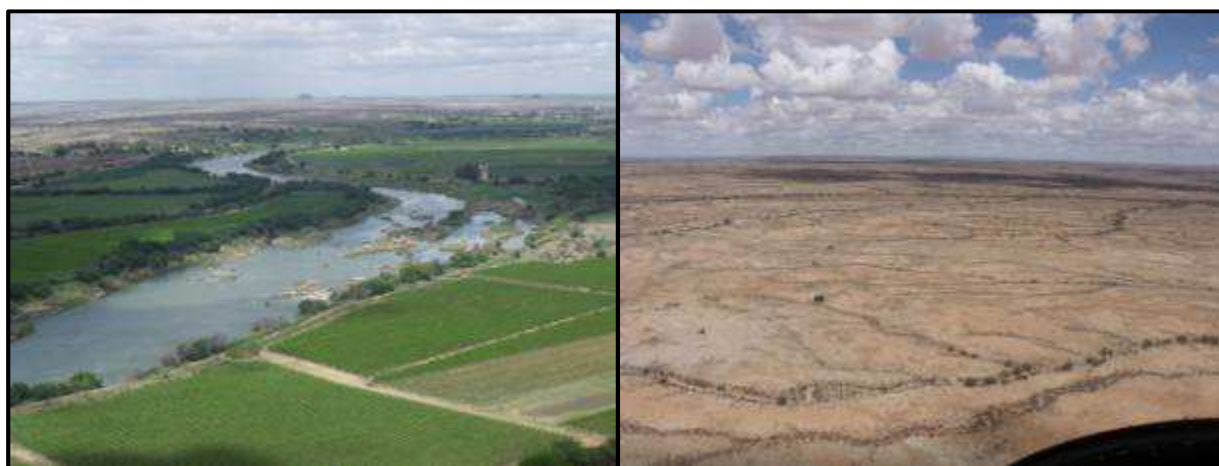
Figure 4-42 illustrates the surface water bodies identified. It should be noted that although the area has a few rivers identified, the only perennial river is the Orange River. The rest of the study area is very arid, and the bulk of the drainage features are drainage lines with sandy beds that can be identified by the concentration of vegetation in these areas. These areas do not however classify as wetlands as they have no signs of wetness within the top 50cm of the soil profile. Please refer to the photographs below for a view of the Orange River as well as the dry drainage lines found on site.

Figure 4-42: Surface Water features on site.

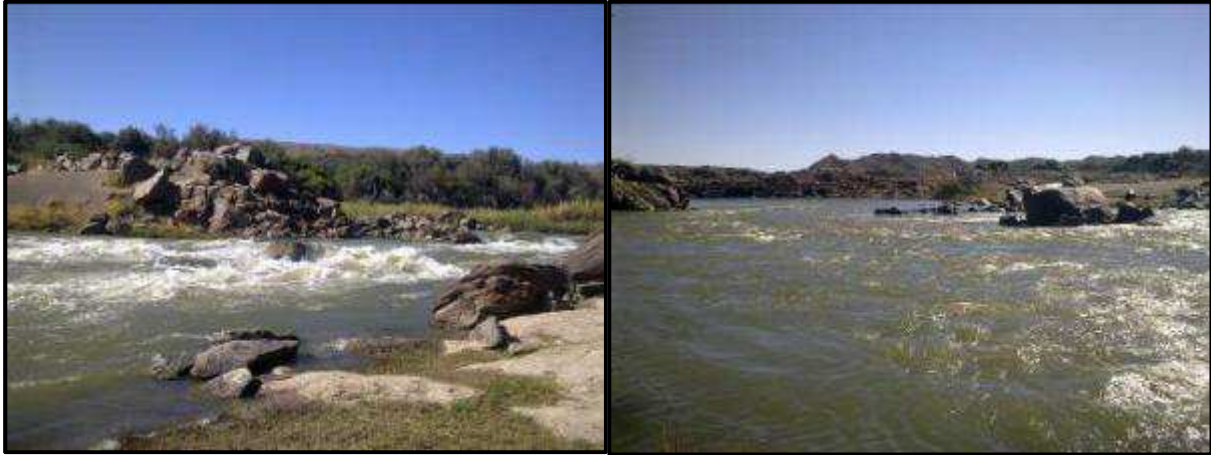
Figure 4-49: C1 site upstream (left) and downstream (right).

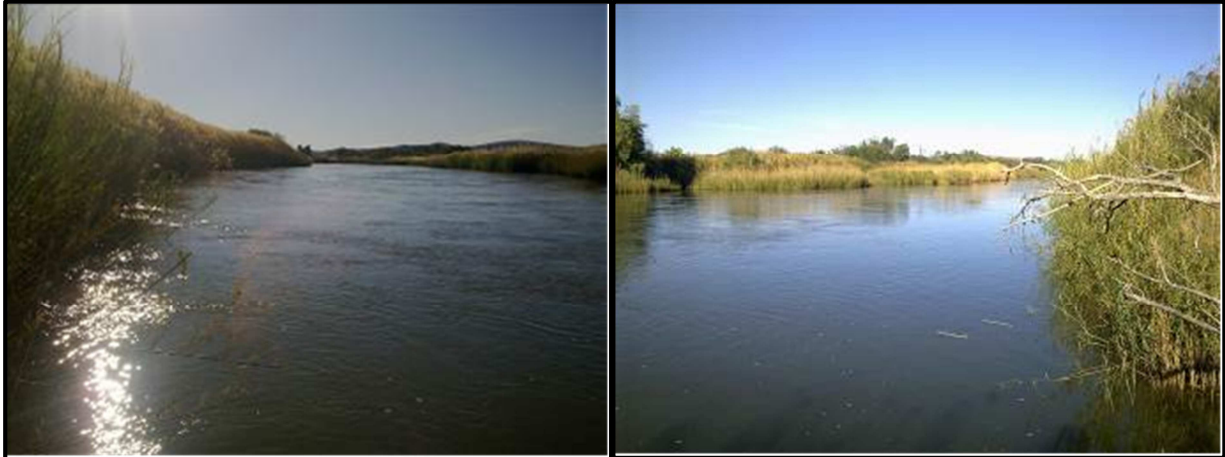
Figure 4-51: C2 site upstream (left) and downstream (right).

- Upstream view indicating moderately deep system with slow flowing water; and
- Downstream view showing the abundant marginal vegetation at the site.

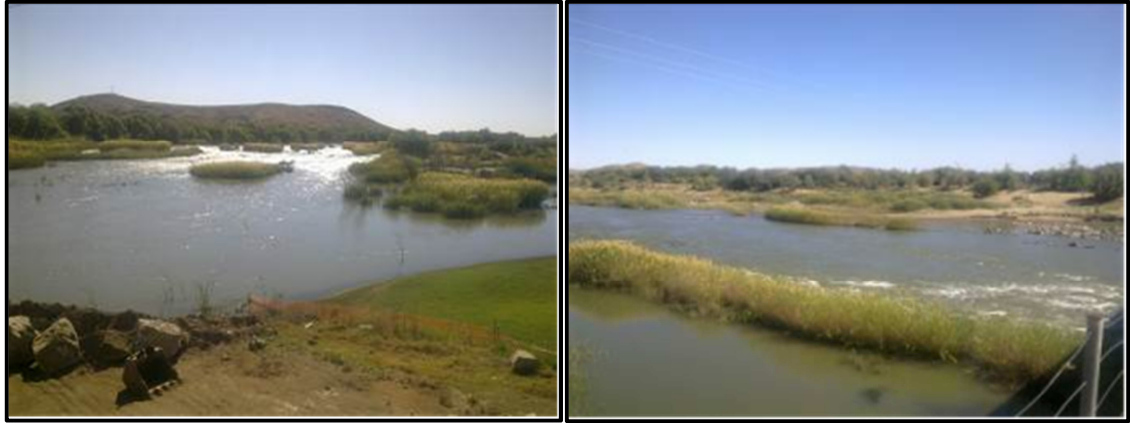
Figure 4-53: View upstream (left) and downstream (right) of C3.

Based on these findings, this crossing point is not recommended as a suitable alternative to cross the Orange River unless it occurs to the west of the existing road crossing. A crossing to the east of the existing road crossing is not deemed suitable unless extensive measures to minimise the impacts on the riparian vegetation and instream habitat can be implemented and that riparian vegetation can be rehabilitated.

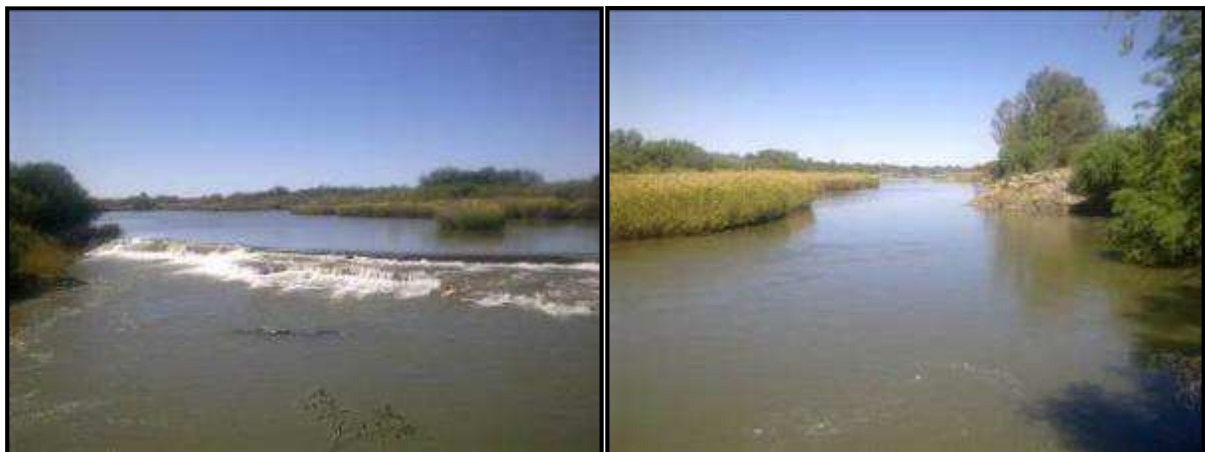
Figure 4-55: Views upstream (left) and downstream (right) at C4.

- Upstream view of the C4 site, indicating the impact from inundation caused by a small weir
- Downstream view of the C4 site showing the laminar flows in the system at this point

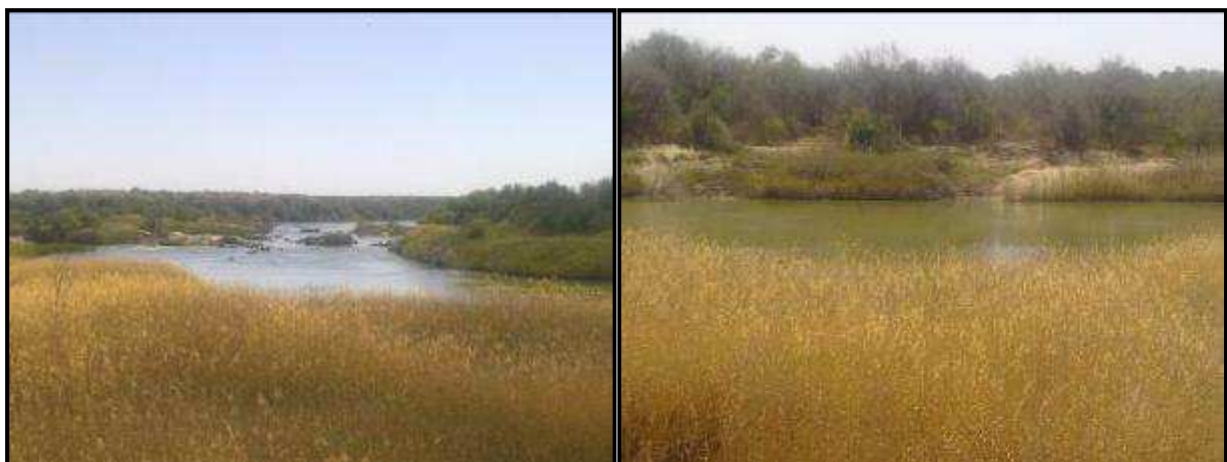
Figure 4-57: Views upstream (left) and downstream (right) at C5.

- Upstream view of the C5 site, indicating rocky rapids and abundant bankside vegetation cover.
- Downstream view of the C5 site showing the slow flowing river and bankside cover.

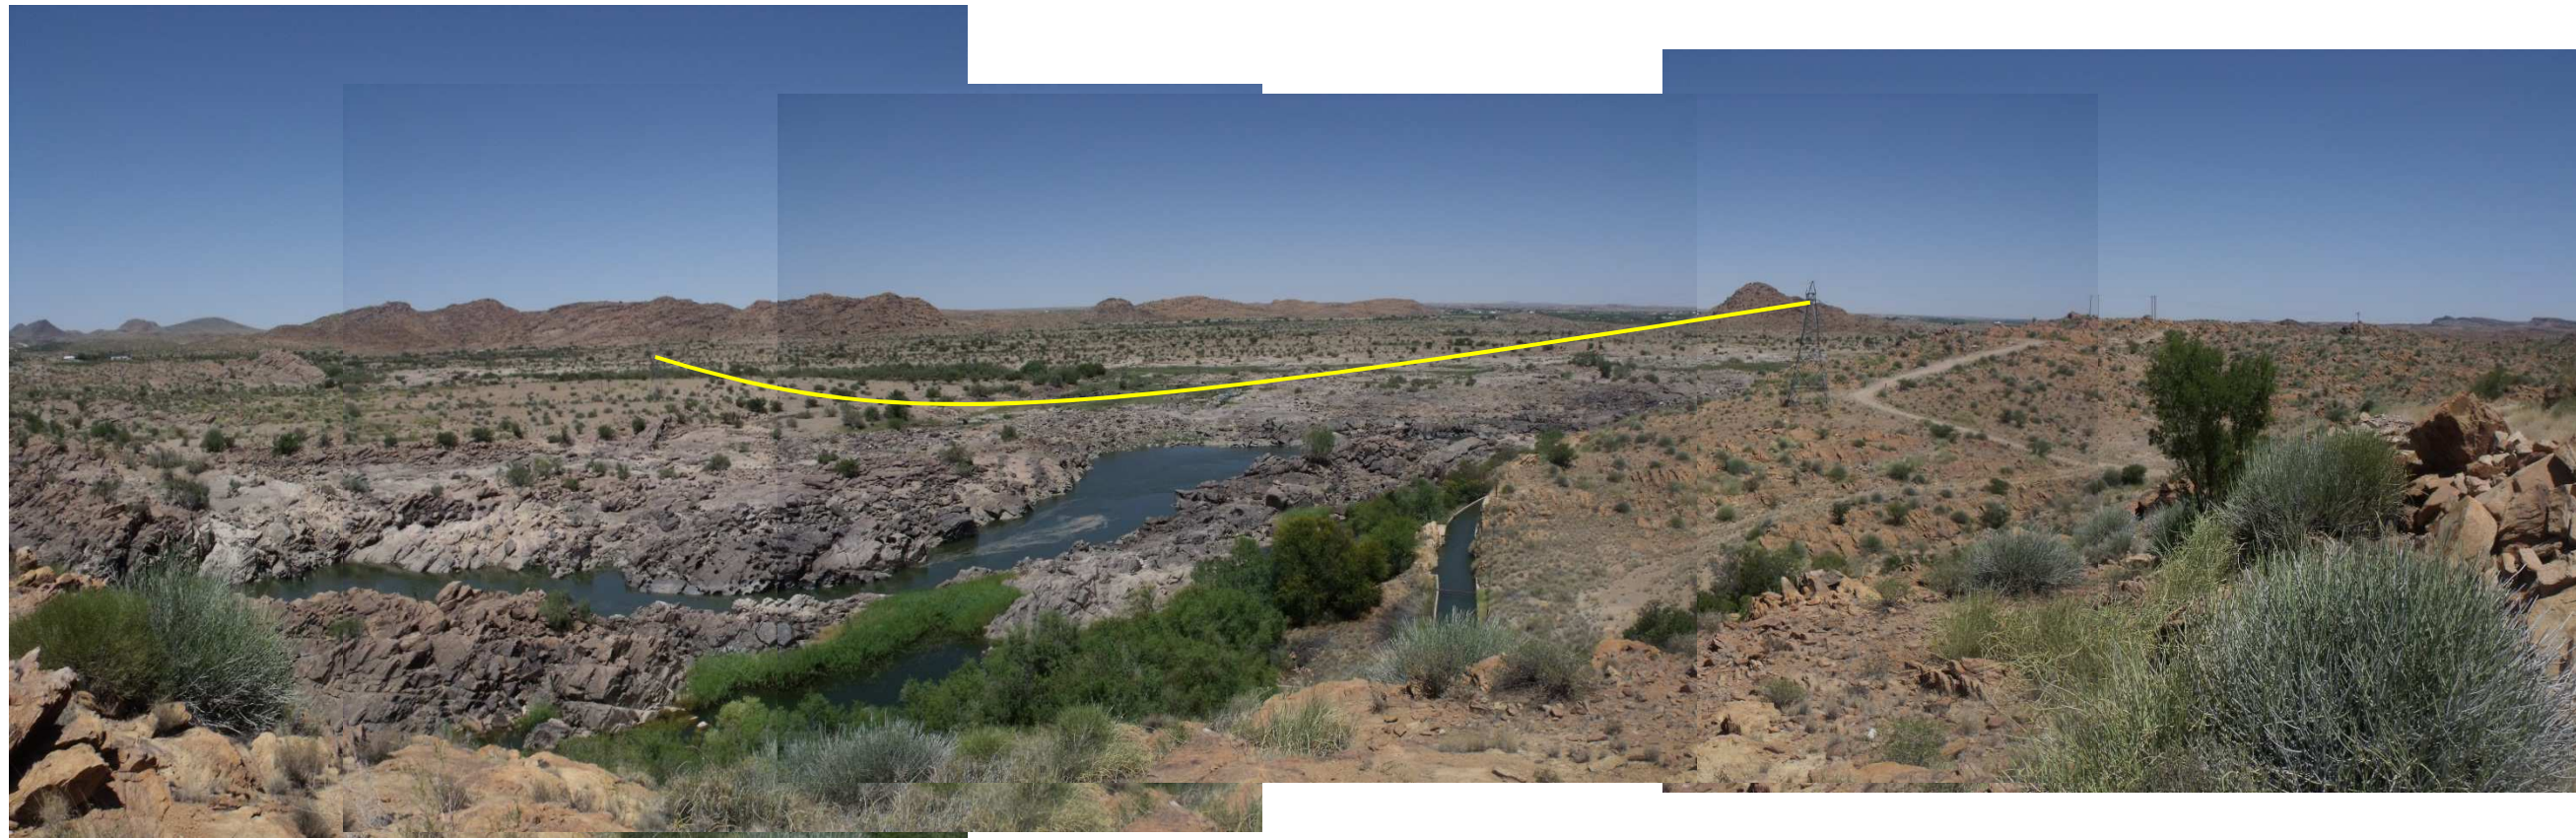
Figure 5-3: Proposed River Crossings (Aries Corridor 1A (top) and Nieuwehoop Corridor 1 (below))

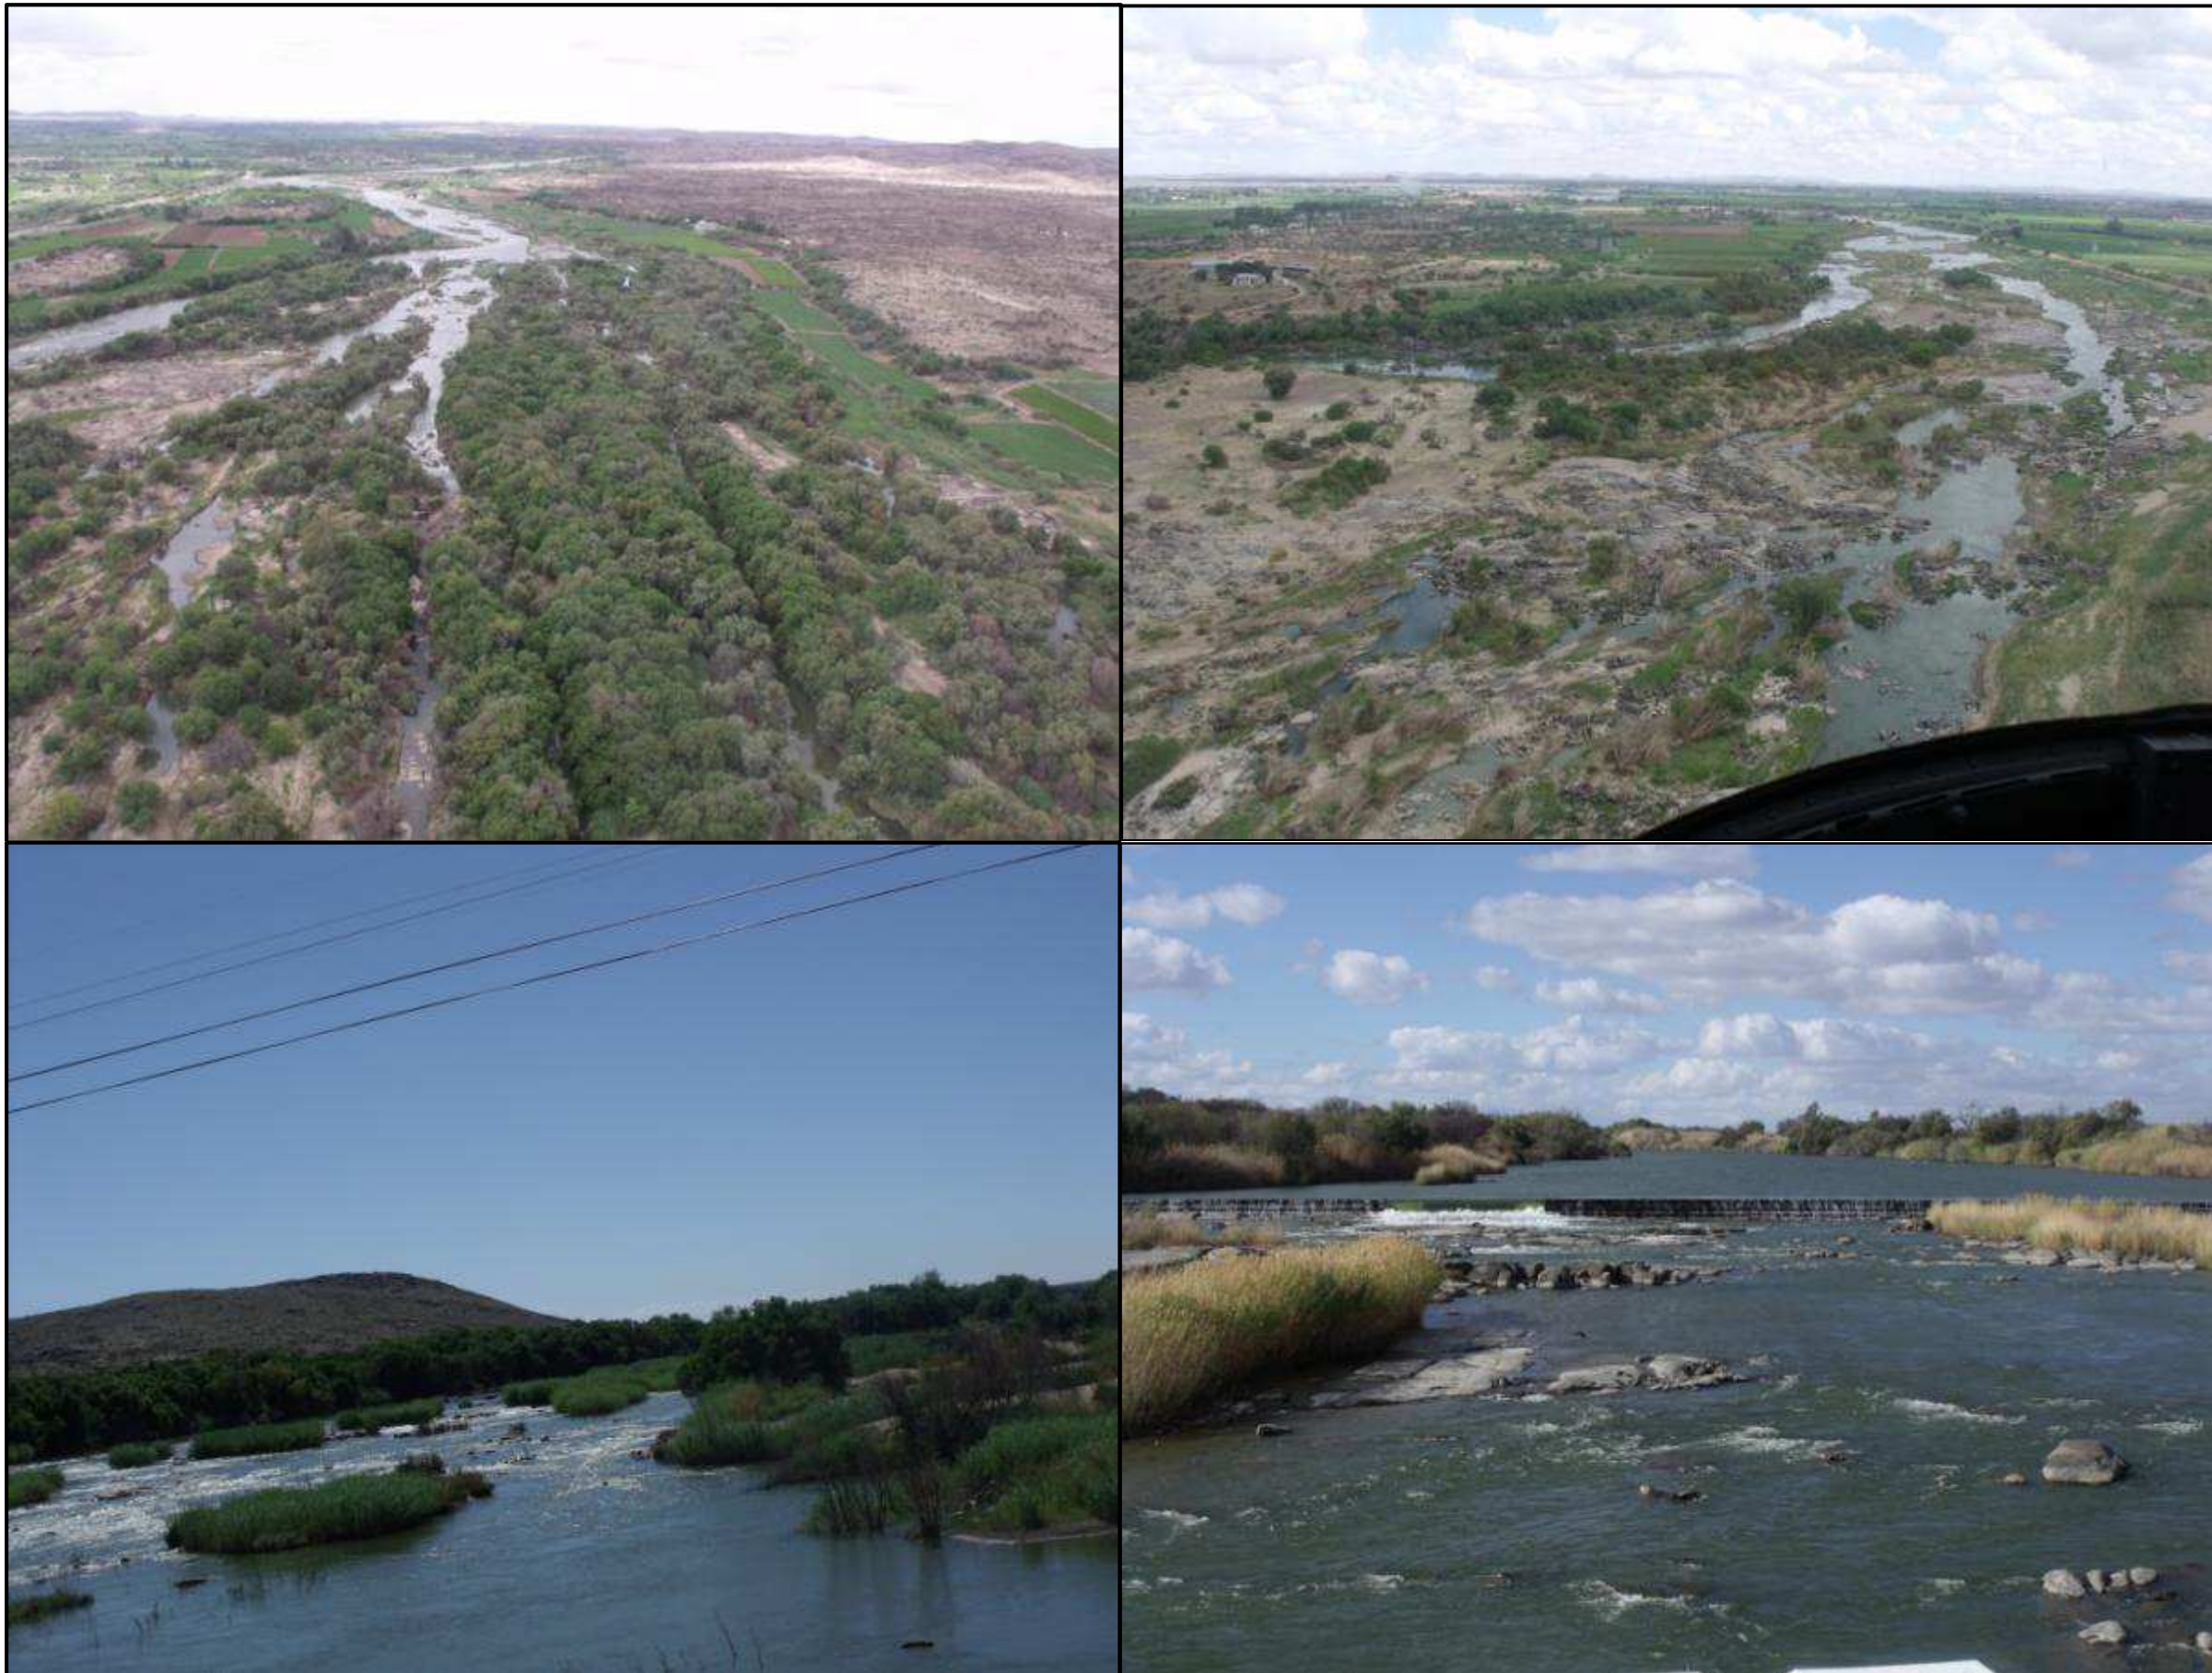
Figure 5-4: Proposed River Crossings not recommended (Aries 2 (top left), Nieuwehoop 3 (top right), Aries 3 (bottom left) and Nieuwehoop 2 (bottom right))
