A HYDROLOGICAL IMPACT ASSESSMENT FOR THE KHUBU SOLAR POWER PLANT, VRYBURG, NORTHWEST PROVINCE

Khubu Solar Power Plant (RF) (Pty) Ltd.

REPORT NO. EM4603 MARCH 2016

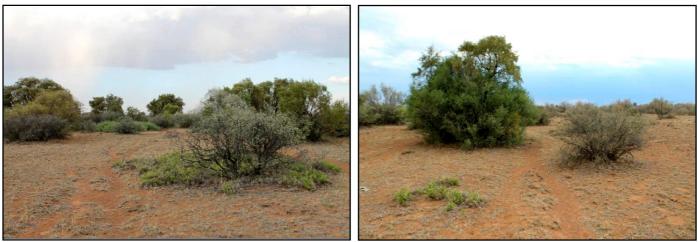
The small, perennial stream is depicted in the photos below. Note that there is no clear and distinct channel that clearly defines the borders of the stream. Furthermore, no floodline information is available for this stream.

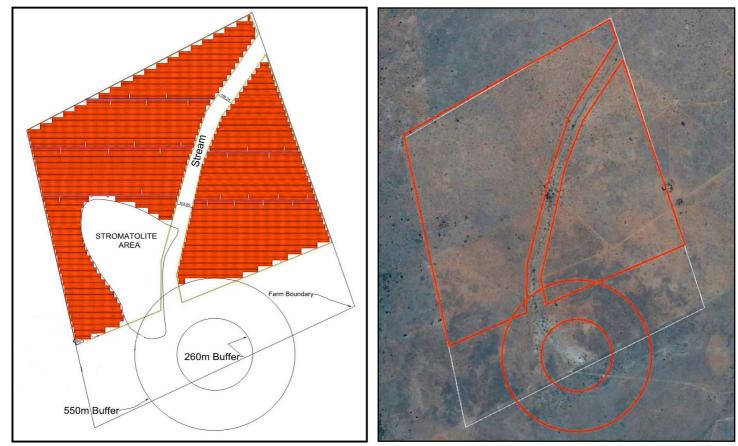
Figure 6: Two schematic drawings of the proposed layout of the Kbubu SPP. Note the buffer provided for the non-perennial stream and for the non-perennial pan.

- it has been stated that the buffer across the stream between the western and eastern arrays of solar panels is 32m on each side (Figure 6)
- a maximum buffer of 550m surrounding the pan is indicated (Figure 6)
