Appendix H.8

**HERITAGE IMPACT ASSESSMENT:
PROPOSED MURA 1-4 PV FACILITIES, BEAUFORT WEST
MAGISTERIAL DISTRICT, WESTERN CAPE AND VICTORIA
WEST MAGISTERIAL DISTRICT, NORTHERN CAPE**

Required under Section 38(8) of the National Heritage Resources Act (No. 25 of 1999)

Final report: 15 December 2022

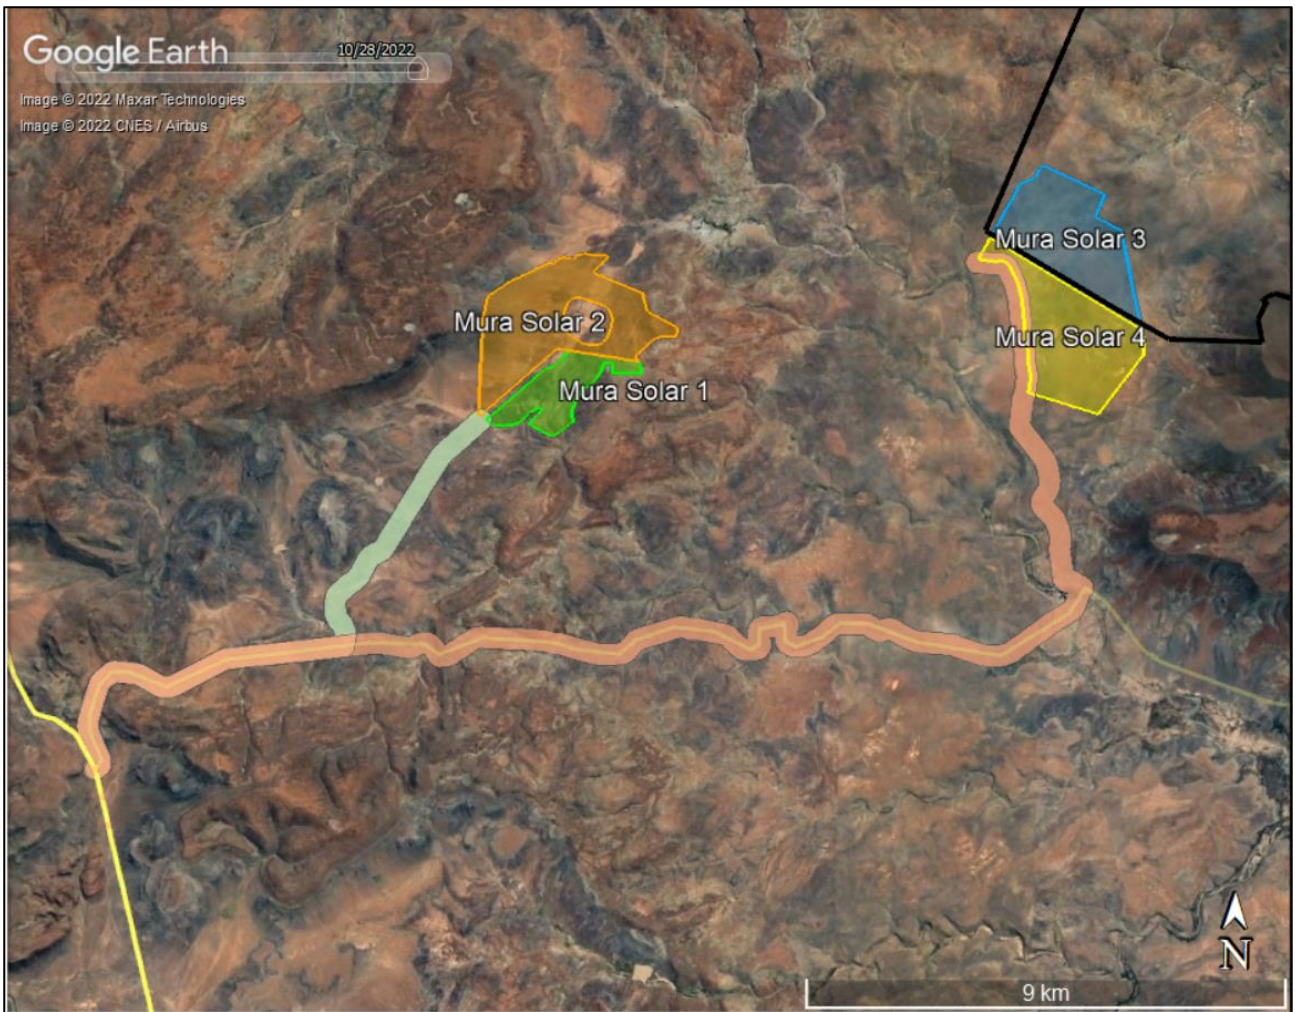
Figure 3: Aerial view showing the four study areas and their proposed access roads relative to the R381 (yellow line at left). The orange road corridor is the DR02317, while the green corridor is an unnamed smaller farm access road².

Figure 3 shows the study areas in their landscape context and also shows the roads that will be upgraded where necessary for access purposes.

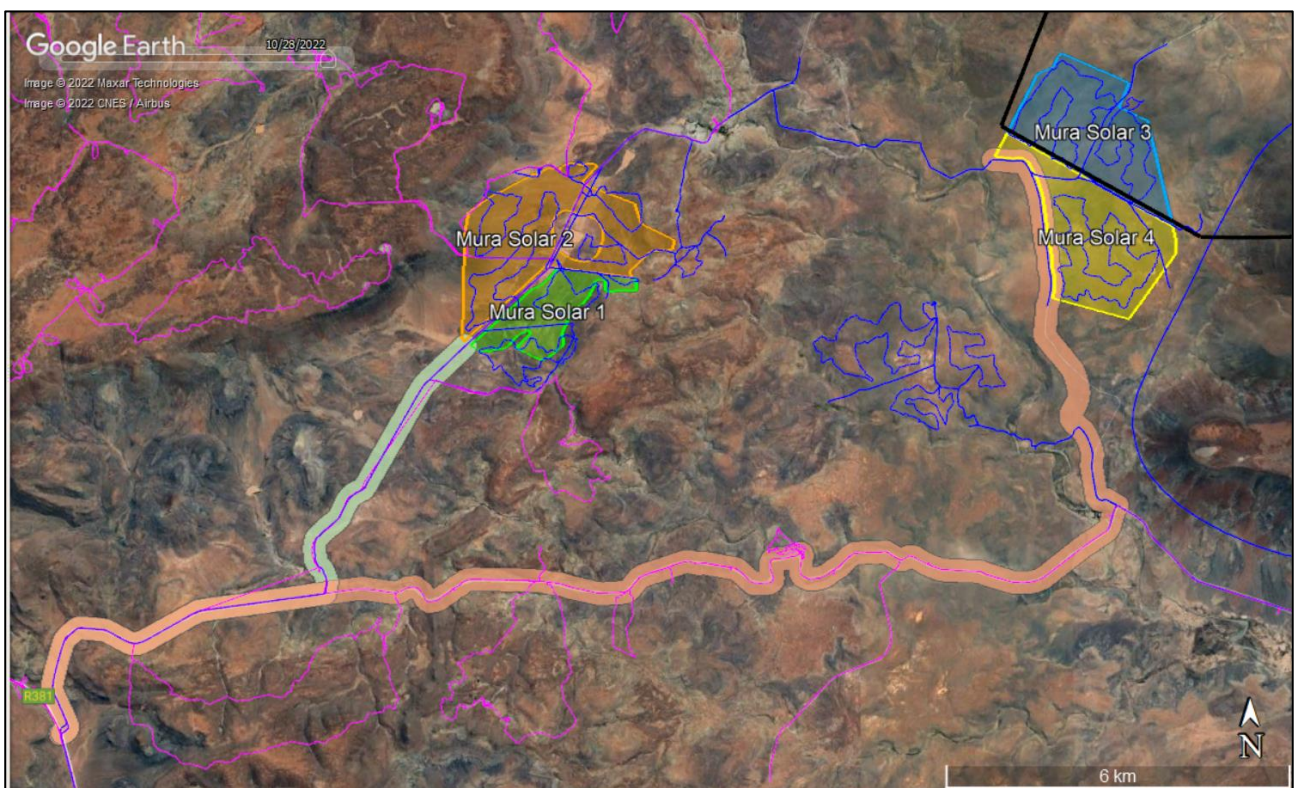
Figure 4: Aerial view of the study area (labelled coloured polygon) showing the survey tracks from 2019 (Nuweveld wind farm surveys, pink lines) and 2022 (current project surveys; blue lines).

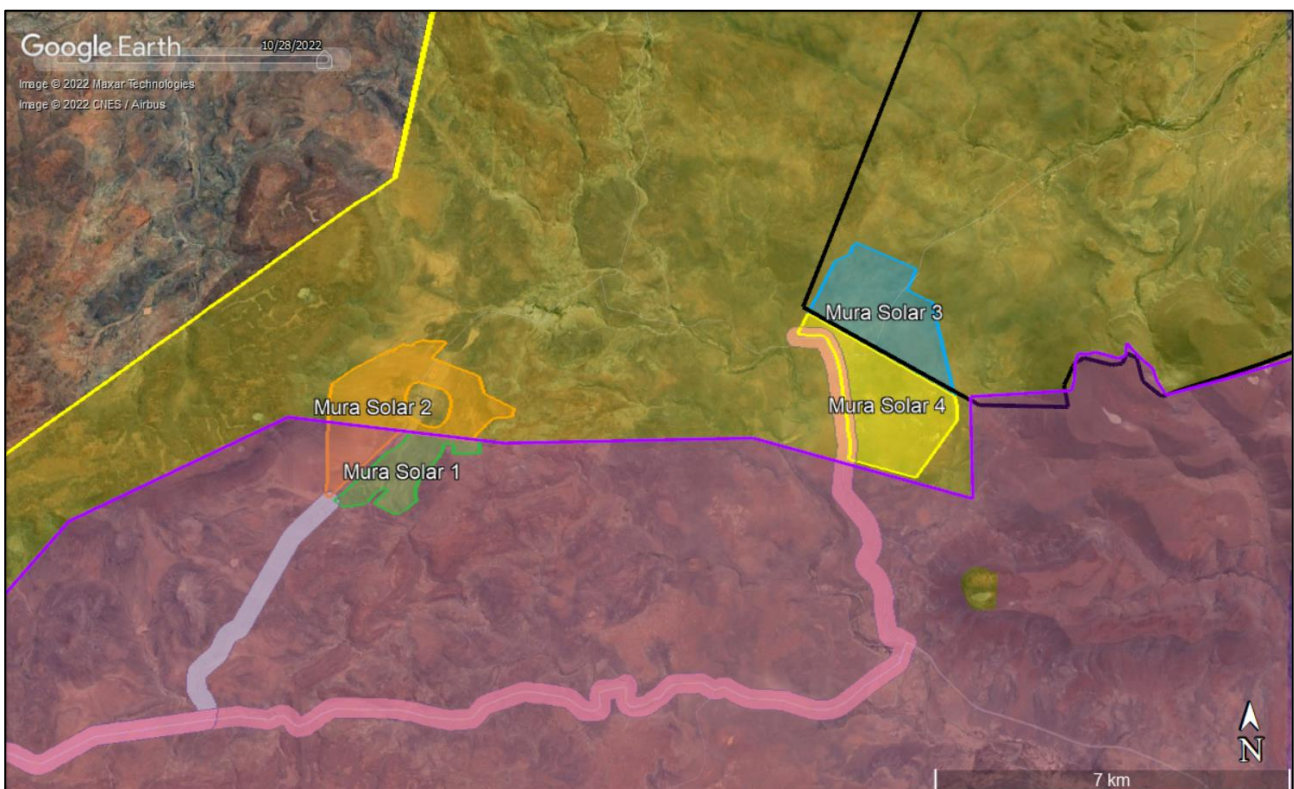
Figure 5: Aerial view of the four study areas showing the extent of the Beaufort West REDZ (purple shading) and the Central EGI Corridor (yellow shading).

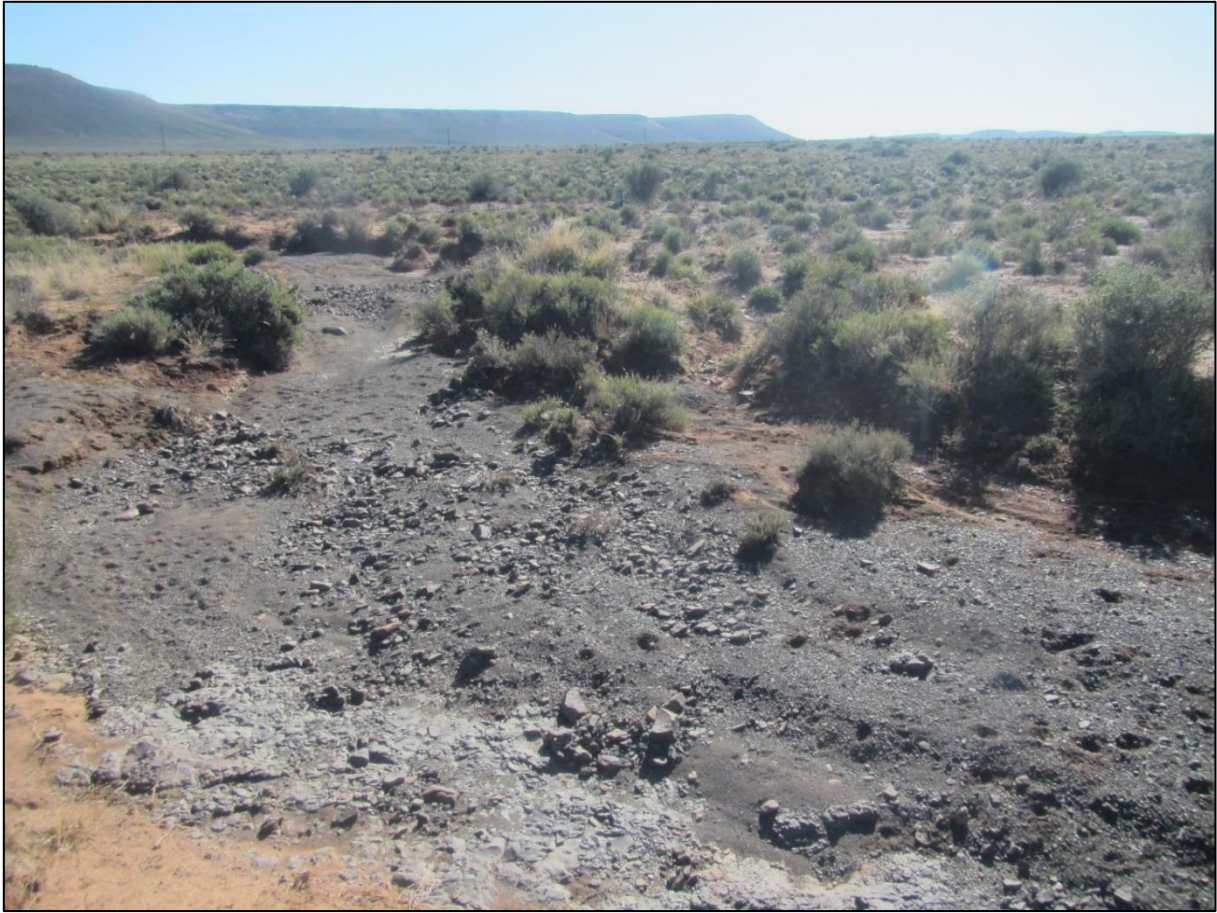
Figure 6: Looking north across a stream bed at the southern edge of Mura 1. The Mura 1 and Mura 2 facilities would be on the very flat terrain in the background.

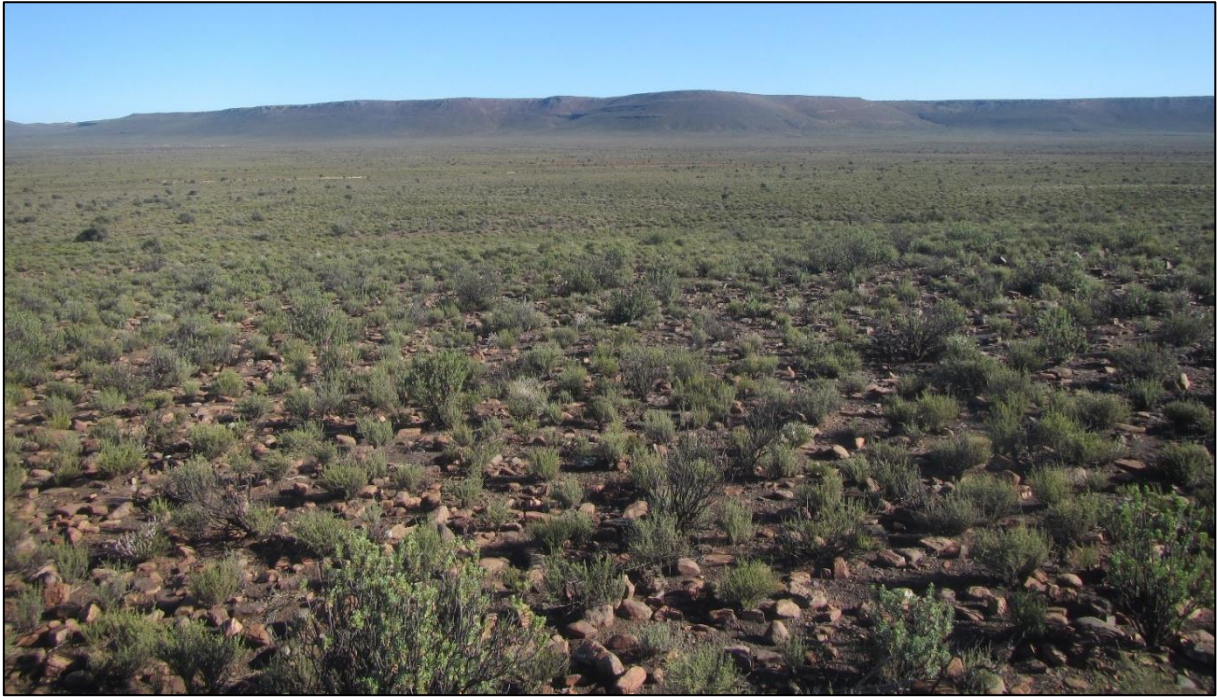
Figure 7: Looking west across the southern part of Mura 1 from immediately outside its eastern boundary showing the flat terrain chosen for development.

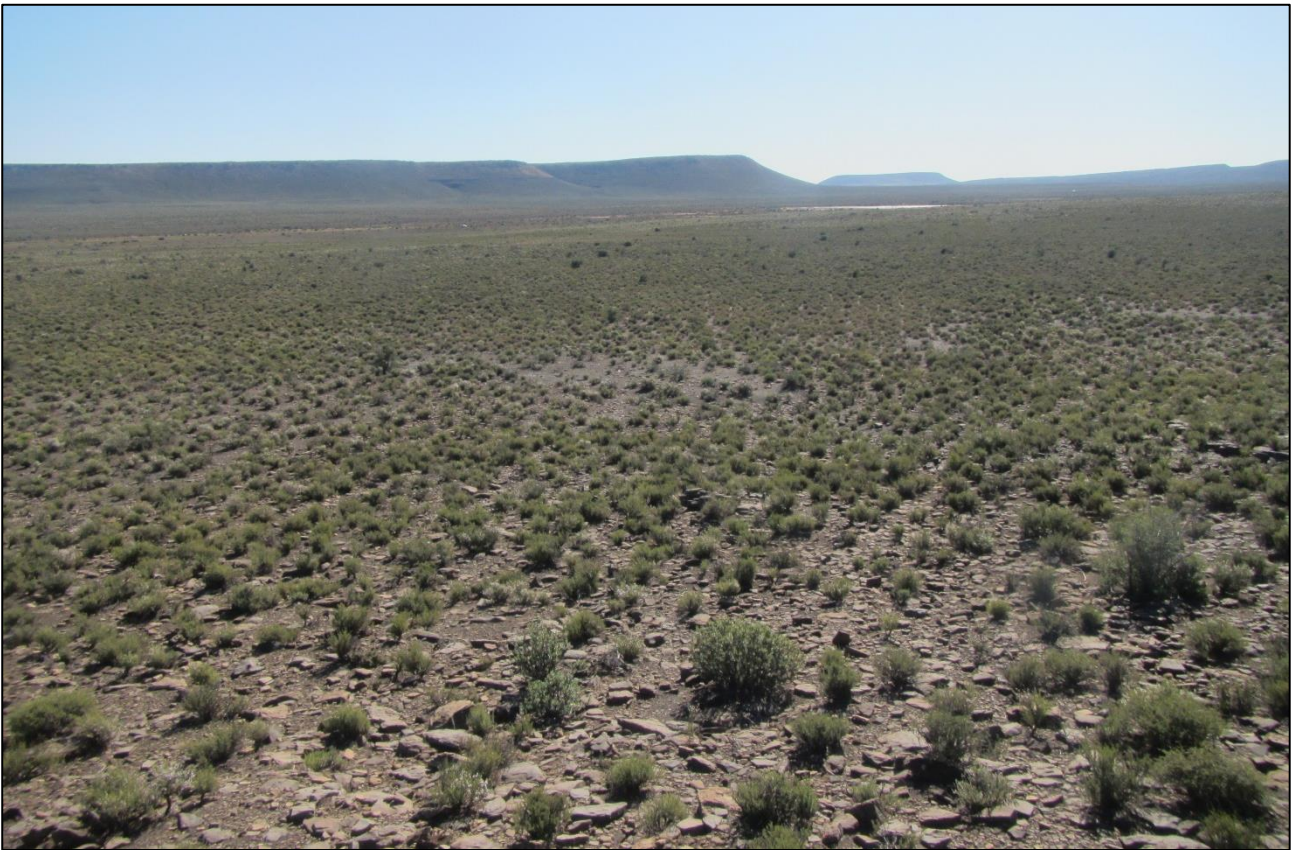
Figure 8: Looking north through the north-eastern part of Mura 1 showing the flat terrain chosen for development.

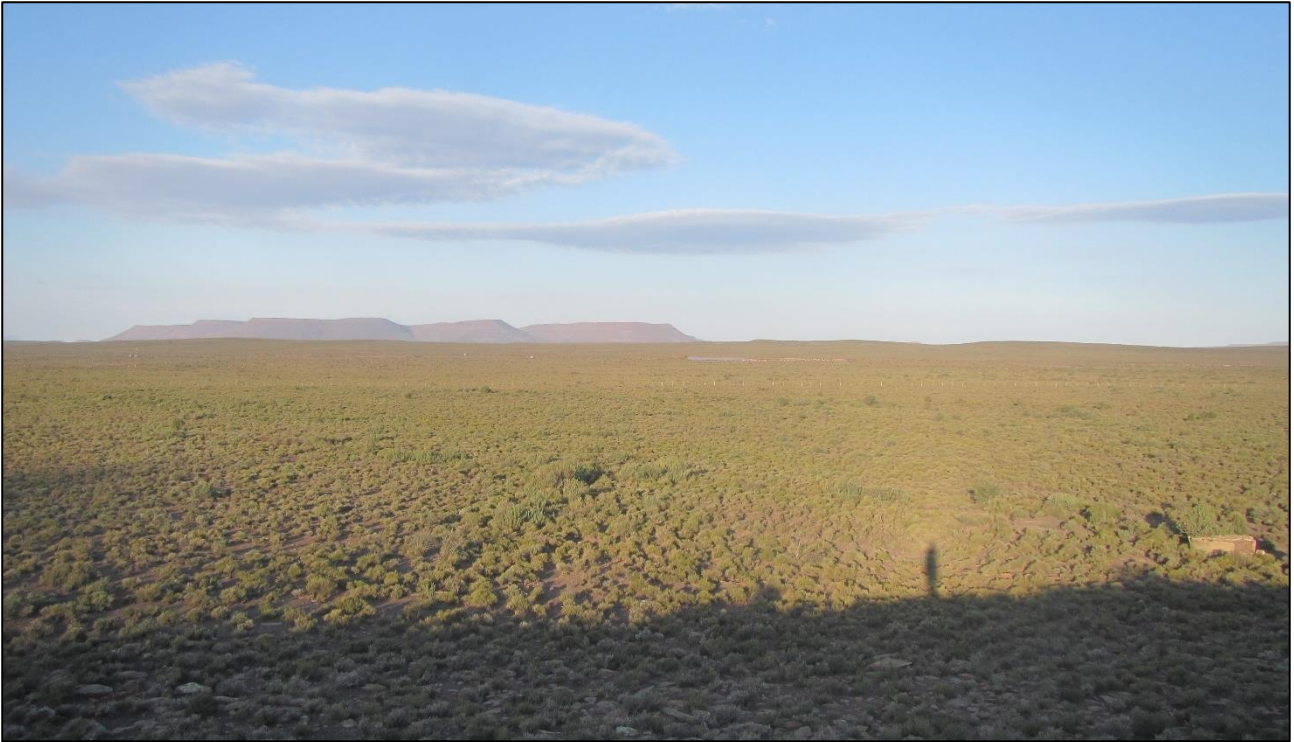
Figure 9: View towards the east from the western edge of Mura 2 showing the very flat plain chosen for development.

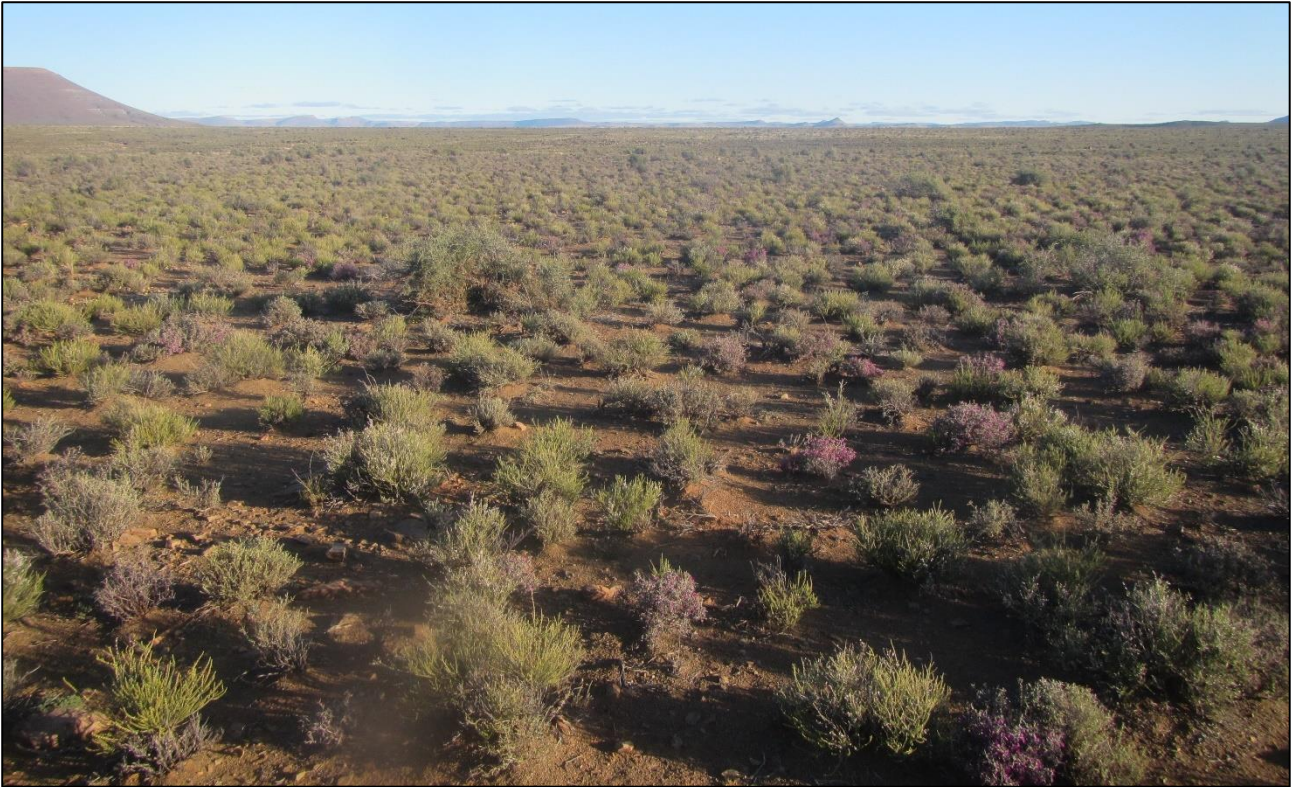
Figure 11: View towards the south from the north-eastern edge of Mura 3 showing a rocky substrate in this area.

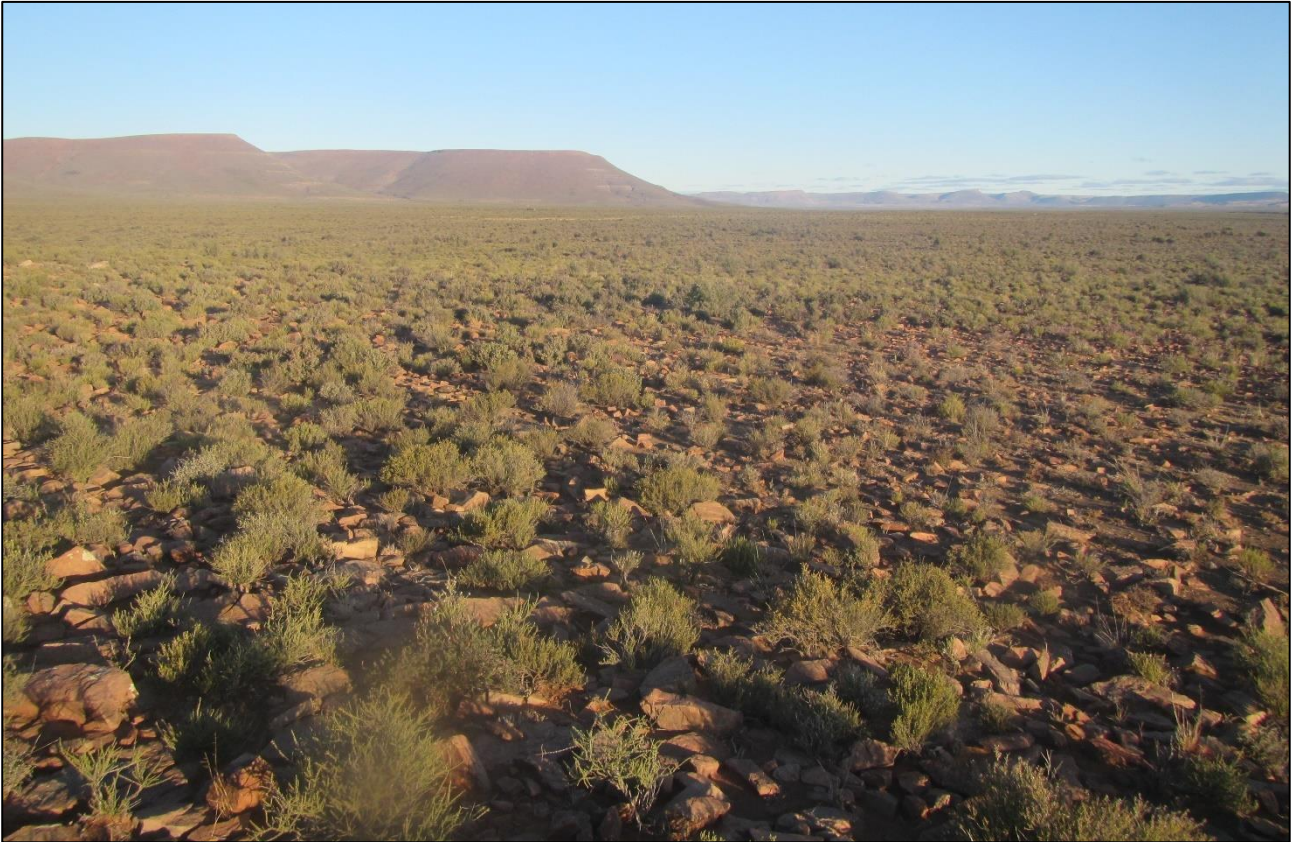
Figure 12: View towards the south from the western edge of Mura 3 showing a rocky substrate in this area.

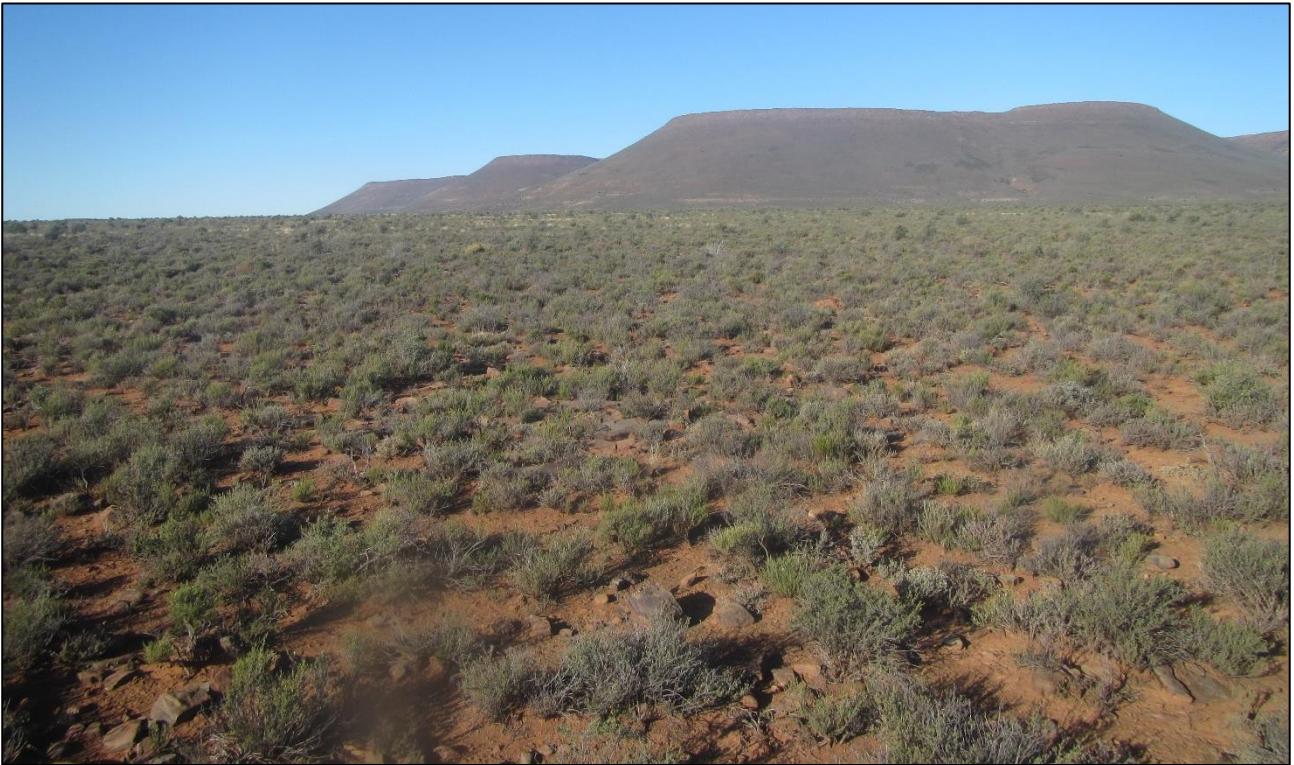
Figure 13: Looking east through the southern part of Mura 3 with the Perdeberg massif in the background.

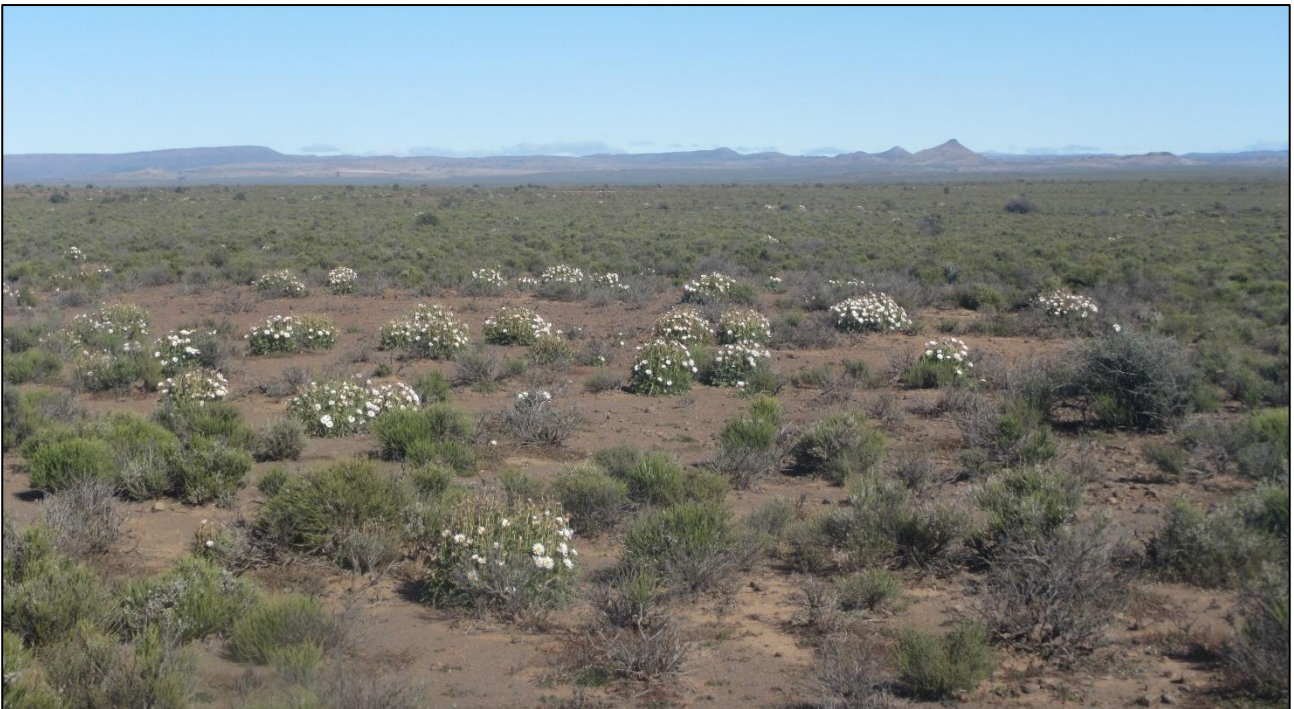
Figure 14: Looking south through the centre of Mura 4.

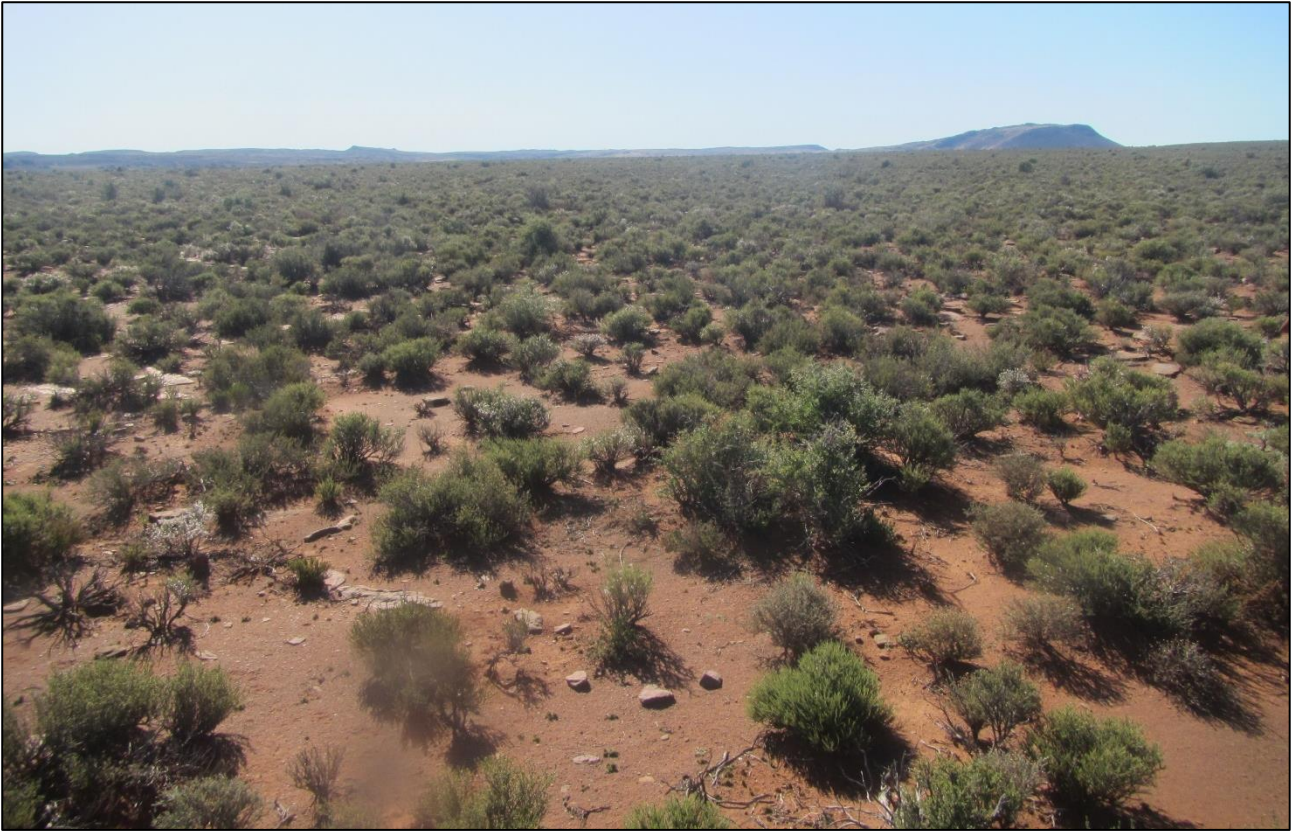
Figure 15: View towards the north from the south-eastern part of Mura 4 showing the flat terrain and sandy substrate with scattered gravel clasts.

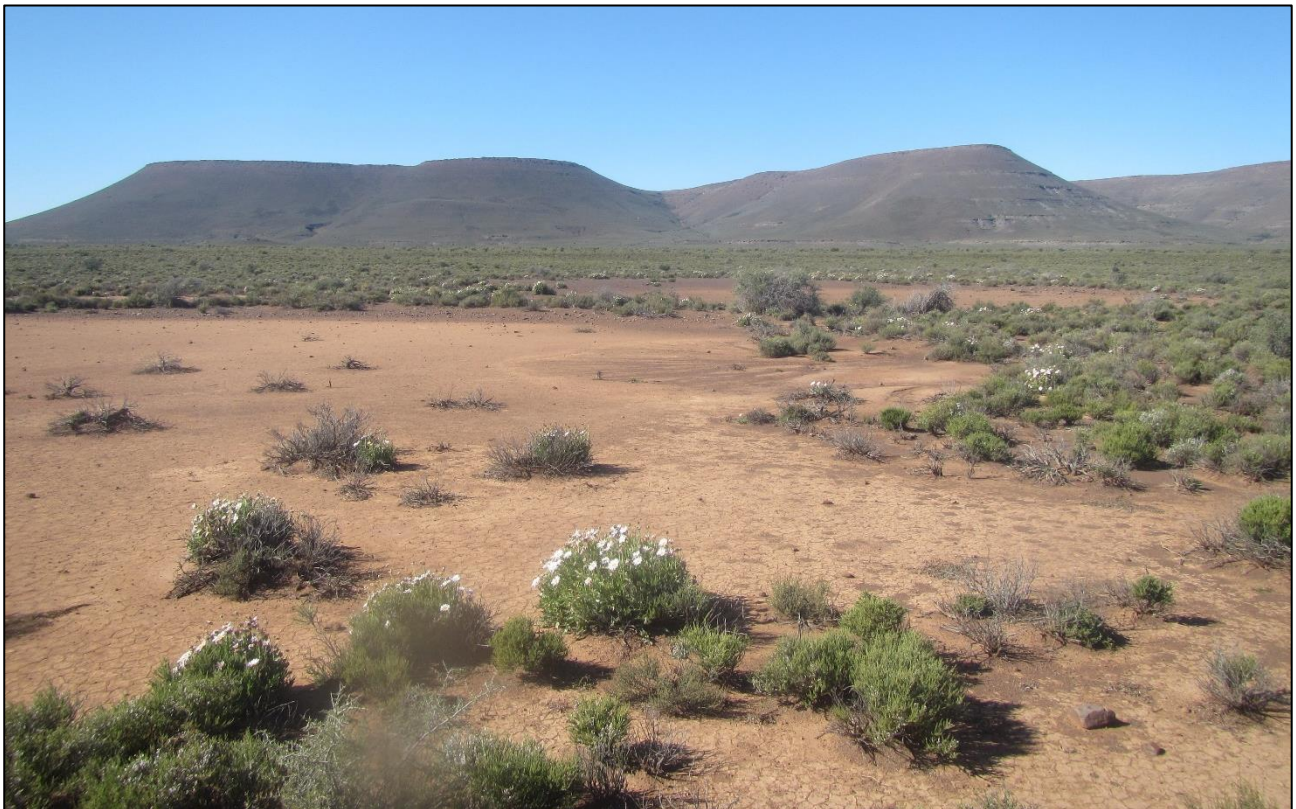
Figure 17: Looking east from near the western edge of Mura 4 showing ephemeral pans and with Perdeberg in the background.

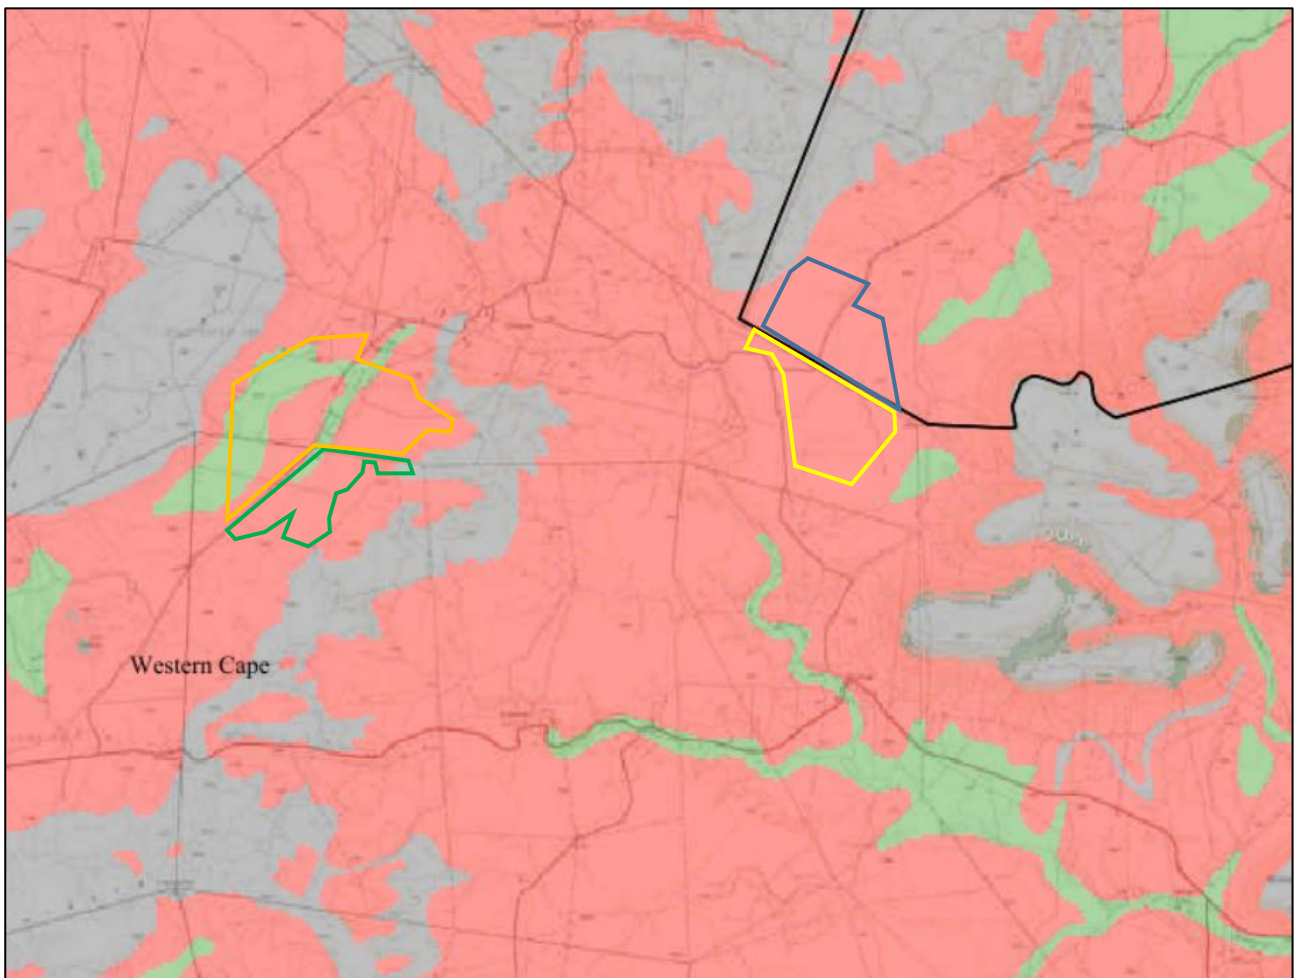
Figure 18: Extract from the SAHRIS Palaeosensitivity Map showing the site to be of largely very high sensitivity (red shading) but with a large part of Mura 2 being of moderate sensitivity.

The SAHRIS Palaeosensitivity Map shows the site to be of largely very high sensitivity, although a large portion of the Mura 2 footprint is shown as of moderate sensitivity (Figure 18). It must be noted that these ratings are theoretical and based on the known potential of the rock types in the

Almond’s (2022) site visit showed that exposures of suitable sedimentary rocks on the very flat sites were very rare and that covering sediments (which contained no fossils) and alteration of the bedrock by dolerite intrusions meant that significant fossils are unlikely to be present. He rates the entire study area as of low palaeontological sensitivity.

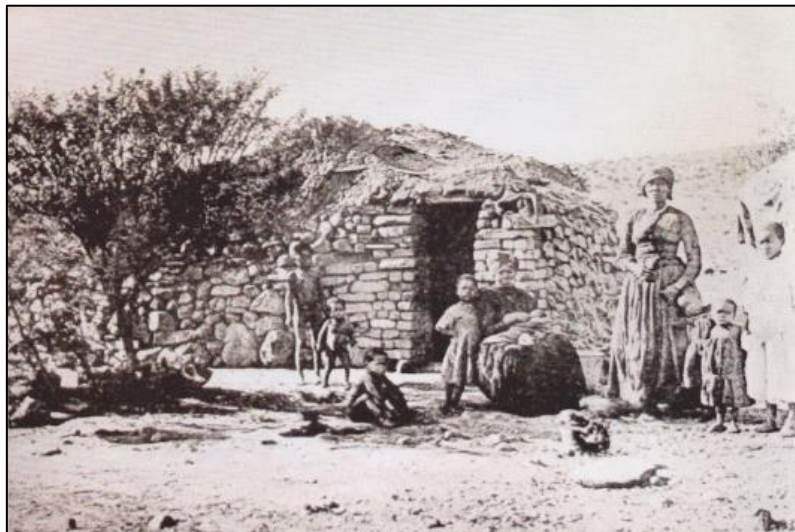
Figure 21: A shepherd's hut photographed near Beaufort West in the early 20th century. Note the low, narrow doorway and informal roof structure. Source: Schoeman (2013:48).

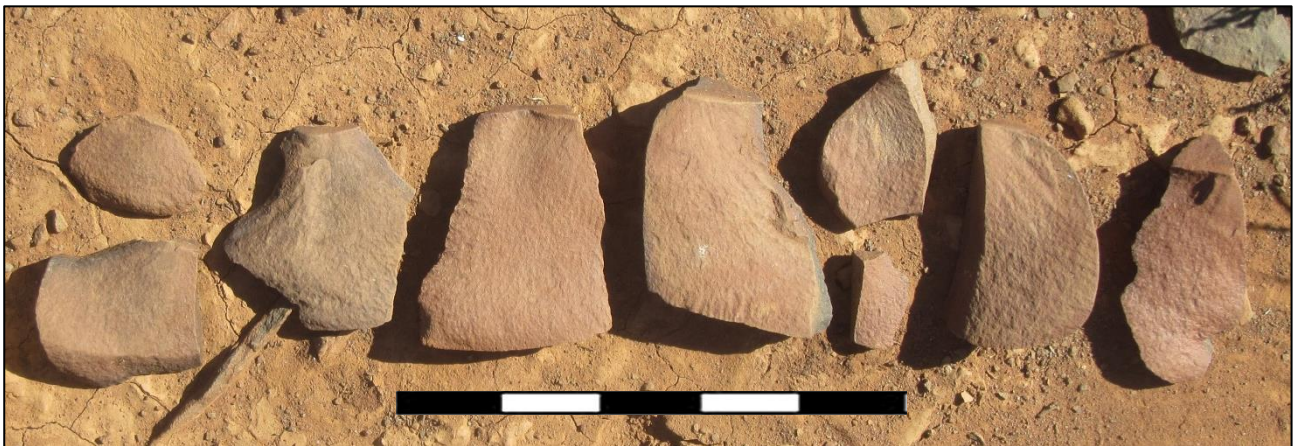
Figure 22: A scatter of ESA flakes from waypoint 1398 within the eastern edge of Mura 4. Scale = 25 cm.

Stone Age materials were generally found to be rare. The only finds made were ephemeral scatters of artefacts. The most interesting was a scatter of nine large artefacts made in what is probably wacke. The artefacts are patinated brown and seem likely, based on their size, to relate to the ESA (Figure 22). They were in an area with several ephemeral pans.

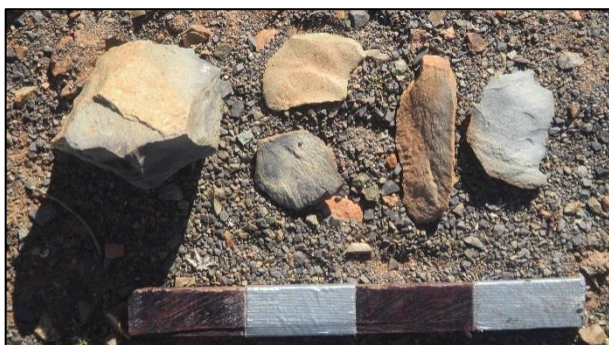
Figure 23: Stone artefacts from waypoint 1321. Scale = 20 cm.

In one area to the south of the Mura 1 footprint there was a very light scattering of artefacts that were only lightly patinated and may be from the LSA (Figures 23 & 24). There was nothing else associated with them. Elsewhere, Stone Age finds were limited to a few isolated background scatter artefacts of Pleistocene and/or Holocene age.

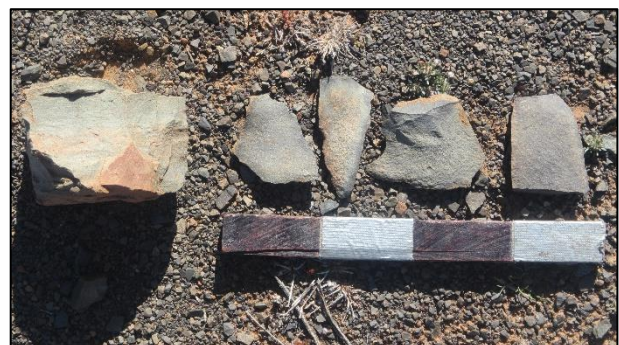
Figure 24: Stone artefacts from waypoint 1322. Scale = 20 cm.

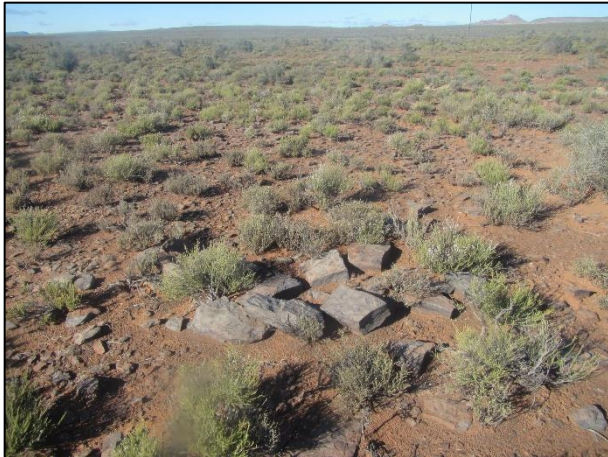
Figure 25: *Small stone cairn/feature at waypoint 1396. This is just within the Mura 2 study area.*

Historical archaeological sites were somewhat more common than Stone Age sites. The smallest sites were small clusters of rocks. These may have been cairns but otherwise their functions could not be determined. None seemed like graves and one of them had a wine bottle base located alongside it (Figures 25 to 28).

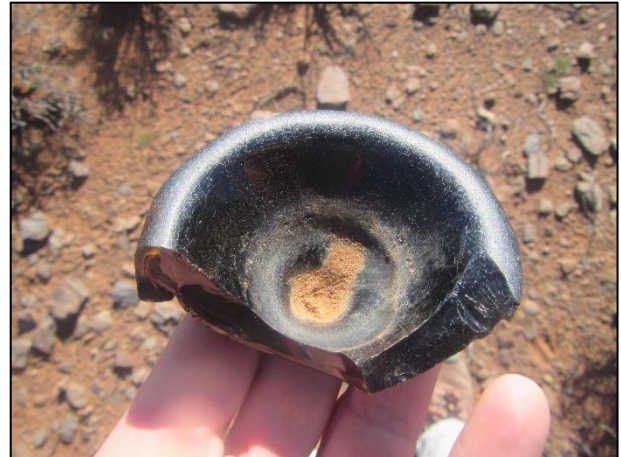
Figure 26: *The base of a black glass wine bottle from waypoint 1396.*

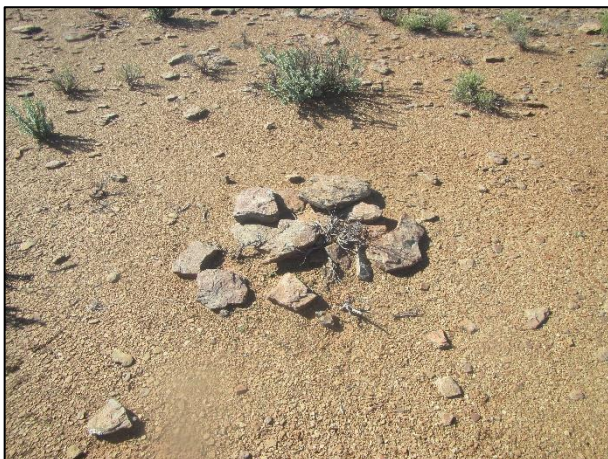
Figure 27: *Small cluster of stones at waypoint 1400 and located within the Mura 4 study area.*

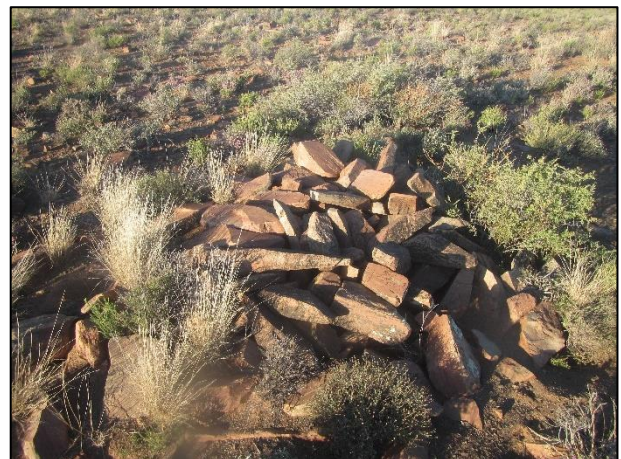
Figure 28: *Loosely packed pile of stones in a rock area at waypoint 1403 and located just inside the north-western corner of Mura 3.*

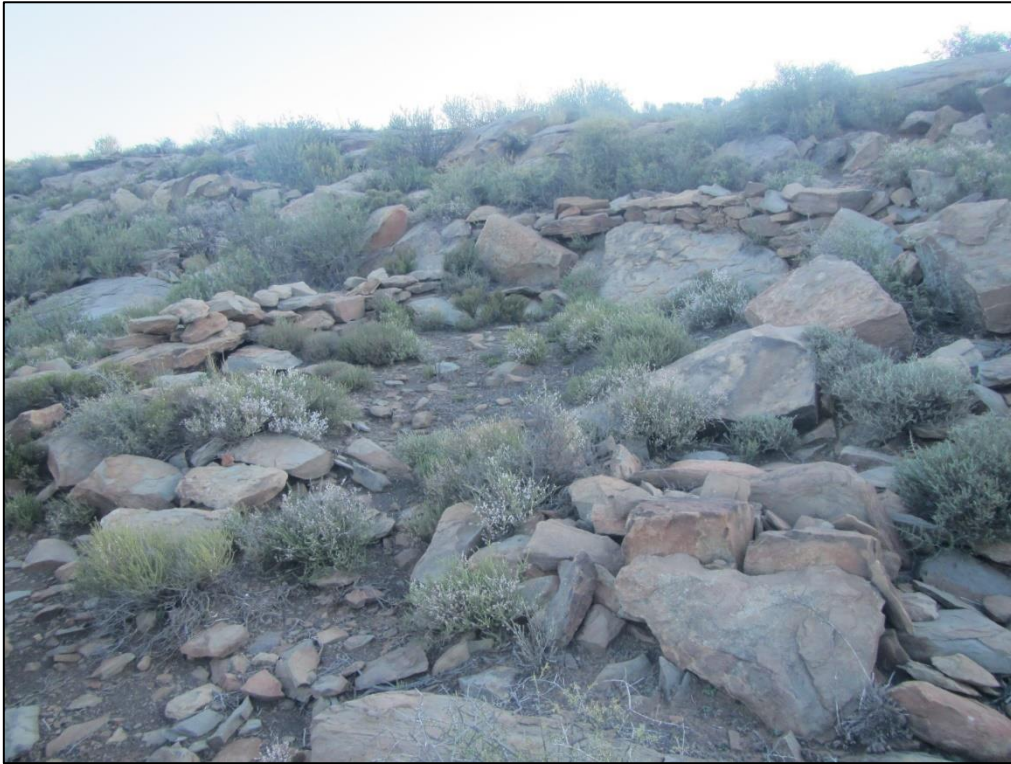
Figure 29: Stone-walled ruin at waypoint 1328. It is likely a livestock enclosure. This site is 120 m outside the Mura 2 study area and located very close to waypoint 1329 (see Figure 30).

A number of stone-walled sites were found. These included a small livestock enclosure (Figure 29) and some small house ruins (Figures 30 to 32). These sites relate early European occupation of the area. Very few artefacts were found with them. Only one of the houses had a light scatter of glass, ceramics and metal associated with it (Figures 33 & 34).

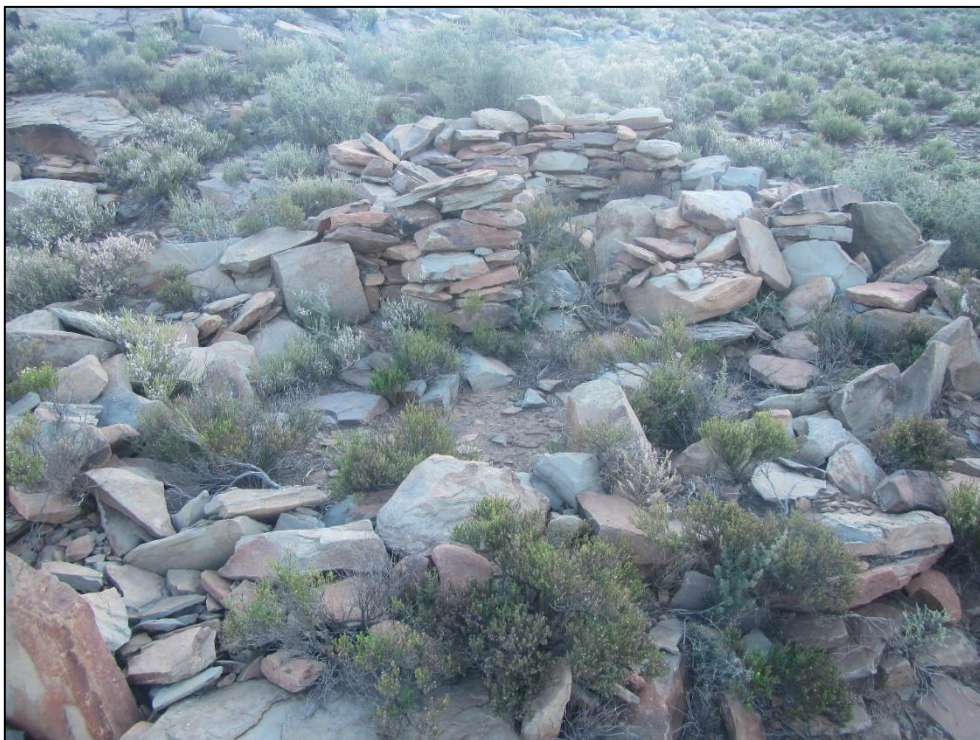
Figure 30: Stone-walled ruin at waypoint 1329. This site is 150 m outside the Mura 2 study area and located very close to waypoint 1328 (see Figure 29).

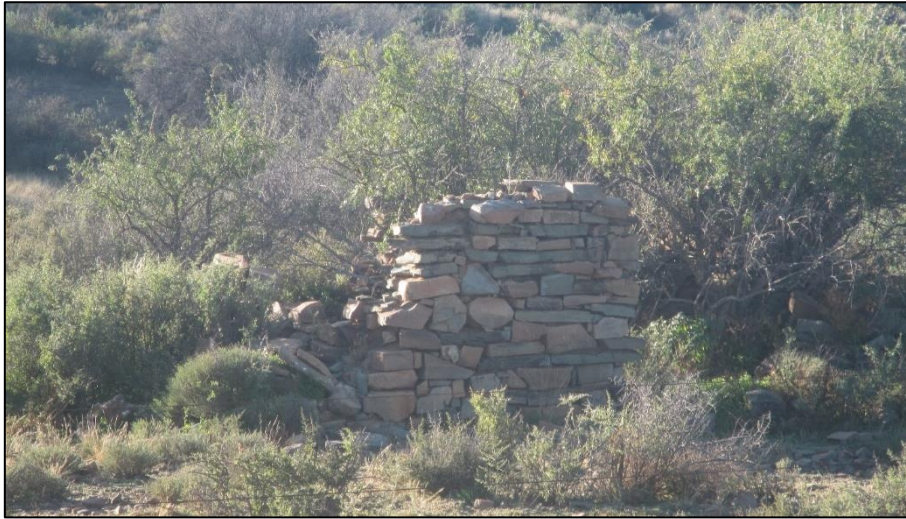
Figure 31: Stone-walled house ruin at waypoint 1401 and located 1 km northeast of the Mura 3 study area.

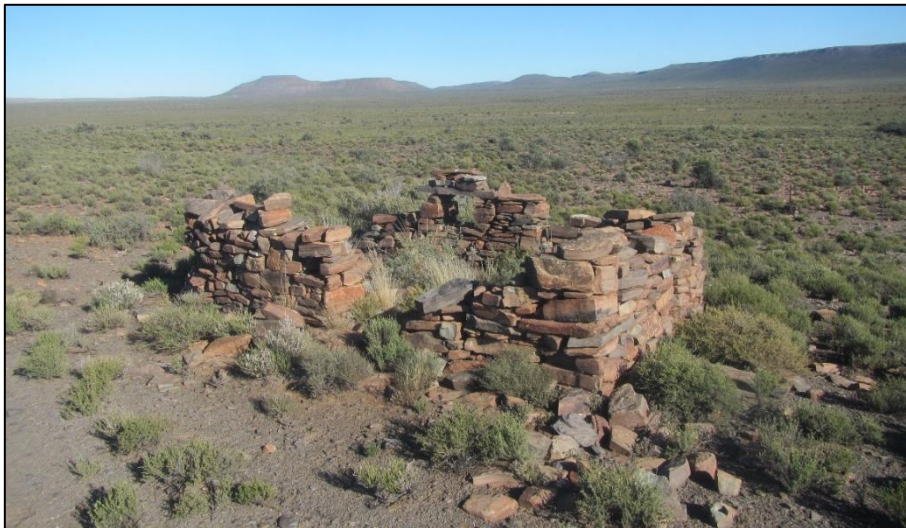
Figure 32: Stone house ruin at waypoint 1320. This site is 230 m outside Mura 1.

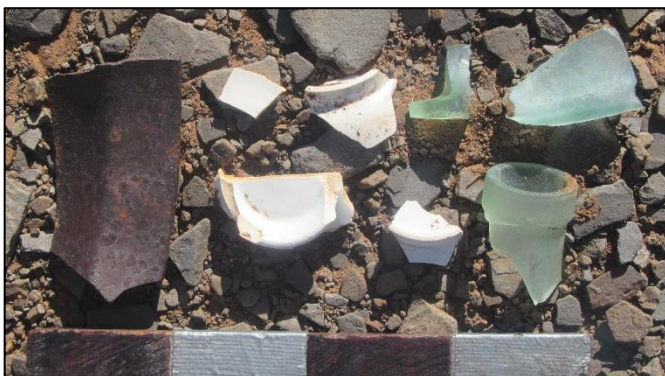
Figure 33: Artefacts from waypoint 1320. They include refined white earthenware, glass and a fragment of iron potjie. Scale = 20 cm.

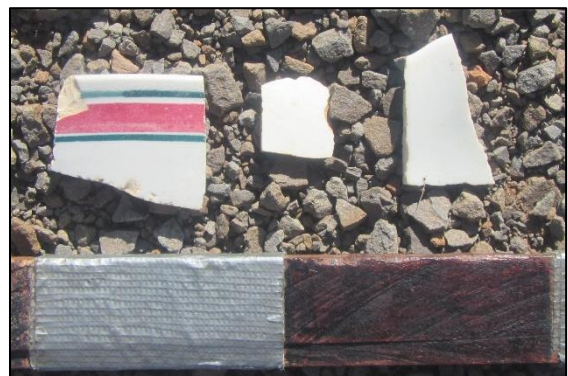
Figure 34: Lined industrial ware and other refined white earthenware from waypoint 1320. Scale = 10 cm.

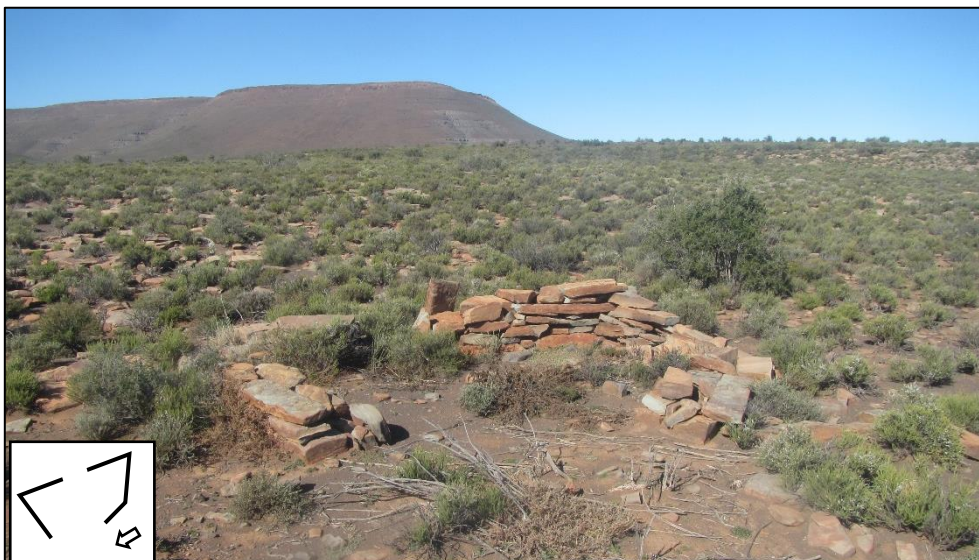
Figure 35: Small stone-walled feature at waypoint 1399 within the southern part of Mura 4. The inset shows a plan view orientated the same way as the photograph with arrow indicating north.

Another small stone-walled site was rather enigmatic due to its unusual shape (Figure 35). It had no associated artefacts and measured about 2 m by 4 m. Its function is unknown but the walls seem far too low to have served a residential function. The last historical site may not actually be archaeological in terms of its age. It comprises of a long line of slabs half buried in the ground and presumably had some sort of agricultural function (Figure 36).

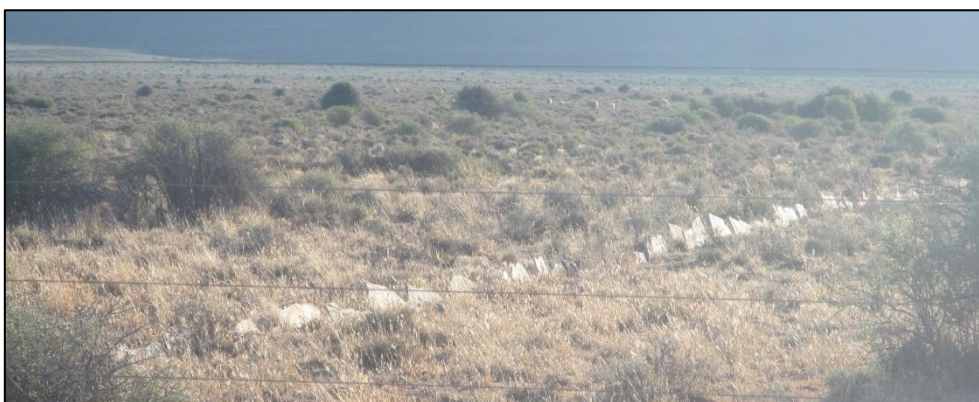
Figure 36: Line of planted stones at waypoint 1327 within the Mura 2 study area.
