Appendix H.8

**HERITAGE IMPACT ASSESSMENT:
PROPOSED MURA 1-4 PV FACILITIES, BEAUFORT WEST
MAGISTERIAL DISTRICT, WESTERN CAPE AND VICTORIA
WEST MAGISTERIAL DISTRICT, NORTHERN CAPE**

Required under Section 38(8) of the National Heritage Resources Act (No. 25 of 1999)

Final report: 15 December 2022

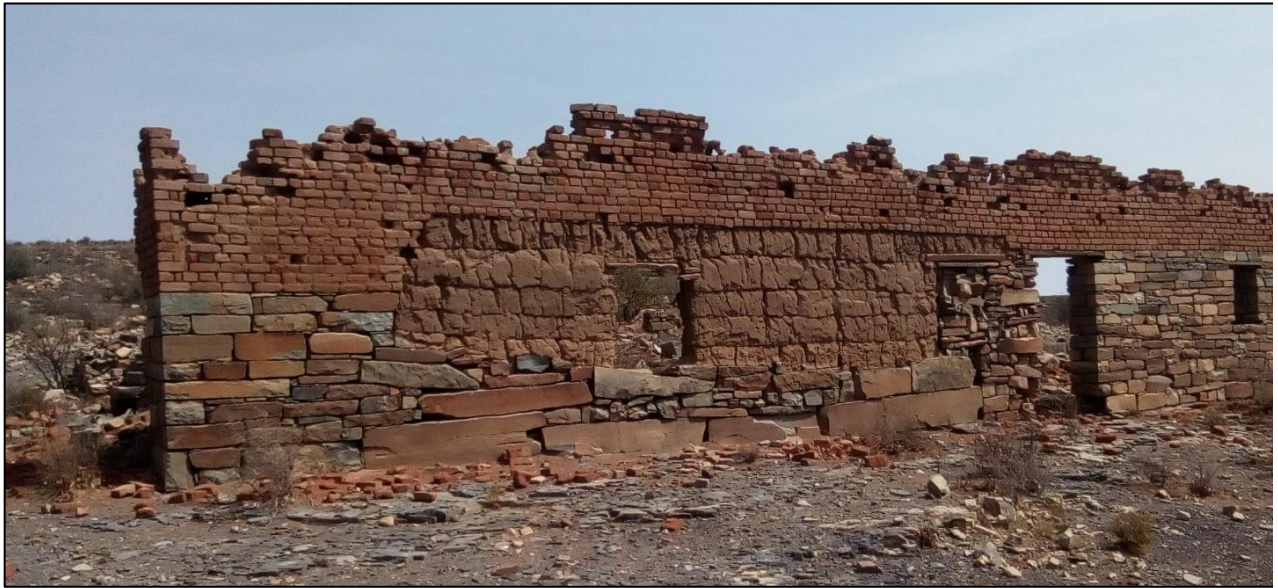
Figure 37: A structure built of stone, sun-dried mud bricks and fired clay bricks at Waypoint 1993. Source: Orton (2021a: fig. 30).

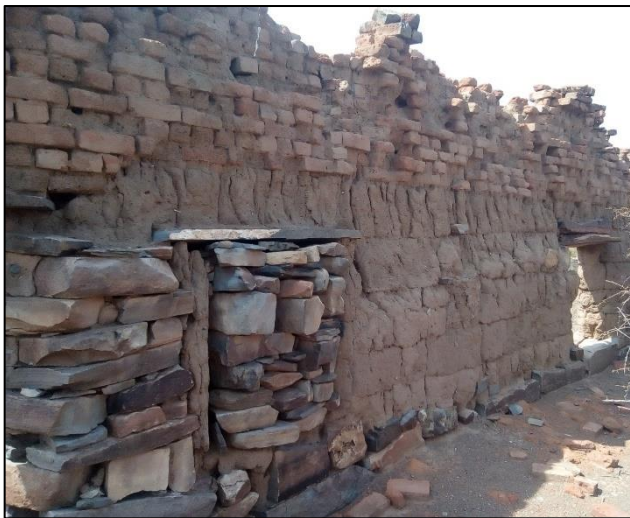
Figure 38: Interior of the front wall of the house at Waypoint 1993. The front door is at the left edge of this photograph. Source: Orton (2021a: fig. 31).

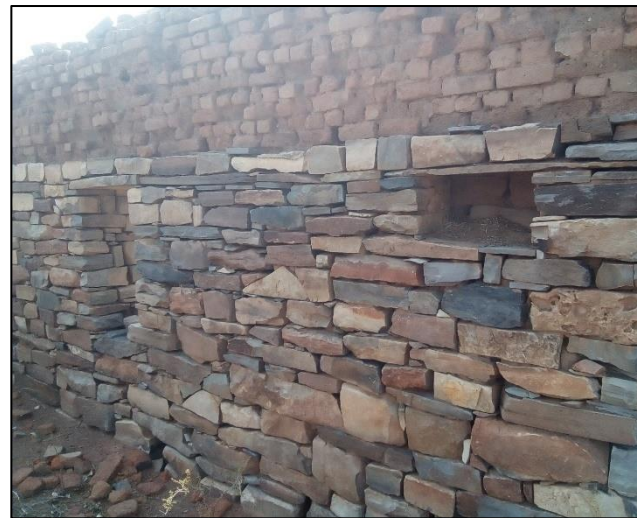
Figure 39: Interior of the front wall of the house at Waypoint 1993. The front door is at the right edge of this photograph. Source: Orton (2021a: fig. 302).

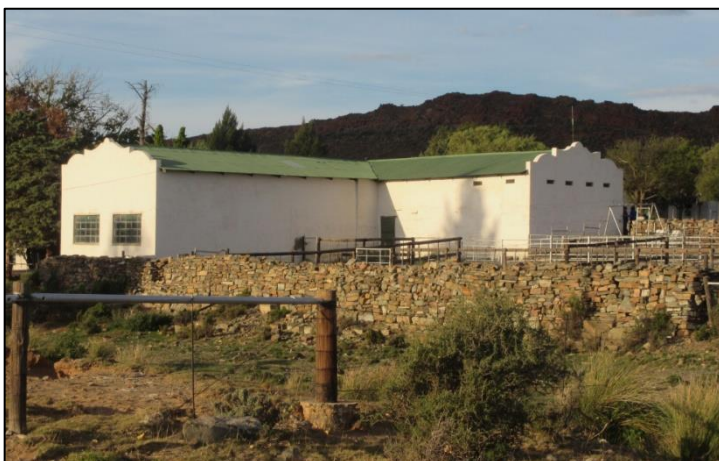
Figure 43: Structure in the Leeukloof Farm complex at Waypoint 1850. Source: Orton (2021a: fig. 49).

Some farmsteads occur in the area but all are more than 1.5 km the Mura PV footprints. None were studied in detail as they will not be affected but it is noted that they include various historical structures, kraals, arable lands and clusters or lines of trees. Two farmsteads lie along the access roads and should be mentioned, although, again, impacts should not occur. These are the Leeukloof farmstead in the south and Booiskraal in the southeast. Figure 43 to 45 show examples of some of the structures at these complexes.

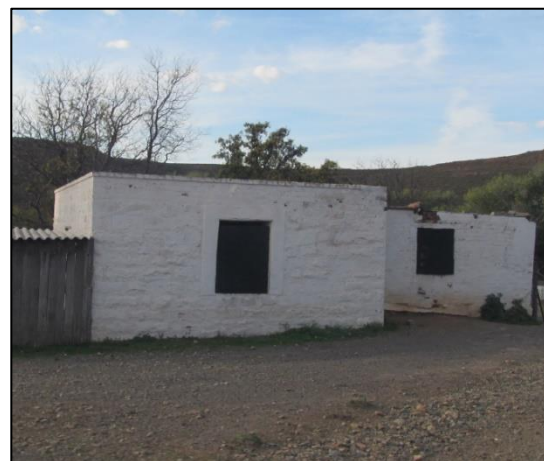
Figure 44: Structure in the Leeukloof Farm complex at Waypoint 1850. Source: Orton (2021a: fig. 50).

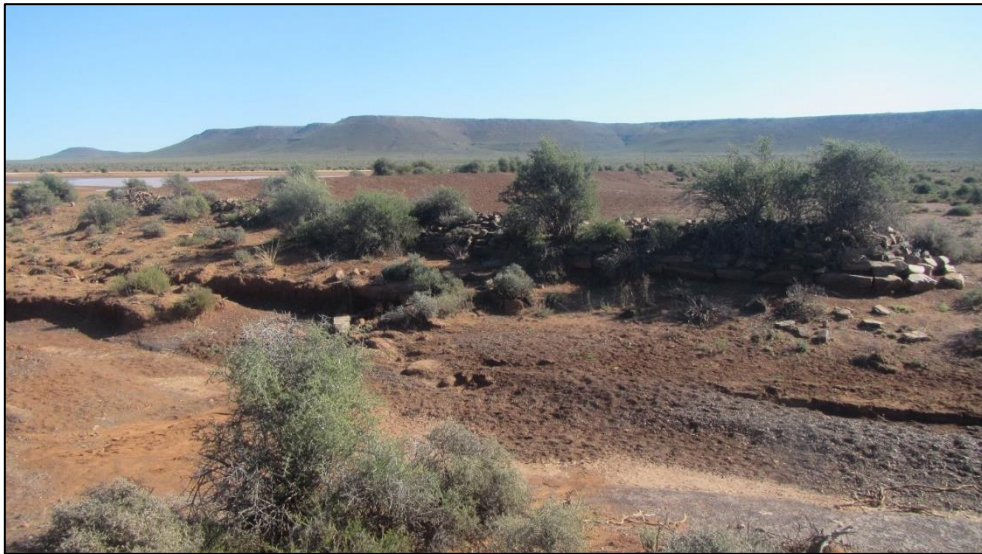
Figure 46: One end of the large earthen dam with stone-packed ends at waypoint 1324. This site is enclosed by, but excluded from, the development area.

The only historical feature close to the PV footprints is the large dam in the centre of – but excluded from – the Mura 2 area. It is an earthen-walled dam but stones have been packed around the ends of the walls to prevent erosion when the dam overflows (Figure 46).

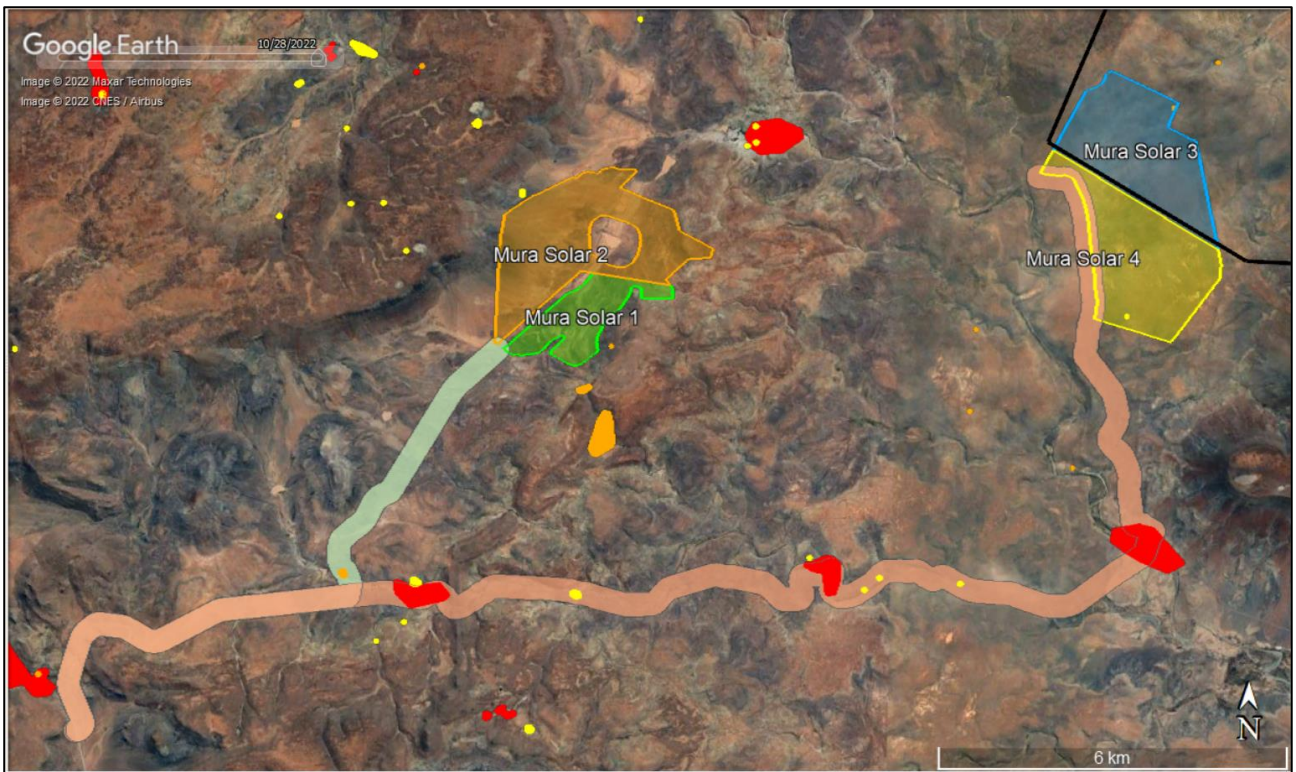
Figure 47: Grade map of the study area. Note that it is constructed using data from several projects but that only those sites directly relevant to this project appear in this report. Red = IIIA, orange = IIIB, yellow = IIIC.

Known heritage resources are mapped with 50 m buffers in Figures 47 to 49.

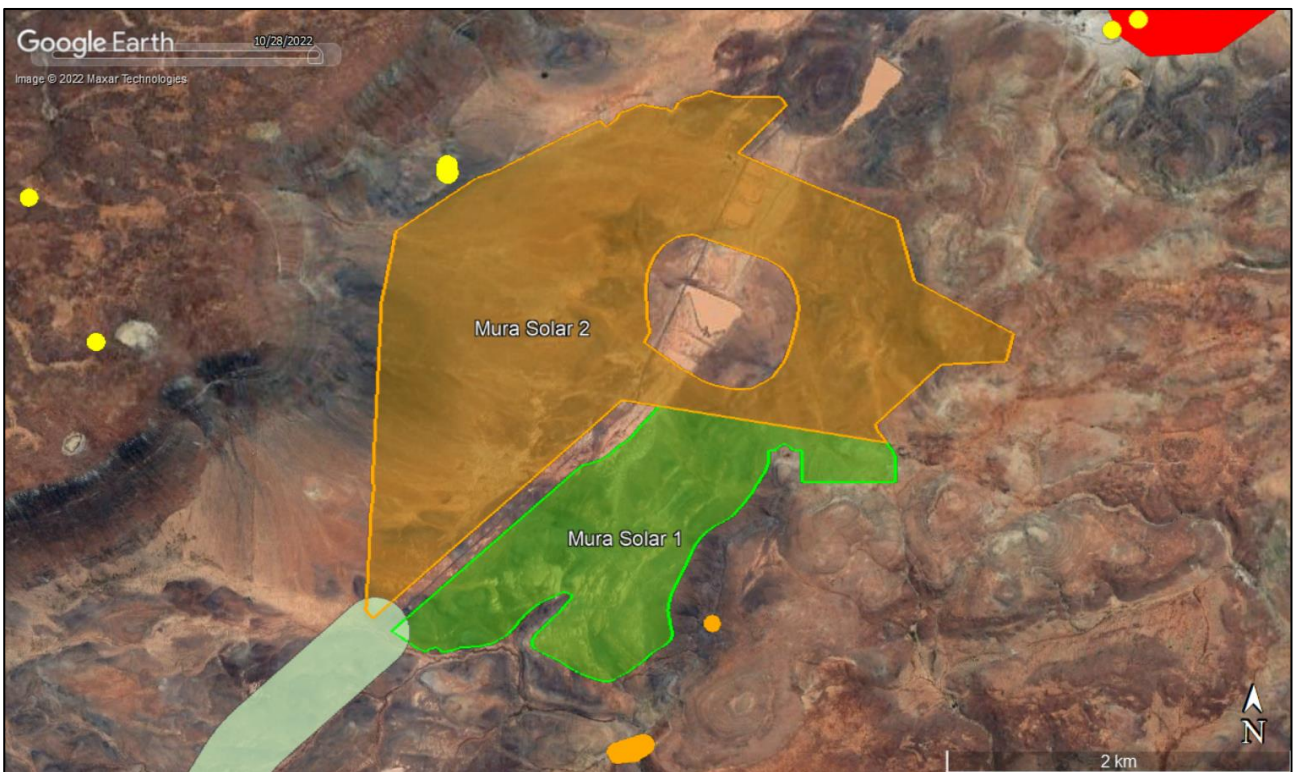
Figure 48: Smaller scale map showing heritage resource grading in the vicinity of the Mura 1 and Mura 2 footprints. Red = IIIA, orange = IIIB, yellow = IIIC.

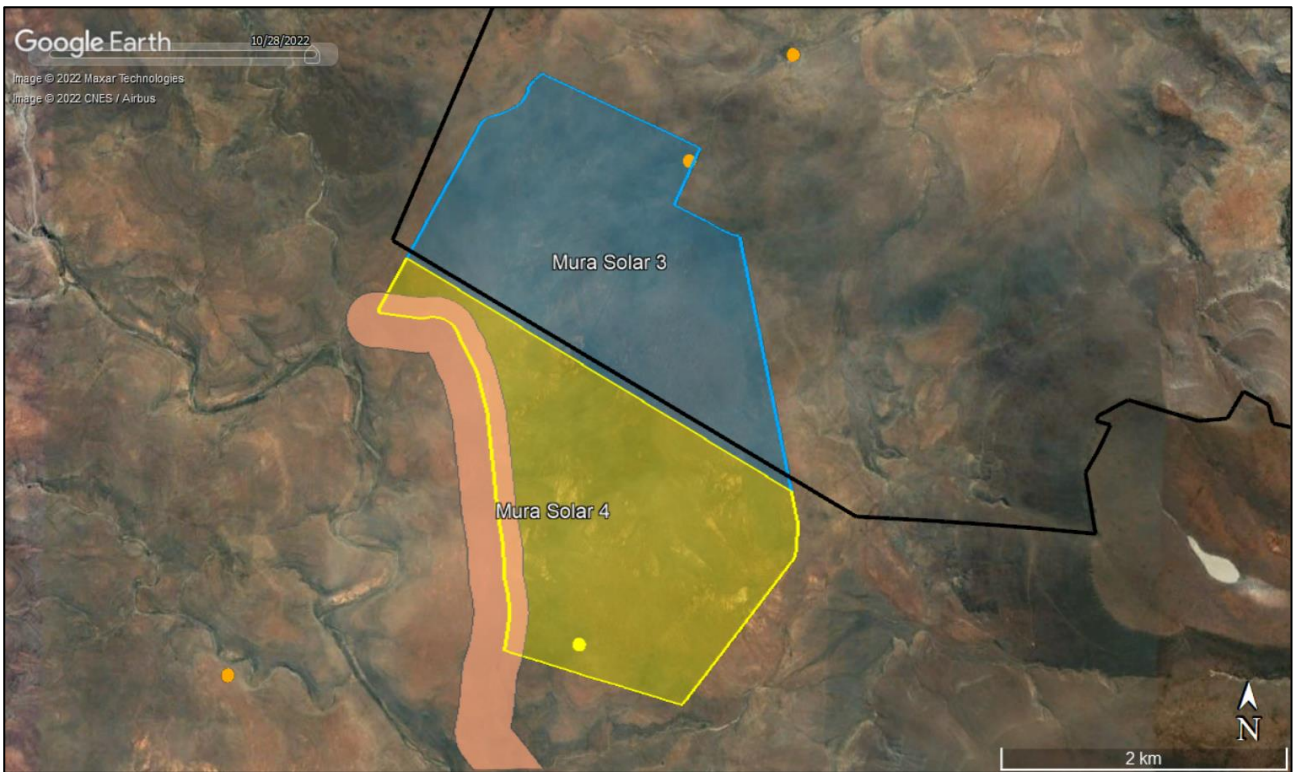
Figure 49: Smaller scale map showing heritage resource grading in the vicinity of the Mura 3 and Mura 4 footprints. Red = IIIA, orange = IIIB, yellow = IIIC.

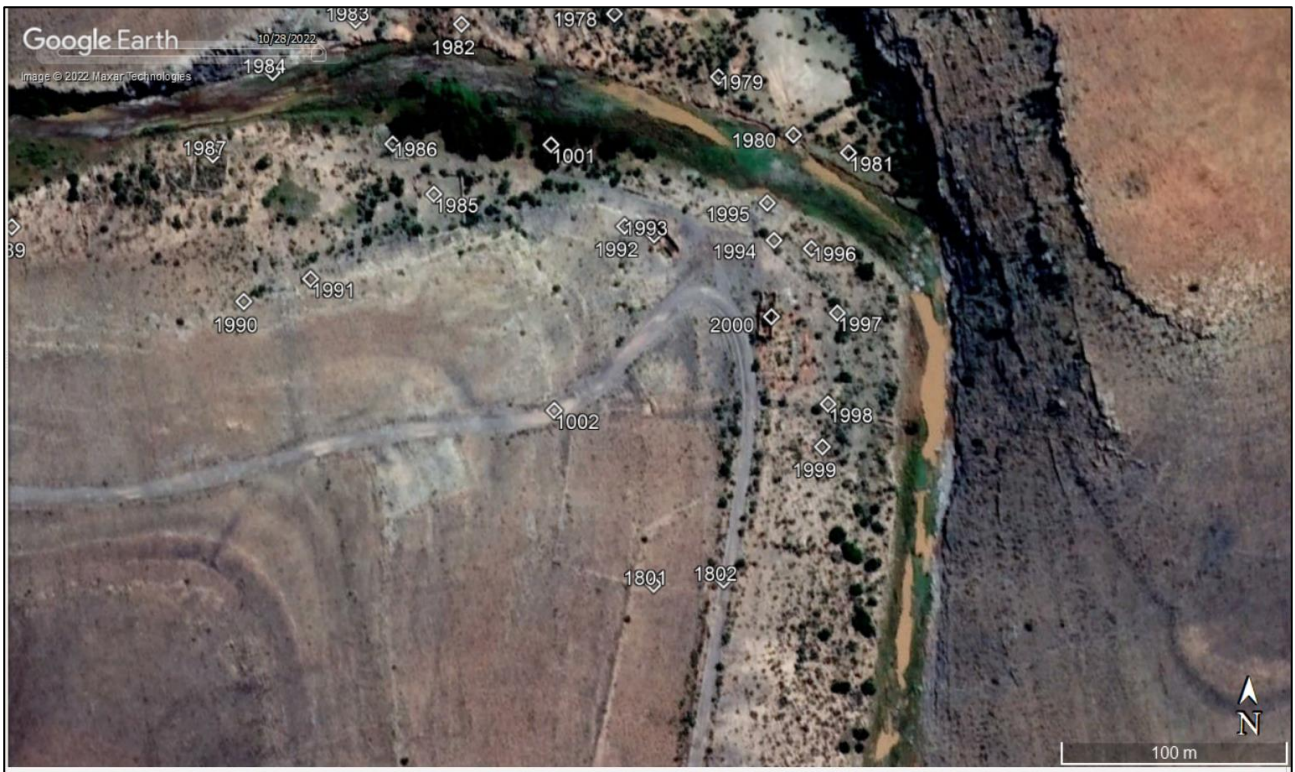
Figure 51: Aerial view of the farm complex at waypoint 2000 showing its relationship to the DR02317 road.

Any alteration in the layout of the Mura 3 and 4 access road within 400 m of waypoint 2000 has the potential to result in damage to one or more elements of the farm complex.

A ruined farm complex along the Mura 3 and Mura 4 access road is a potential concern since the road makes a tight turn within the area of the complex (Figure 51). Although all significant features (building ruins, kraals, graves) are located outside of the turn, there is some stone walling inside it (agricultural terracing, etc). Should road realignment be required in this area then some stone walling (likely all of low cultural significance) may well be affected. This will need to be determined once the detailed design is done.
