**Unlawful Construction and Infilling of a Watercourse on the  
Remainder of Portion 274 of the Farm Tiegervoort 371 JR**

**Environmental Management Programme**

**GDARD Reference Number: S24G/03/22-23/0577**

March 2023

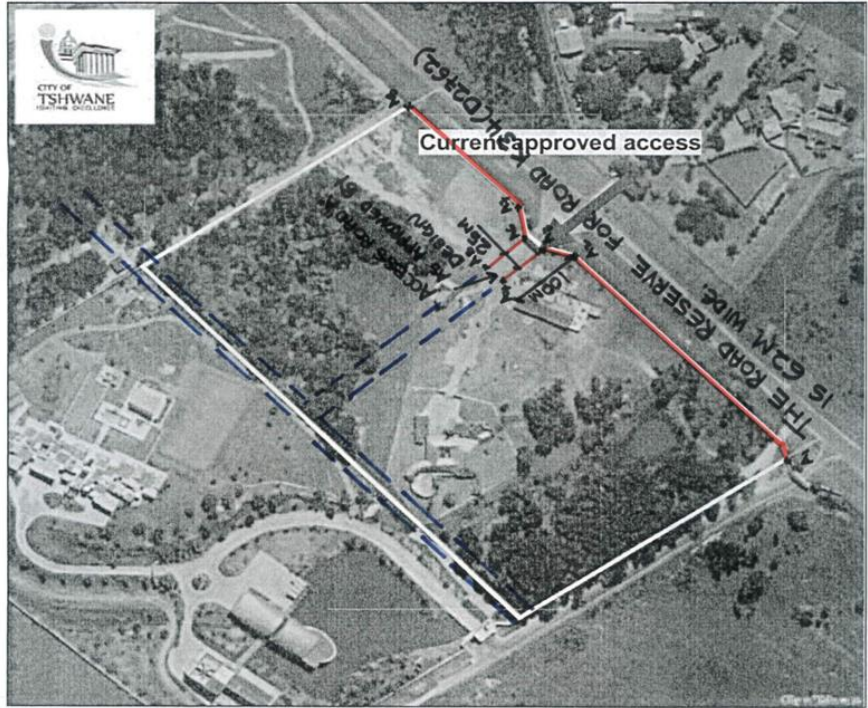
**Figure 3-2: Access road recommended by GAUTRANS (indicated with the blue broken line)**

Approval in terms of the consent use application has not yet been obtained from the City of Tshwane (CoT). In February 2021, the Gauteng Department of Roads and Transport (Gautrans) as a Commentary Authority commented on the application with certain conditions and recommended the change in access point to the site. Two access points were recommended by GAUTRANS. The two access points are shown in **Figure 3-2** with the blue broken lines.

Comments received from the CoT: Transportation Planning Division indicated that the current access point to the facility shall be relocated as it is not in line with the CoT Roads Master Plan (RMP). Currently access to the site is gained from the north eastern boundary off Graham Road. The CoT also advised that they are not in agreement with the comments provided by GAUTRANS and the CoT requested that access to the property should be gained from the right of way servitude that intersects with Graham Road.

This is the gravel road to the south east of the property. The new access road will join an existing road (developed prior to 1998). The existing road is a narrow width gravel road, approximately 4m wide which traversed the watercourse. (Figure 3-3 Error! Reference source not found.). In order to make use of the existing access road, access to the site will have to be via the south eastern boundary.

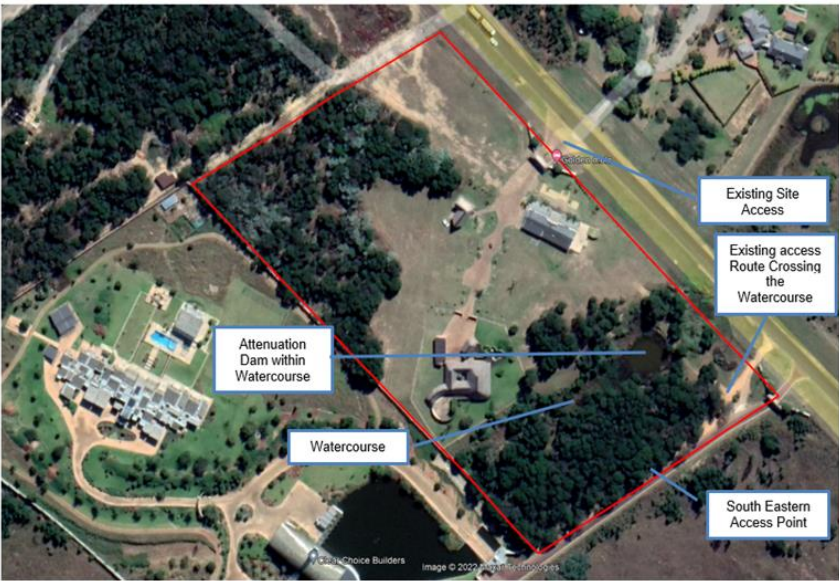
**Figure 3-3: Google Earth Image (2019) showing the access points in relation to the site**

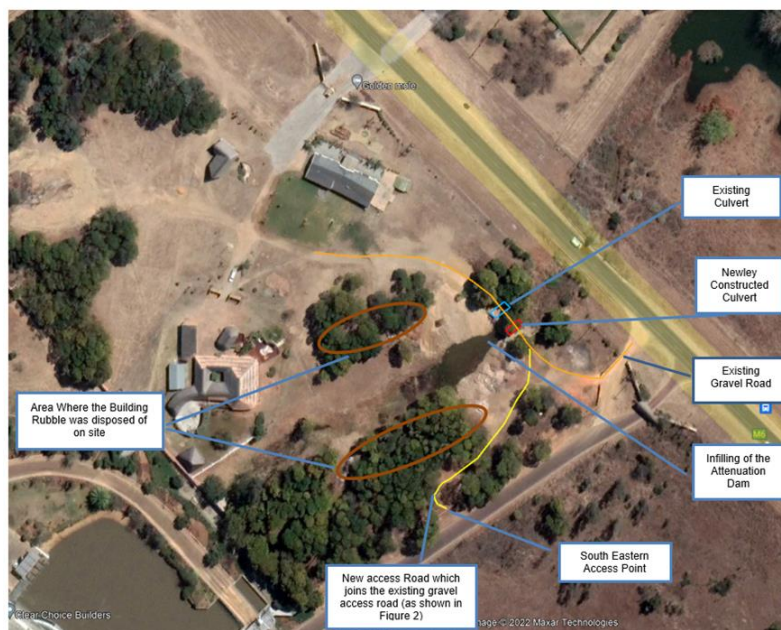
Figure 3-4: Google Earth Image (2021) showing the construction activities undertaken on site

An attenuation dam previously existed along the watercourse, west of the existing water crossing. Ms Sethole has infilled the attenuation dam and constructed a second culvert with the intention to channelize the watercourse. The construction of a new culvert which serves as a new flow path (diversion) of the watercourse. In terms of the site topography, steeper slopes are located within the vicinity of the watercourse situated on site. Due to the steep slopes, extensive erosion is encountered on site, whereby the bank of the watercourse is extensively eroded. It was the intention of Ms Sethole to stabilise the banks of the watercourse by the infilling and compaction of waste/rubble material to achieve a levelled grassed area, hence the building rubble that has been disposed off on site.

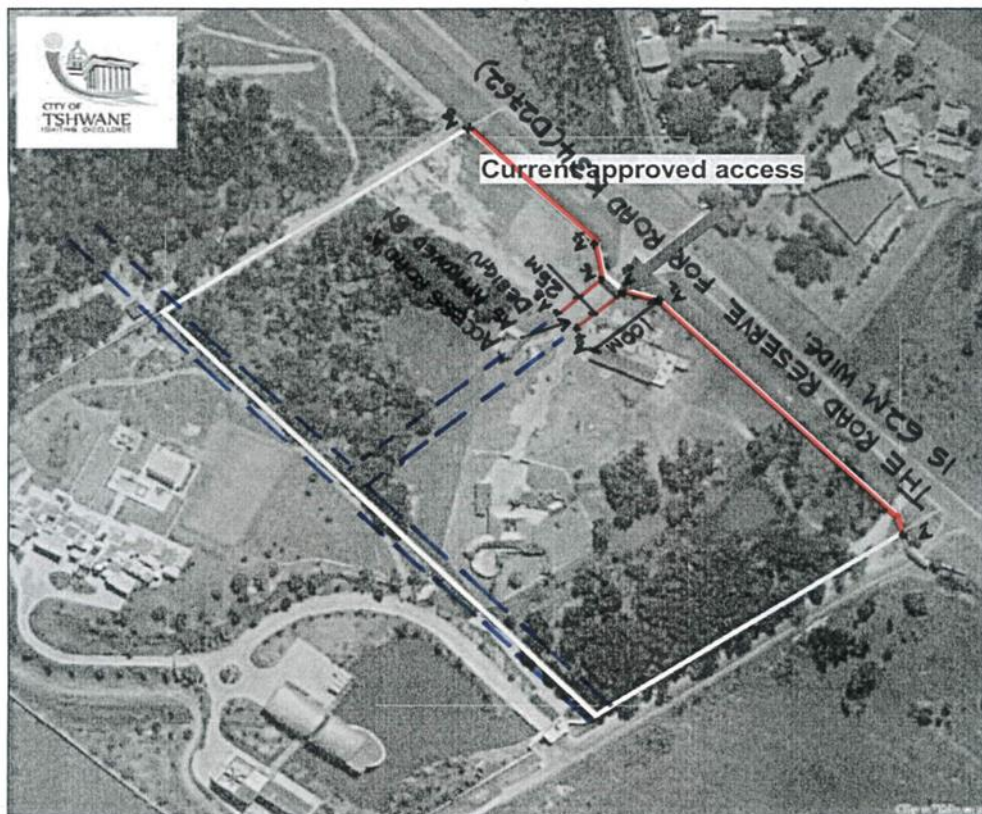
**Figure 2-1** Access road recommended by Gautrans (indicated with the blue broken line)

Approval in terms of the consent use application has not yet been obtained from the CoT. In February 2021, the Gauteng Department of Roads and Transport (Gautrans) as a Commentary Authority commented on the application with certain conditions and recommended the change in access point to the site. Two access points were recommended by Gautrans. The two access points are shown in **Figure 2-1** with the blue broken lines.

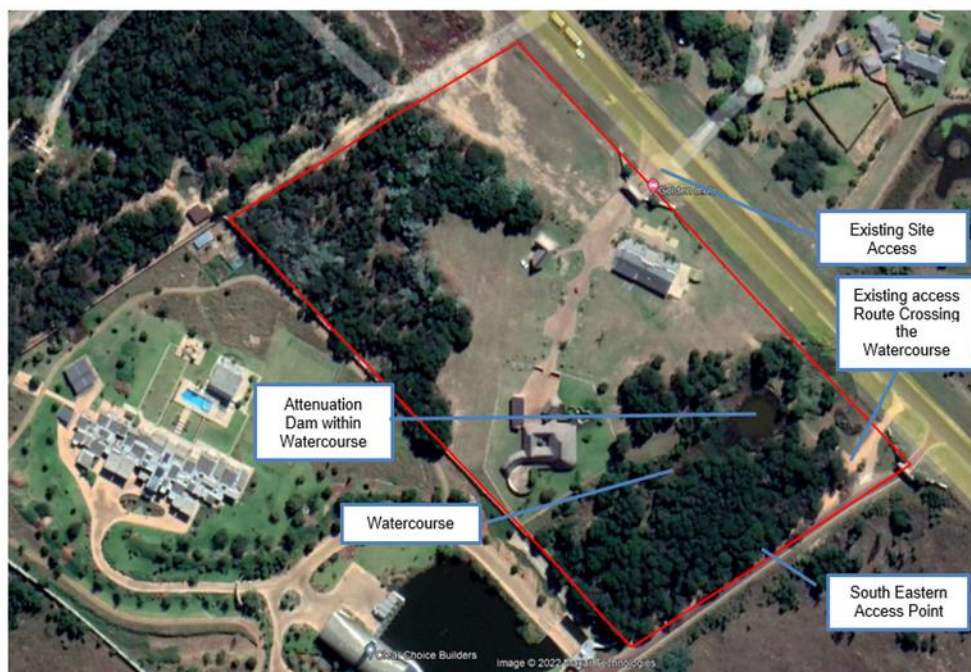
**Figure 2-2 Google Earth Image (2019) showing the access points in relation to the site**

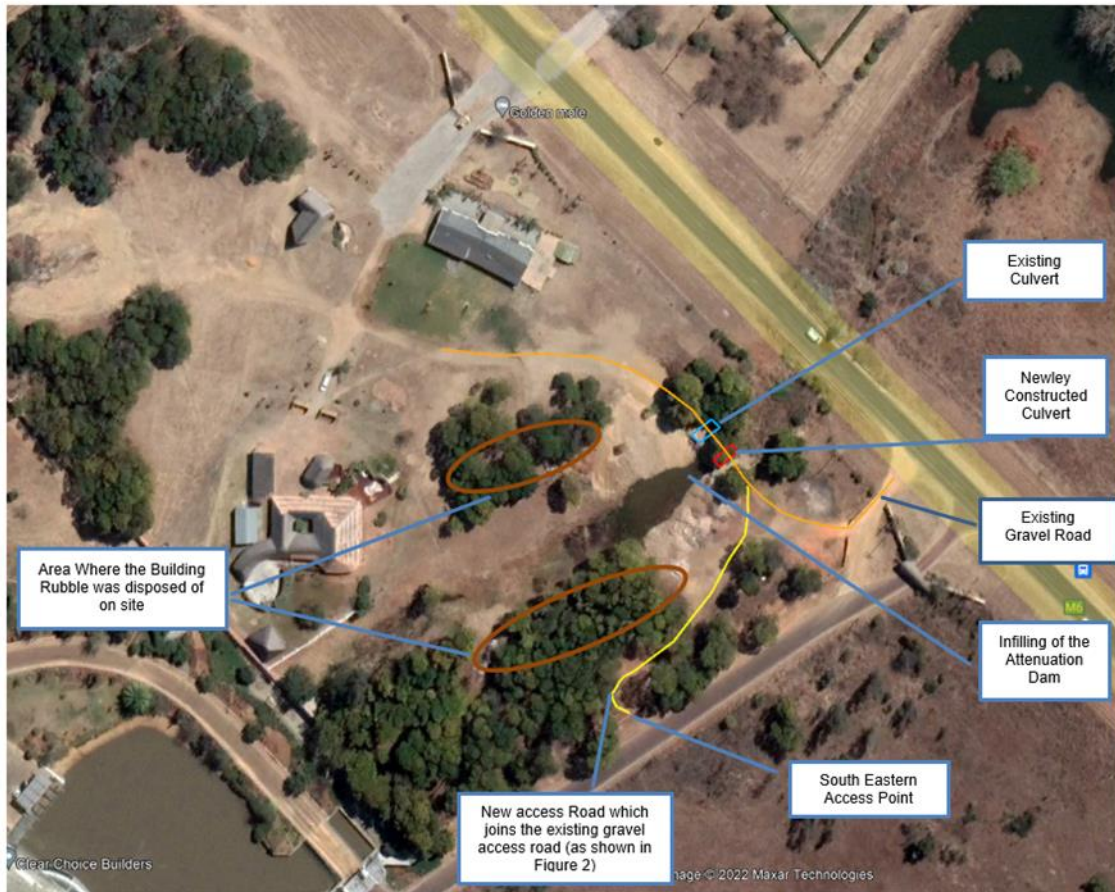
**Figure 2-3 Google Earth Image (2021) showing the construction activities undertaken on site**

An attenuation dam previously existed along the watercourse, west of the existing water crossing. Ms Sethole has infilled the attenuation dam and constructed a second culvert with the intention to channelize the watercourse. The construction of a new culvert which serves as a new flow path (diversion) of the watercourse. In terms of the site topography, steeper slopes are located within the vicinity of the watercourse situated on site. Due to the steep slopes, extensive erosion is encountered on site, whereby the bank of the watercourse is extensively eroded. It was the intention of Ms Sethole to stabilise the banks of the watercourse by the infilling and compaction of waste/rubble material to achieve a levelled grassed area, hence the building rubble that has been disposed off on site.

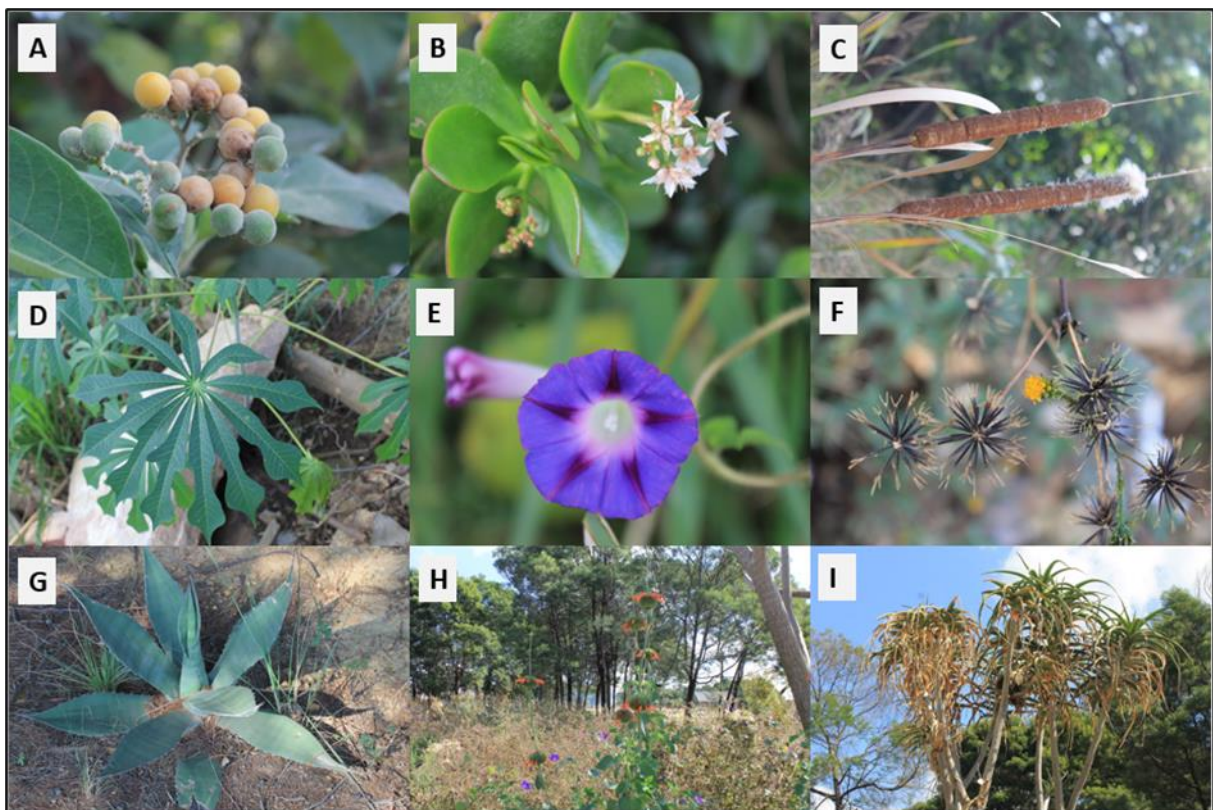
Figure 3-1: Plant species dominating the riparian area (may 2022) (TBC, 2022)

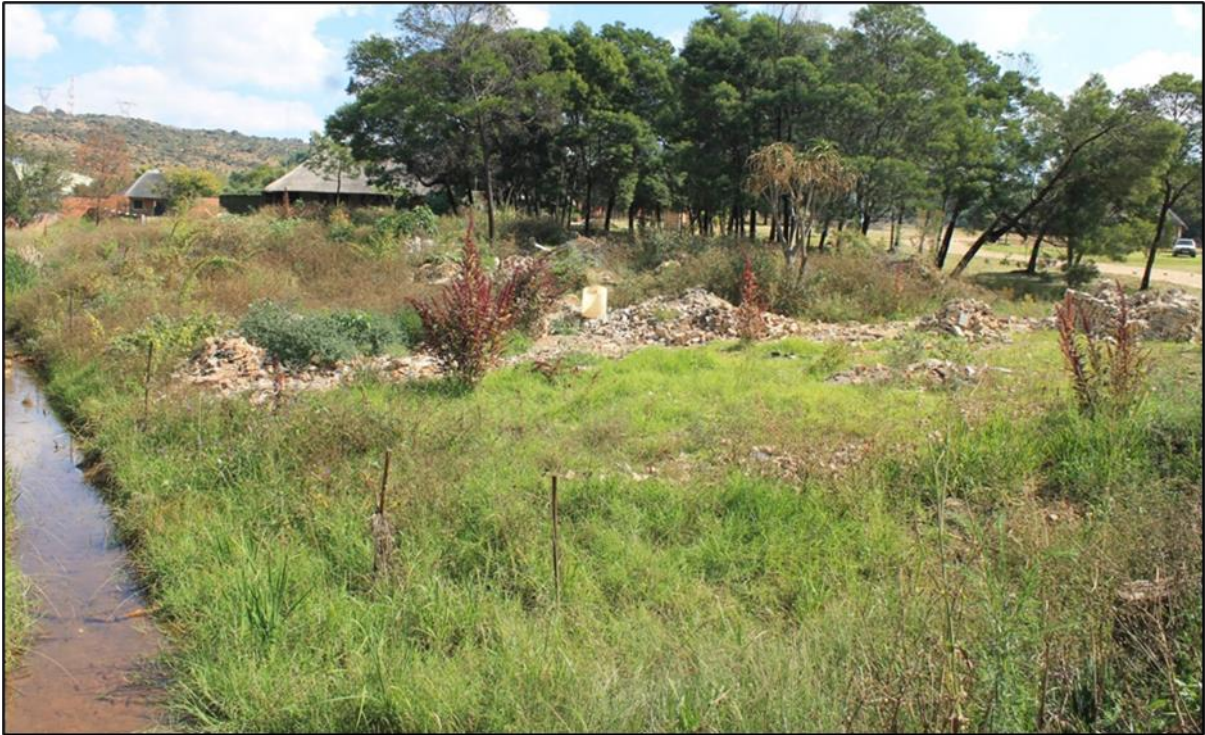
Figure 3-2: The right river bank facing upstream (May 2022) (TBC, 2022)

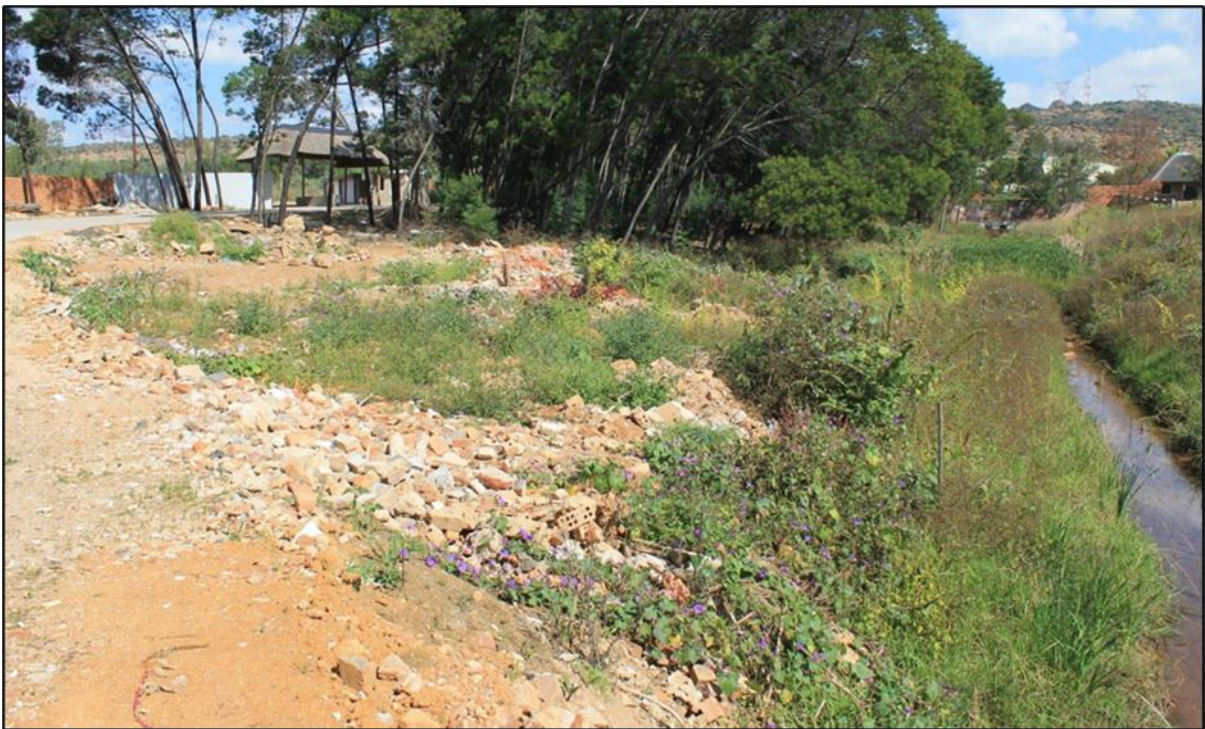
Figure 3-3: The left riverbank facing upstream (May 2022) (TBC, 2022)

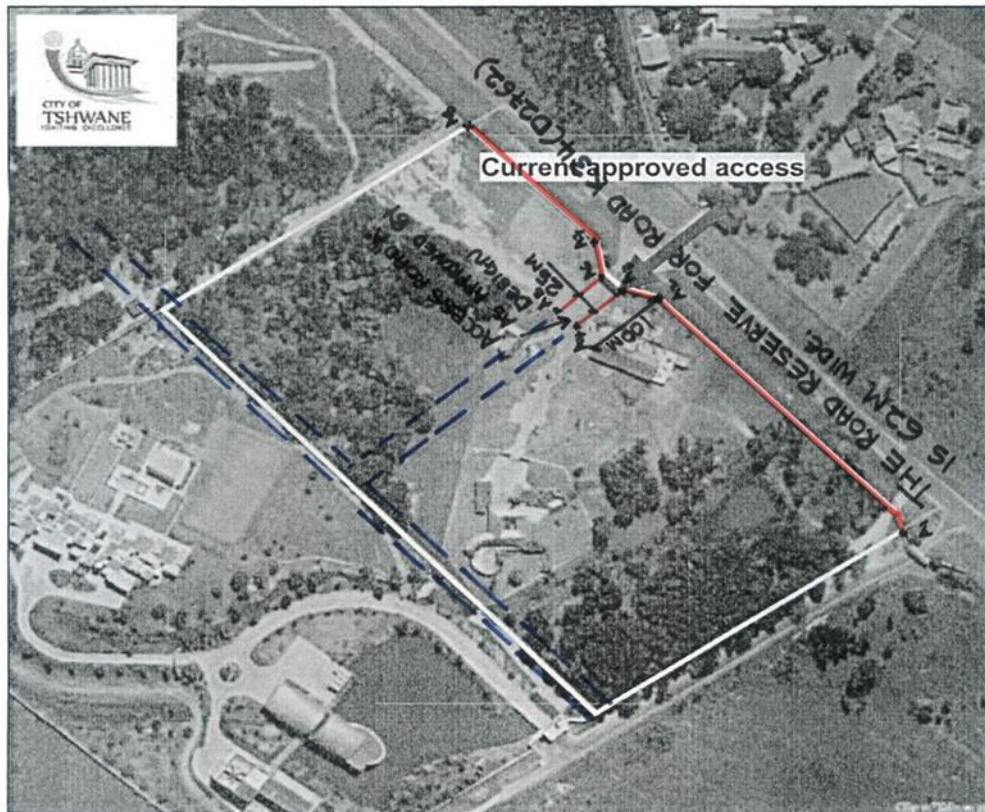
**Figure 2:1 Access road recommended by Gautrans (indicated with the blue broken line)**

Approval in terms of the consent use application has not yet been obtained from the CoT. In February 2021, the Gauteng Department of Roads and Transport (Gautrans) as a Commentary Authority commented on the application with certain conditions and recommended the change in access point to the site. Two access points were recommended by Gautrans. The two access points are shown in Figure 2:1 with the blue broken lines.

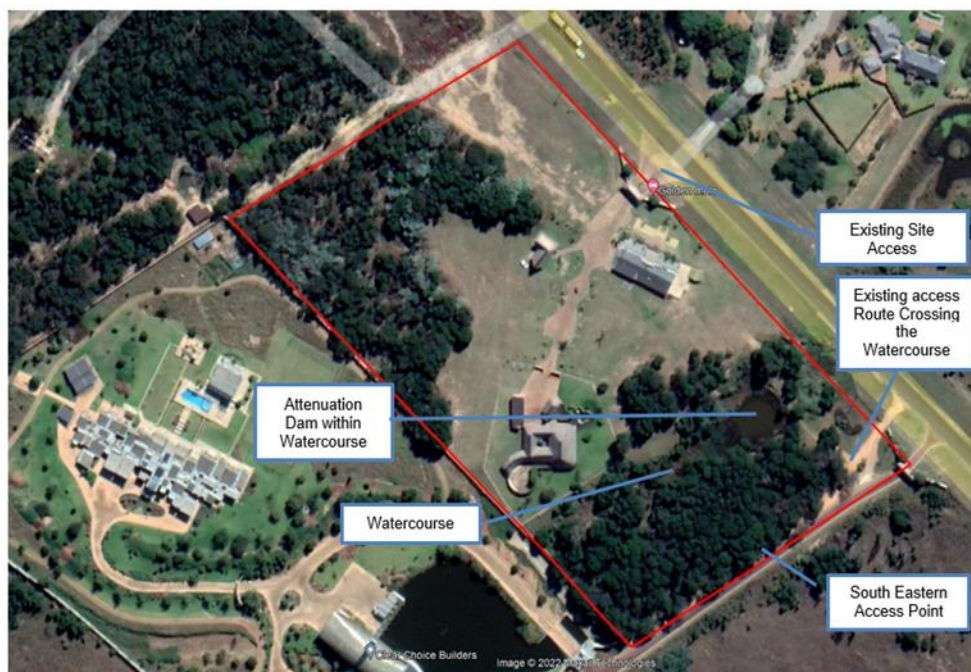
**Figure 2:2** Google Earth Image (2019) showing the access points in relation to the site

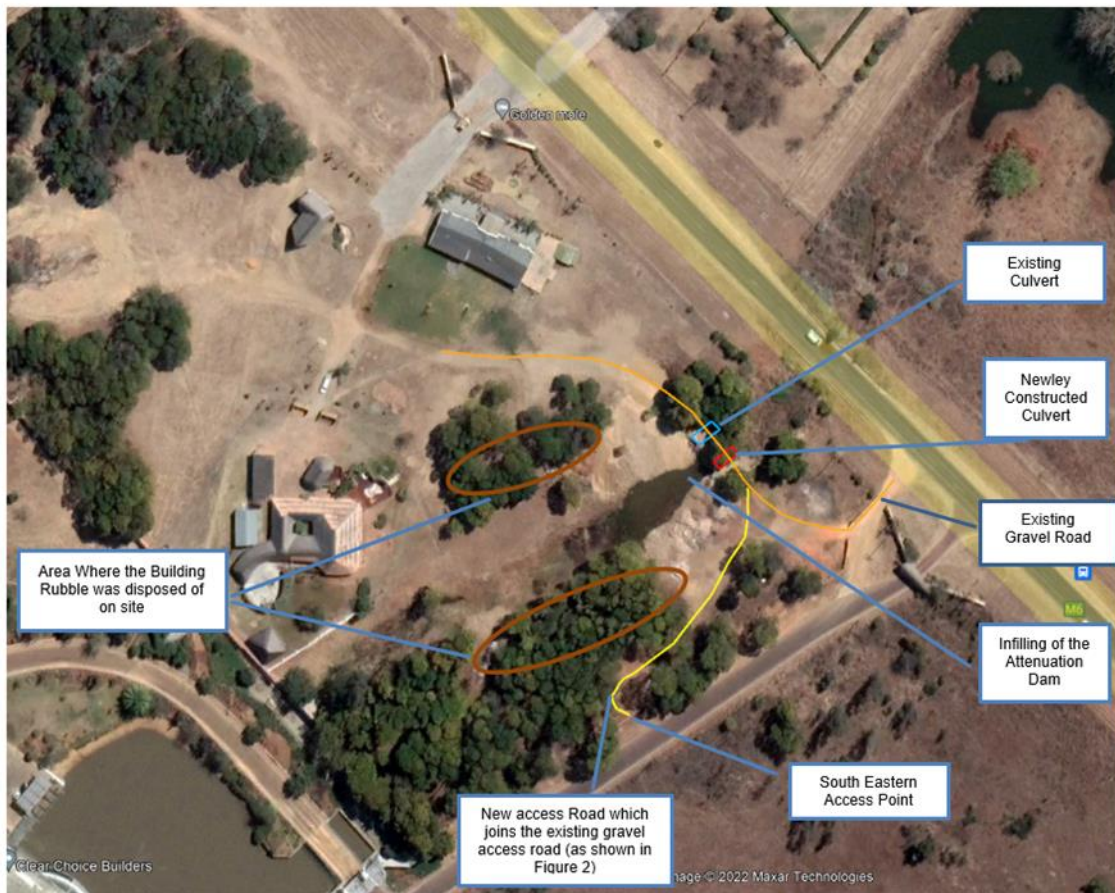
**Figure 2:3 Google Earth Image (2021) showing the construction activities undertaken on site**

An attenuation dam previously existed along the watercourse, west of the existing water crossing. Ms Sethole has infilled the attenuation dam and constructed a second culvert with the intention to channelize the watercourse. The construction of a new culvert which serves as a new flow path (diversion) of the watercourse. In terms of the site topography, steeper slopes are located within the vicinity of the watercourse situated on site. Due to the steep slopes, extensive erosion is encountered on site, whereby the

bank of the watercourse is extensively eroded. It was the intention of Ms Sethole to stabilise the banks of the watercourse by the infilling and compaction of waste/rubble material to achieve a levelled grassed area, hence the building rubble that has been disposed off on site.
