AGRICULTURAL ASSESSMENT OF THE PROPOSED GAROB 1 WIND ENERGY FACILITY SITE

ON PORTION 5 OF THE FARM NELSPOORTJE NO. 103, SIYATHEMBA
LOCAL MUNICIPALITY, NORTHERN CAPE PROVINCE

AUGUST 2012

PREPARED FOR: juwi RENEWABLE ENERGIES (PTY) LTD,
REPRESENTED BY SAVANNAH
ENVIRONMENTAL (PTY) LTD

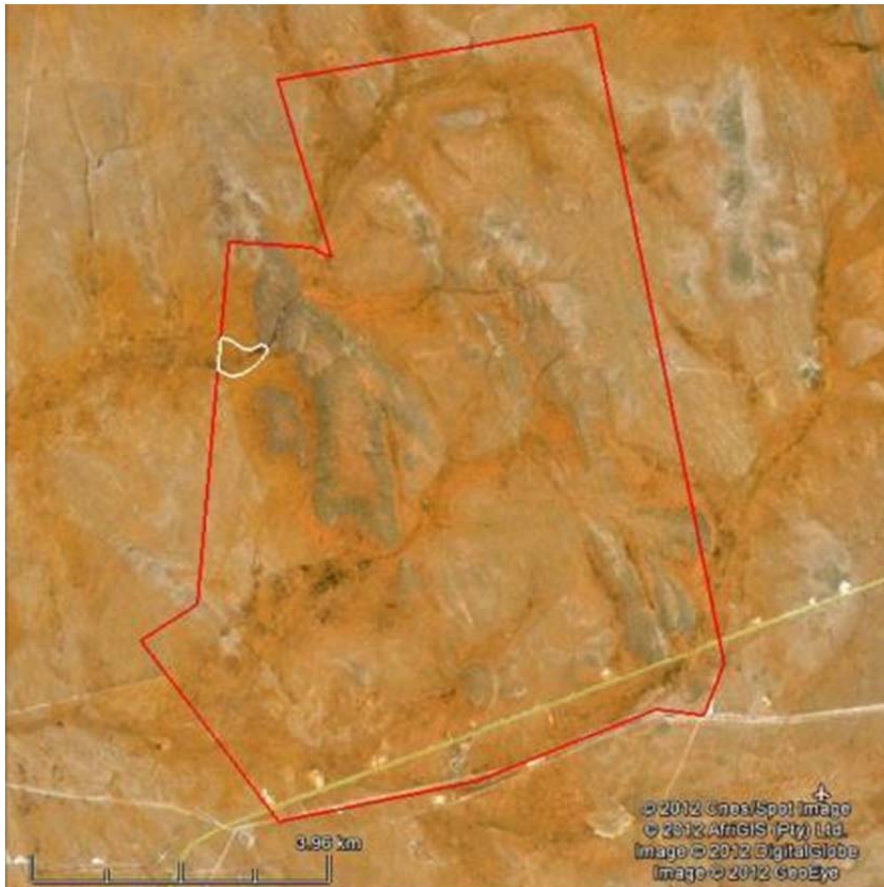
Appendix 20 No Go watercourse

WATERCOURSES & LANDS

There is a watercourse present on the site that is identified as a NO GO area.
- 8 Due diligence should be observed with the placement of the development footprint.
- 9 The identified impacts must be properly managed.
