**PROPOSED HARTEBEESTPOORT HOUSING
DEVELOPMENT, CITY OF TSHWANE MUNICIPALITY,
GAUTENG PROVINCE**

Draft Heritage Assessment Report

20 November 2017

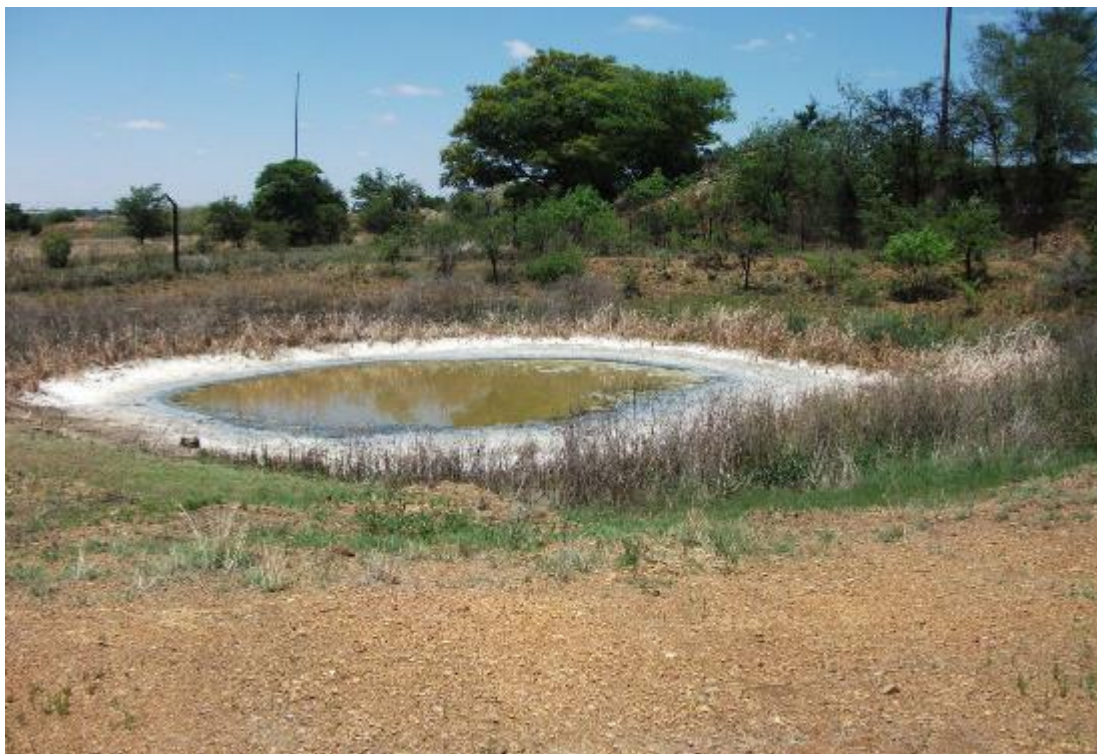
Figure 4: Man-made dam

On the western boundary is a large wetland that is thickly overgrown with vegetation. There are several man-made dams/ponds in the south western corner of the project area as well as some furrows and man-holes. It is unclear if this infrastructure is related to the railway depot or to the water works that is located on the southern boundary of the area to be developed (see **Figure 3** below). There are new groundwater monitoring points close to the aforementioned dams. Fence posts were found near the dams which indicates that the dams were fenced off from the rest of the property at some time in the past.

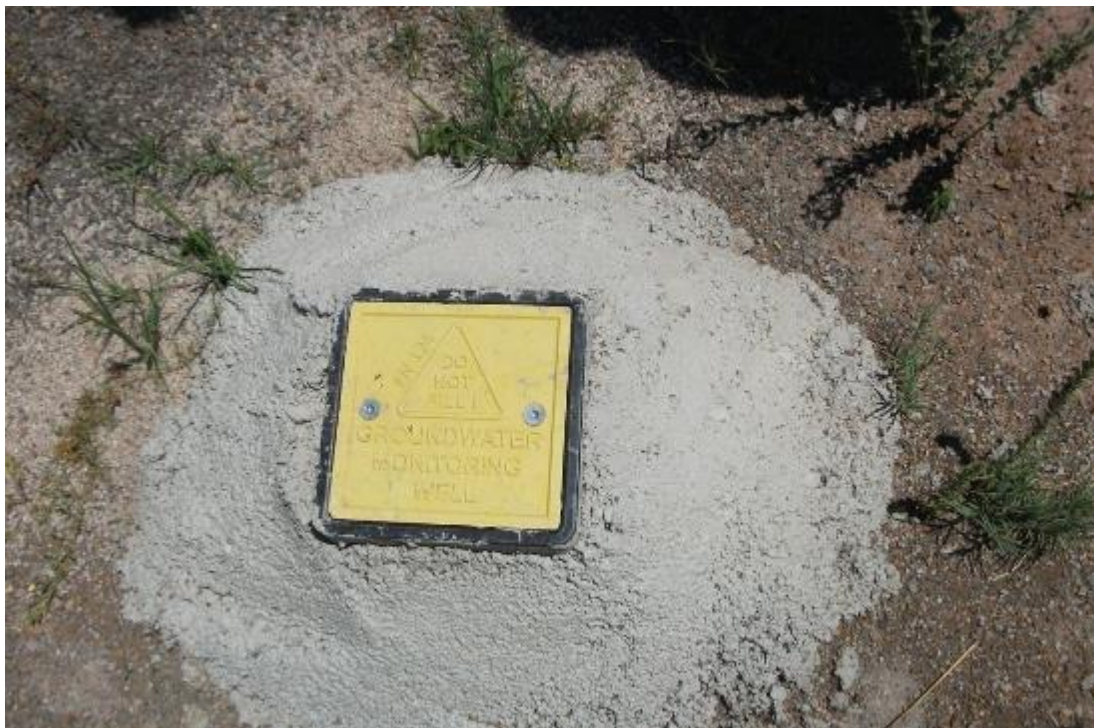
Figure 6: Groundwater monitoring indicator

There are several man-made dams/ponds in the south western corner of the project area as well as some furrows and man-holes. It is unclear if the infrastructure is related to the railway depot or to the water works that is located on the southern boundary of the area to be developed. There are new groundwater monitoring points close to the aforementioned dams. Fence posts were found near the dams indicating that the dams were fenced off from the rest of the property at some time in the past. There is also dumping of building rubble taking place throughout the project area.

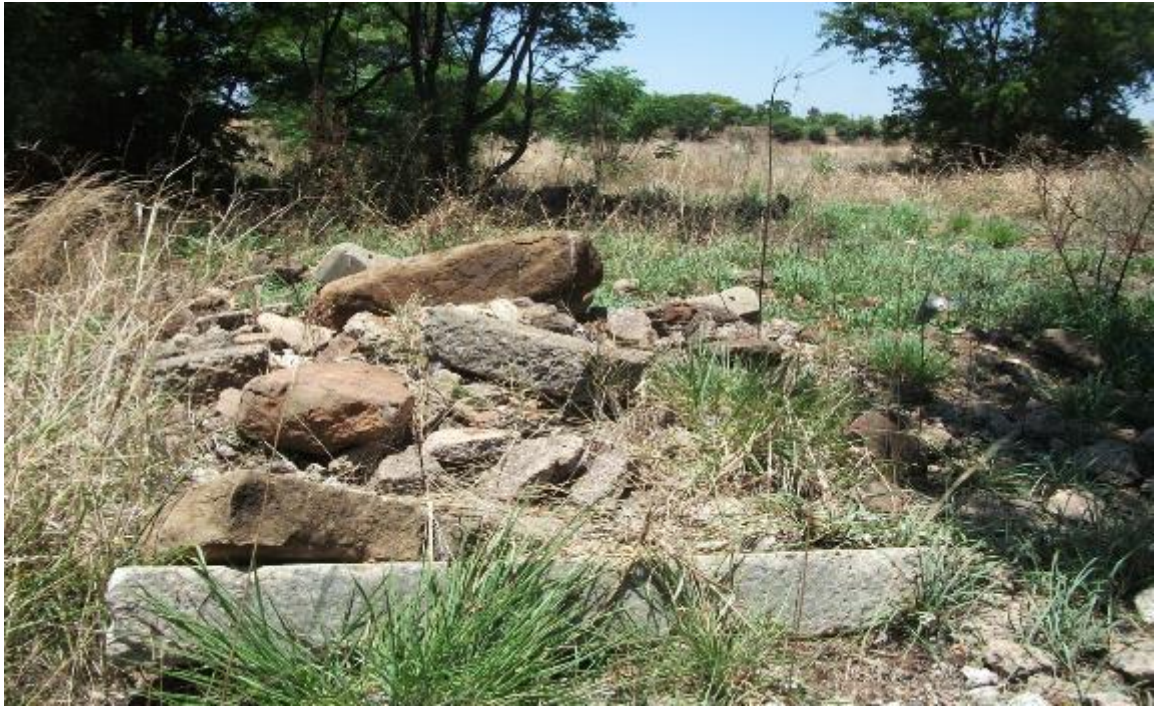
Figure 7: Rubble dumped on site

Much of the area proposed to be developed was inspected on foot. The area is disturbed by past activities including railway activity, the water works as well as the use of some of the property by car dealerships. There is also dumping of mainly building rubble taking place throughout the project area.

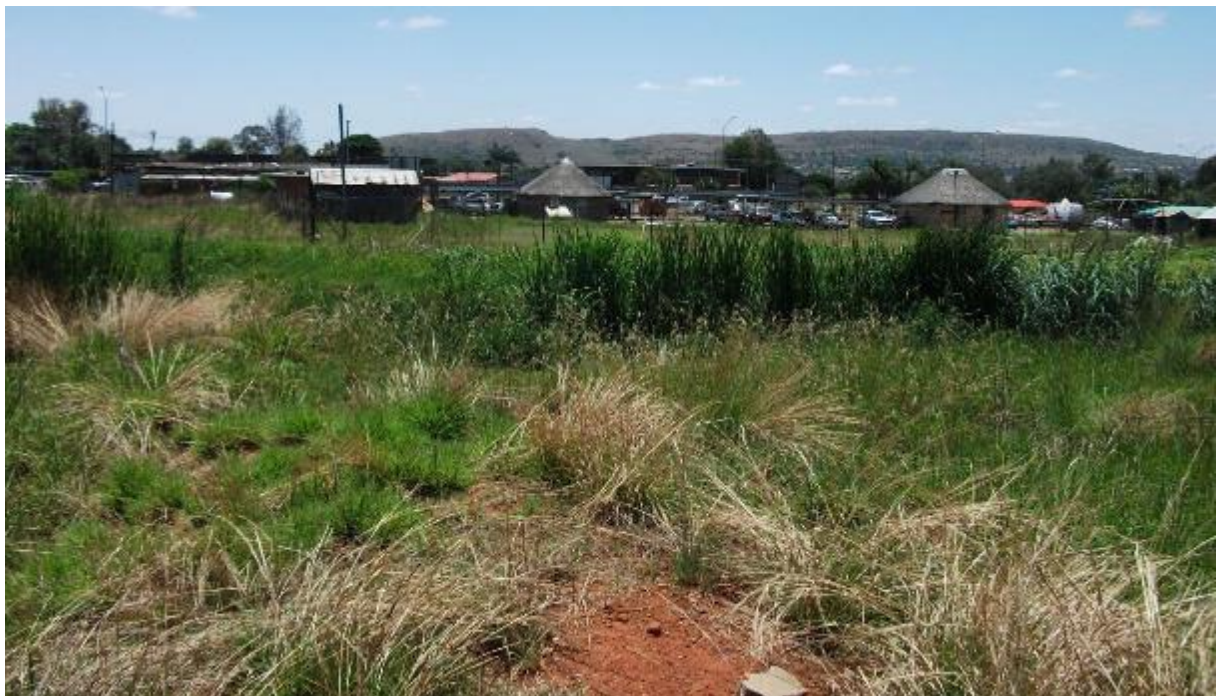
Figure 8: View of businesses on northern boundary of project area

There are existing businesses and industry on the northern boundary and eastern boundary of the project area. It is unknown if these businesses and industries will be removed for the purposes of the housing development. Although the structures are below 60 years of age (historical imagery from Google Earth shows that the businesses along the northern and eastern boundary of the development only developed around 2005) and are therefore not protected by the NHRA, the

negative impact on people's livelihoods with the removal of such businesses should not be underestimated.

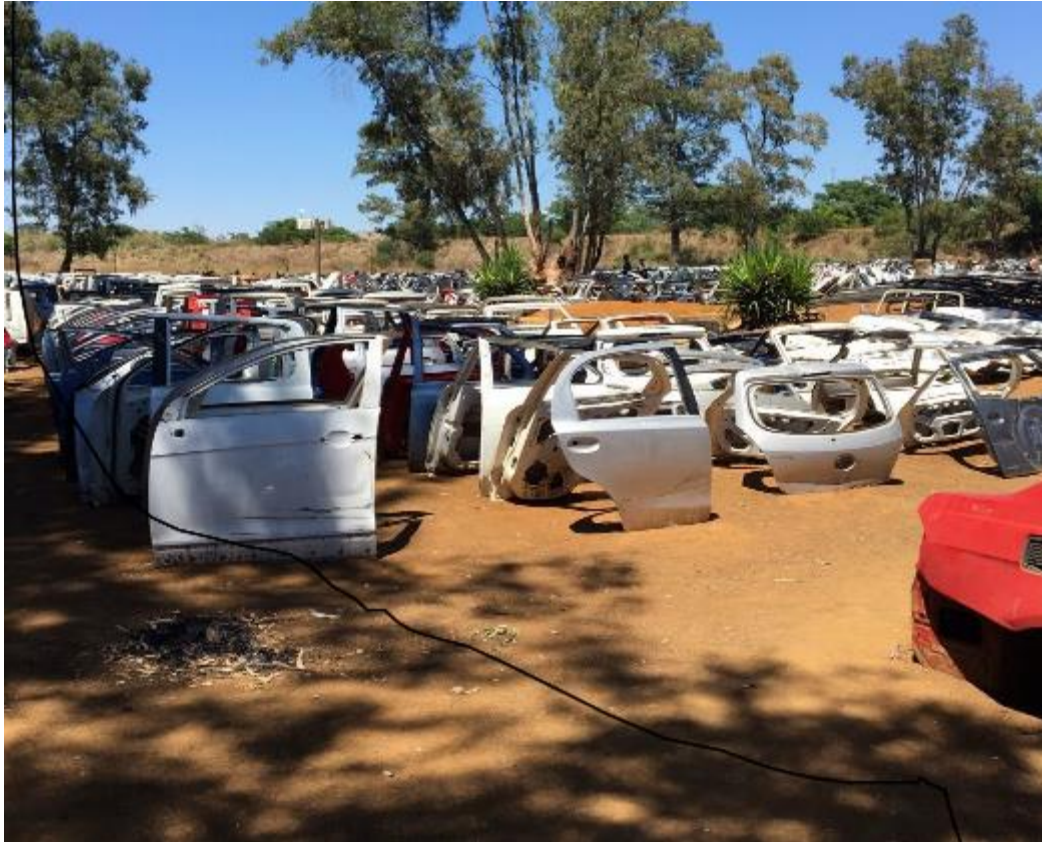
Figure 11: Car parts on project site

Second hand car dealerships situated on Stormvoel Road have used part of the eastern section to store car doors and other car parts for. The area used for this purpose is quite large and the car parts restricted access to some extent but no heritage resources were found in this area.
