PROPOSED POOLE'S BAY CONNECTION PATH
Hermanus
(Pre-application EA DEA&DP Ref no: 16/3/3/6/7/1/E2/15/1135/19)

SITE SENSITIVITY VERIFICATION REPORT

November 2021

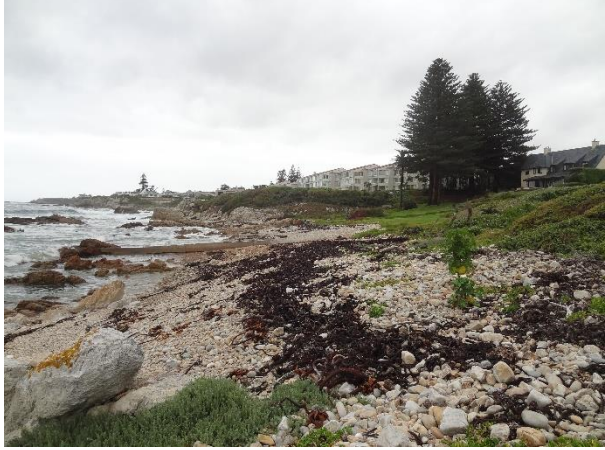
<p>Figure 2: The area is not suitable for agriculture as it falls below the HWM with pebbled beaches bordering onto private property with landscaped gardens</p> <p>Figure 3: Some other areas along the pathway is very rocky with steep cliff faces, not suitable for agriculture</p>

No	Theme	Very High sensitivity	High sensitivity	Medium sensitivity	Low sensitivity	Relevant (yes/no)	EAP's comment
1.	Agriculture Theme			X		No	The land capability is indicated to be low to moderate. The cliff path will be on a thin strip of rocky coastline, wedged between private residential property within the urban edge and ocean, with no potential for agriculture. Medium sensitivity is therefore refuted.

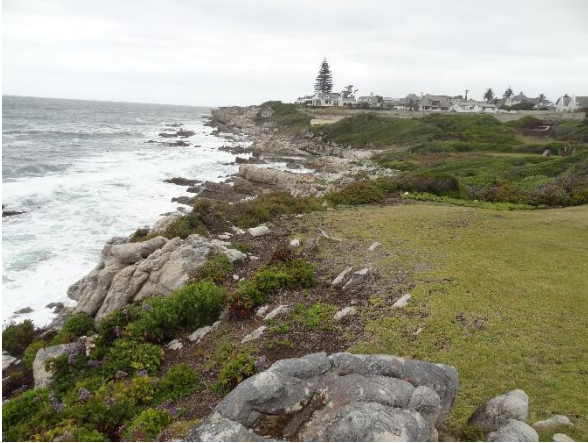
<p>Figure 4: The path being located below the HWM doesn't provide suitable natural habitat for terrestrial animal species</p>

<p>species with high reproductive and growth rates (e.g. small crustaceans and polychaetes) (Newell et al. 1998 as cited by Anchor Environmental). As marine invertebrates will start to re-colonise the affected areas through recruitment from adjacent rocky and sandy habitats immediately after construction is completed, the temporary disturbance within each relatively small construction footprint is expected to be 'low' to 'insignificant' and no mitigation is required. Low sensitivity was confirmed in the Marine Impact Assessment.</p> <p>Bird habitat on the island, a rocky outcrop off the coastline where the path will be situated, was the only area near the site that, according to the aviation study done, two South African Red Data species were recorded– the Near Threatened African Black Oystercatcher <i>Haemotopus moquini</i> and the Endangered Cape Cormorant, <i>Phalacrocorax capensis</i>. These species were not disturbed by the presence of humans on the nearby mainland.</p> <p>According to the survey none of the birds on the beach, where the cliff path would pass through, were threatened Red Data species.</p> <p>The Avian Specialists concluded that no fatal flaws were found that may compromise the birds' presence or possible breeding. Even though endangered species occur, these should not be significantly affected by the proposed path and the high sensitivity in site and project specific context is therefore refuted.</p>

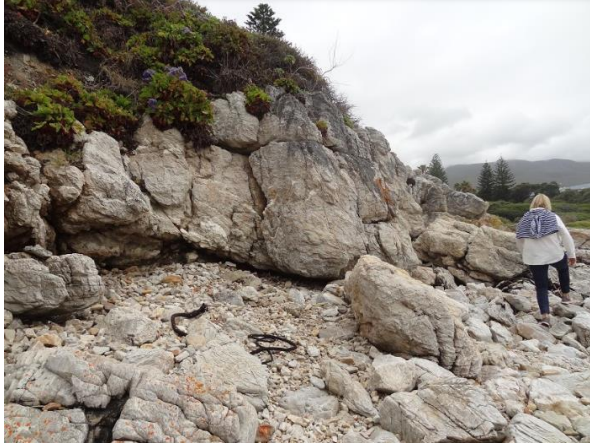
<p>Figure 5: Rocky region between the HWM and the LWM</p>

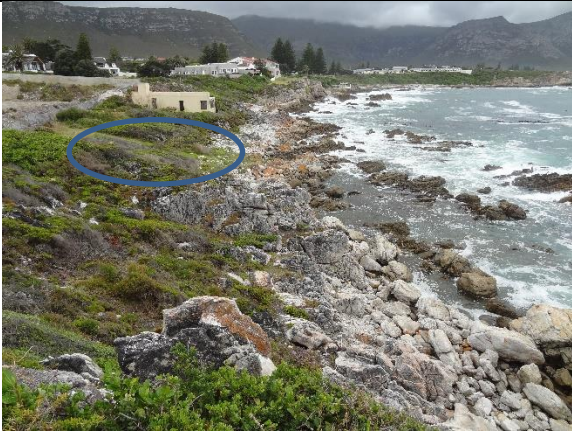
Figure 6: Wetland area below Erf 12557 above the HWM

3.	Aquatic Biodiversity Theme				X	Yes	<p>It is agreed with the sensitivity that is indicated as low - some habitat is present adjacent to the site according to a freshwater Ecology screening (31st of March 2019 and 23 September 2021). DWS must still indicated if they require a GA / WUL, in which case an assessment would be required.</p> <p>Low sensitivity is therefore confirmed and an assessment for the WUA would include a compliance statement as per the Protocols.</p>

wetlands were identified adjacent to the site, but these would not be affected significantly. A risk assessment would however be required for the purposes of a WUA. Refer to Figure 7-10 above.

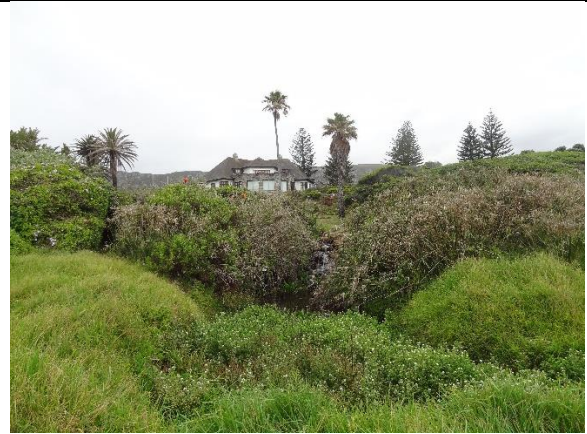
Figure 7: The channel (choked with exotic *Nasturtium officinale*), is visible, with the alien *Pennisetum clandestinum* in the foreground and the indigenous *Cyperus textillis* in the background

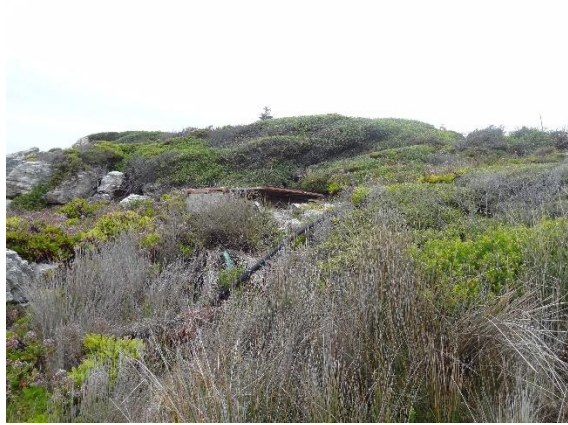
Figure 8: Close-up of wetland area in Figure 7

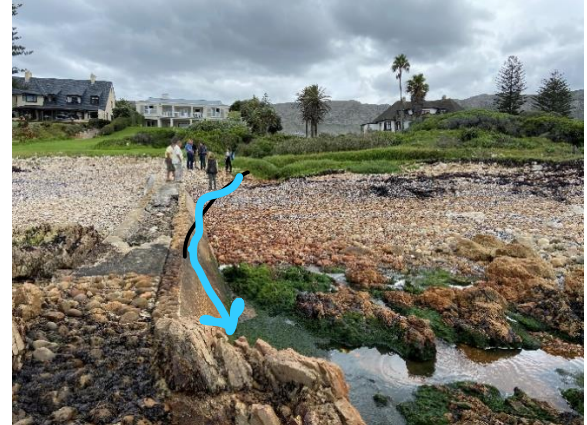
Figure 9: Small stream flowing into the sea

crossing of the wetland areas and stream would be done by boardwalk as to not impede the flow of water.
8.	Socio-Economic Assessment	https://screening.environment.gov.za/ScreeningDownloads/AssessmentProtocols/DraftGazetted_General_Requirement_Assessment_Protocols.pdf	No	A socio-economic impact assessment weighs the socio-economic cost against the socio-economic benefit of a proposed project. The proposed connection path would be a privately funded and executed initiative and would have no significant negative impact on socio-economics of Hermanus as it is a 850m connecting path to an already informal trodden coastal path used freely for recreational purposes.

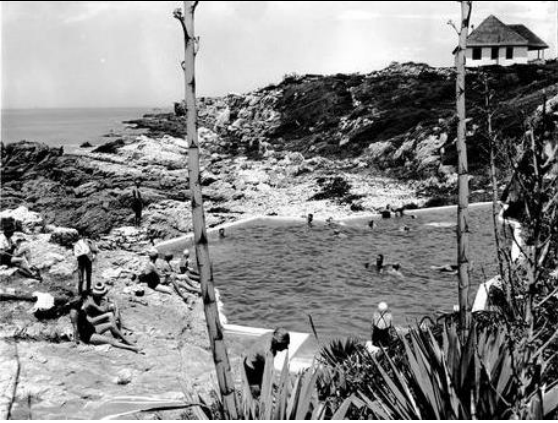
Figure 10: Historic photograph of pool at Bayview apartments (then Bayview hotel), circa 1950's

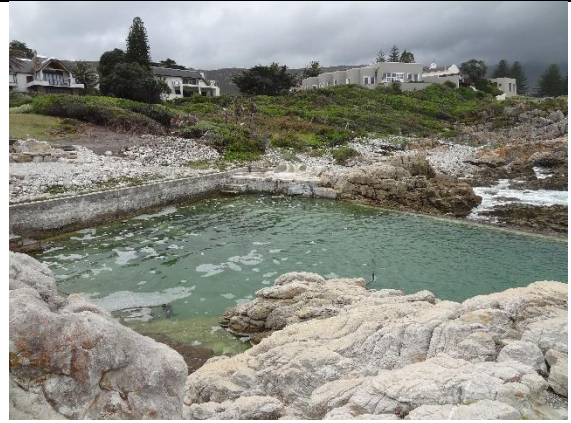
Figure 11: Tidal pool at Erf 1234

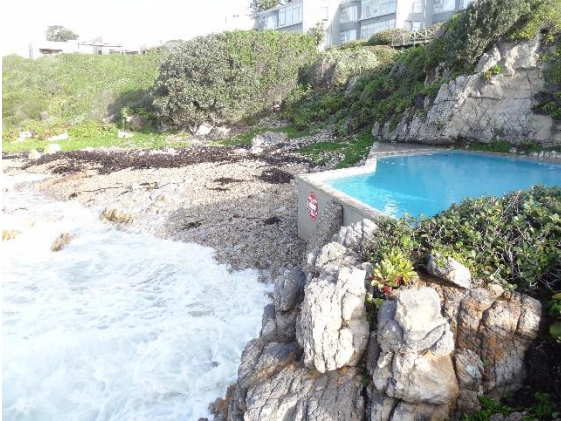
Figure 12: Present day appearance of pool at Bayview apartments

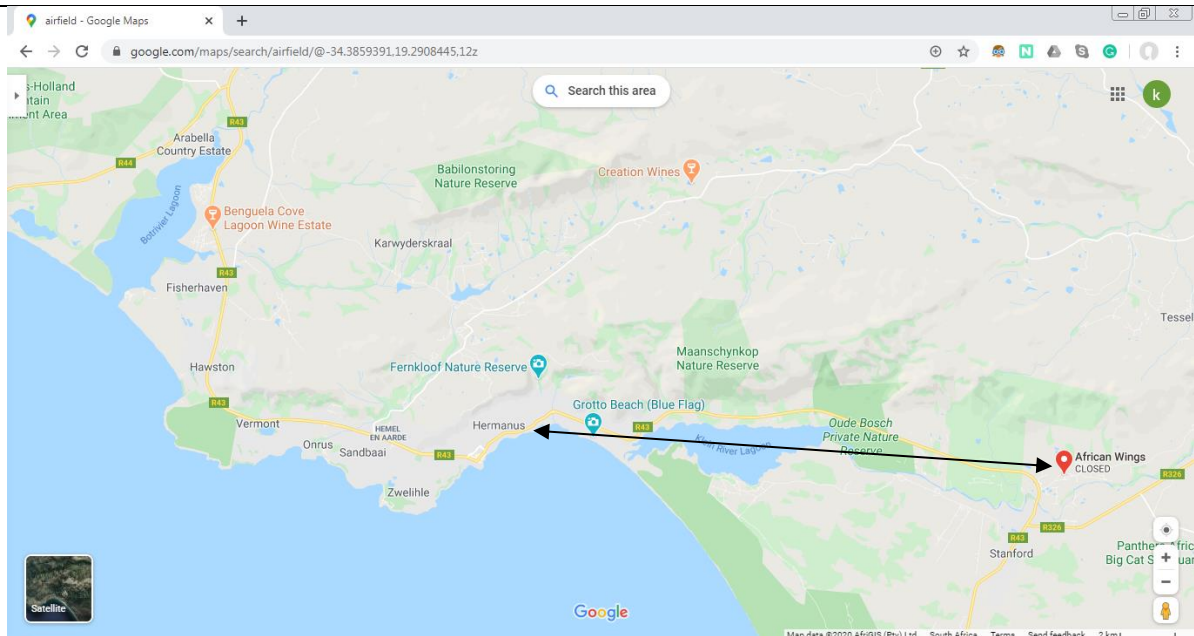
Figure 14: Distance to closest airfield

5.	Civil Aviation Theme			X		No	<p>The site is within 15 km of a civil aviation aerodrome (Private Airfield - African wings). However, the proposed cliff path would not have elements that would affect civil aviation. Markings and further consideration is only required for structures higher than 45m and which has the potential to endanger aviation in navigable airspace, or has the potential to interfere with the operation of navigation or surveillance systems or Instrument Landing Systems, including meteorological systems for aeronautical purposes (http://www.caa.co.za/Pages/Obstacles/Objects-affecting-airspace.aspx). Medium sensitivity in the site-specific context is therefore refuted.</p>
----	----------------------	--	--	---	--	----	---

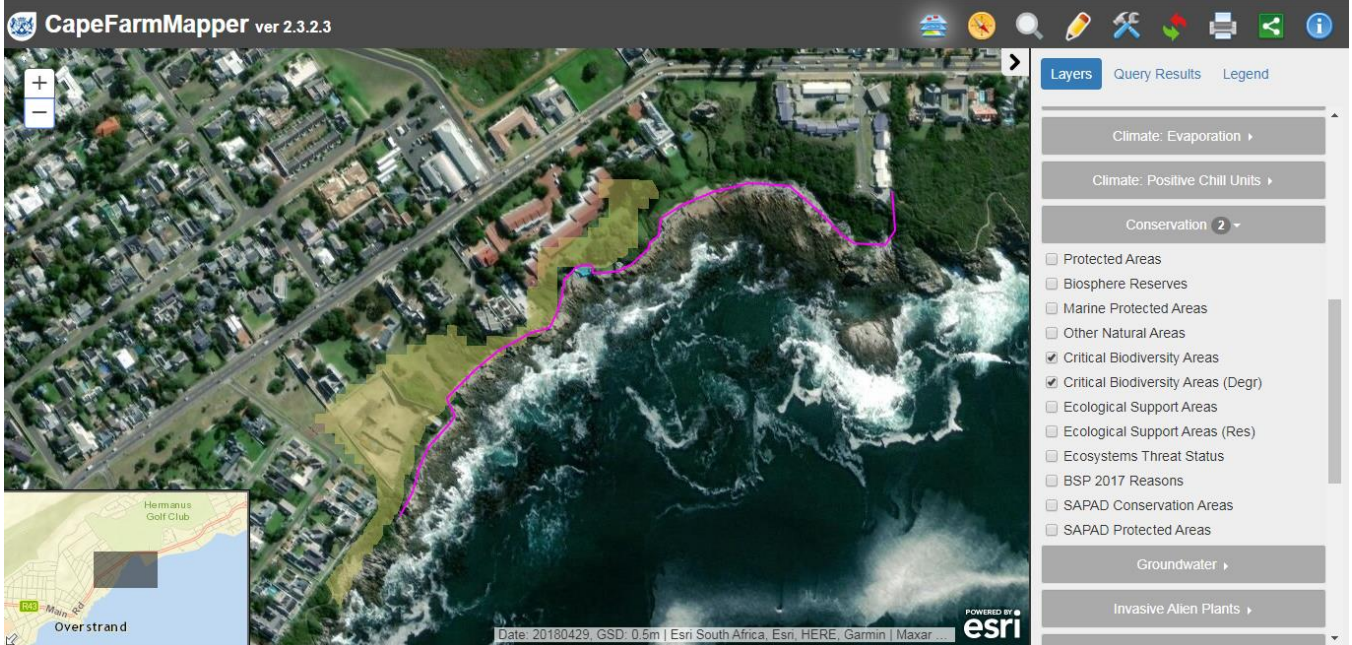
Figure 16: Degraded Critical Biodiversity Areas

9.	Terrestrial Biodiversity Theme	X				No	<p>The proposed site is adjacent to a degraded Terrestrial Critical Biodiversity Area, according to the WCBSA on Cape Farm Mapper. The cliff path would be low-impact according to specialist investigations and would not have a significant effect on remaining biodiversity in the area.</p> <p>The path would cross a small stream into the ocean (described as Aquatic Ecological support area). However, where the stream enters the HWM, there is no further functionality in terms of terrestrial biodiversity. The path will also not impede faunal movement, thus the high sensitivity is therefore refuted within the project and site specific context.</p>
----	--------------------------------	---	--	--	--	----	---

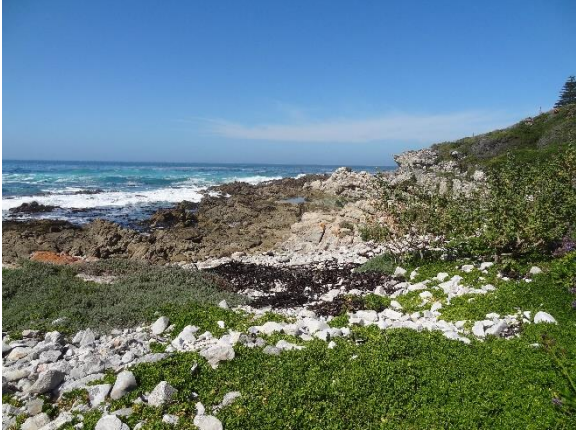
Figure 19: Areas where creeping vegetation would need to be removed

4.	Terrestrial Biodiversity Impact Assessment	https://screening.environment.gov.za/ScreeningDownloads/AssessmentProtocols/DraftGazetted_Terrestrial_Biodiversity_Assessment_Protocols.pdf	No	No terrestrial biodiversity is found below the HWM, where the path is proposed. Marine Biodiversity was however investigated and determined not to be of ecological sensitivity. Some vegetation does extend below the HWM though. Minor removal of vegetation may be required at the connection points to the existing path, but this would likely be less than 300m ² .
----	--	---	----	--

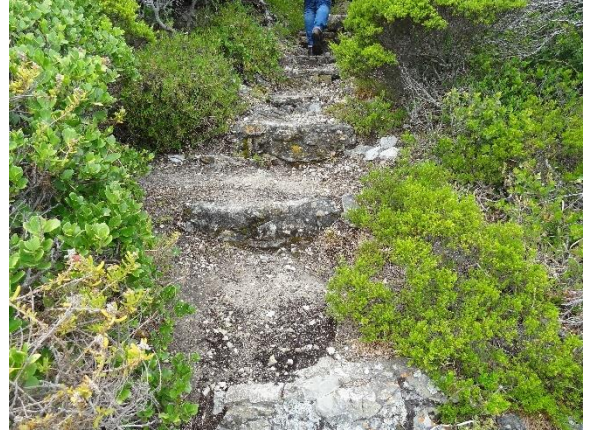
Figure 20: Steps at eastern connection point, which would be incorporated into the path, thus not requiring significant removal of vegetation other than pruning.

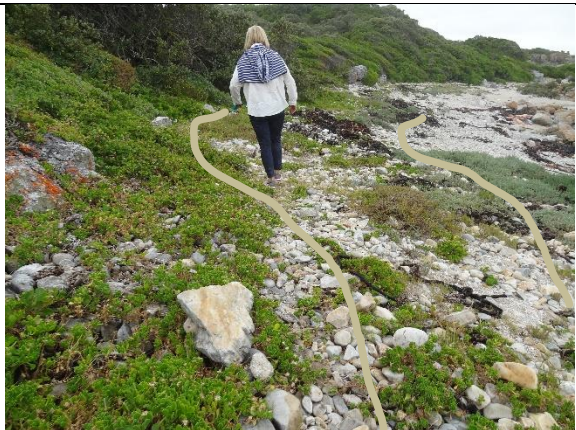
Figure 21: 5m 'construction zone' within which the ±1,2m wide path will be constructed, containing sparse hydrophytic vegetation

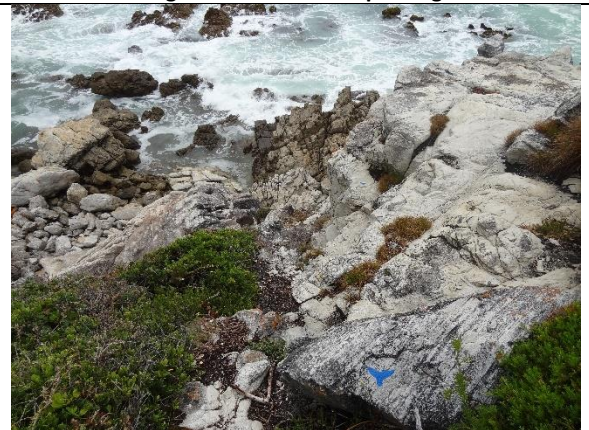
Figure 22: Rocky areas with minimal vegetation

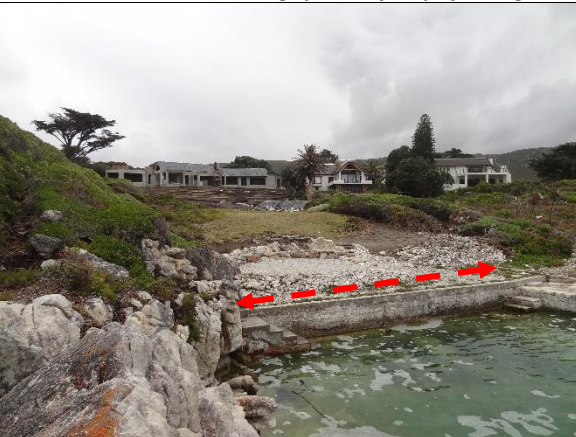
Figure 23: Pathway to follow HWM along edge of tidal pool at Erf 1234

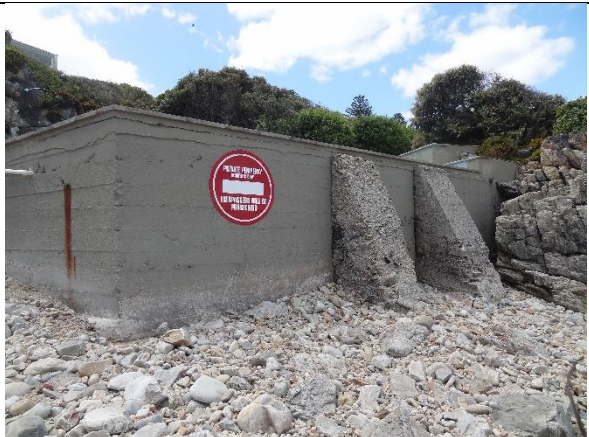
Figure 24: Pathway to follow edge of swimming pool at Bayview Apartments with no terrestrial vegetation occurring on rocky areas

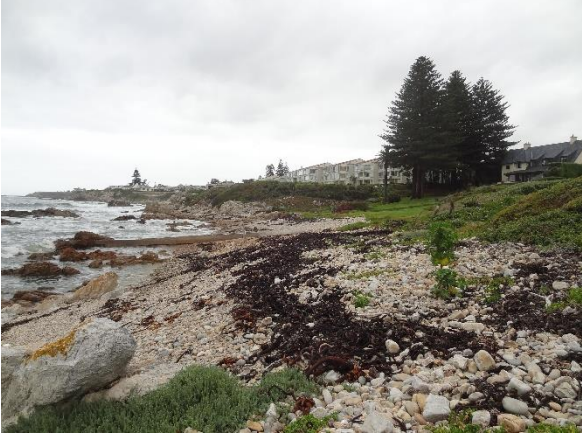
<p>Figure 25 Proposed location of pathway between HWM and LWM (intertidal zone)</p>		<p>Figure 26: Rocky areas within intertidal zone with evidence of previous infrastructure</p>

6.	Marine Impact Assessment	https://screening.environment.gov.za/ScreeningDownloads/AssessmentProtocols/DraftGazetted_General_Requirement_Assessment_Protocols.pdf	Yes	The proposed connection path will be located between the HWM and LWM (intertidal zone). Upon request of CapeNature and to clarify uncertainties, a MIA was undertaken, also considering coastal aspects.

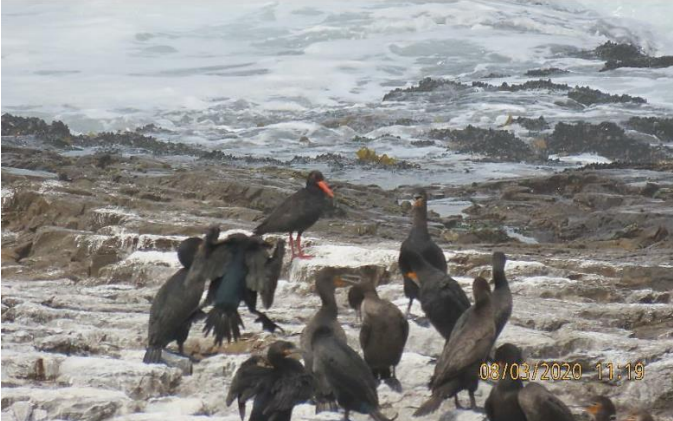
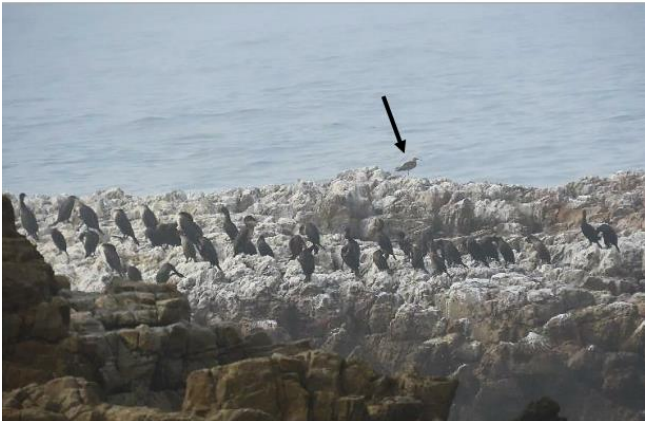
<p>Figure 28: Black Oyster catchers and cormorants - courtesy of Dr Rob Simmons, Avian Specialist</p>		<p>Figure 29: Kraalrock Island with birds such as cormorants, gulls and whimbrels (arrowed) - courtesy of Dr Rob Simmons, Avian Specialist</p>

The cliff path lies between the HWM and the LWM of the ocean. There are endangered bird species in the area, concentrated at the island adjacent to the proposed site. This confirms the Animal Species Sensitivity, however, the avian specialist found no breeding sites along the proposed pathway and concluded that the path should not compromise the birds' presence or possible breeding. Further assessments are therefore not warranted. The site, according to EnviroSwift, lies along the perimeter of the Critically Endangered Overberg Sandstone Fynbos vegetation type and there are also wetlands associated with the proposed site. Thus, confirming Aquatic Biodiversity Sensitivity. However, as the path will be situated in the intertidal zone, neither sensitivities should be affected by the path.
