PRELIMINARY GEOTECHNICAL INVESTIGATION
for

PROPOSED CSP - NEW SITE 5

Client: Emvelo Eco Projects

Job No: 15107/3

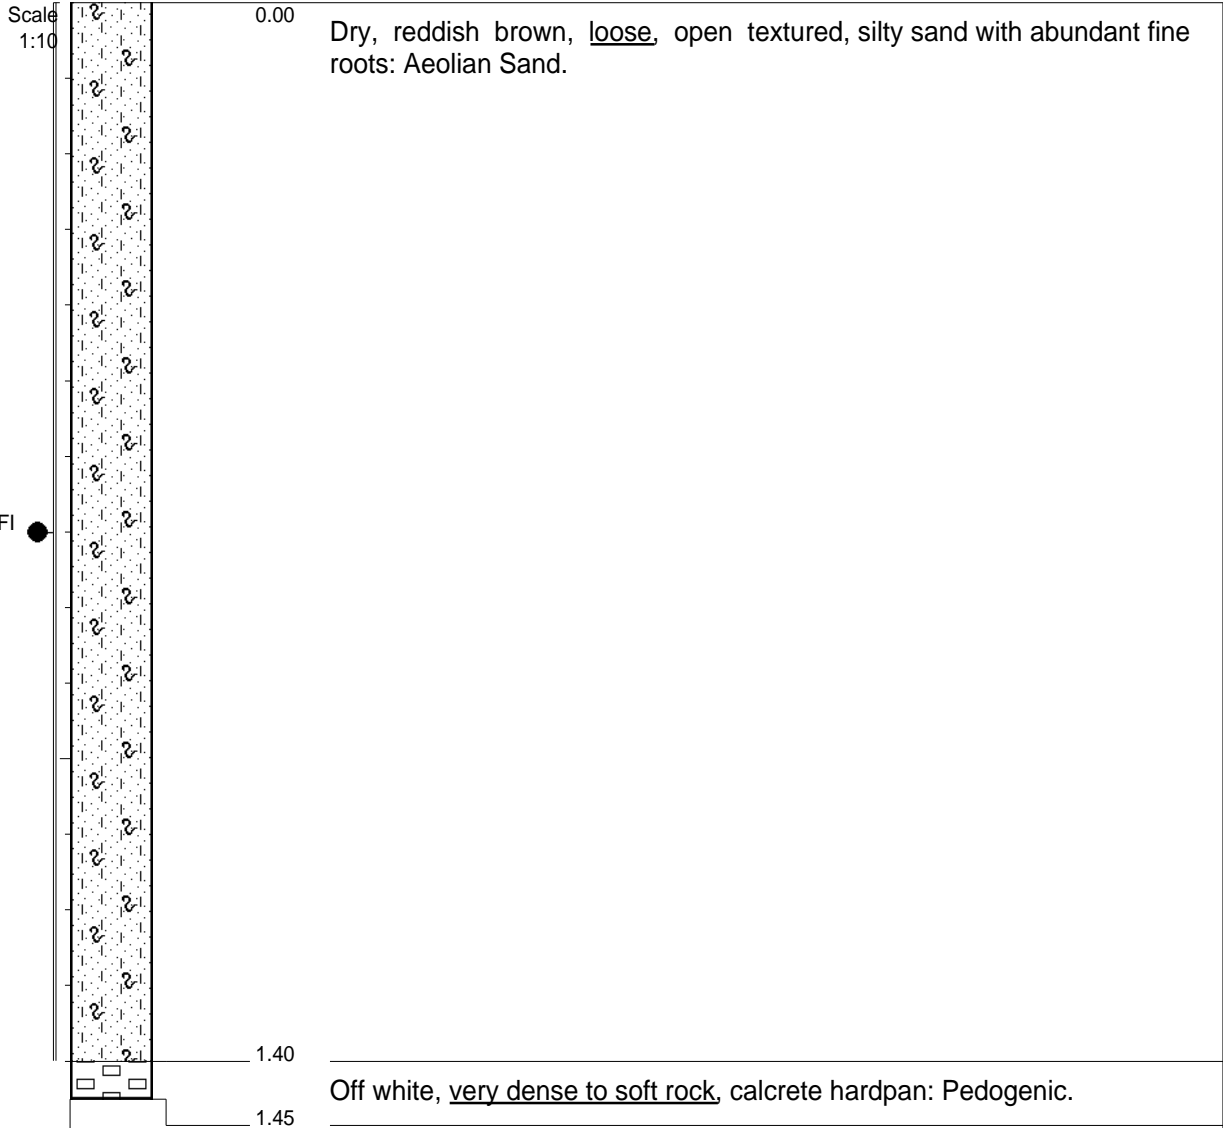
HOLE No: TPF29

- 1) EOH @ 1.45m, refusal of TLB
- 2) No water seepage observed
- 3) Disturbed sample FI @ 0--1.4m

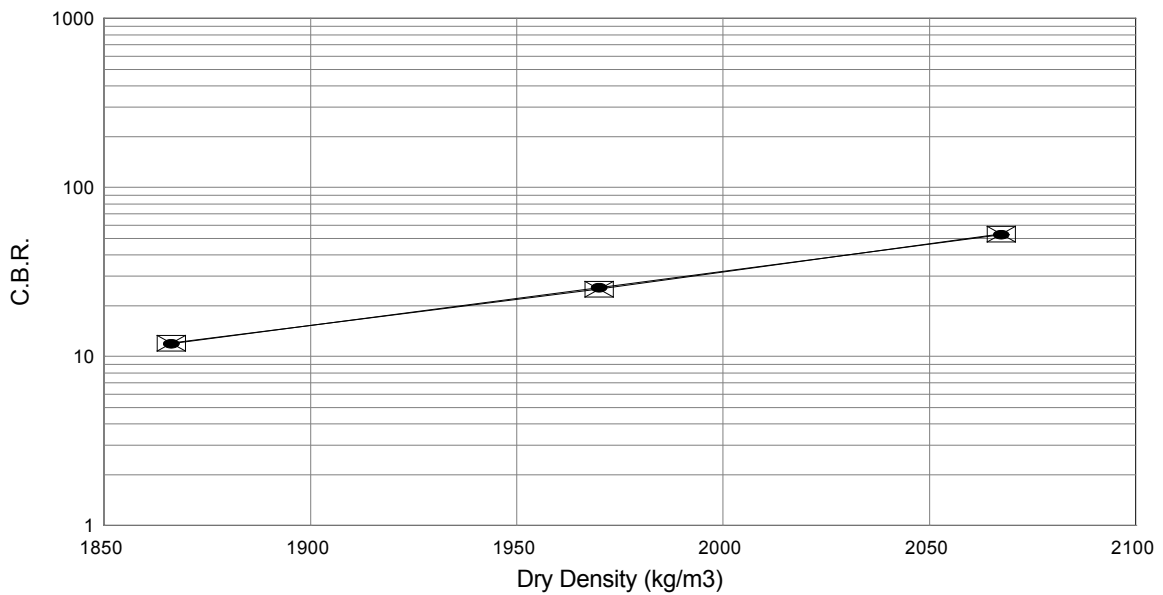
Percentage Mod AASHTO	90	93	95	98	100
CBR	12	18	25	39	53

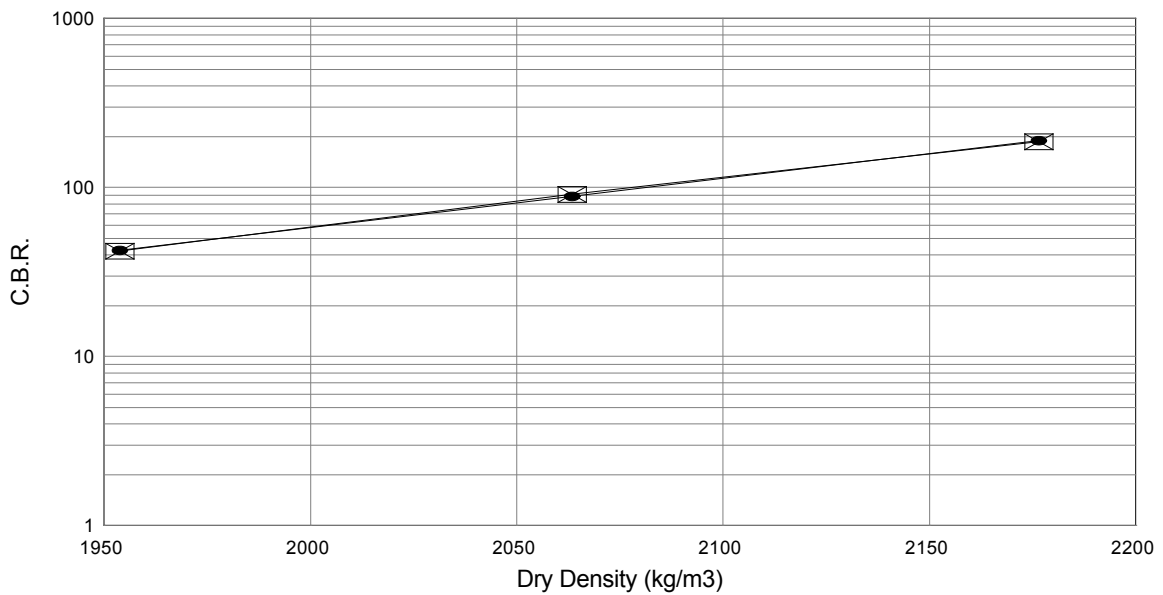
Percentage Mod AASHTO	90	93	95	98	100
CBR	43	67	90	139	186

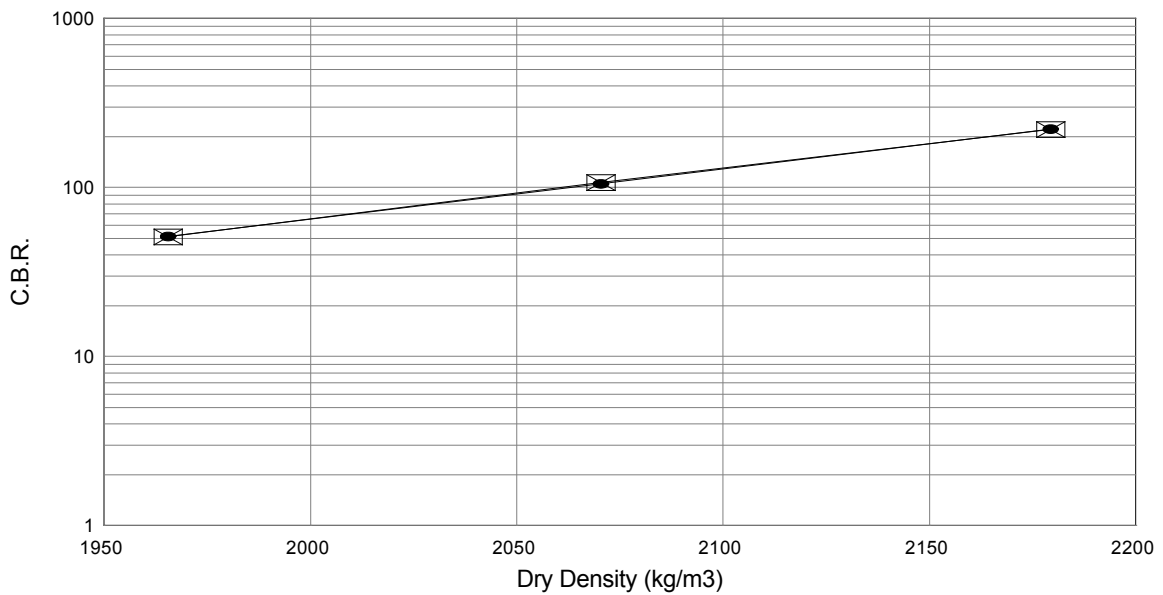
Percentage Mod AASHTO	90	93	95	98	100
CBR	51	80	108	168	227

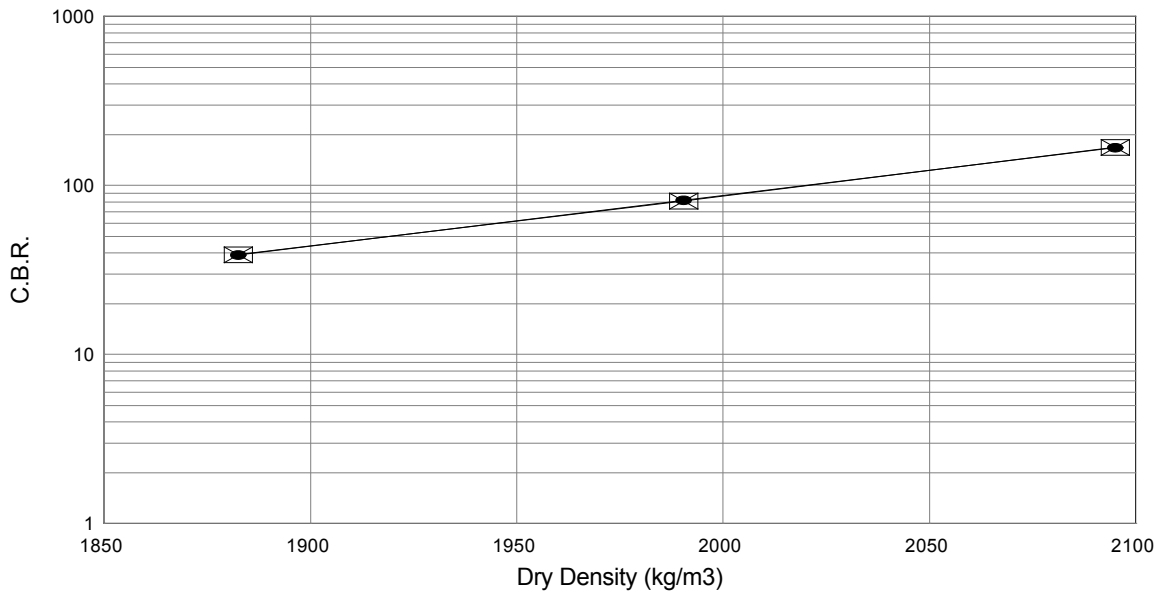
Percentage Mod AASHTO	90	93	95	98	100
CBR	39	60	81	124	166

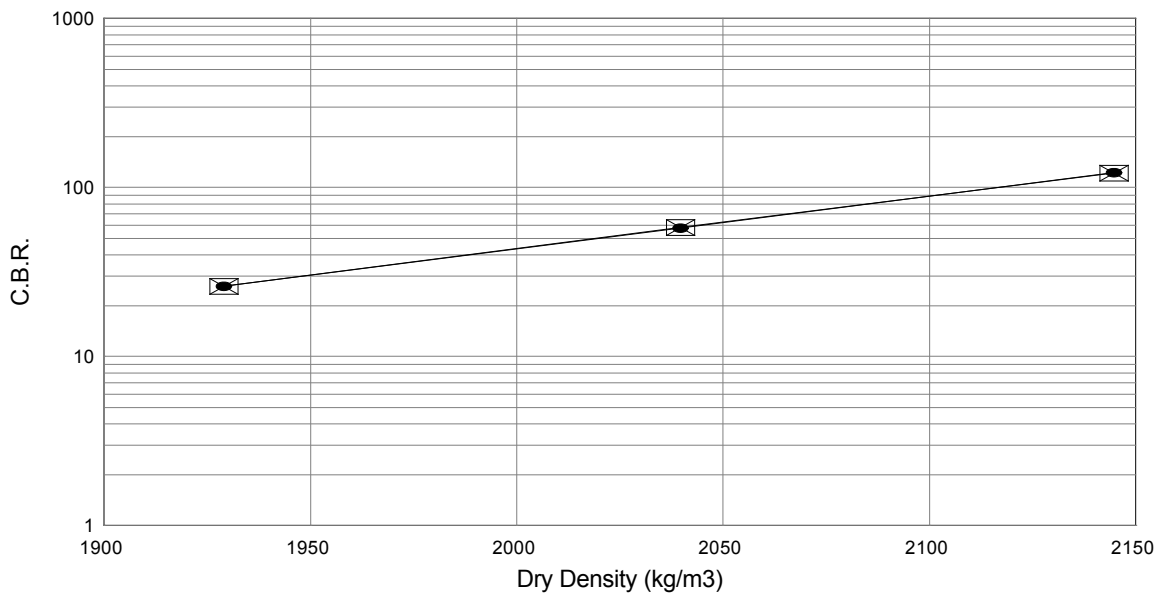
Percentage Mod AASHTO	90	93	95	98	100
CBR	27	42	58	91	124

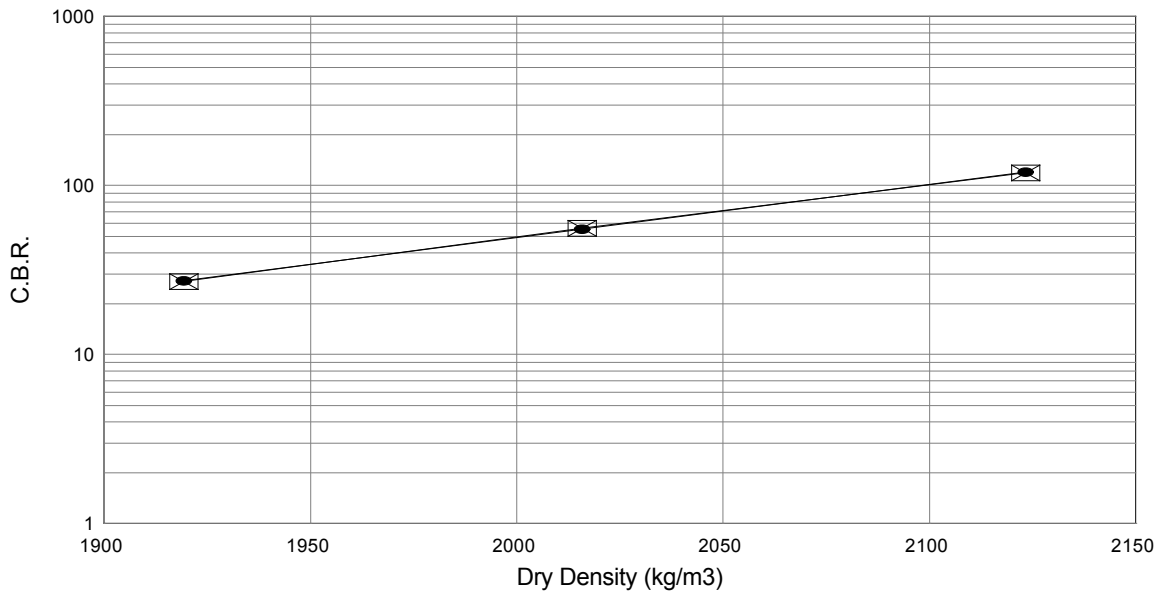
Percentage Mod AASHTO	90	93	95	98	100
CBR	26	41	56	89	121

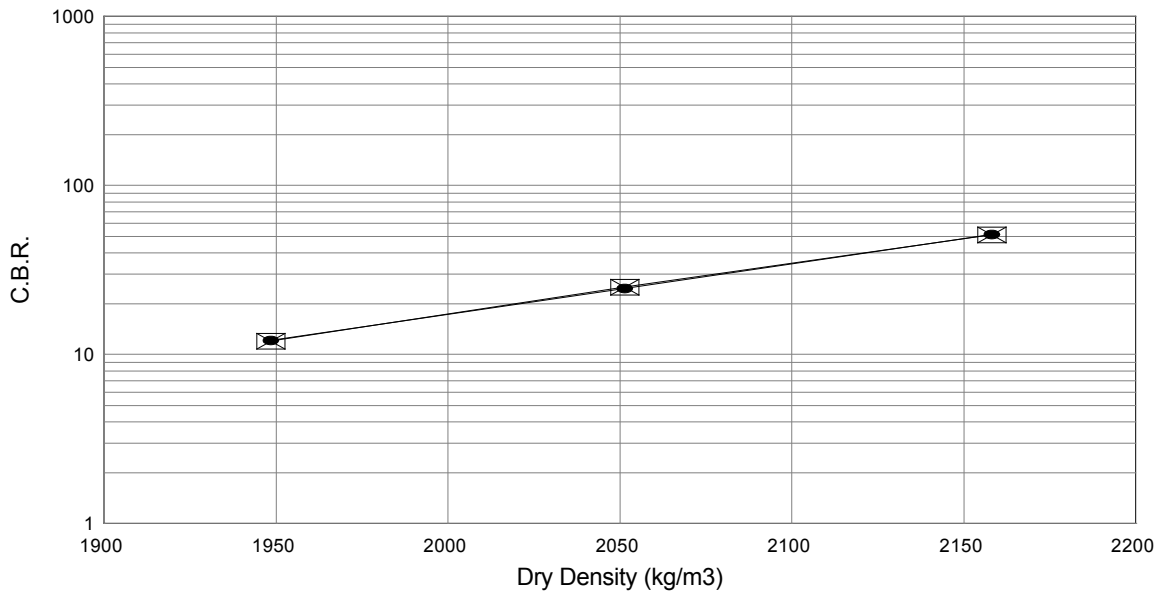
Percentage Mod AASHTO	90	93	95	98	100
CBR	12	18	24	38	51
