# Proposed Majuba solar photovoltaic facility, Mpumalanga

Wetland Delineation and Functional Assessment  
February 2015

Limosella Consulting Pty Ltd

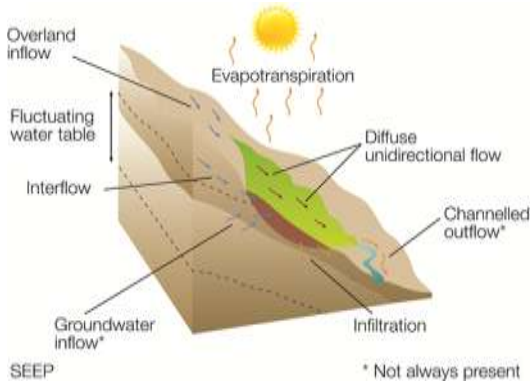
| Hydro-geomorphic types (Ollis <i>et al</i> , 2013) | Description (Kotze <i>et al</i> , 2005) |
|--|--|
| <p>Seepage Wetlands</p> <p>The diagram illustrates the hydro-geomorphic processes in seepage wetlands. It shows a cross-section of a hillside with a fluctuating water table. Water enters from overland inflow and groundwater inflow (marked with an asterisk). Evapotranspiration is shown as upward arrows from the soil surface. Diffuse unidirectional flow moves through the soil profile, and channelled outflow is shown as a stream at the surface. Infiltration is also indicated. The word 'SEEP' is written at the bottom left, and '* Not always present' is at the bottom right.</p> | <p>Seepage wetlands can be located on the mid- and footslopes of hillsides; either as isolated systems or connected to downslope valley bottom wetlands. Seepages occur where springs are decanting into the soil profile near the surface, causing hydric conditions to develop; or where through flow in the soil profile is forced close to the surface due to impervious layers.</p> |

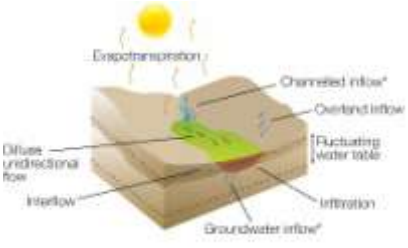
| Hydro-geomorphic types (Ollis <i>et al</i> , 2013) | Description (Kotze <i>et al</i> , 2005) |
|--|--|
| <p>Unchannelled Valley-bottom Wetlands</p> <p>The diagram illustrates the hydro-geomorphic processes in unchannelled valley-bottom wetlands. It shows a cross-section of a valley floor with a fluctuating water table. Water enters from a channelled inflow (marked with an asterisk) and a constant inflow. Evapotranspiration is shown as upward arrows from the soil surface. Diffuse unidirectional flow moves through the soil profile, and interflow is shown as water moving horizontally through the soil. Infiltration is also indicated. The text 'UNCHANNELLED VALLEY-BOTTOM WETLAND' and '* Not always present' are at the bottom.</p> | <p>Unchannelled Valley-bottom Wetlands are characterised by their location on valley floors, their absence of distinct channelled banks and prevalence of diffuse flows. These wetlands occur where a river loses its confinement (often brought about by a change in gradient) or at the downstream end of a seep.</p> |

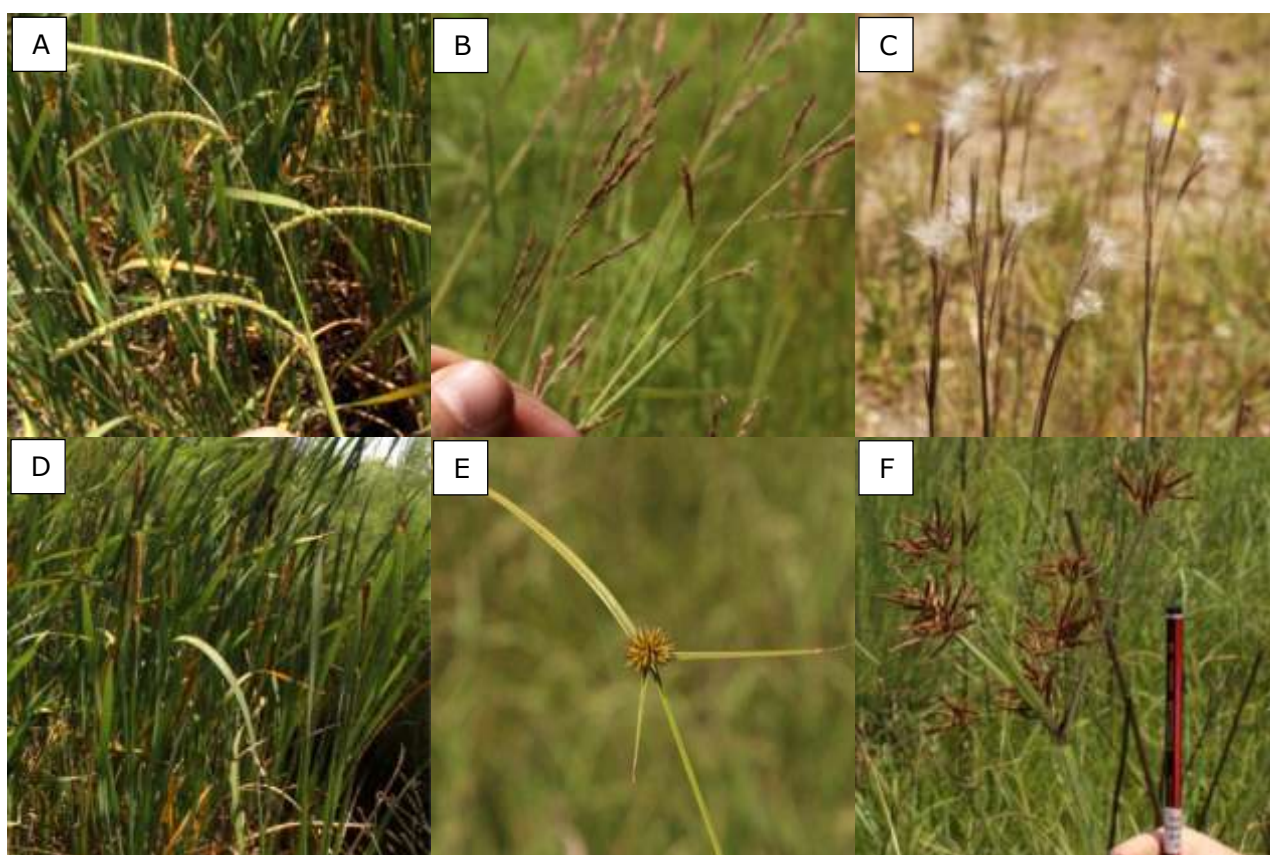
**Figure 7.** Examples of some wetland indicator species found. **A:** *Paspalum dilatatum* – facultative wetland species, **B:** *Leersia hexandra* (Rice grass) – obligate wetland species, **C:** *Andropogon eucomus* (Snowflake grass) – obligate wetland species, **D:** *Typha capensis* (Bulrush) – obligate wetland species, **E:** *Kyllinga erecta* – obligate wetland species, **F:** *Cyperus longus* – obligate wetland species.

Wetland plants were an important indicator for the delineation process. *Typha capensis* (Bulrush) was found in ponding water, while a community of wetland species indicated the extent of the permanent, seasonal and temporary zones. Some common obligate and facultative wetland species used to delineate the wetlands were: *Agrostis lachnantha*, *Leersia hexandra* (Rice grass), *Andropogon eucomus* (Snowflake grass), *Kyllinga erecta*, *Cyperus longus*, *Cyperus denudatus* and *Verbena bonariensis*. Several of these species are shown in Figure 7. For the most part wetland plant community correlated with the soils except for where disturbance had altered the plant community.

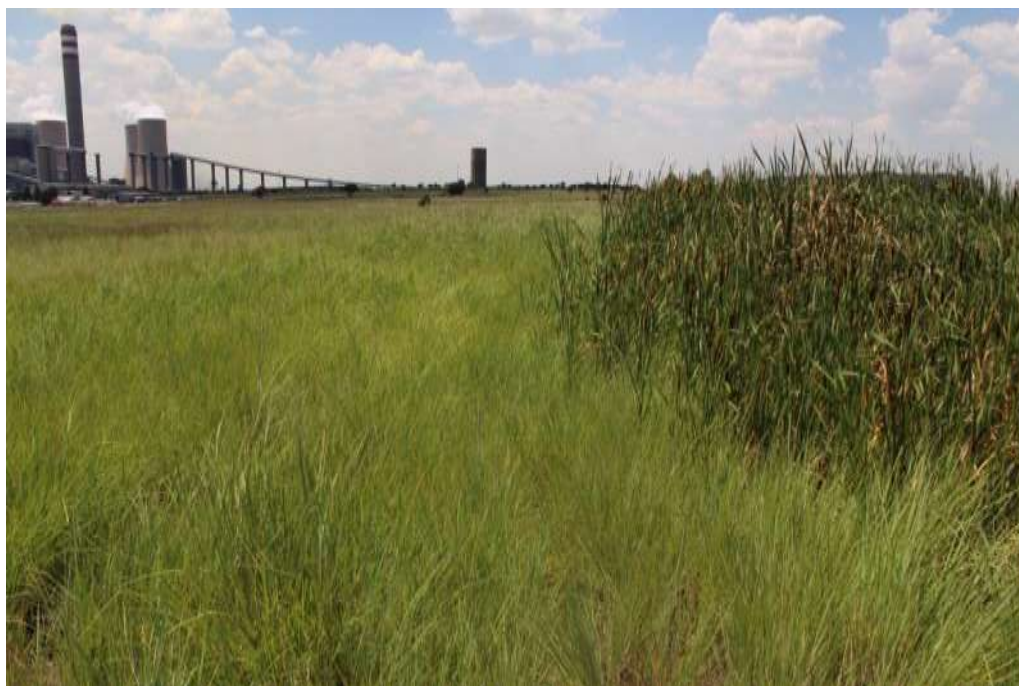
**Figure 8.** The wetland boundary between dryland on the right and a seep (indicated by the bulrush (*Typha capensis*) on the left.

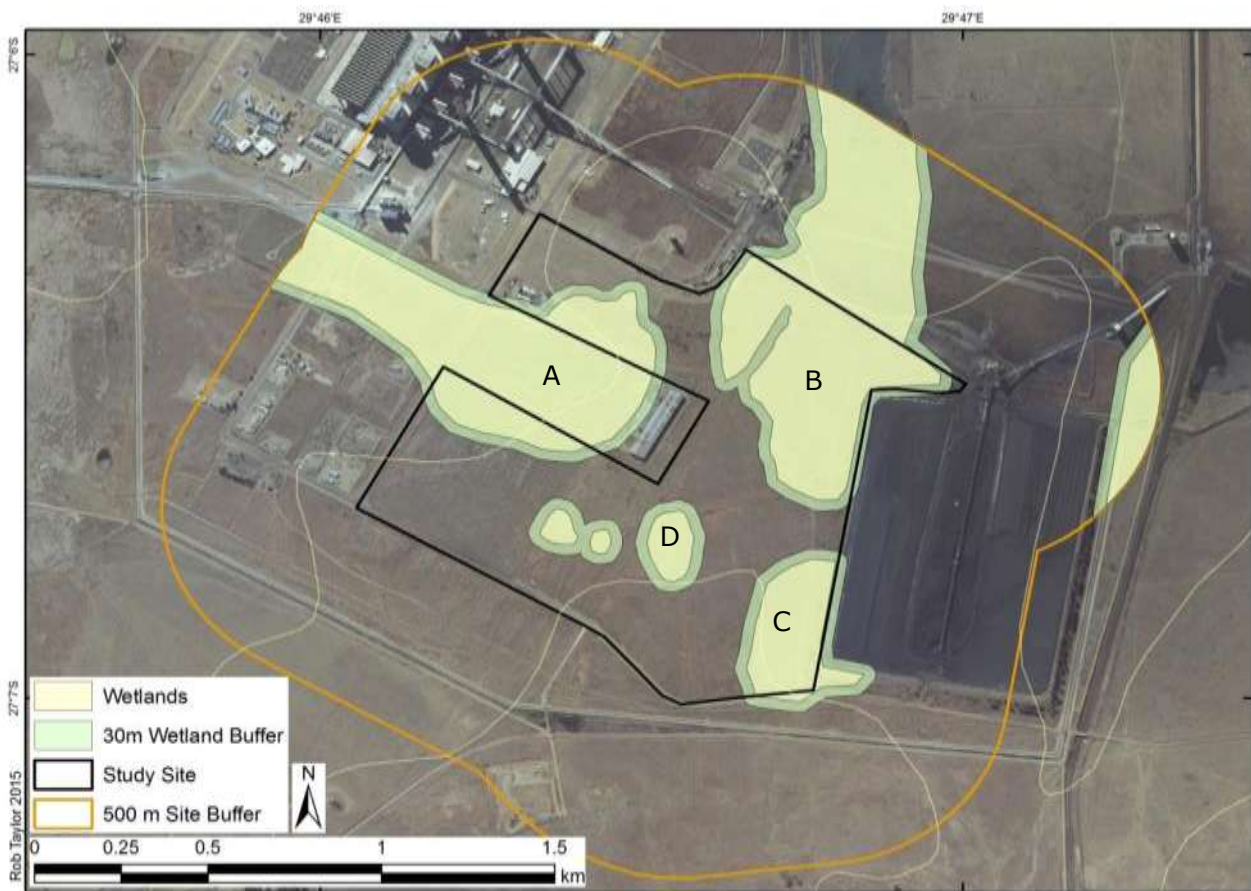
**Figure 9.** The wetlands and wetland buffers on the study site; **A:** the unchannelled valley-bottom wetland, **B:** a hillside seep draining northwards, **C:** a hillside seep draining south-eastwards, **D:** a cluster of hillside seeps draining north-westwards. All wetlands within a 500m buffer of the construction are prescribed by the DWA as relevant to the Water Use Licence application process.

Four wetlands were delineated on the study site comprising of an unchannelled valley-bottom (7.3ha) wetland and three hillside seeps (the one hillside seep consisting of a series of small seeps lumped together for this assessment – 2.8ha, south-east seep – 6.3ha, north seep – 18.9ha,). Figure 9 shows the delineated wetlands together with the 30m wetland buffers. Figure 10 shows a regional perspective on how the wetlands drain from the site.
