Environmental Authorisation and Integrated Water Use Licence Applications for the Proposed Water Treatment Plant at the Klipspruit Colliery, Mpumalanga Province

Aquatic Impact Assessment

SOU5014

August 2018

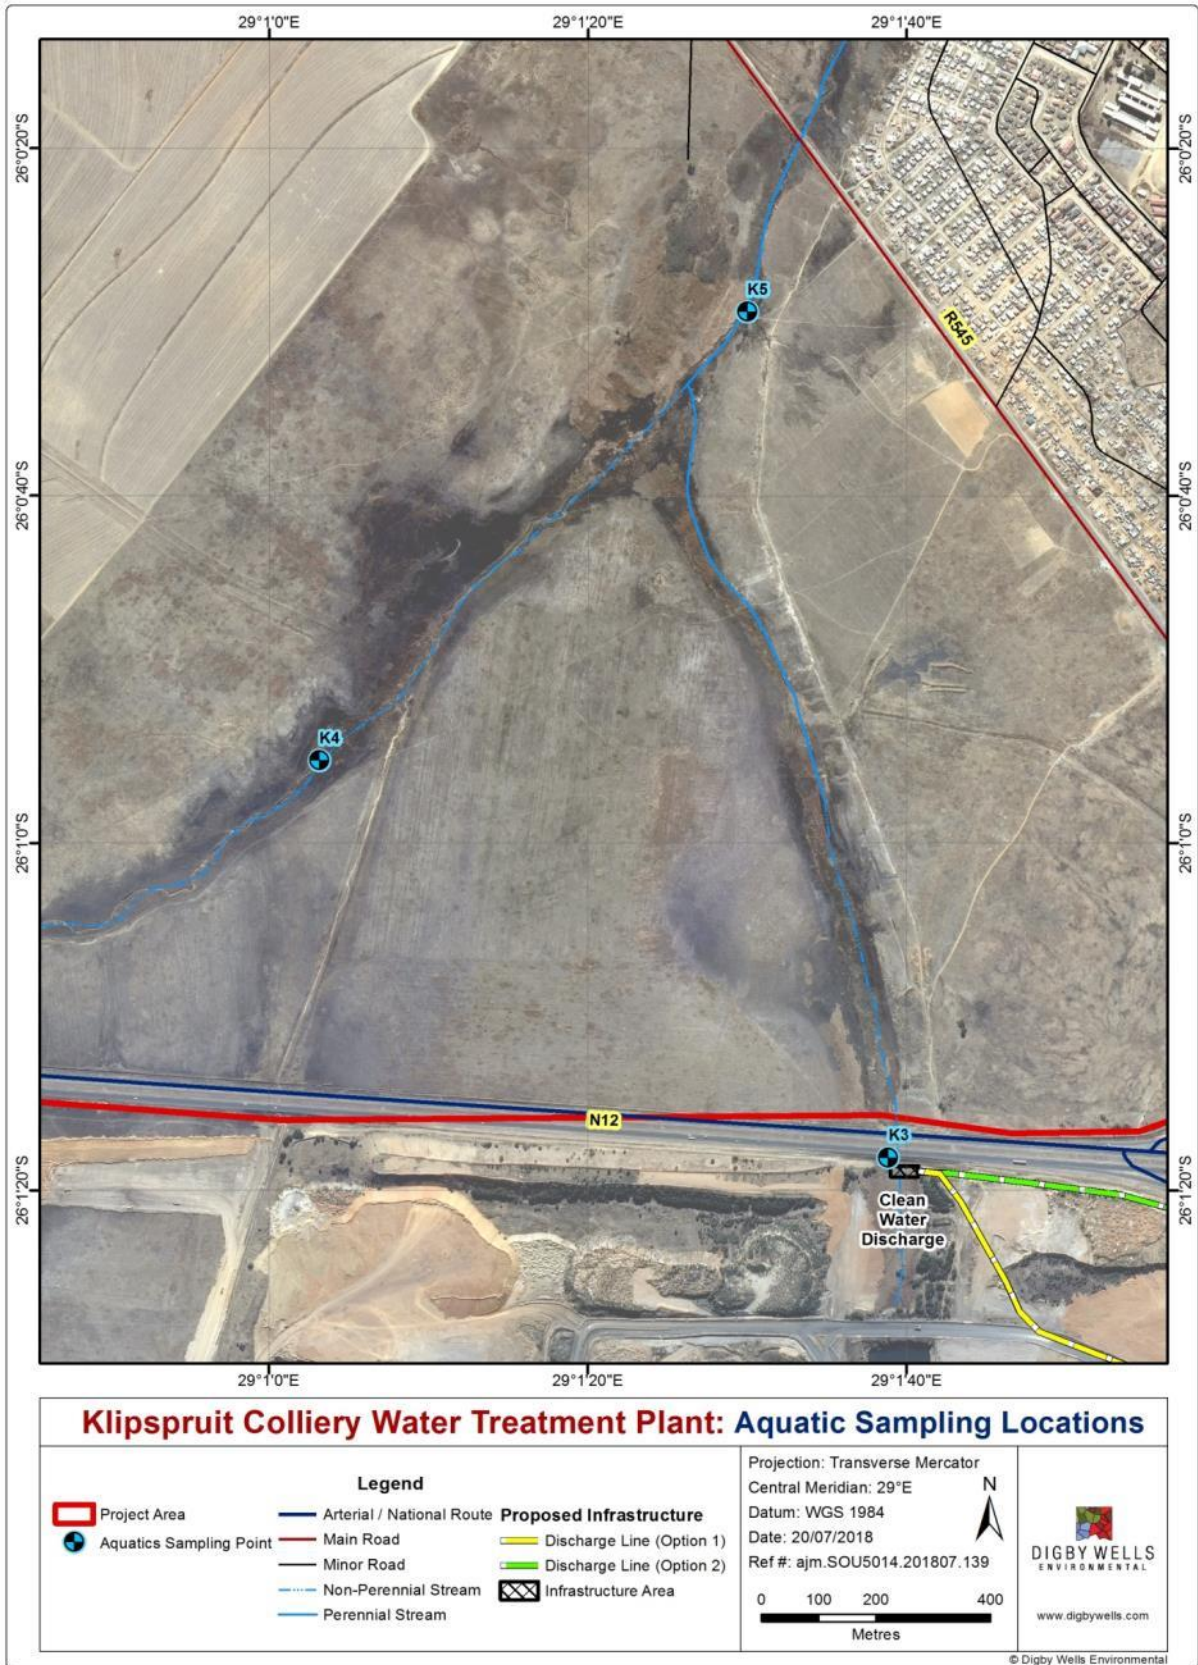
Figure 5-2: Sampling site localities

Thus, sampling sites outlined in Table 5-1 below and displayed in Figure 5-2 were determined in order to establish baseline conditions for the Saalklapspruit SQR of concern and based on previous aquatic biomonitoring studies (i.e. Ecology International, 2017). Photographs of the sampling sites are provided for in Appendix A.

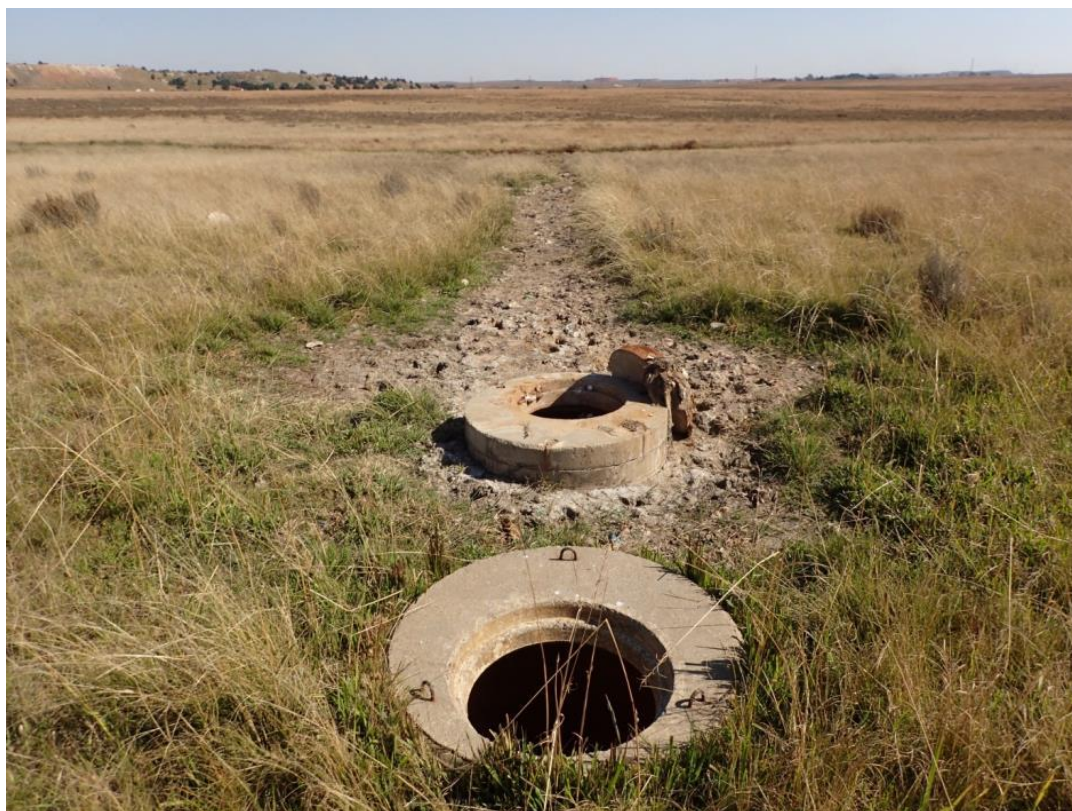
Figure 7-1: Open sewage cover with signs of flow into the Saalkspruit

Furthermore, leaking sewage has been observed entering the system for an extending period of time with open man holes observed even during the current survey (Figure 7-1). This impact has almost certainly deteriorated the water quality of the tributary and the adjoining Saalklapspruit SQR.

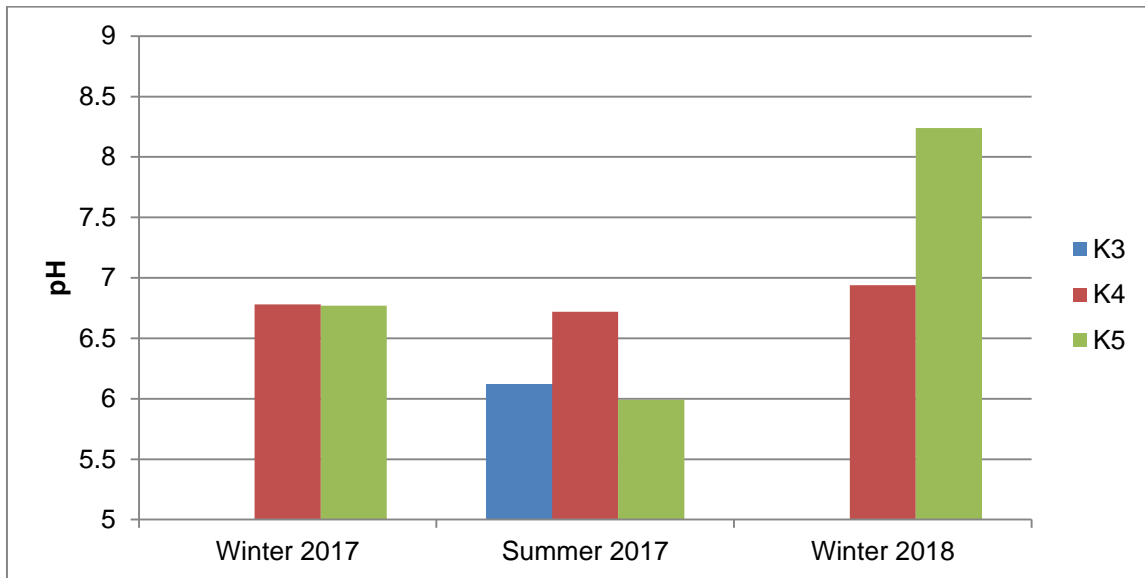
Figure 7-2: pH findings in comparison to the previous biomonitoring period

The pH findings at both sampling sites (i.e. Sites K4 and K5) were recorded within the recommended guideline values (DWAF, 1996). The findings at Site K4 were similar to those

recorded during the 2017 biomonitoring period (Ecology International, 2017), whereas the pH recorded at Site K5 increased notably from the previous study. A possible cause for this increase can be due to the lack of potentially acidic water flowing from the KPS upstream activities as noted in the Ecology International (2017) study. Conductivity findings at both Sites K4 and K5 were also below the recommended guideline value of 700 $\mu\text{S}/\text{cm}$ (DWAf, 1996) and fairly similar to those recorded during the 2017 study (Ecology International, 2017).

Figure 7-2 and Figure 7-3 display the temporal and spatial variation of the pH and conductivity findings between the previous monitoring period and the current study. It is clear that the conductivity at downstream Site K5 is being influenced by water high in dissolved

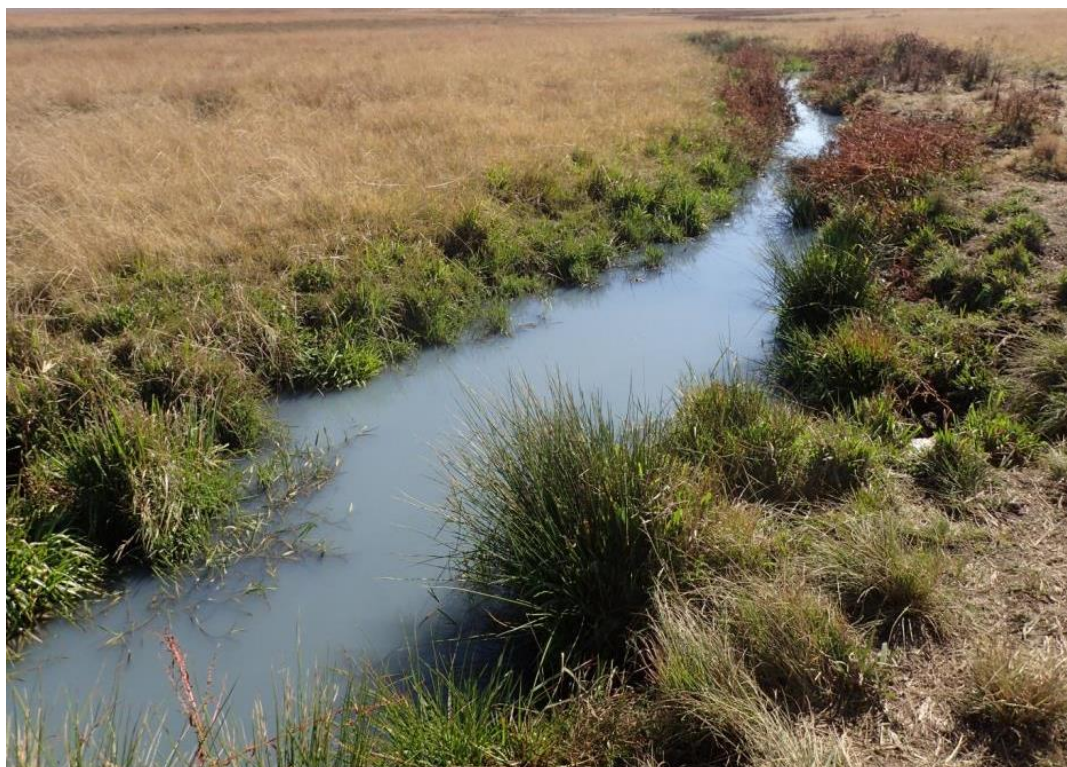
Figure 7-4: Signs of dirty water flowing into the Saalklapspruit from the Saalkspruit

Figure 7-4 below displays signs of sewage contaminated water entering into the Saalklapspruit from the Saalkspruit. The habitat metric group is also largely influencing this modified score as numerous taxa with a preference for specific biotopes, such as cobbles, gravel and sand, were not sampled (e.g. Caenidae and Gomphidae). Flow modification, according to the MIRAI findings, is also prevalent and influencing the macroinvertebrate assemblages recorded during the study. This can partially be attributed to the KPS mining activities that have taken place in the upper reaches of the watercourse of concern. However, mining activities in the upper reaches of the Saalklapspruit and in a tributary upstream from the site (i.e. GPS coordinates: 26° 02'06.55"S 28°59'57.28"E) appear to be impacting the flow to a greater extent compared to the KPS mining activities.
