SOLAR PV PROJECT, MPUMALANGA

NEAR-SURFACE GEOTECHNICAL INVESTIGATION REPORT

2010329/R02

February 2021

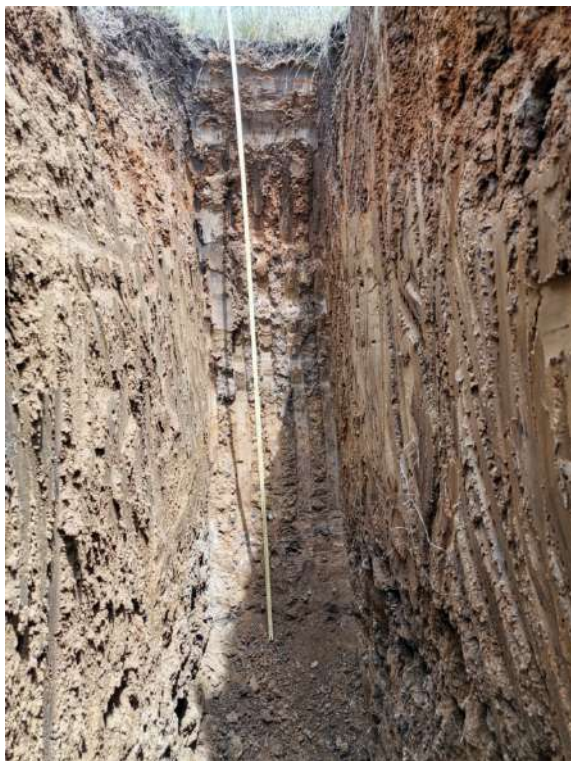
TP02

13.1.3 Groundwater seepage was encountered in test pit TP2 at a depth of 1.6m below ground level. No groundwater seepage was observed in any of the other test pits.
