ARCHAEOLOGICAL IMPACT ASSESSMENT PROPOSED DEVELOPMENT OF ERF 2569 WELLINGTON WESTERN CAPE

Aquatic Ecosystem Assessment of the Mbekweni River,

ERF 2569 Wellington

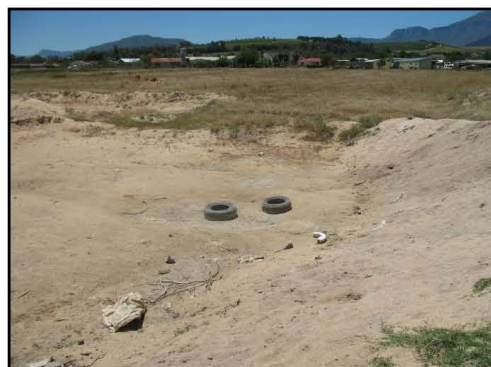
Figure 7. Large pit on the study site. View facing north east

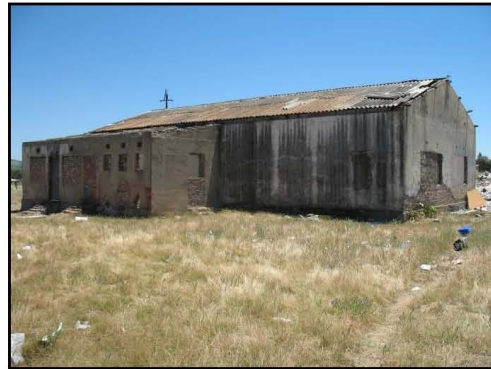
Figure 11. Back of the building

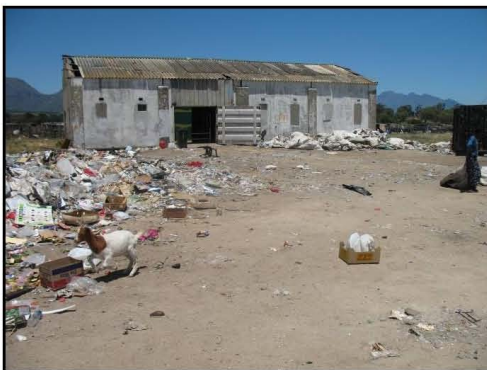
Figure 10. Metal and concrete building

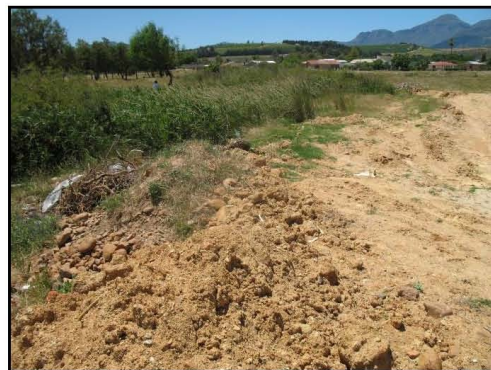
Erf 2569 is located alongside the R301 (Van Riebeeck Road) between Paarl and Wellington. Access to the property is via Vallei Street. The site is flat and slopes gently from east to west. The highly degraded Mbekweni River is situated on the northern boundary of the property the old Wellington Paarl Road is on the western boundary, informal housing and vacant land on the south and the residential township of Newton on the east. A decommissioned Waste Water Treatment Works (WWTW) is situated in the south east (refer to Figure 2). Virtually no natural vegetation occurs on the site, which is in a severely degraded and transformed state. The property must have at some stage been used for agricultural activities as old plough lines are still visible across much of the eastern portion. The site is covered in short, but thick Kweek grass. A few sporadic trees occur over the property. A wide gravel road and numerous small pedestrian footpaths intersect the site. There is a large pit that has been excavated in the centre of the site, and large volumes of clay and gravel have been dumped alongside the river in the northern boundary, which has been brought onto the property from elsewhere. A large informal rubbish dump and recycling enterprise is located in the western portion, where several large metal containers are also situated. A metal and concrete building on the site is currently being used as storage facility and accommodation for some of the workers. Dumping of building rubble is widespread over the property, as it litter. A small (dry) pond is located in the north east, which may be the remnants of the Mbekweni wetland system. There are no significant landscape features on the property (Figures 3-12).

Figure 12. View of the study site and the Mbekweni River facing east

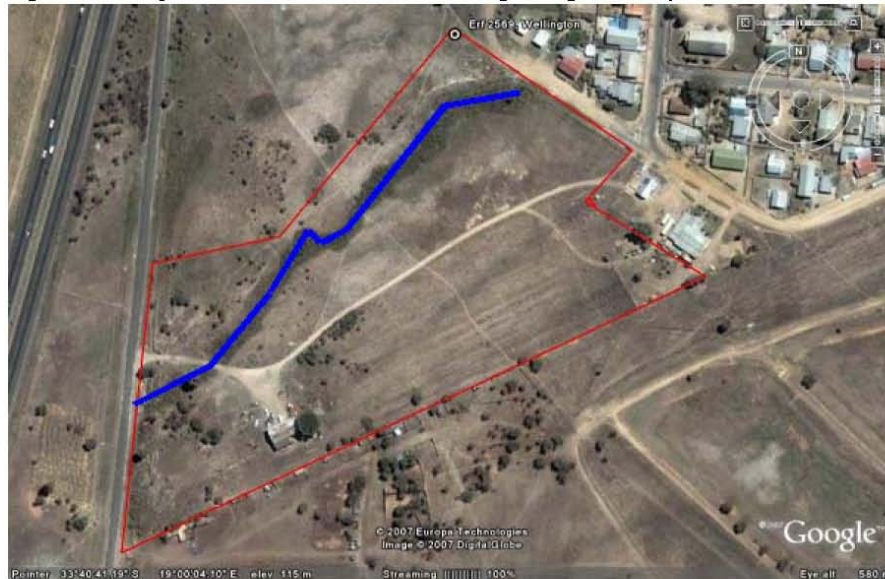
Figure 2. Aerial photo of the Mbekweni River running through the study site

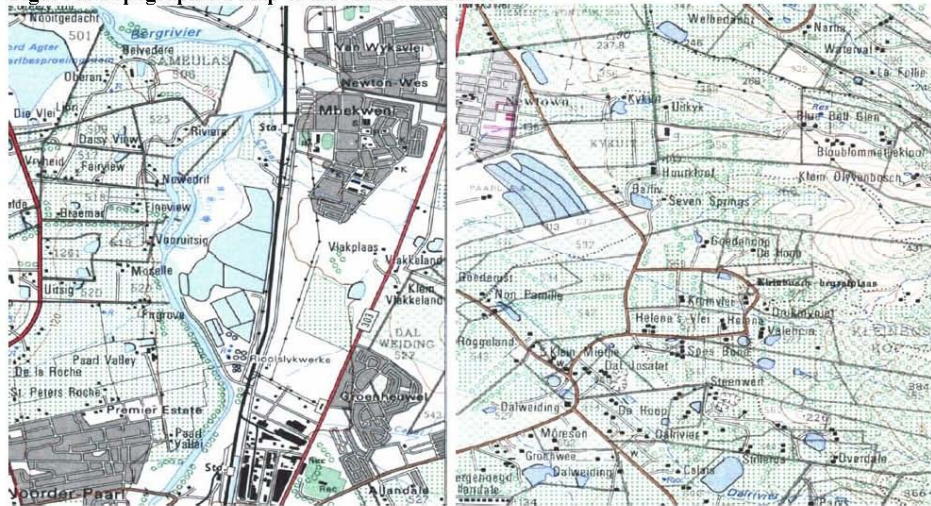
Figure 3. Topographical map of the Mbekweni River

The natural vegetation of the region is West Coast Renosterveld and Southwest Fynbos. Over time, this vegetation has been largely transformed or replaced by farming and urban related developments. Much of the river channel has also been altered by land use activities, where the upper reaches have been highly modified by agriculture and a number of farm dams are present in this reach. In Newtown, downstream of the agricultural area, the river channel has most been canalised and is no longer a clearly defined channel. Downstream of the proposed development site, the river again flows through agricultural and the river is confined to channel alongside the roads.

As a result, the Mbekweni catchment has lost many of its natural functionality due to channel straightening, additions of storm water and invasion of exotic vegetation species.

The catchment condition and land-use impacts on the site include agricultural related disturbance activities and direct habitat disturbance related activities. From figure 3, it can be seen that the

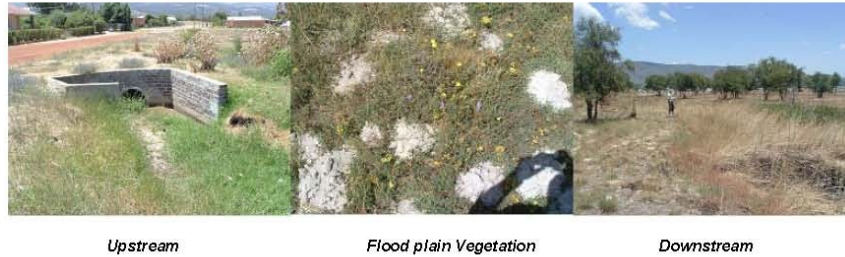
river flows into the site via a storm water structure (photo titled upstream) used for the development of the residential area North-west of the site (Newtown). The photo titled “downstream” shows some alien vegetation stands (*A. saligna*) with no indigenous riparian shrubs present on the left hand bank (LHB) of the river. The photo titled “floodplain vegetation” displays the scattered representation of the few plant species found, which was mostly common weeds and indigenous grassy vegetation. Wetland features were common on the site, particularly around the storm water outlet and on the right hand bank (RHB) of the river. This can probably be as a result of a historic wetland area prior to the construction of the Newtown settlement and storm water modifications.

Figure 5. Photographs representing various views of the river segment.

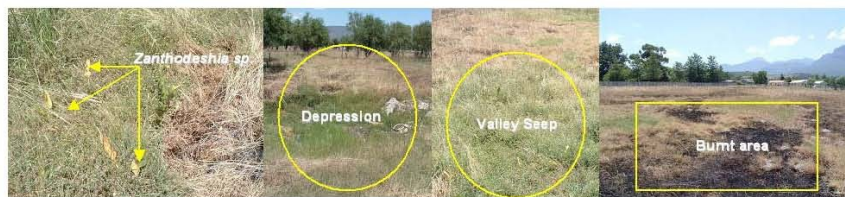
Evidence of a remnant wetland system is consistent across the northern regions of the Erf, indicated by the seeps, depressions, resilience of burnt areas and hydrophilic plant species scattered in these areas (figure 5). This remnant wetland area has become highly disturbed as a result of dumping of rubble and removal and sand from the area.

Figure 6. Photographs representing various wetland areas adjacent to the river segment

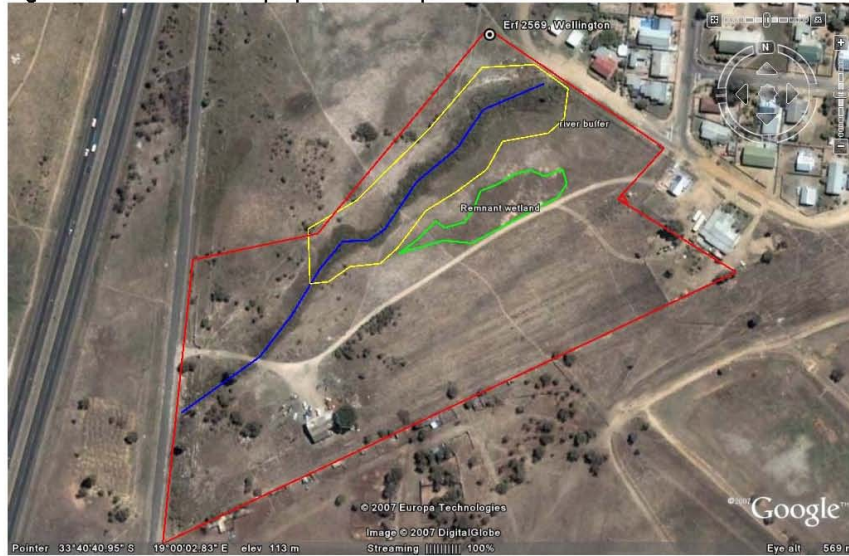
The Mbekweni River has a low ecological importance, but as it is a seasonal river, it is quite sensitive to flow and water quality changes. The current ecological condition is fair with a section of the river and wetland area having a good potential for rehabilitation. Thus, the river and the associated wetland area, as shown in the figure below, should be protected by a development setback or buffer of preferably that recommended by the Western Cape Provincial Spatial Development framework, i.e. 30m measured on either side of the centre line of the river. This buffer will provide at least some protection from the impacts of the proposed development.

Figure 7. Aerial view of the proposed development site with the recommended buffer area

Where this buffer width cannot be established, a riverine corridor of not less than 40m as depicted in the figure should be maintained. Erf boundaries can encroach into the buffer, but no hard development should be located here. This buffer will provide some protection for the aquatic systems from the impacts of the development, such as pollution, introduction of invasive alien plant species and human disturbance.

Road crossings should be minimized within the identified buffer area in the above figure and any work on the streams that constitutes alterations to the bed and banks should require authorization from the Department of Water Affairs and Forestry.
