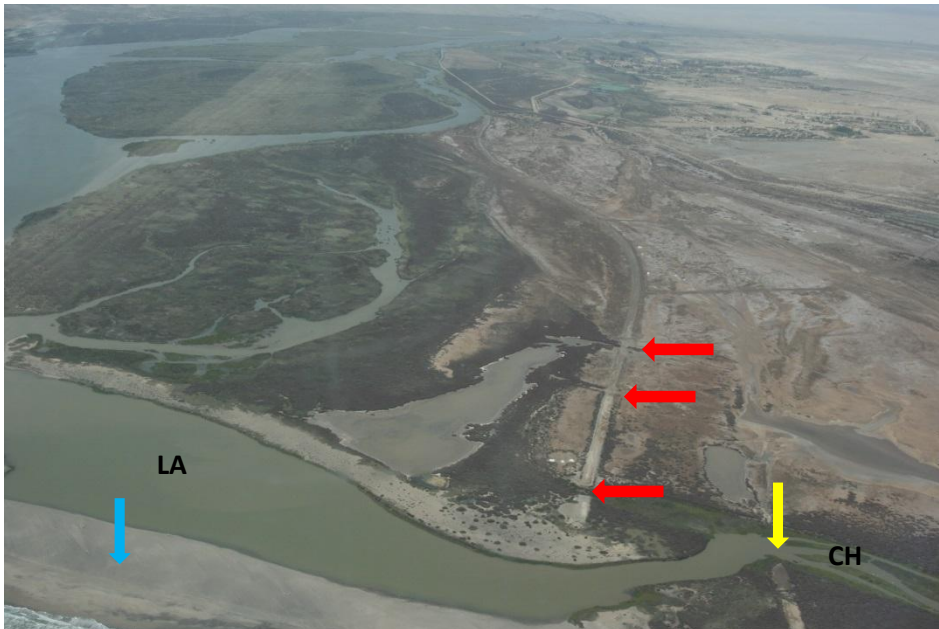
Photo 1: Aerial photo of area to south of the Orange River Mouth showing cut-off channel (**CH**) and cut-off lagoon (**LA**) behind the southern spit (blue arrow). Note the causeway that has been removed from channel (yellow arrow) and the removal of small sections of the flood attenuation berm (red arrows)

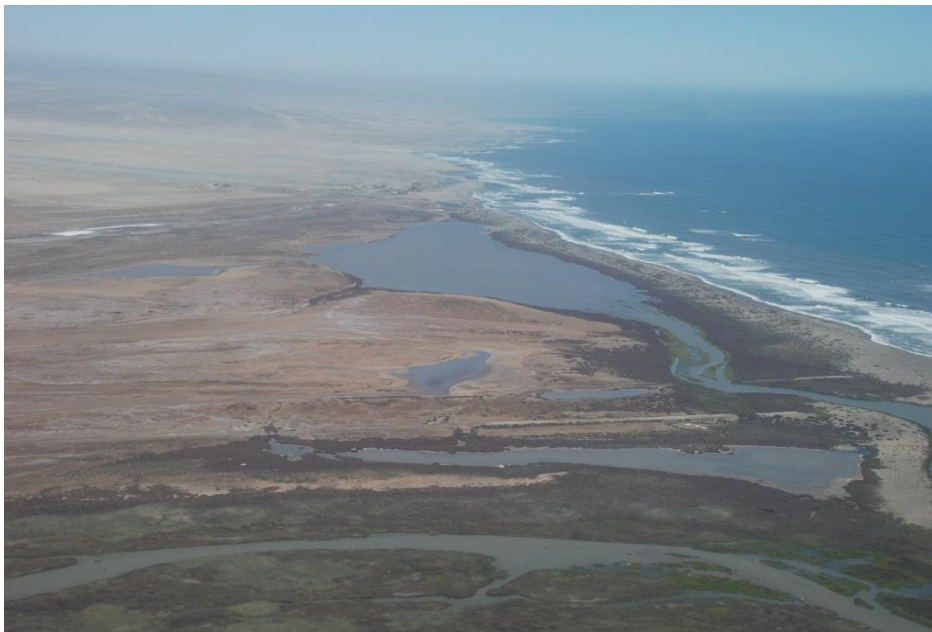
Photo 2: Aerial photo looking south of the Orange River Mouth showing cut-off channel and cut-off lagoon behind the southern spit.

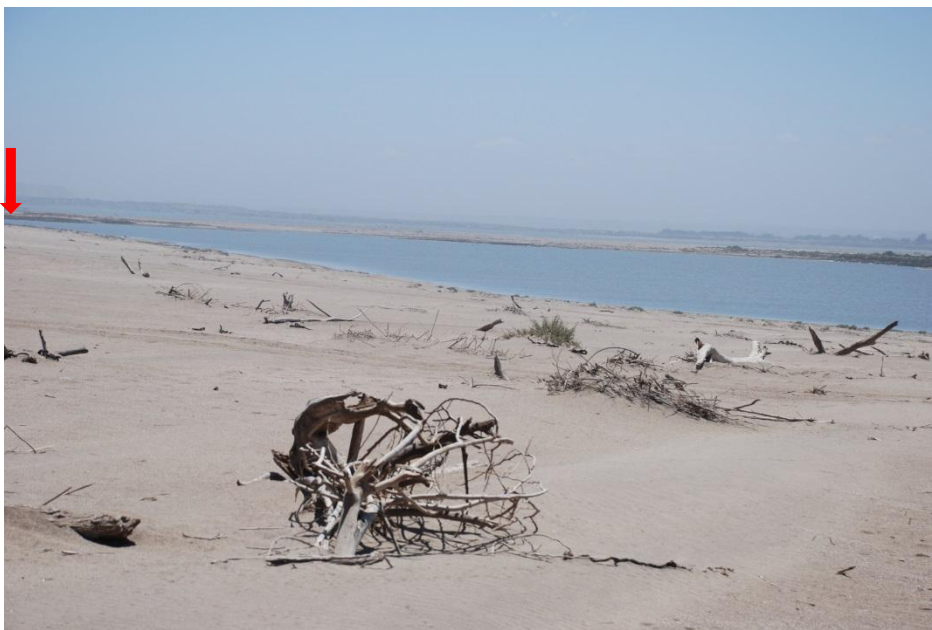
Photo 3: Photo looking north towards the Orange River Mouth showing cut-off lagoon behind the southern spit. A sand berm has built up near the mouth of the river (red arrow) denying any tidal flow of salt water, resulting in hypersaline conditions within the lagoon.

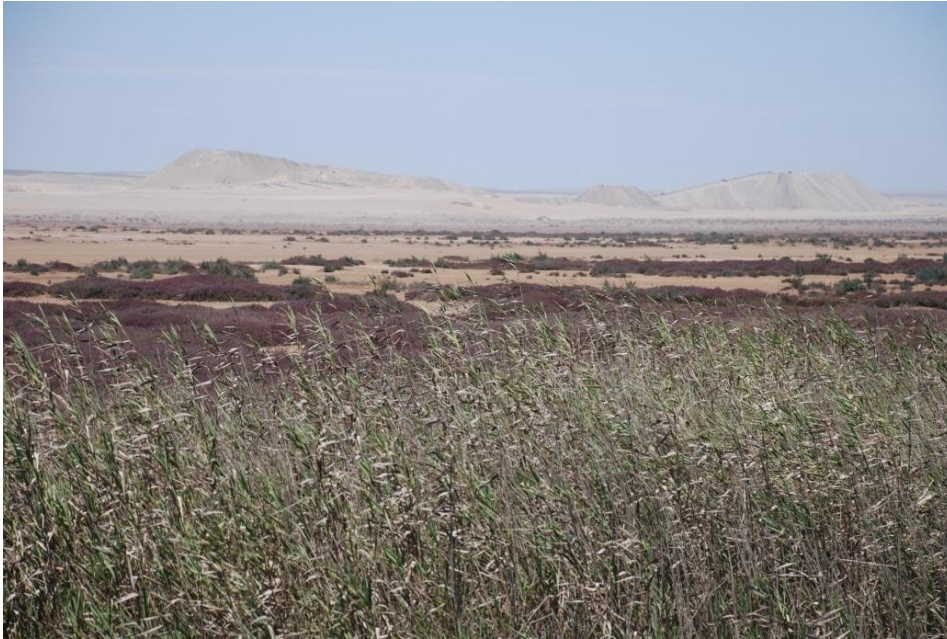
Photo 4: Photo looking south towards the mine workings of Alexkor. Note the windblown sediment emanating from the slimes dam of this plant. Sediment is entering into the degraded wetland between the berm (where photo is being taken from) towards the mine workings.

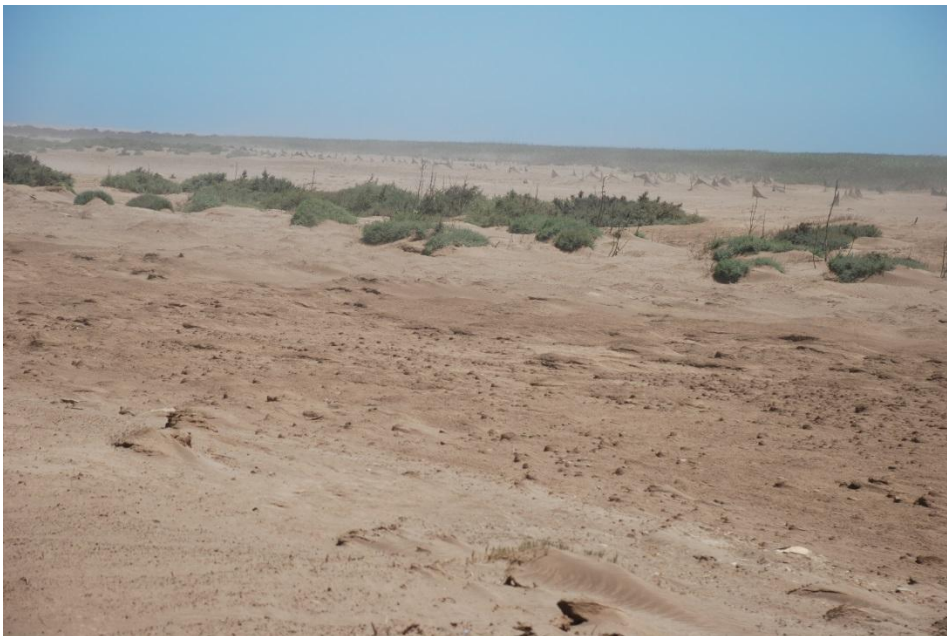
Photo 5: Photo looking northwest over the degraded wetland showing the accumulation of sediment from slimes dam within Alexkor mine. Note the attempt to trap sediment by netting and the growth of vegetation. This attempt to trap sediment has been abandoned.

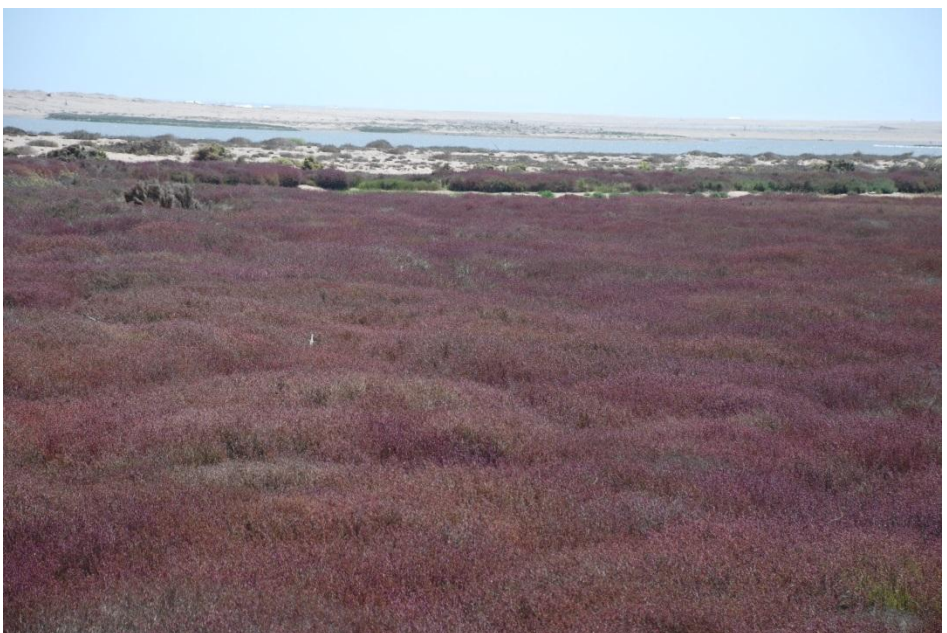
Photo 6: Photo looking northwest over good quality saltmarsh vegetation within the degraded cut-off saltmarsh area. The cut-off lagoon is in the background.

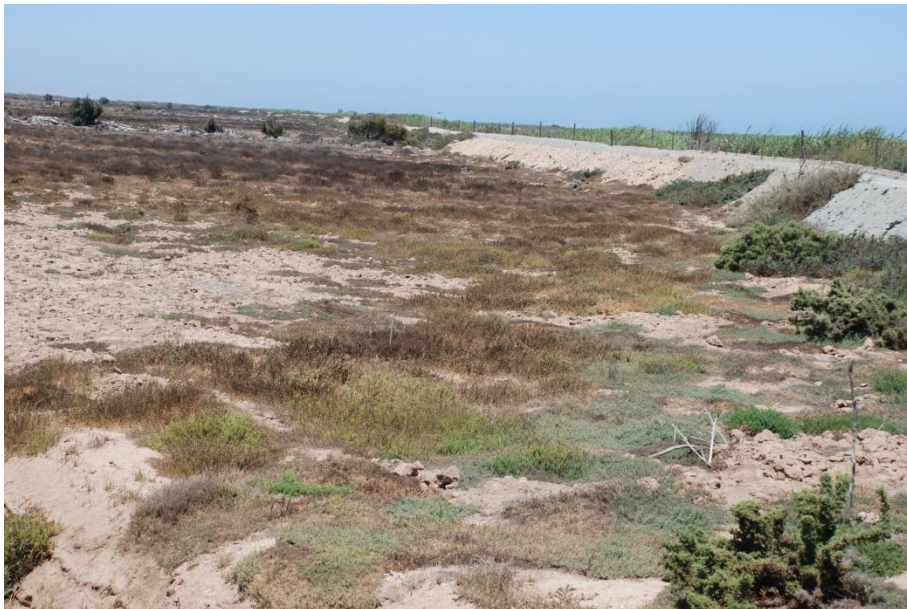
Photo 7: Photo showing the flood attenuation berm close to the Orange River (reeds to right of berm) and the degraded old saltmarsh which was dried out for agricultural purposes. Once the berm has been removed this area will need to be rehabilitated to a saltmarsh again. Remnants of saltmarsh vegetation are present on the old field.

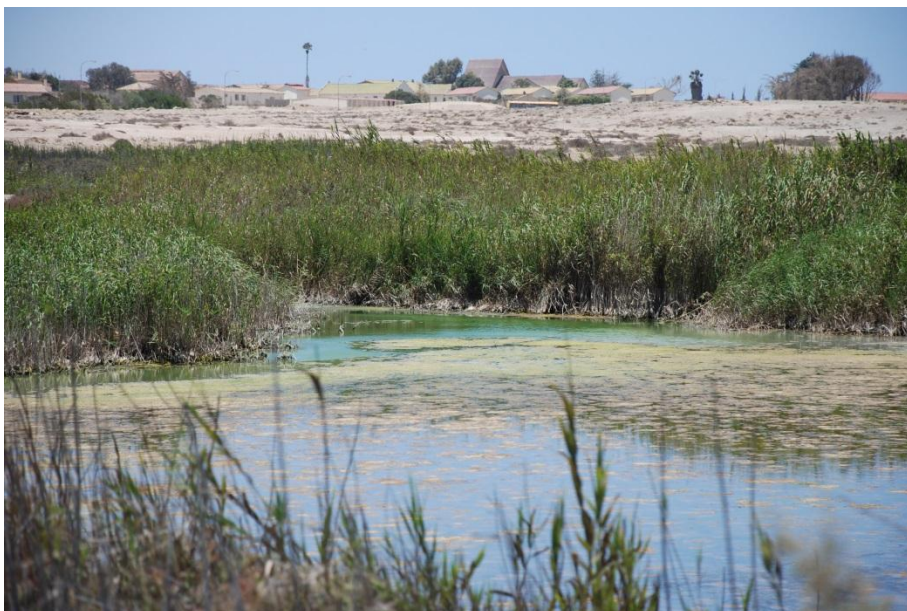
Photo 8: Photo showing a portion of the sewage oxidation ponds that have been developed within an old flood channel cut-off from the Orange River by the flood attenuation berm. Note the eutrophic conditions of the water and the prolific growth of fluitjiesriet and bulrushes. The town of Alexander Bay is in the background. A new sewage treatment works has been commissioned by Alexander Bay

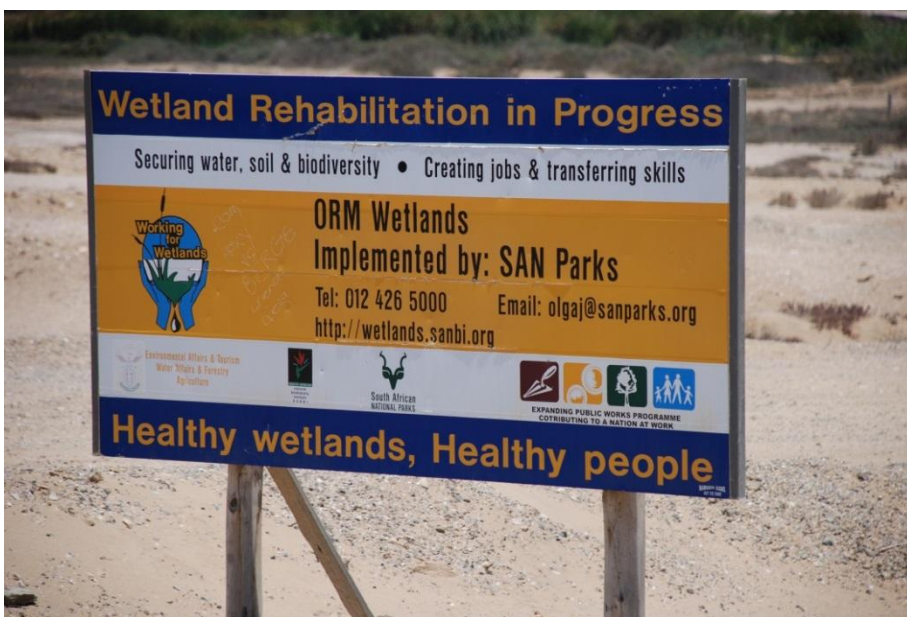
Photo 9: Photo showing a notice board indicating that rehabilitation of the cut-off wetland is in progress.

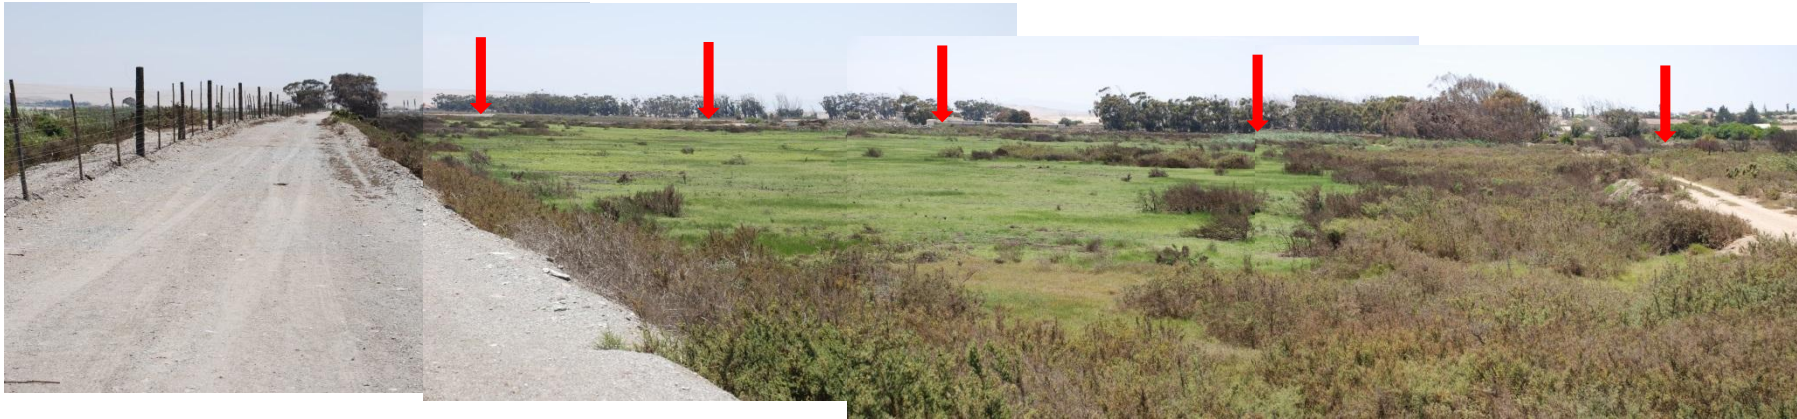
Photomontage of that portion of the berm that is to be removed to allow floodwaters to once again inundate this area. A new berm will need to be built to protect the low-lying areas of Alexander Bay and the sports fields. The red arrows show where the new berm is to be located. The sports fields are to the right of the photomontage.

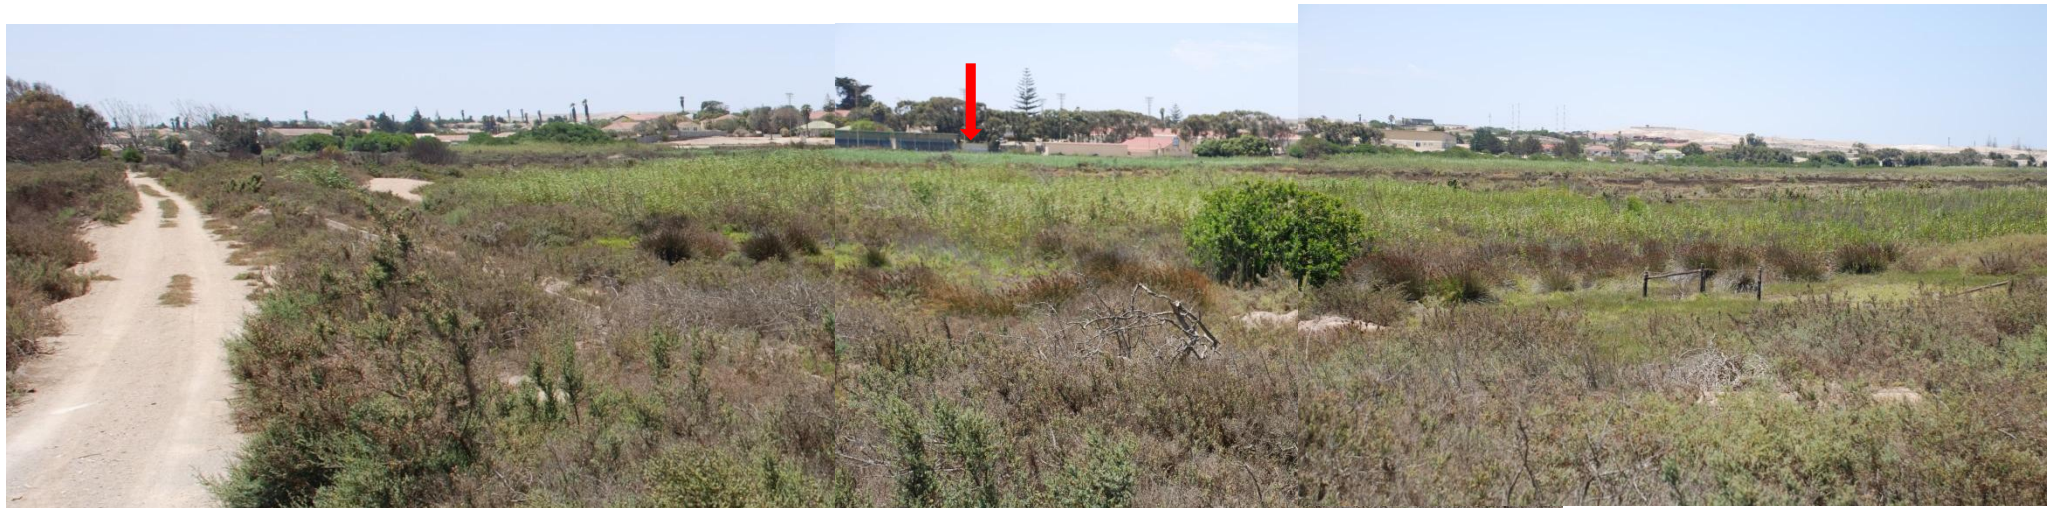
Photomontage of the area to be rehabilitated back to a saltmarsh and wetland. The sport fields are shown by the red arrow. Note the wetland vegetation in the foreground (fluitjiesriet). The new berm will be built in front of the infrastructure seen.
