AQUATIC IMPACT ASSESSMENT FOR THE PROPOSED PLATREEF UNDERGROUND MINE

Platreef Resources Pty (Ltd)

DECEMBER 2013

Project Number: **PLA1677**

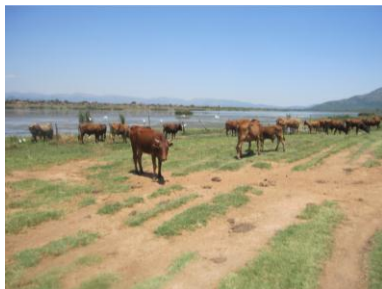
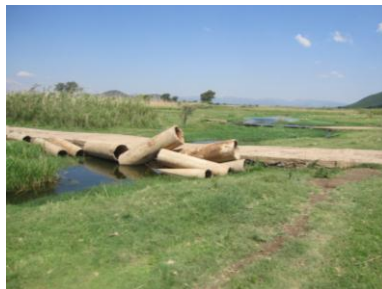
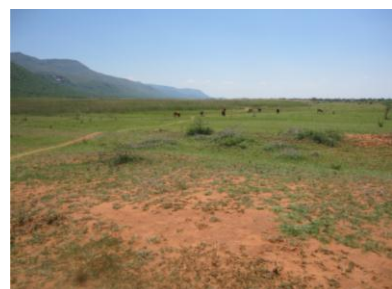
Figure 7-2: Photographs of threats to the ecological functioning of the system

The current land-uses have impacted on the functioning of this system. Local agricultural practices, pertaining predominantly to livestock have impacted on the ability of this system to provide important services. Agricultural activities have altered the natural hydrology of the system. The decrease in surface roughness due to overgrazing has resulted in a potentially destructive hydrological regime for the system. In addition to this, livestock also impact directly on the quality of water as a result of nutrient input and trampling of the system. Owing to the fact that agricultural practices are on-going for the project area, coupled by the absence of mitigation measures for the current land-uses, it is assumed that the ability of the units to provide important ecological services will continue to deteriorate. The severity of the current identified impacts was however determined to be minor at this stage. Photographs of threats to the ecological functioning of the floodplain are presented in Figure 7-2

Livestock and cattle paths

Hydrological alterations

Overgrazing

Current land uses illustrated above have impacted the system and as a result a preliminary buffer zone of 100 m has been allocated for all the delineated aquatic and wetland systems. This buffer was suggested with consultation of the National Freshwater Ecosystem Priority Areas (NFEPA) implementation manual. Only two provinces have legislated required buffers for development they are Gauteng which requires 50m in rural areas and 30m in urban. Mpumalanga requires a 100m buffer be placed on aquatic systems. Using the precautionary principle, due to the lack of knowledge about the system, and as it forms part of the Nylsvlei floodplain a minimum 100m buffer is recommended.
