BASIC ASSESSMENT FOR THE PROPOSED GOUDKOPPIES WATER PIPELINE

Aquatic Ecology Assessment

Report Type:	Aquatic Ecology Assessment
Project Name:	Basic assessment for the proposed Goudkoppies water pipeline.
Project Code:	ERG3057

Wetland Basic Assessment Report

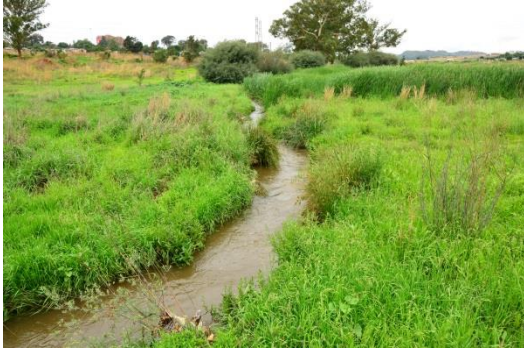
E1	26°15'41.61"S 27°55'39.18"E	Site E1 is located on the Diepkloofspruit, and was characterised by a channelled system with a large amount of riparian vegetation.

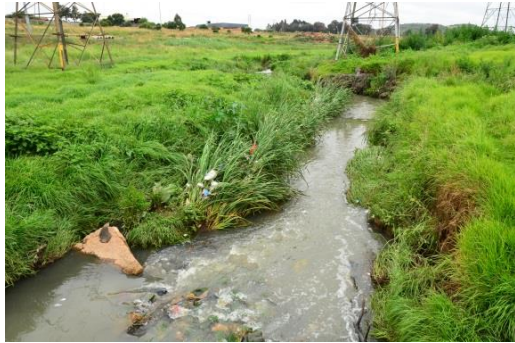
E2	26°15'12.66"S 27°55'58.55"E	Site E2 is located on the Baileyspruit, and was characterised as run-riffle-run with a large amount of riparian vegetation. The site had a strong odour of raw sewage and a large amount of solid waste.

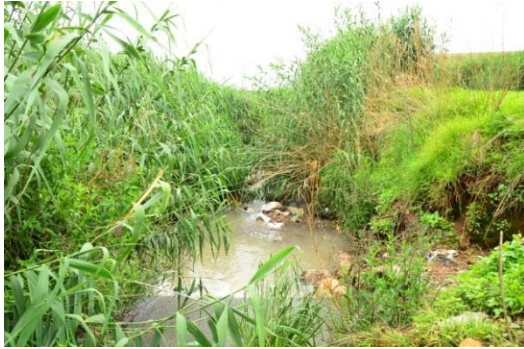
E3	26°14'2.21"S 27°56'34.82"E	Site E3 is located south of the Soweto highway along an existing servitude. The site presented normal riverine habitat, with stones in current and good riparian vegetation. However a large amount of domestic (sewerage) and solid (pollution) waste was present.

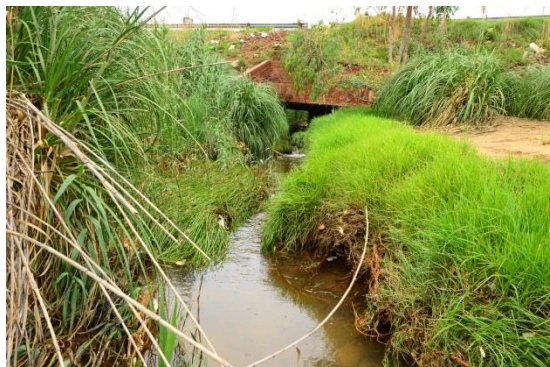
E4	26°13'59.97"S 27°57'18.60"E	Site E4 was located on a tributary running underneath the Soweto highway and adjacent to the Diepkoof tailings facility. Habitat was considered poor however a large amount of exotic riparian vegetation was present.

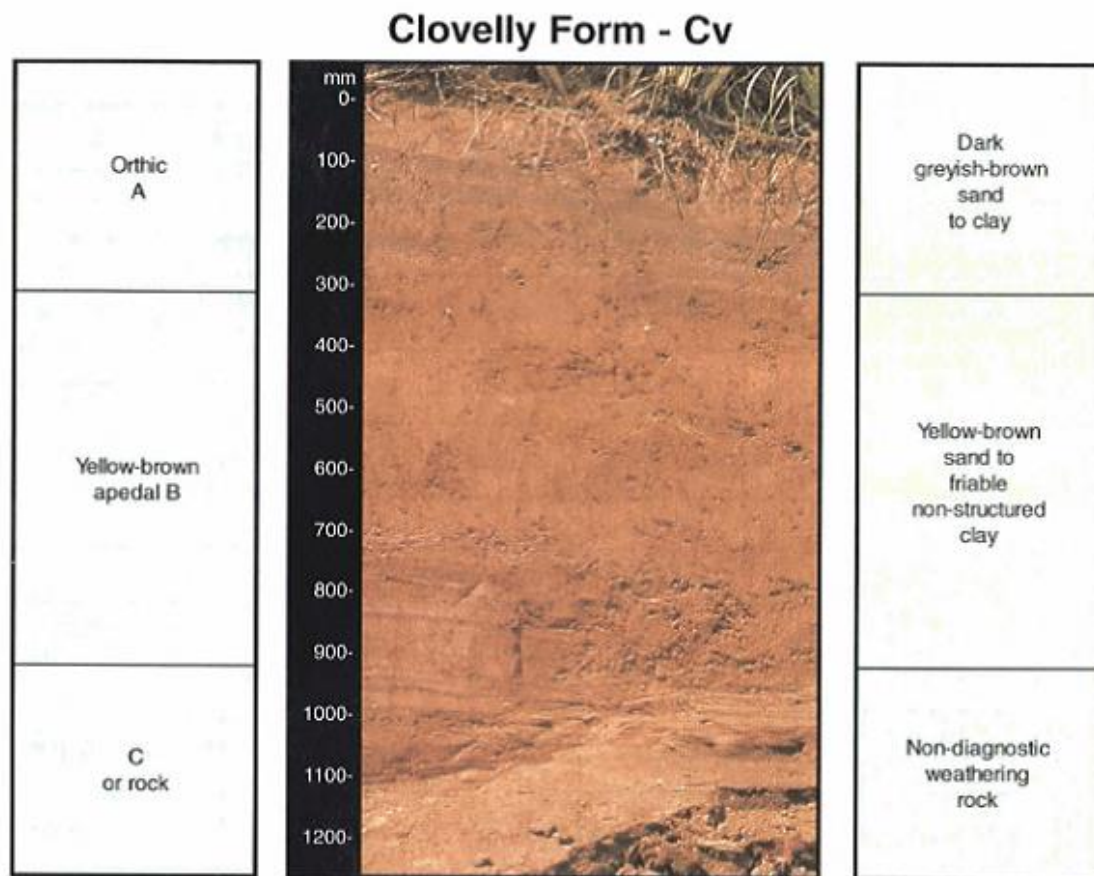
The Clovelly soil consists of an Orthic A horizon, overlying a yellow brown apedal B horizon. Both the A and B horizons have good internal drainage properties allowing free draining, see Figure 2-2.

Figure 2-2 shows a typical cross section of the Hutton Soil Form (Soil Classification Working Group, 1991)

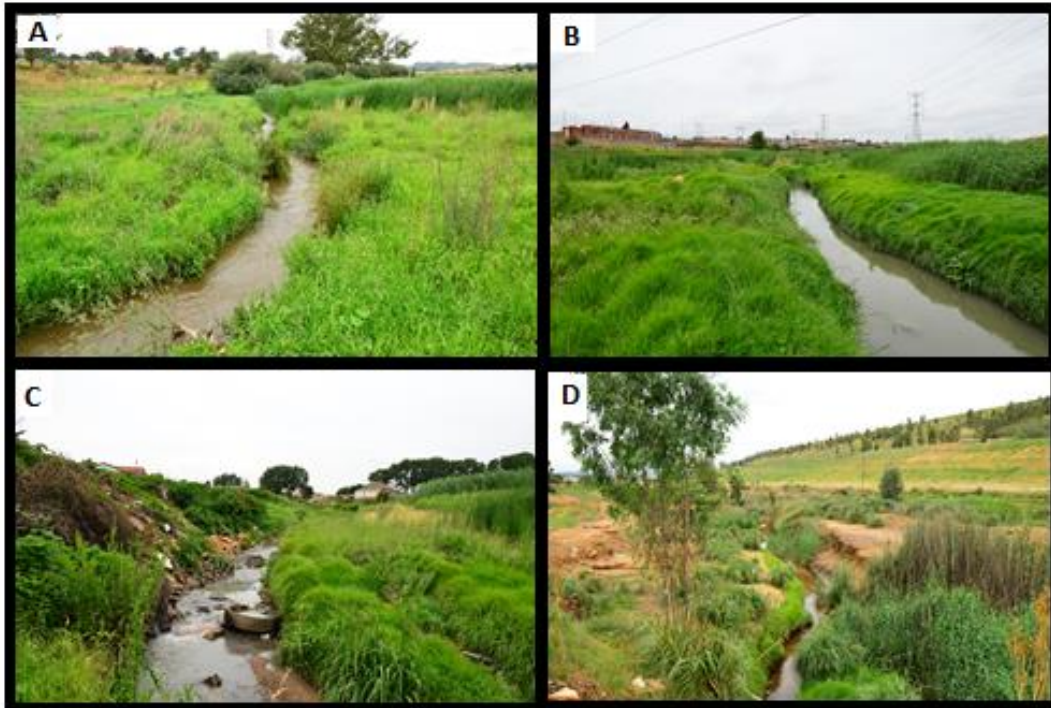
The wetland areas on the pipeline route were identified at points where the pipeline crossed streams. The pipeline route intersected watercourses (streams) four times along its path and the sites are numbered in ascending order from the point of origin of the pipeline. Figure 4-3 shows the sites, E1, E2, E3 and E4 and Figure 4-4 showing the location of the sites.

**Figure 4-3: Wetland crossings along the pipeline route (a) Site E1 (b) Site E2
(c) Site E3 (d) Site E4**

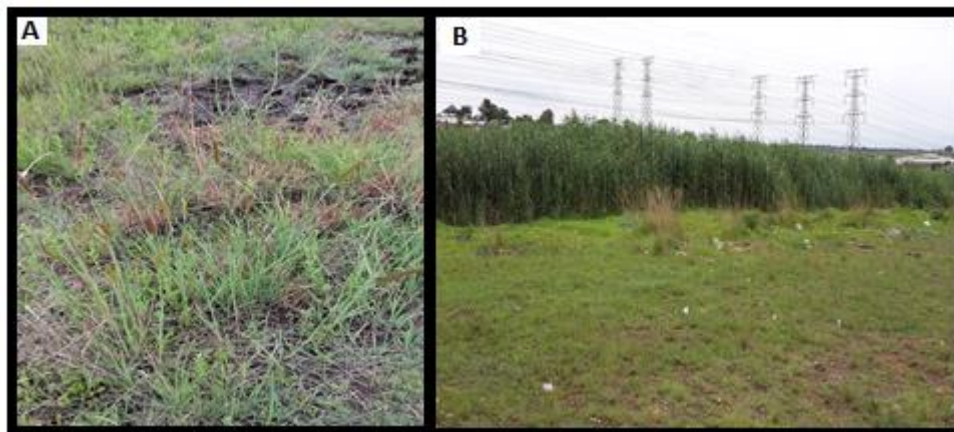
The wetlands were delineated using the four properties as described in section 3.1 and classified using the hydro-geomorphic approach. The wetland vegetation indicator species most prominent were *Phragmites australis* (Giant Reed). *Imperata cylindrica* (Cottonwool Grass). Figure 4-5 shows the wetland vegetation Indicators. The vegetation of the area is described in Ergo Goudkoppies Fauna and Flora Report, Digby Wells.

Figure 4-5: Wetland vegetation (a) *Imperata cylindrica* (b) *Phragmites australis*

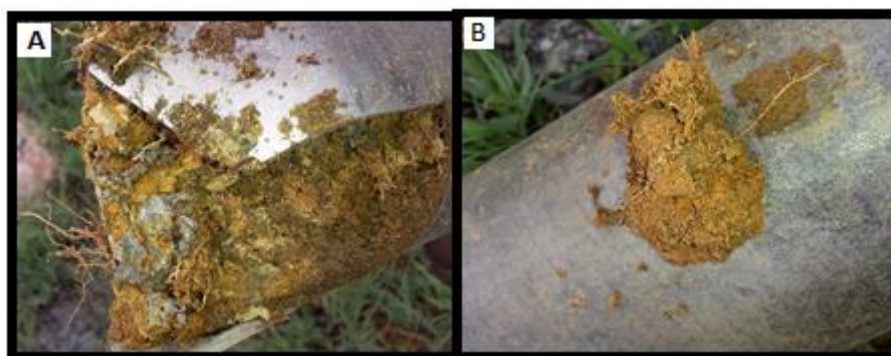
The soil form indicator for wetlands, formation of mottles in soils that are saturated for prolonged periods, was identified (Figure 4-6 (b)). It is important to note that in most areas along the pipeline route, the soils were underlain by a quartzite layer at 25-30cm deep. The quartzite layer in the wetland areas did not permit augering deeper than 30cm, however mottles were present, seen below in Figure 4-6 (a & b).

Figure 4-6: Soil form indicator (a) The quartzite layer at 30 cm (b) mottles in the soil
