Aquatic Ecology Assessment for the Proposed Esperanza Weir Rehabilitation

Umzinto, Kwa-Zulu Natal Province, South Africa

July 2018

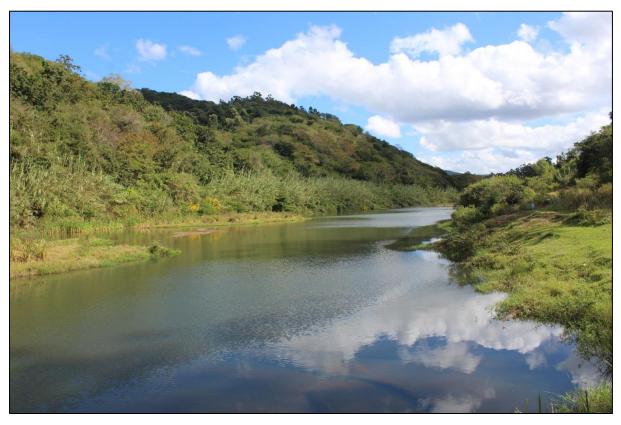
The Esperanza Impoundment on the Mzinto River (May 2018)

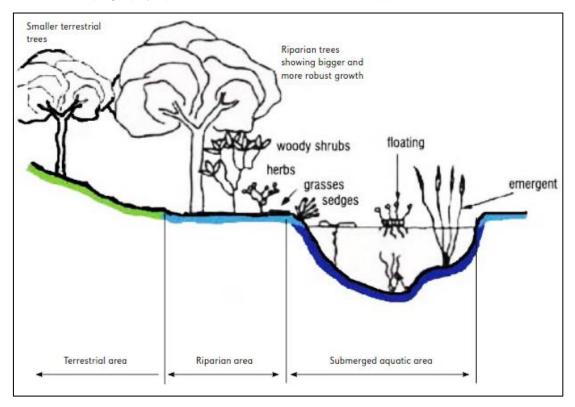
Figure 3-1: Riparian Habitat Delineations (DWS, 2005)

The riparian delineation was completed according to DWS (2005). Typical riparian cross sections and structures are provided in Figure 3-1. Indicators such as topography and vegetation were the primary indicators used to define the riparian zone. Contour data obtained from topography spatial data was also utilised to support the infield assessment.

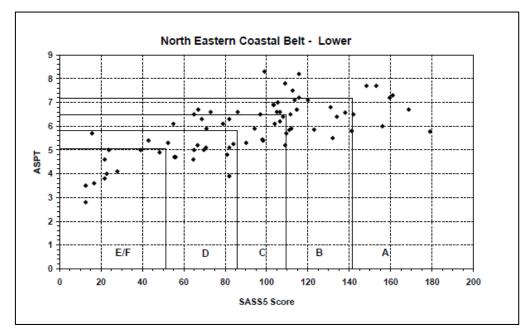
Figure 3-2: Guidelines used for the interpretation and classification of the SASS5 scores (Dallas, 2007)

All SASS5 and ASPT scores are compared with the SASS5 Data Interpretation Guidelines (Dallas, 2007) for the North Eastern Coastal Belt ecoregion. This method seeks to develop biological bands depicting the various ecological states and is derived from data contained within the Rivers Database and supplemented with other data not yet in the database.

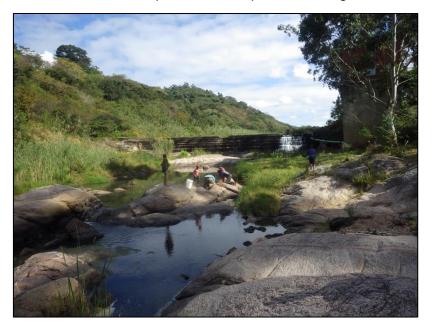
The results of the instream and riparian integrity assessment derived a class D (largely modified) status for the considered river reach in this assessment. The predominant factor influencing the quality of the habitats are largely attributed to instream habitat modification relating to the direct impacts of the Esperanza impoundment (Figure 5-1). However, alien vegetation and riparian clearing was evident during the survey (Figure 5-2; Figure 5-3).

Figure 5-1: Flow Regulation, abstraction, Channel and bed Modification (A1; May 2018)

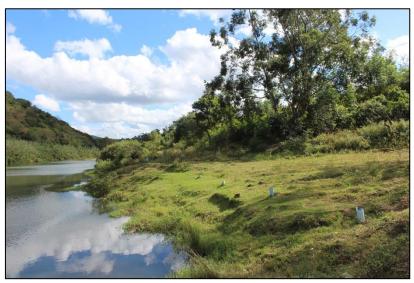
Figure 5-2: Cleared marginal and upper riparian zone in the Mzinto River at A1 (May 2018)

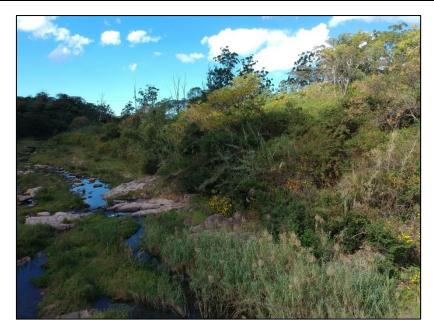
The riparian delineation indicated dominance of the marginal zone by *Arundo donax* upstream of the weir and *Phragmites australis* downstream of the weir. As demonstrated above, the riparian zone has a high abundance of alien vegetation and was determined to be largely modified. The delineated riparian zone is provided in Figure 5-4.

Figure 5-3: Riparian habitat downstream of the Esperanza Weir. Note abundance of alien vegetation (*Melia azedarach, Tithonia diversifolia*; May 2018)

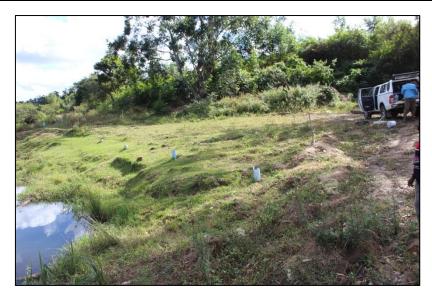
It is noted that the riparian area adjacent to the existing weir has been cleared of vegetation. Considering this, limited impacts to this area are anticipated (Figure 6-1).

Figure 6-1: Cleared area on the left bank of the Mzinto River (May 2018)
