**HERITAGE ASSESSMENT (ARCHITECTURAL)  
OF BUILDINGS ON THE FARM  
STEENKOOLSPRUIT (Site 3) - WITBANK  
(MPUMALANGA PROVINCE)**

*Date: August-September 2013*

*Project by: M. Naude*

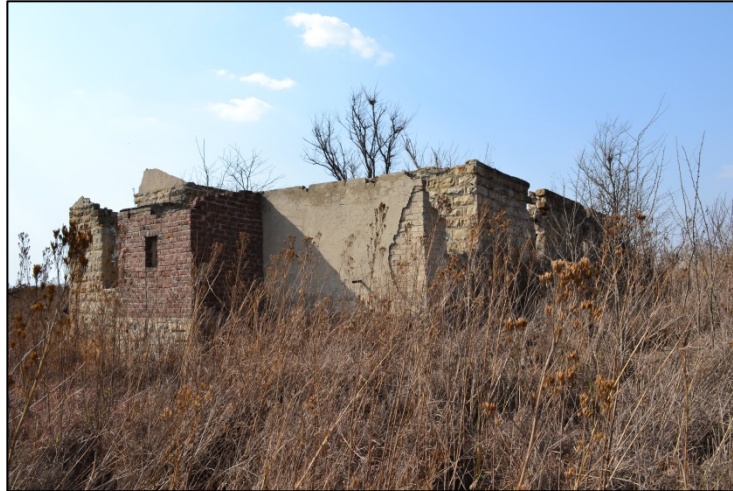
Figure 1. Exterior of the dwelling indicating the degradation of the building (Photograph: M. Naude 2013)

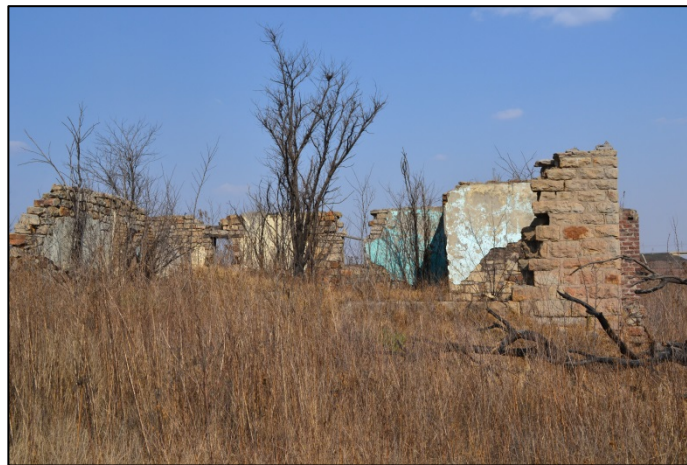
Figure 2. Remains of the front facade of the dwelling (Photograph: M. Naude 2013)

Sandstone farm dwelling with several additions to the core section of the building. The original core was constructed with sandstone and the interior walls were done in plastered brick. The walls were plastered with clay. Some effort was made to do the later additions in sympathy with the original dwelling and the walling was executed in sandstone – but of lesser quality craftsmanship than the original. A unique aspect of the dwelling is the simple gable that was added to the front façade which is completely out of style with the rest of the sandstone structure. The original verandah was constructed with timber posts that later disintegrated and were replaced with plastered brick columns and low steep walling. The building may date from the 19<sup>th</sup> century and

may have been destroyed during the Anglo Boer War. The original gable may have been destroyed in the process and was reconstructed after the war.

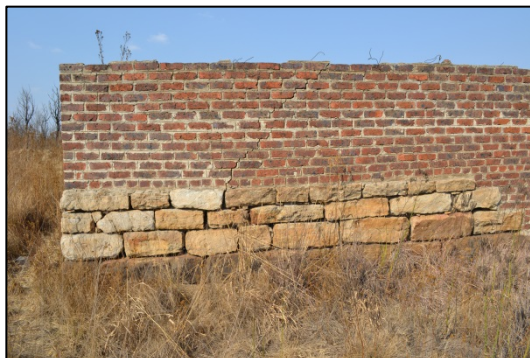
A garage for two standard motorized vehicles constructed with bricks with the entire roof structure removed.

**Figure 3. Exterior wall of the garage indicating the various building materials that were used for construction (Photograph: M. Naude 2013).**

Structure 2 - garage: The building is the size of a double garage for standard vehicles. It was constructed with red stock bricks but never plastered. The most northern corner was constructed with dressed sandstone blocks using simple coursework. The entire roof has been removed.

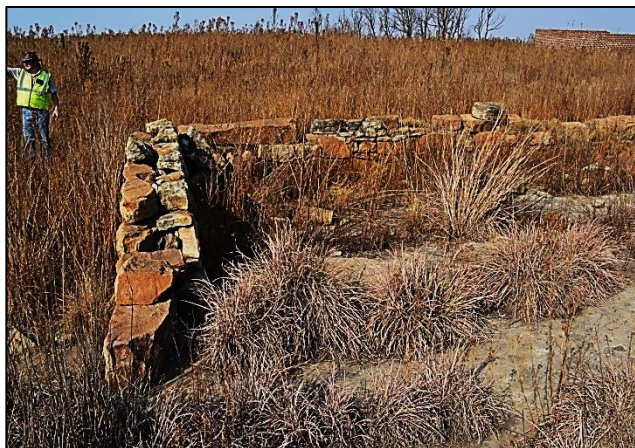
Remains of a sandstone stock kraal located about 30 m from the dwelling. This structure was constructed in a relatively crude manner with dry stacked walling. One of the special features of the kraal is the way it was located and the choice of setting where it was built. One elevation of the kraal is set directly along a cut in the sandstone outcrop. This ‘saved’ the builder to construct four walls but allowed the kraal to be set slightly below the terraced landscape serving as some protection against cold winter winds at night. Almost the entire floor of the small kraal consists of a flat bed of solid sandstone.

**Figure 5. The remains of a small stock kraal located some distance from the dwelling, set along the vertical slope of stone outcrop (Photograph: M. Naude 2013)**

Structure 4 – sandstone stock kraal: A low walled kraal occurs about 30m from the dwelling along the lower part of the slope where natural sandstone is exposed in horizontal strips forming terraces that were used as part of the stock kraal. The cliffs of these sandstone strips create a safe and protective backdrop to the kraal while a low dry stacked sandstone wall completes the enclosed space.

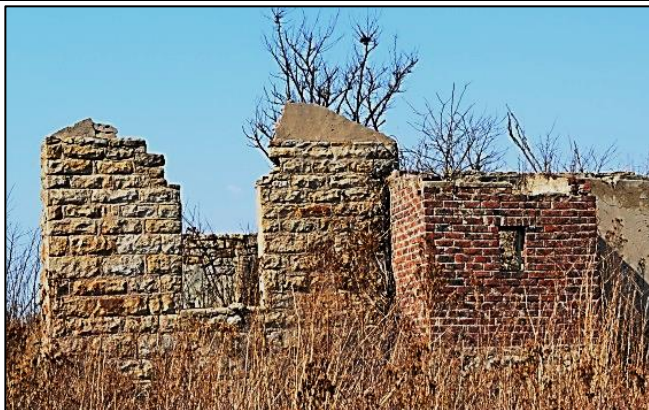
Figure 6. Small remnant of the front gable (Photograph: M. Naude 2013).

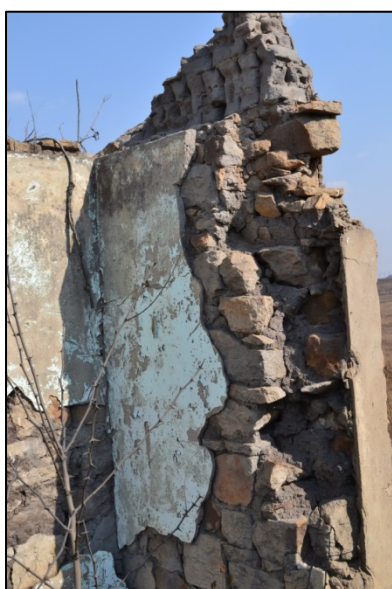
Figure 7. Remnants of the front gable seen from the interior (Photograph: M. Naude 2013)

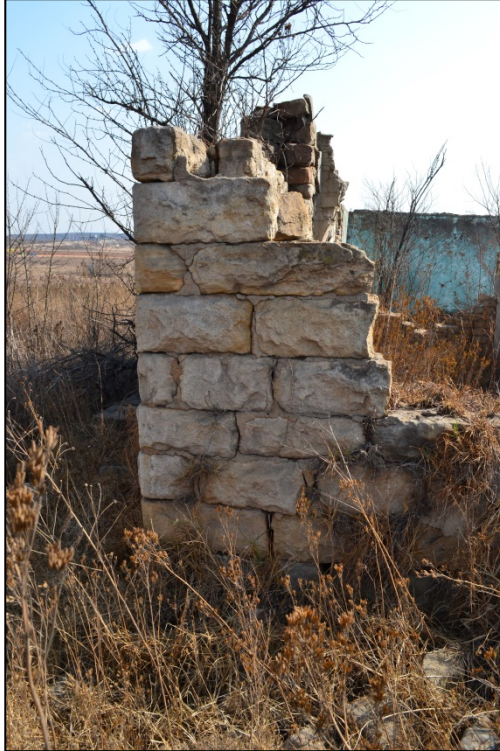
The building contains details but they tend to be unrefined such as the construction of the window sills, the lack of attention to quoining at the corners, around windows and doors and the manner in which the front gable has been executed.

**Figure 8. Quoining at the one corner of the dwelling that has remained intact demonstrating the level the stone was dressed (Photograph: M. Naude 2013)**

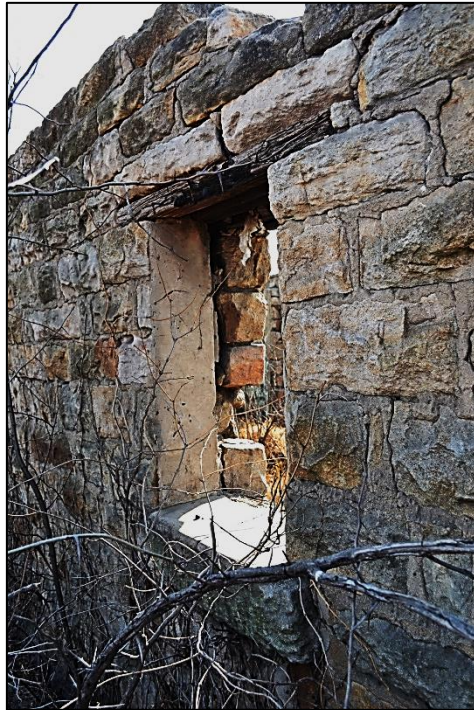
**Figure 9. Sandstone window sill and timber lintel (Photograph: M. Naude 2103)**

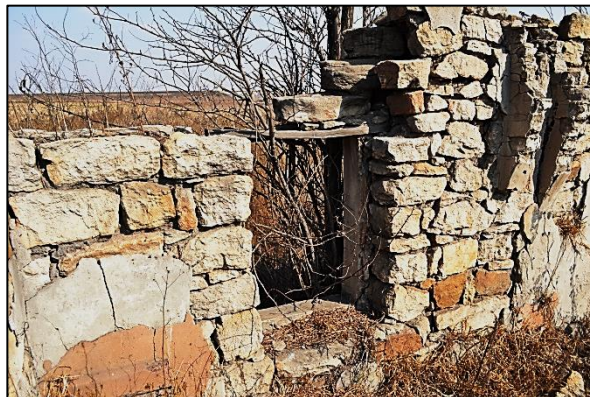
**Figure 10. Remains of timber lintel of window (Photograph: M. Naude 2013)**

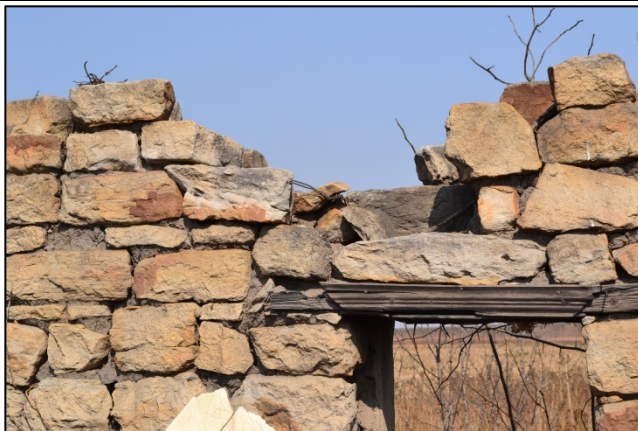
**Figure 11. Detail of window lintel with architrave strip on top, still intact (Photograph: M. Naude 2013)**

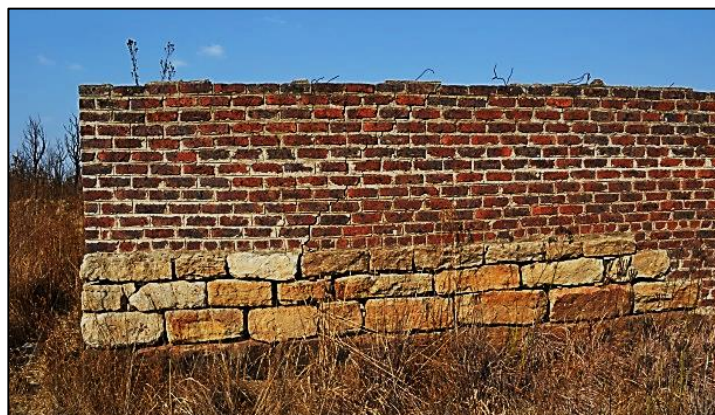
<p><u>Structure 2 - garage</u>: The building has a single unique element: the occurrence of a stonemasonry section serving as a plinth at the lowest end and corner of the structure. It is assumed that this was the part of the structure that needed a proper foundation and this may be the reason why large dressed sandstone blocks were used at this point. This alteration to the standard practice may add value to the pool of knowledge of vernacular architecture in the region.</p> <p><u>Structure 3 – coal container</u>: The occurrence of a coal shack as detached building from the dwelling is rather unique.</p> <p><u>Structure 4 – sandstone stock kraal</u>: The location and construction of the kraal reflects a particular mindset in terms of local building methods and locating the structure at a particular point in the landscape (along the vertical cliff of a sandstone outcrop).</p>	<p>Low</p> <p>Low</p> <p>low</p>

**Figure 12. Original sandstone base that could have served as a wall or may have been built specifically as base for the garage wall (Photograph: M. Naude 2013)**

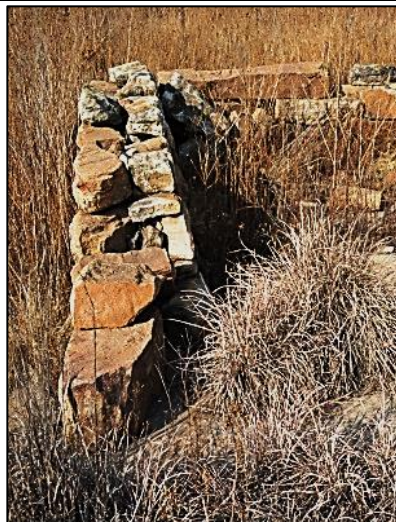
Structure 4 – sandstone stock kraal: The kraal walls were constructed with dry-stacking of sandstone. Stone was selected on site and roughly chipped prior to construction. Construction commenced directly on the surface without foundations and the walls are not very stable.

Figure 13. Section of the sandstone walling of the stock kraal (Photograph: M. Naude 2013)

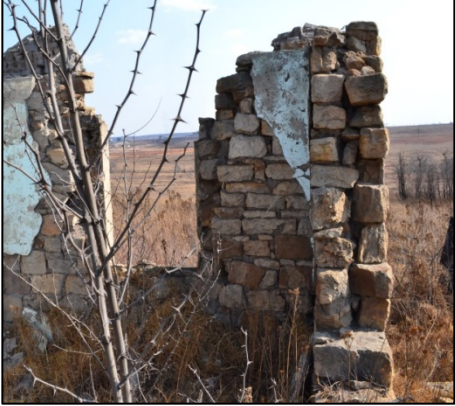
<p data-bbox="329 642 1105 726"><b>Figure 15. The construction method of the stone walling of the dwelling has been exposed at several locations indicating the simple construction method used (Photograph: M. Naude 2013)</b></p>	
<p data-bbox="237 785 261 810">5.</p>	<p data-bbox="326 785 1052 842"><b><i>What is the state of the architectural and structural integrity of the building?</i></b></p> <p data-bbox="326 877 1105 1024"><u>Structure 1 sandstone dwelling:</u> Both the architectural and structural integrity of the building has seriously deteriorated. The building has been altered so many times that the original floor plan of the building is difficult to reconstruct. The entire roof has disappeared and the walls have deteriorated to the extent that it cannot be reversed.</p>

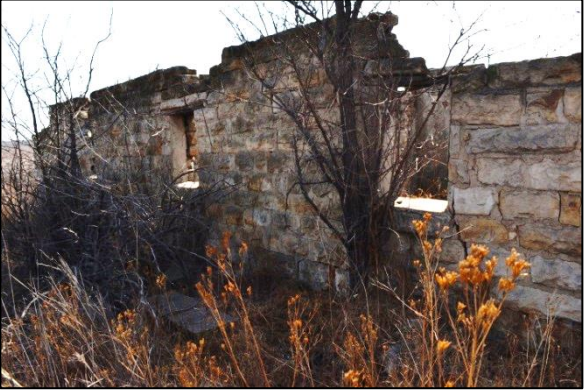
<p data-bbox="386 1486 1049 1543"><b>Figure 16. Exterior of the only elevation that has remained intact (Photograph: M. Naude 2013).</b></p>	<p data-bbox="1138 785 1211 810"><b><i>Rating</i></b></p> <p data-bbox="1138 877 1187 903"><b><i>Low</i></b></p>

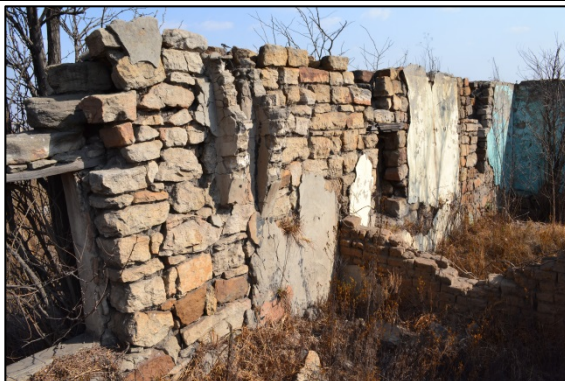
Figure 17. Interior of the same wall (Photograph: M. Naude 2013)

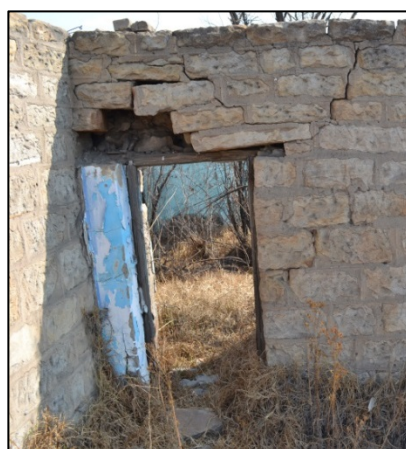
Figure 18. Disintegration of the walling due to permanent exposure to rain and sun resulting in the destruction of the entire building (Photograph: M. Naude, 2013)

2. The dwelling, garage and other structures may be demolished with some conditions: Recording of the floor plan prior to any demolition Recording must consist of the following procedures and products: (a) photographic recording of all buildings,(b) measured drawings of the floor plan of the dwelling with (c) descriptions of the materials and features in standard architectural terminology and (d) compiled into a single report. The compilation of this material must be submitted to the PHRA-Mpumalanga.

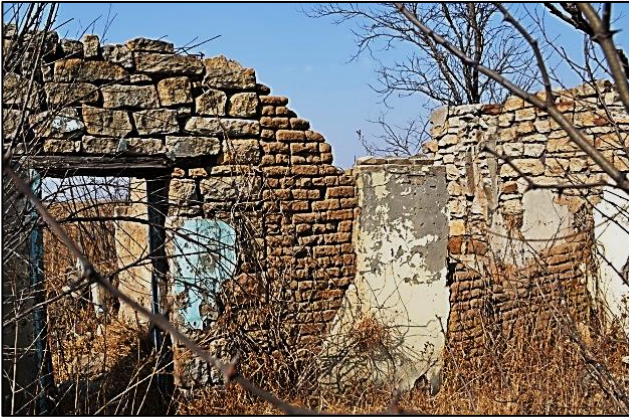
7.	<p><b><i>Were the alterations done in sympathy with the original design.</i></b></p> <p><u>Structure 1- sandstone dwelling</u>: The dwelling has been altered extensively and both sandstone and brick walling were added to the original core structure. Some effort was made to do the alterations in sympathy with the original structure but the difference in style, materials and craftsmanship is obvious and clearly distinguishable.</p>

<p><b>Figure 19. An interior wall was added to subdivide a room into two separate rooms - using sundried bricks (Photograph: M. Naude 2013)</b></p> <p><u>Structure 2 - garage</u>: The building has not been extended and it remains difficult to interpret the reason for the use of two building materials: sandstone masonry and unplastered red stock bricks.</p> <p><u>Structure 3 – coal container</u>: No alterations were made to the building</p> <p><u>Structure 4 – sandstone stock kraal</u>: The kraal is still in its original form and shape.</p>	<p><b><i>Rating</i></b></p> <p><i>Not in sympathy</i></p> <p><i>Sympathetic</i></p> <p><i>NA</i></p> <p><i>NA</i></p>

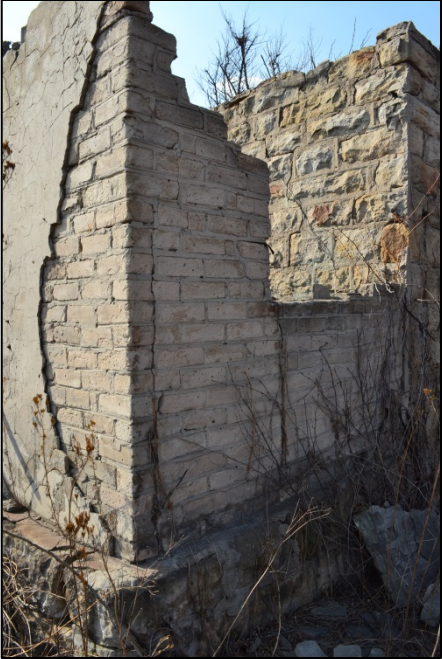
8.	<p><b><i>Were the additions and extensions done in sympathy with the original design?</i></b></p> <p><u>Structure 1 sandstone dwelling</u>: The dwelling was extended and added-onto several times with different degrees of success.</p>	<p><b><i>Rating</i></b></p> <p><i>Low</i></p>

<p><b>Figure 20. Exposed sundried brick walling of a later extension (Photograph: M. Naude 2013)</b></p> <p><u>Structure 2 - garage:</u> The building has not been extended.</p> <p><u>Structure 3 – coal container:</u> The building has not been extended</p> <p><u>Structure 4 – sandstone stock kraal:</u> The kraal is still in its original form and shape.</p>	<p><i>Low</i></p> <p><i>Low</i></p> <p><i>low</i></p>
9.	<p><i>Are any of the buildings or structures the work of a major architect, engineer or builder?</i></p> <p>None of the buildings were designed by an architect or engineer as they were built in the vernacular tradition.</p>	<p><i>Rating</i></p> <p><i>low</i></p>
