**HERITAGE ASSESSMENT (ARCHITECTURAL)  
OF BUILDINGS ON THE FARM  
STEENKOOLSPRUIT (Site 2) - WITBANK  
(MPUMALANGA PROVINCE)**

*Date: September-October 2012*

*Project by: M. Naude*

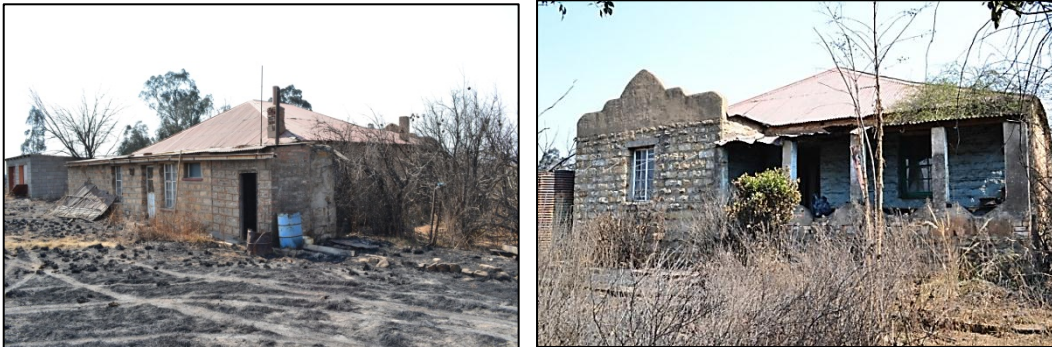
Building 1:

Sandstone farm dwelling with several additions to the core section of the building. The original core was constructed with sandstone and the interior walls were done in plastered brick. The walls were plastered with clay and were covered with wal paper which was later stripped and the clay exposed. Some effort was made to do the later additions in sympathy with the original dwelling and the walling was executed in sandstone – but of lesser quality craftsmanship than the original. A unique aspect of the dwelling is the simple gable that was added to the front façade which is completely out of style with the rest of the sandstone structure. The original verandah was constructed with timber posts that later disintegrated and were replaced with plastered brick columns and low stoep walling. The building may date from the 19<sup>th</sup> century and may have been destroyed during the Anglo Boer War. The original gable may have been destroyed in the process and was reconstructed after the war.

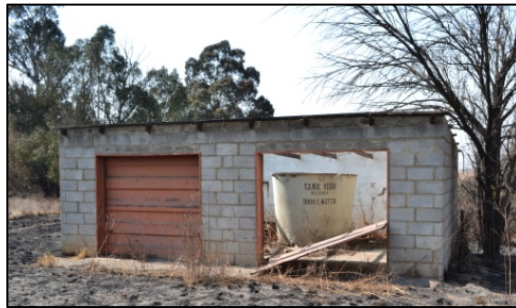
Building 2:

Garage constructed with cement bricks with all the roof sheeting removed.

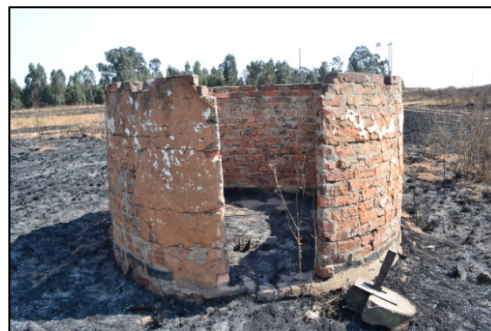
Building 3:

The ruins of a brick rondavel near the back door. No indication of the roof type has been left in situ.

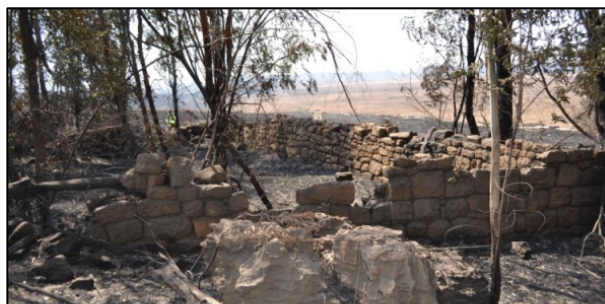
**Building 4:**

Remains of a sandstone cattle kraal located about 150 m from the dwelling. This structure was constructed with special craftsmanship and the great effort was made to ensure that the walls are stable and solid. One of the special features of the kraal is the way it was located and the choice of setting where it was built. One elevation of the kraal is set directly along a cut in the sandstone outcrop of the river bank. This allowed the builder to save on building four walls but allowed the kraal to be set slightly below the terraced landscape serving as some protection against cold winter winds at night.

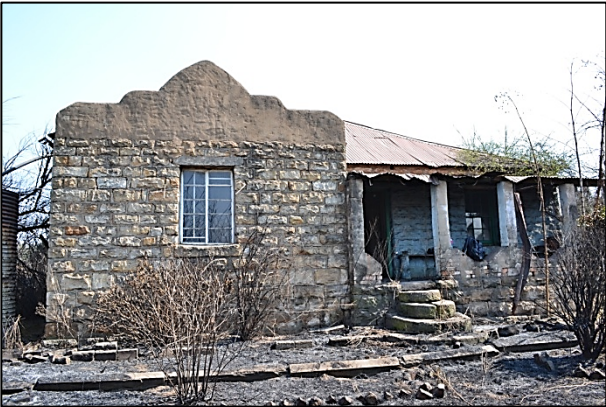
<p><b>Figure 1. The facade of the dwelling is the most exceptional feature of the building with its folk gable addition and alter additions of plastered brick verandah columns</b></p>

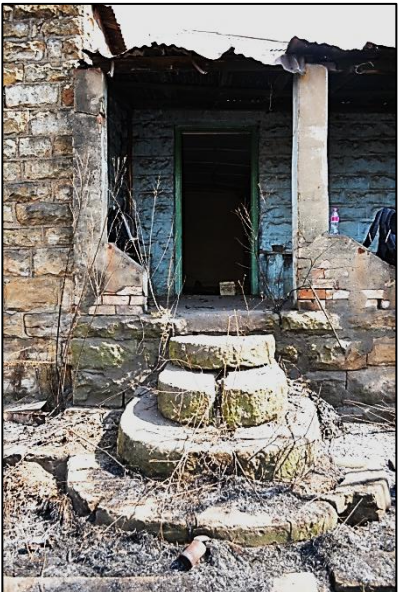
**Figure 2. Of exceptional significance is the crude sandstone staircase in front of the principal entrance and towards the stoep**

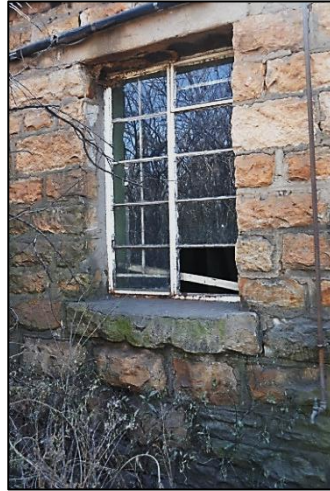
**Figure 3. No exceptional stone work appears around the windows and the window sills were dealt with in a direct and unrefined way.**

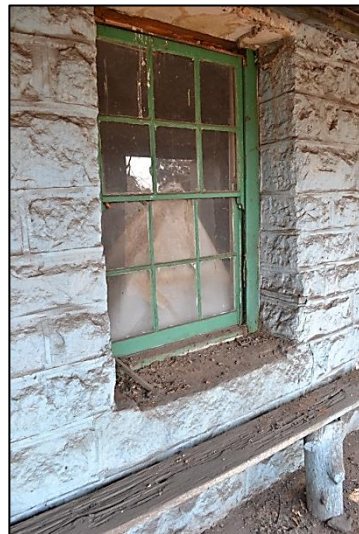
**Figure 4. One of the few sash windows that have remained intact on the front verandah.**

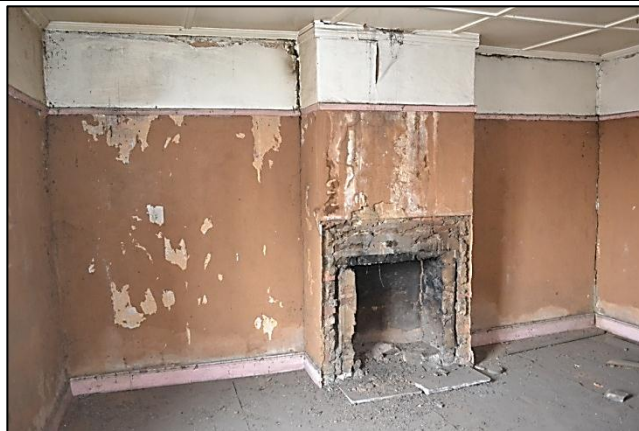
**Figure 5. Remains of clay plastering in the principal lounge. The mantelpiece has been removed.**

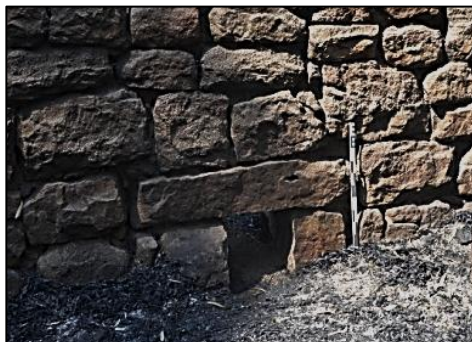
The kraal walls were constructed applying the double-row-method with filling in between. Stone was selected on site and roughly chipped into square cubes prior to construction. Construction commenced directly on the surface without foundations and the walls have retained their stability over time reflecting the quality of the masonry work.

**Figure 6. Water drain along the lower wall of the kraal with narrow stone lintel.**

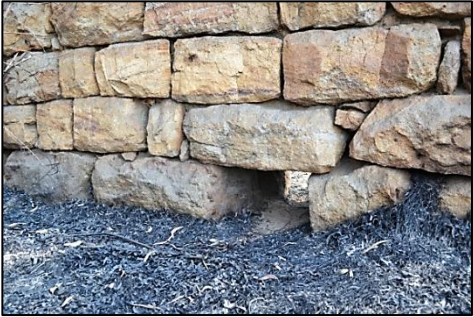
<p data-bbox="331 548 1101 604"><b>Figure 7. Water drain along the lower elevation wall with crude large stone lintel.</b></p>	
4.	<p data-bbox="321 663 1073 720"><i>Are any of the buildings an example of an industrial, engineering or technological development.</i></p> <p data-bbox="321 751 1084 846">The kraal is the only structure with some exceptional folk or vernacular engineering work reflected in the construction and the way the stones were prepared and the masonry was executed.</p>	<p data-bbox="1133 663 1211 695"><i>Rating</i></p> <p data-bbox="1133 751 1227 783"><i>Medium</i></p>

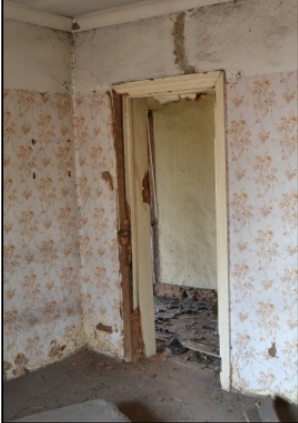
5.	<p data-bbox="321 909 1052 966"><i>What is the state of the architectural and structural integrity of the building?</i></p> <p data-bbox="321 999 444 1031"><u>Building 1:</u></p> <p data-bbox="321 1031 1094 1146">The structural integrity of the building has seriously deteriorated and the woodwork has been infested by termites. The building has been altered so many times that the original floor plan of the building is difficult to reconstruct.</p>

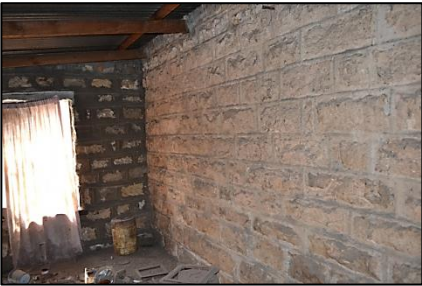
<p><b>Figure 8. Original back wall of the dwelling with later additions closing the back stoep that used to be an open space.</b></p>

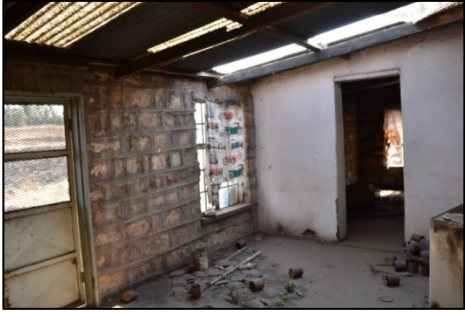
<p><b>Figure 9. Closing of the open stoep at the back of the dwelling. The stoepkamer was closed with plastered brick walling.</b></p>

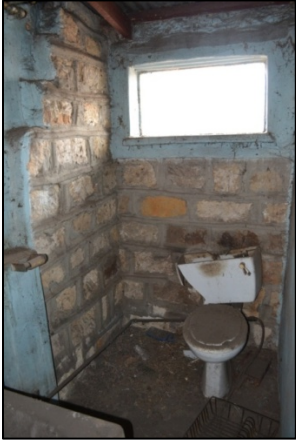
<p><b>Figure 10. Crude addition and closing of the privy that was added on the back stoep of the original dwelling.</b></p> <p><u>Building 2:</u> The building has not been extended.</p> <p><u>Building 3:</u> The building has not been extended</p> <p><u>Building 4:</u> The kraal is still in its original form and shape</p>	<p><i>NA</i></p> <p><i>NA</i></p> <p><i>Still in original form.</i></p>
