HERITAGE IMPACT ASSESSMENT FOR THE PROPOSED REPAIR, MAINTENANCE AND UPGRADE OF EXISTING INFRASTRUCTURE AND DEVELOPMENT OF ROCK REVETMENT AT THE ARNISTON FISHING HARBOUR, WESTERN CAPE

WESTERN CAPE

Report #: 2017/WC/002
Status: Interim
Revision #: 0
Date: 09 November 2017

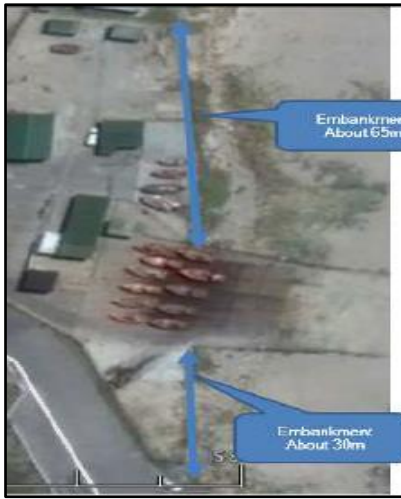
Figure 3: Rock Embankment at Arniston Fishing Harbour (PBPS 2017)

The existing harbour embankment has been eroded by wave action. Portions of the embankment are failing, this is undermining the fence and parking area above. The continuing erosion of the embankment is endangering existing harbour infrastructure. The stability of the embankment is further undermined by a lack of stabilising vegetation. The erosion of the embankment has exposed the stratigraphy which indicates that the fill material used was rubble.

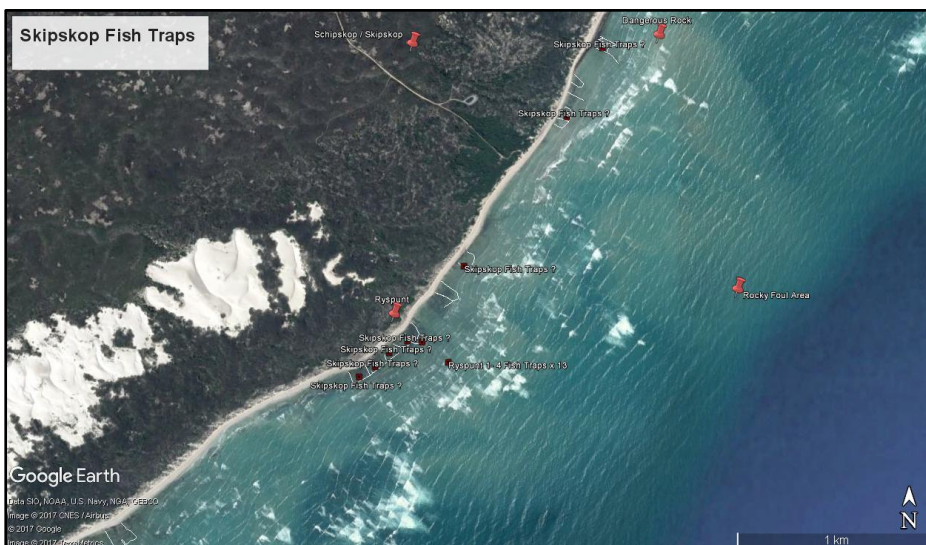
Figure 5: Fish Traps near Skipskop and Rys Point, east of the fishing harbour (Google Earth 2017)

Stone-walled enclosures are a common feature along the south Cape coast. Shell middens associated with these fish traps have been excavated and the evidence points to their use throughout the last 2 000 years (Deacon & Deacon 1999). This timeline coincides with the introduction of pastoralism to South Africa through the Khoekhoe people.

Oral histories state that the fish traps had always been there and the process of building, maintaining and using them was passed through the generations. The community elders report that the fish traps were used before the Europeans came with nets (Dennis 2009). According to Kemp (2007) the fish traps at Arniston and Still Bay are the only ones in South Africa still being actively used by the local fishing communities.

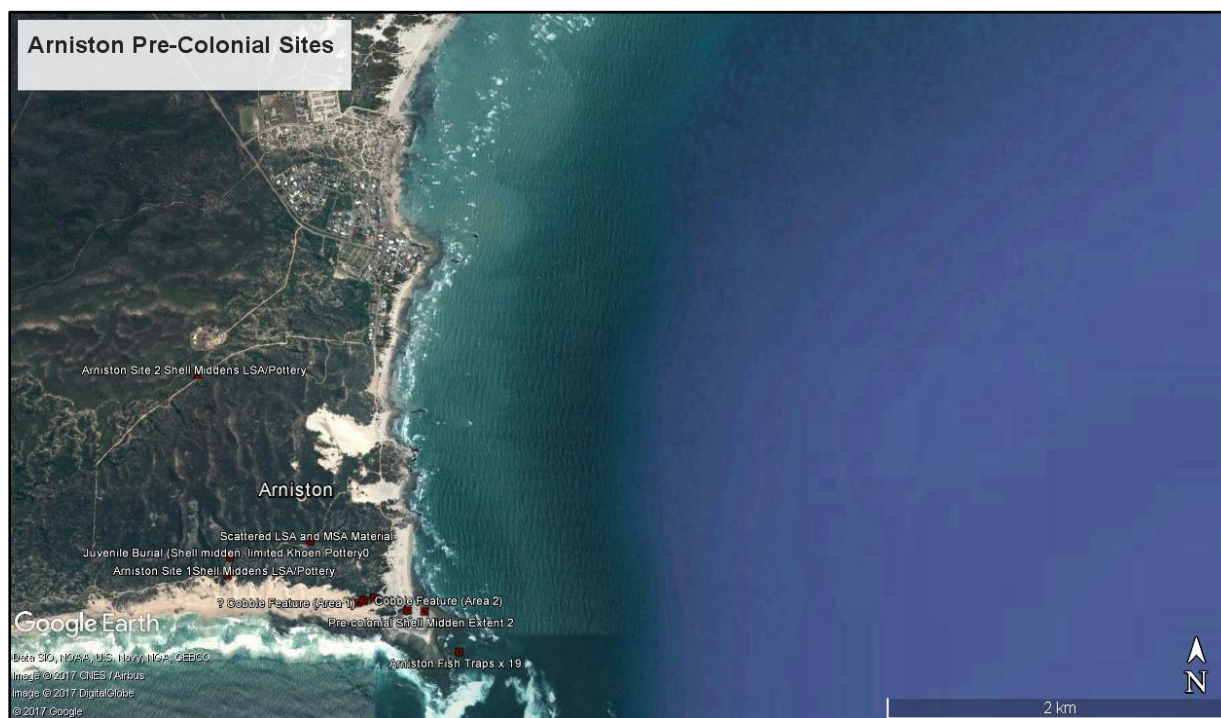
Figure 6: Arniston Pre-colonial Sites (Google Earth 2017; Yates 1999)

The use of marine resources in the archaeological record along the south Cape Coast extends from the Middle Stone Age (c. 250 000 – c. 22 000 years ago) to modern times. The coast has hundreds of shell middens in the open and in caves and shelters. (See Figure 4 for some of these sites).

Yates (1999) documents a number of shell middens and cobble structures at Struis Point. Kaplan (1999) also recorded a number of sites in the Suiderstrand area. However, the likelihood of this type of cultural heritage site being found within the development area is very low, as the area is within the urban zone.

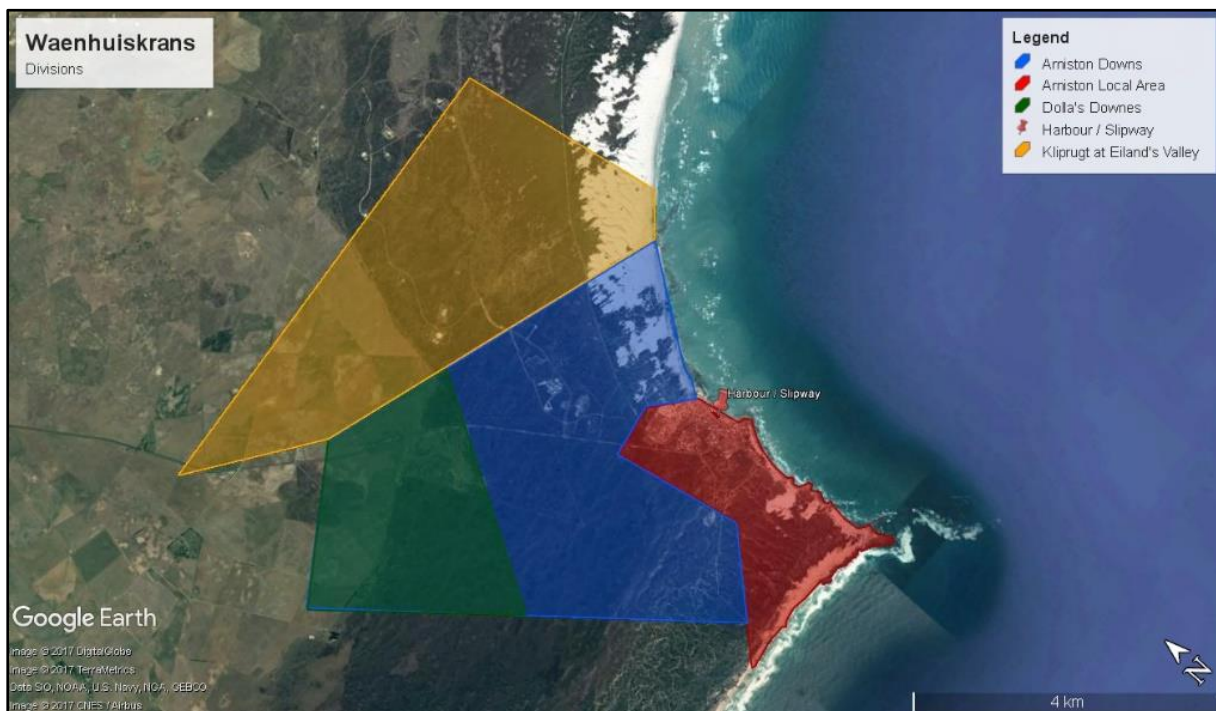
Figure 7: Waenhuiskrans/Arniston Land Divisions (Google Earth 2017; Dennis 2009)

This area incorporates Kassiesbaai Fishing Village (blue), parts of Arniston (red), Dolla's Downs (green) and parts of the coastline to the northeast (Figure 7). The village is located directly to the west of the harbour.

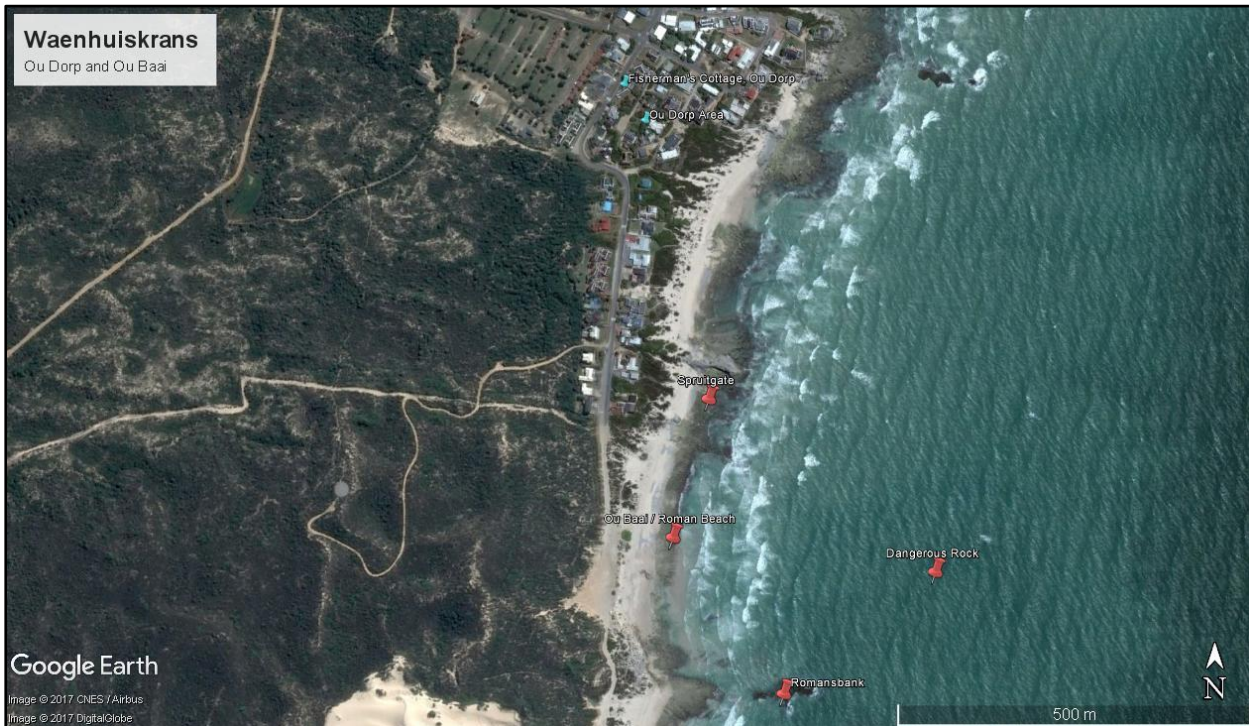
Figure 9: Map showing the area of Ou Dorp and Ou Baai (Google Earth 2017)

Around 1850, the ancestors of the present fishing village moved into the area. At this time, according to Dennis (2009) the fishing community was staying in Ou Dorp and fished from Ou Baai (Roman Beach) (Figure 9). The original five families had grown to 30 families by 1870.

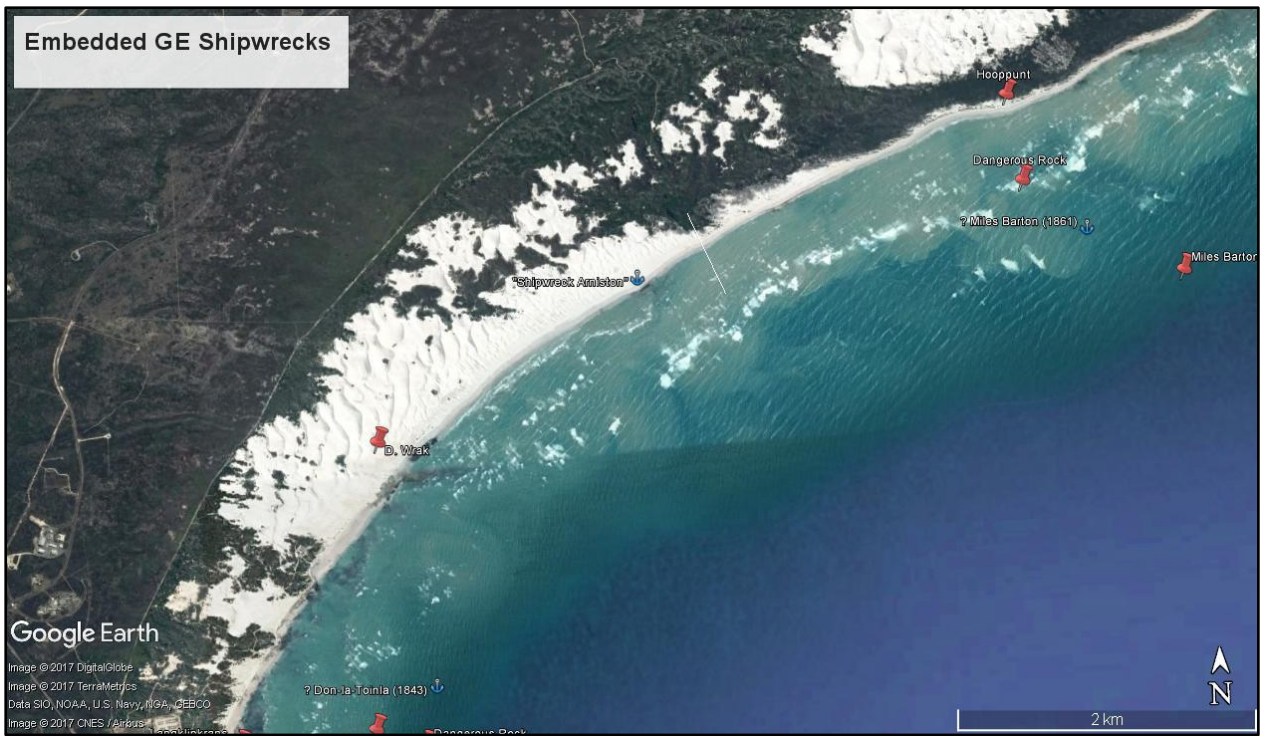
Figure 15: Embedded Google Earth Shipwrecks (Google Earth 2017)

There two wreck photographs embedded in Google Earth (Figure 15), the first is supposed to be the wreck of the *Arniston* (1815) (Figure 18) and the second is merely called D.Wrak (Figure 16). These are geo-referenced into the program and their co-ordinates have not been validated. D.Wrak is an unknown iron wreck. Further research would no doubt clear up its identity.

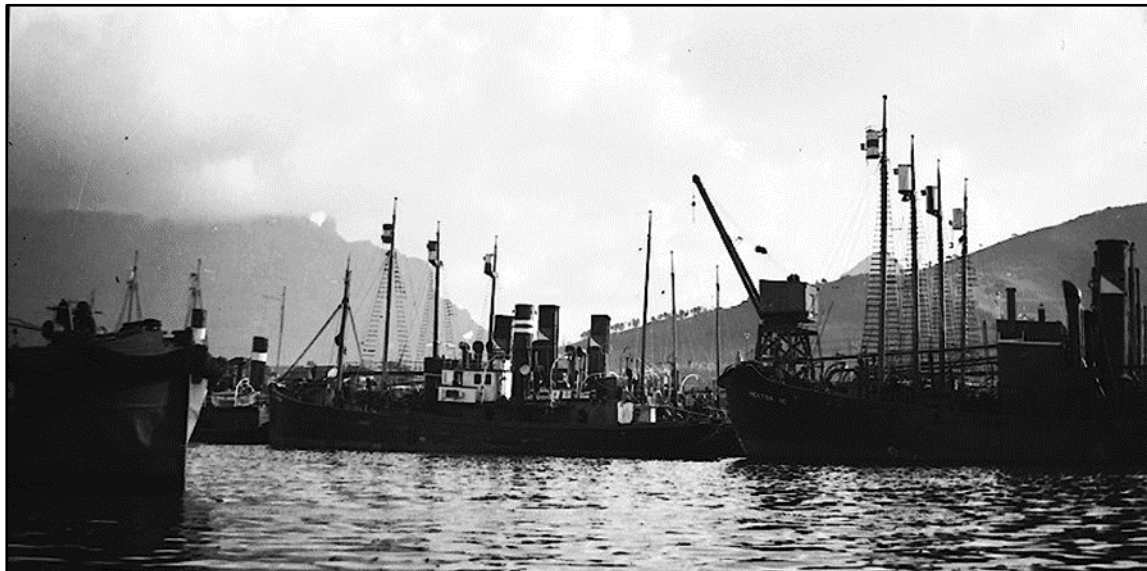
Figure 17: The *Anker* in Victoria Basin (Photo: George Young in van den Bosch (2009))

6	<i>Anker</i>	Wrecked	Cape Town	1935	This 149-ton steam ketch, owned by Fish Products Ltd. / National Fishing and Trawling Co. was built in 1916. Under Captain E. de la Channette / Chaumette on 2 November 1935, she was wrecked at Bull Dog Reef, near Arniston. Apparently, there was poor visibility. Initially the crew of fourteen were unable to lower the lifeboats due to high sea. However, just after sunrise, two boats put off from the shore and rescued the crew. The trawler became a total wreck. (Levine 1989; van den Bosch 2009)	Bull Dog or Saxon Reef, Struis Point
---	--------------	---------	-----------	------	--	--------------------------------------

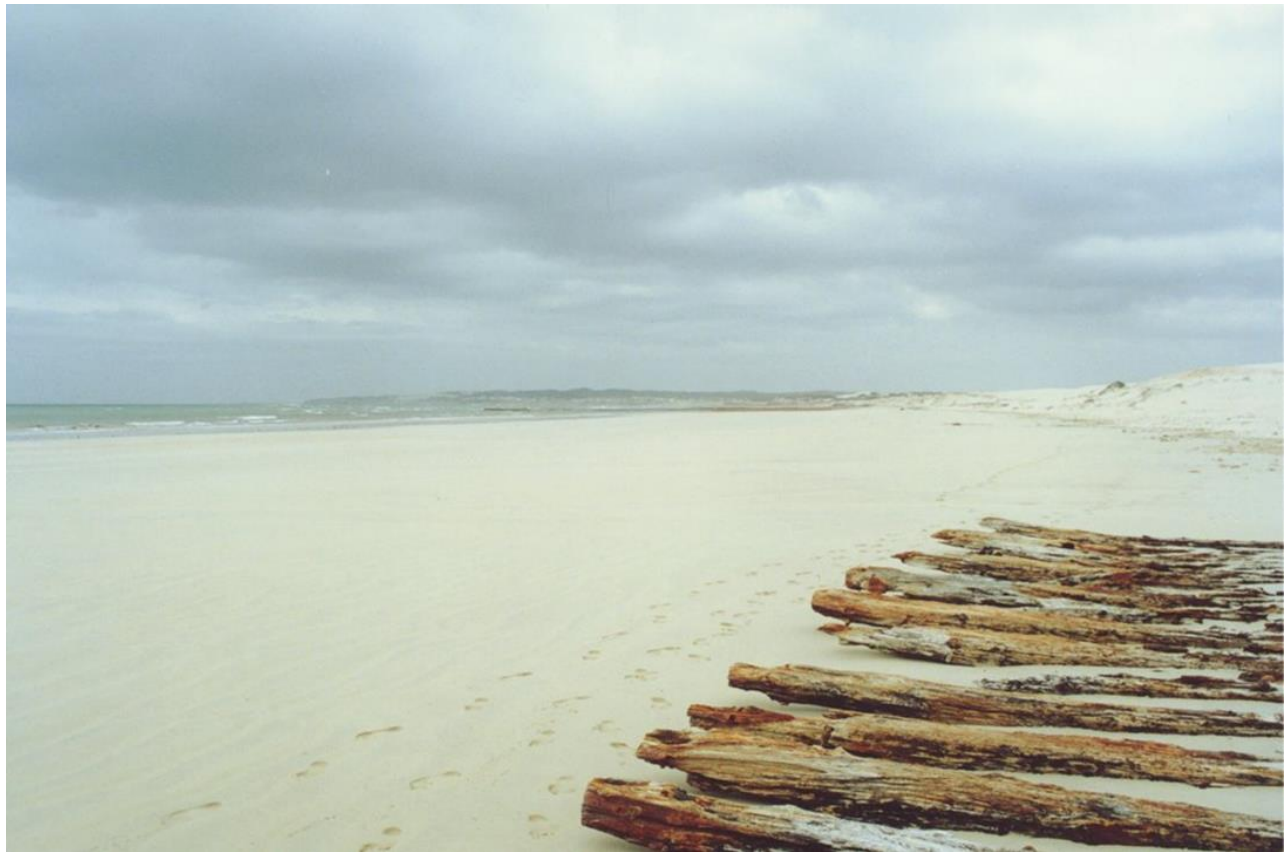
Figure 18: The alleged ribs of the *Arniston* (1815) (Photo: Avenues Guesthouse on Google Earth)

7	<i>Amiston</i>	Wrecked	Britain	1815	<p>This transport / hospital ship of 1498-tons and 22-guns was built on the Thames in 1794. She had been requisitioned by the Royal Navy and was under the command of Captain George Simpson. On 30 May 1815, while on a voyage from Ceylon to England, she came to a tragic end. Aboard the vessel was Viscount and Lady Molesworth as well as invalid soldiers. Of the 378 people on board, only six survived (Turner 1988; Levine 1989). The survivors apparently walked up the coast to the Breede River and back until they were finally rescued by Jan Swart, the son of a farmer of Elandsvallij. They then travelled to Cape Town by ox-wagon (van Zyl n.d.).</p> <p>There was a sale notice on 30 May 1815 in the Cape Town Gazette for cargo salvaged from the wreck, these included, casks of wine, arrack and pitch, cordage and rattans and various pieces of wreckage. The sale was held "on the beach near Eilands Valley".</p> <p>In 1982, salvors found the wreck and recovered numerous artefacts including, star pagodas, rupees, mercury and jewellery. The co-ordinates here are from Turner (1988).</p> <p>In 2009, the skull and bones of one of the victims was removed from the Bredasdorp Shipwreck Museum and finally interred at Amiston. Up until the law forbade it, the bones had been on display.</p> <p>Locals believe that the ribs sticking out of the dunes (see Figure 18) are the remains of the Amiston. (Turner 1988; Levine 1989; van den Bosch 2009) The co-ordinates are near Struis Point, the photograph of the hull is on the beach. It has been disclosed to me by Malcolm Turner that his co-ordinates (especially of those that were salvaged) are incorrect in order to protect the wrecks from other salvors. In addition, Eiland's Valley (Figure 7) is in the beach to the east of the village.</p>	Probably between langklipkrans and Hoopunt 34 41.40S,20 14.60E

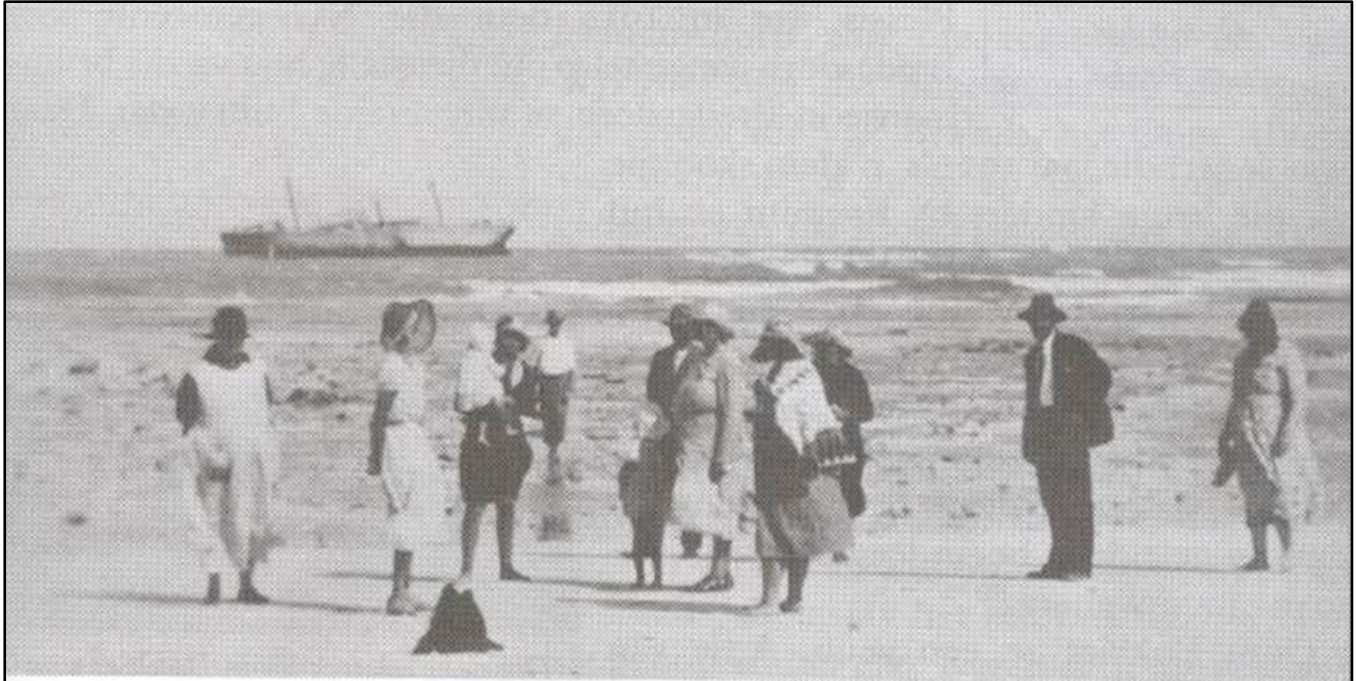
Figure 19: The Clan Macgregor just after she was wrecked at Schipskop. (The spelling later changed to Skipskop) (Human T. in van den Bosch 2009)

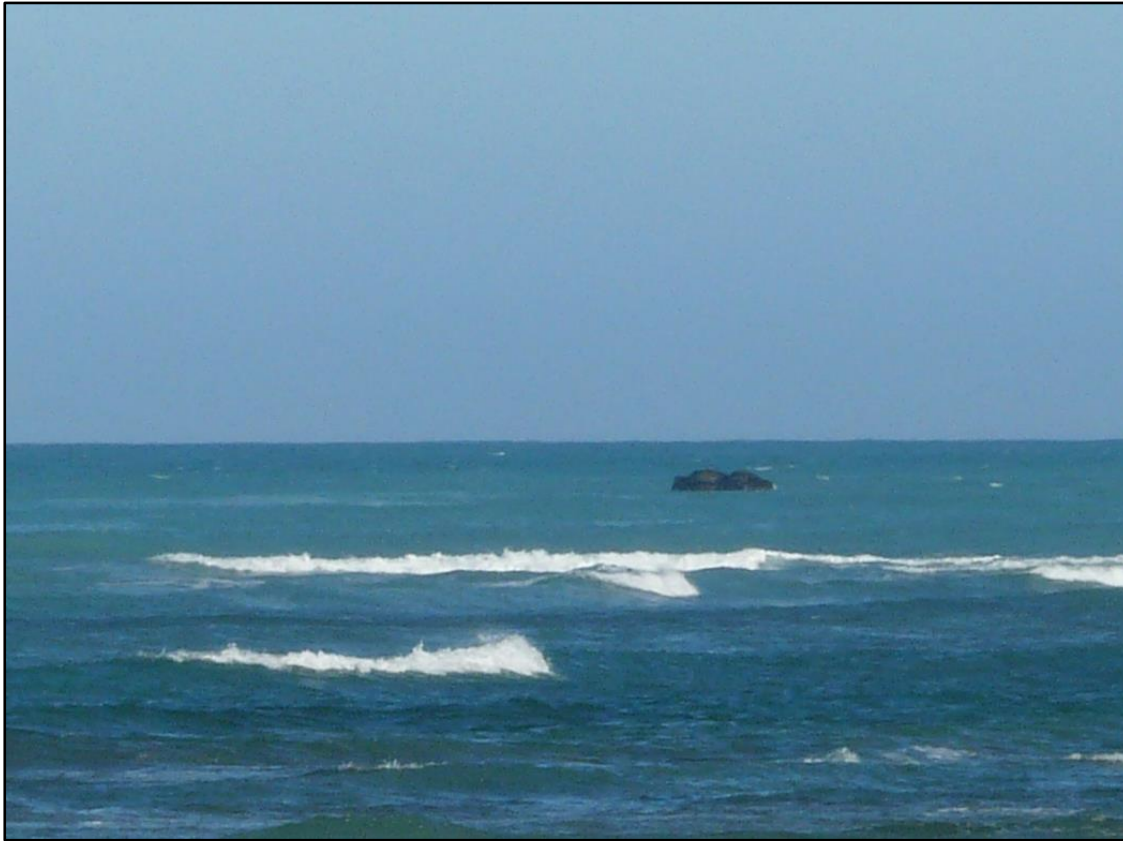
Figure 20: The remains of the *Queen of the Thames* (van den Bosch 2009)
