# **SOUTH AFRICAN HERITAGE RESOURCES AGENCY**

## **CONSERVATION MANAGEMENT PLAN FOR “BLACKIE” A SPECIFICALLY DECLARED STEAM RAILWAY LOCOMOTIVE**

**SAHRA/HO/07/2014**

**31 July 2015**

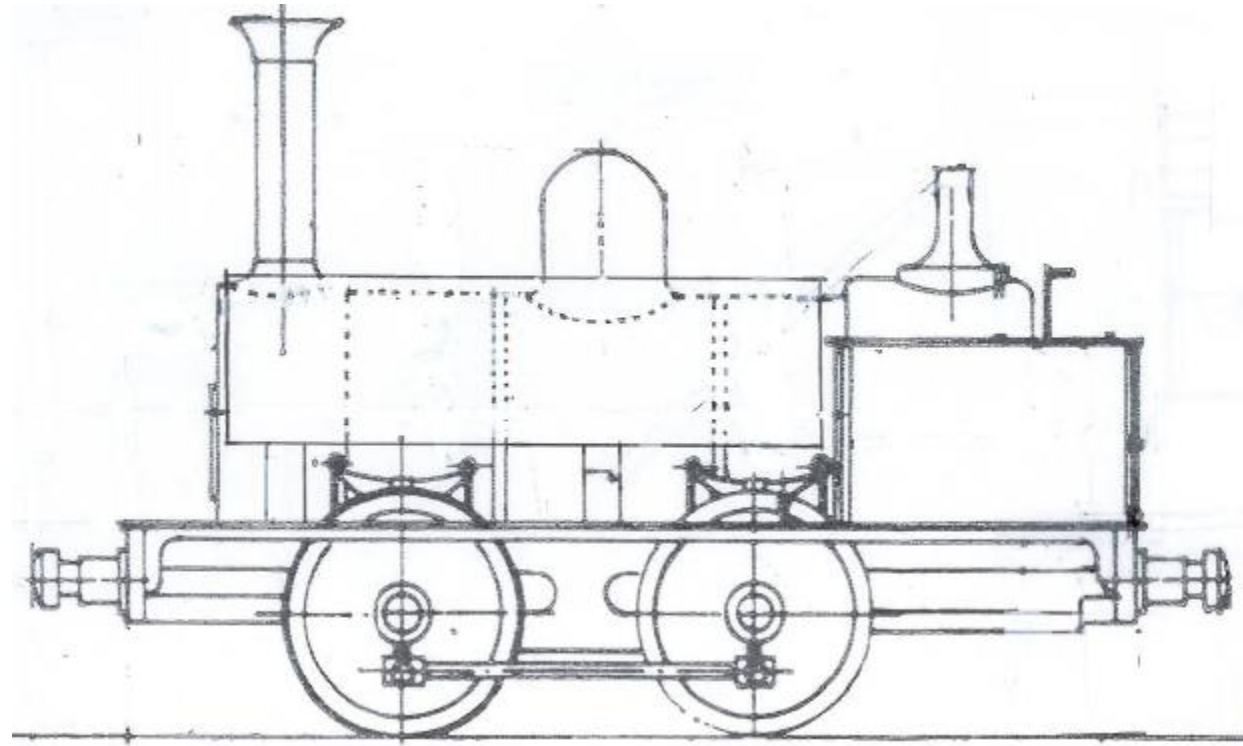
PROVISIONAL DIAGRAM OF BLACKIE IN ORIGINAL CONDITION AS A 0-4-0 WITH SIDE TANKS

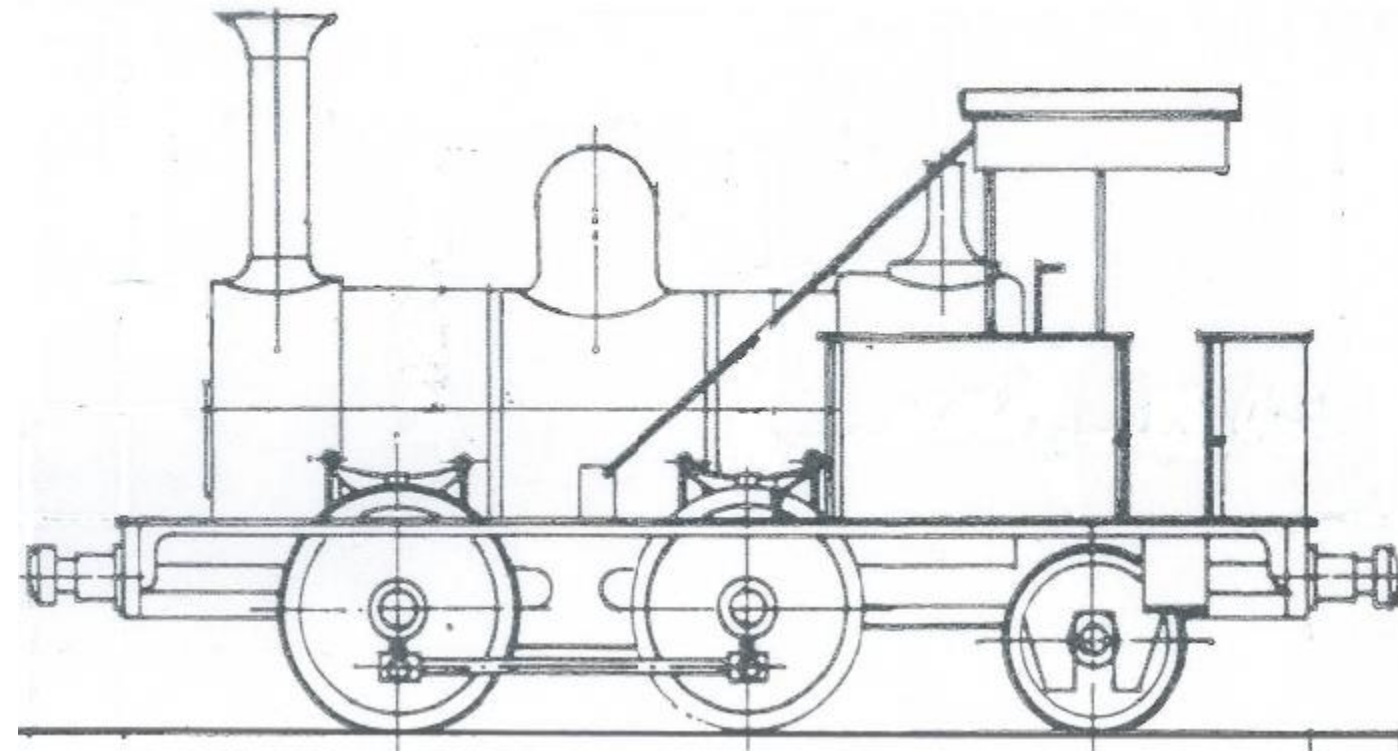
- 2.3.18. The provision of the additional wheel set created a problem when the locomotive was put to work in Port Alfred as the longer wheel-base caused fouling on the curves and to alleviate this the middle set of wheels had their flanges removed and a 3 kph (2 mph) speed limit enforced.

DIAGRAM OF BLACKIE IN MODIFIED CONDITION AS A 0-4-2 AS USED AT PORT ALFRED

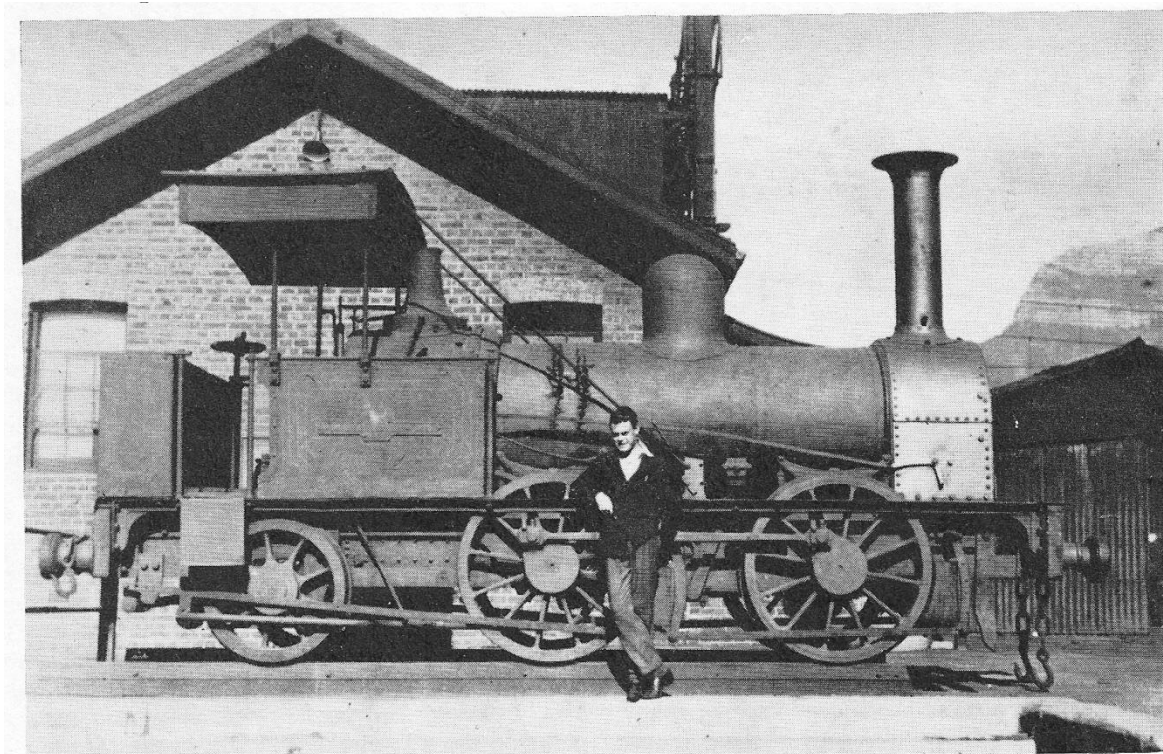
*Old No 9 standing in the traverser yard at Salt River works in 1928 with the author, then an improver fitter, standing in front*

The locomotive is in the same condition that it is now in and is standing on the same type of rails

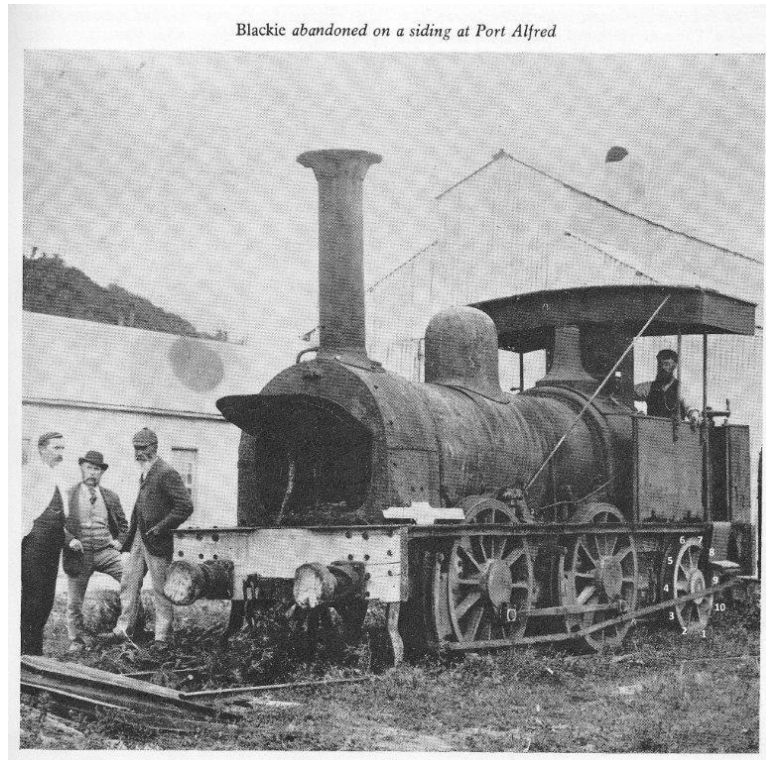
5.7. From photographic evidence of the locomotive based on photographs taken when the locomotive was staged out of use at Port Alfred and later when the locomotive was plinthed at the Salt River Workshops in Cape Town it is noted that the rear carrying wheels were changed at some point in time after the photograph was taken at Port Alfred.

5.8. The rear wheels as seen in the Port Alfred photograph have 10 spokes.

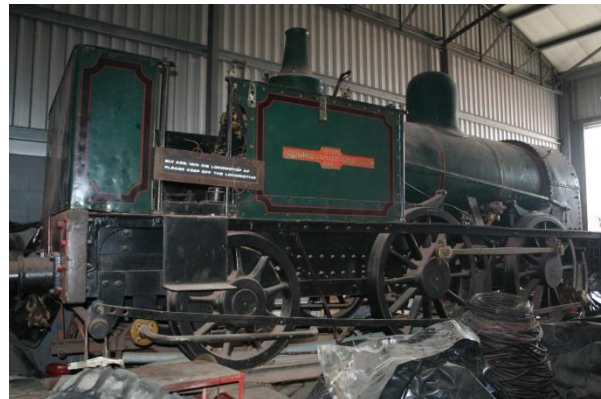
5.10. The rear wheels as seen currently in storage at Firgrove have 9 spokes.

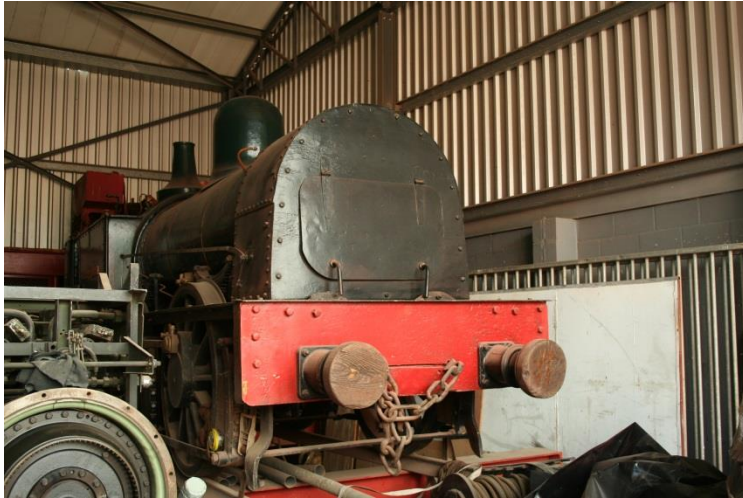
- 6.1. The locomotive was inspected on 04 February 2015 at the premises of ALE in Firgrove by Bruce Brinkman & Mark Robinson of B4 Architects with Regina Isaacs and Nolitha Ngcai of SAHRA.
- 6.2. The inspection at ALE in Firgrove was only partially successful as it is difficult to properly inspect the whole locomotive in its present position.
- 6.3. The locomotive is currently covered in black plastic sheeting with no protective material between the paintwork and the sheeting.
- 6.4. The locomotive although under cover inside a building is not in a climate controlled environment.
- 6.5. At present neither the cab roof or the smokestack (chimney) are fitted to the locomotive nor were these not available for viewing.

- 6.6. The locomotive is currently extremely dirty and will need to be properly cleaned before a final review of the condition of the paintwork can be finally determined – it does not seem to be too bad.

- 6.10. We recommend that additional supports be inserted under the rails below the rear driving wheels (centre wheels) to avoid any further possible damage – this has not yet been done.

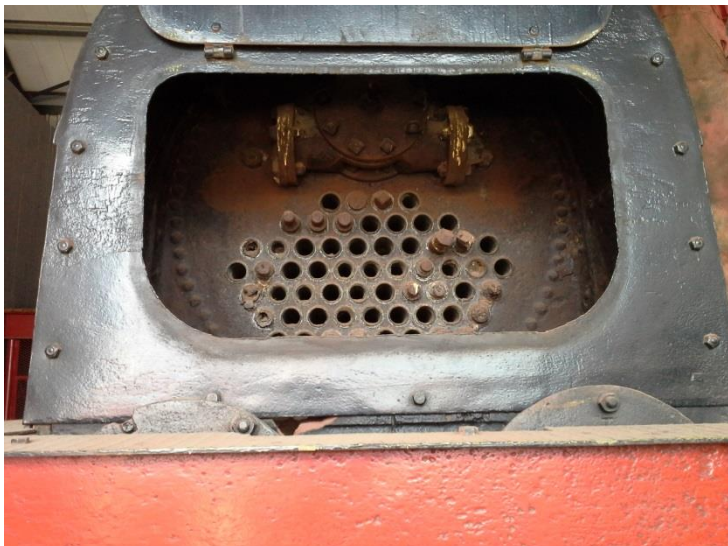
- 6.12. The boiler tubes are still in place although some of them have been plugged and sealed off.
- 6.13. The main steam pipes and exhaust blast pipe are missing from the smokebox.

6.14. Based on the inspection we believe that the insulation under the boiler cladding is still in place.

6.14.1. This insulation may include asbestos fibres – however this is not a health hazard as long as the boiler cladding remains in place and the cladding is maintained in good condition.

6.14.2. The removal of the cladding is a major task and will result in damage to both the paintwork and the sheet metal cladding.

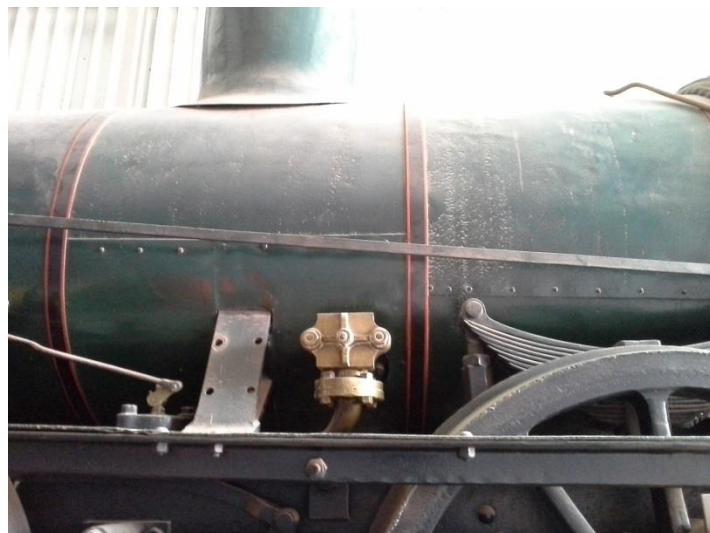
6.16. There are brackets on either side of the boiler which have bolt holes that are not currently used except for the cab stays.

6.16.1. There is also evidence that there was something fixed to the brackets on either side of the smokebox which corresponds to the early picture of "Blackie" which shows the locomotive as an 0-4-0 tank locomotive with pannier tanks.

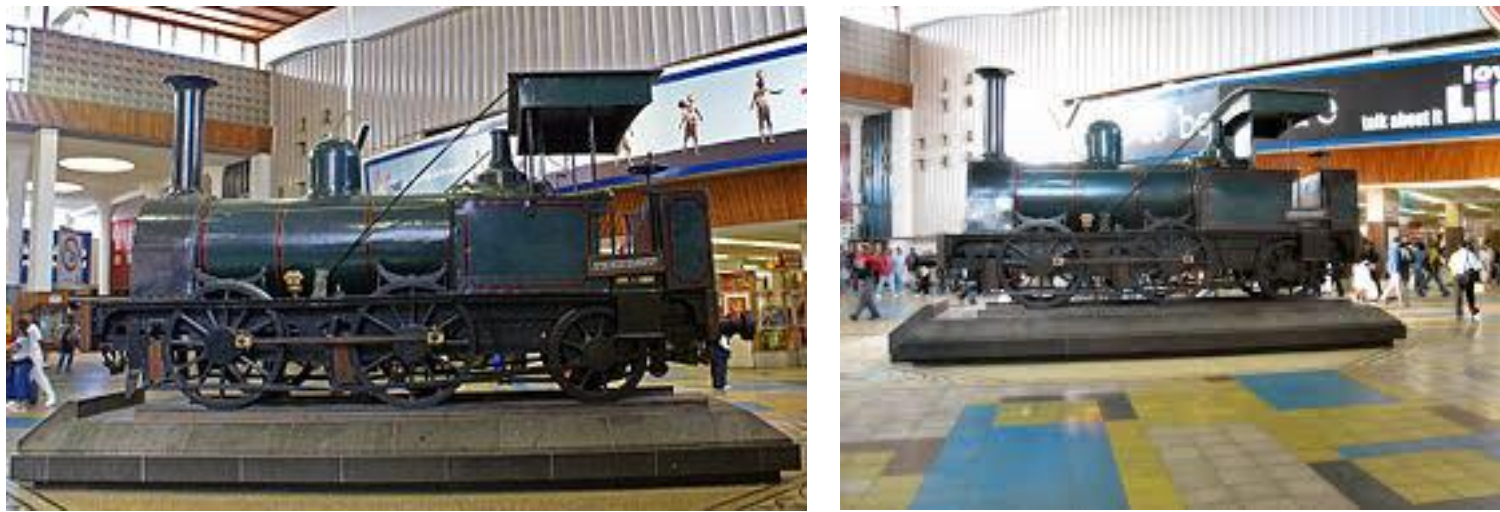
- 7.3.1. Since the locomotive has been displayed in its current Cape Government Railways livery for between 80 and 100 years and this was the livery that it was in when it was proclaimed a national monument it is recommended that it continues to be displayed in a Cape Government Railways livery.

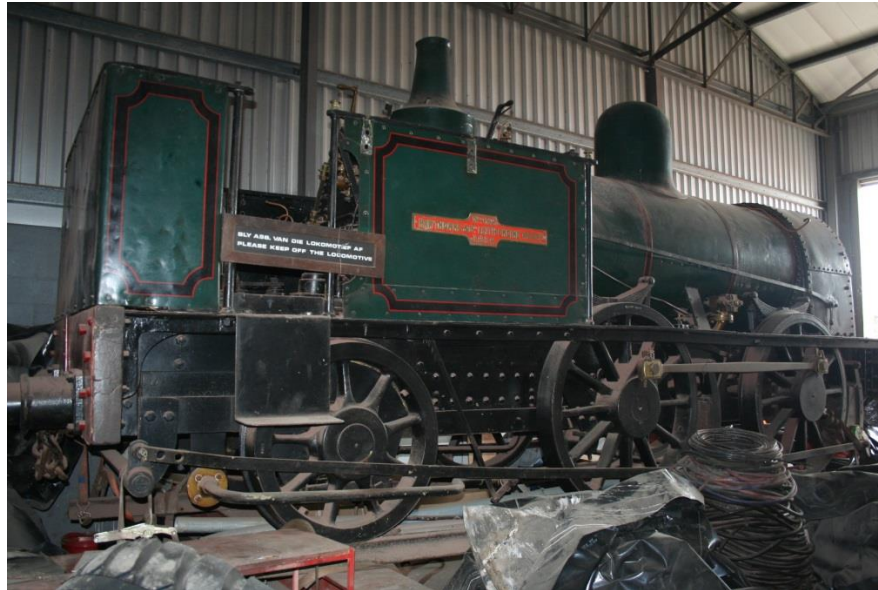
- 8.1. The locomotive "Blackie" was inspected on 04 February 2015, at the premises of ALE at Firgrove where it is in temporary storage.
- 8.2. The locomotive although under cover inside a building is not in a climate controlled environment.

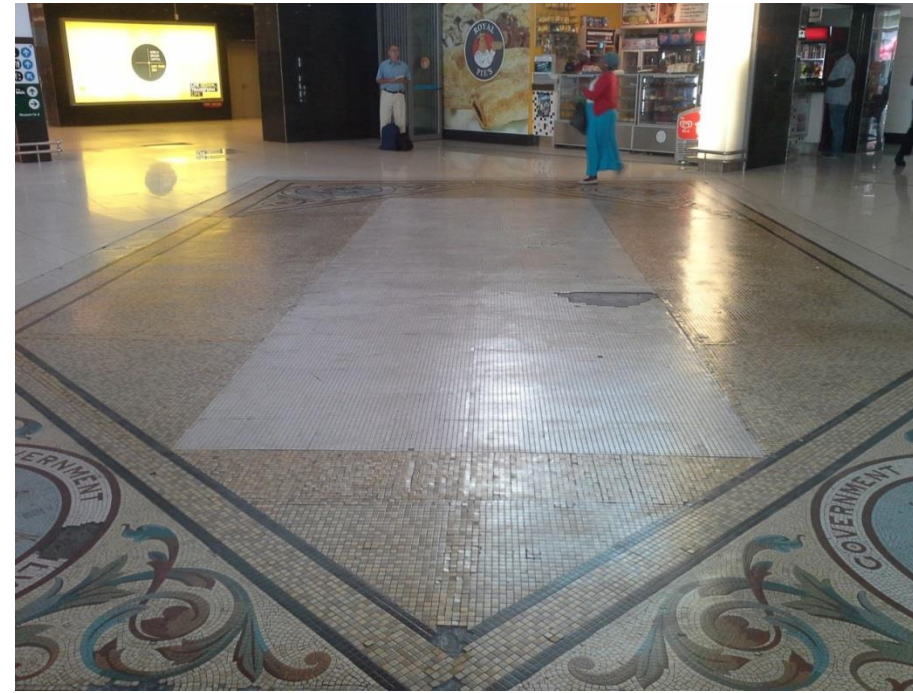
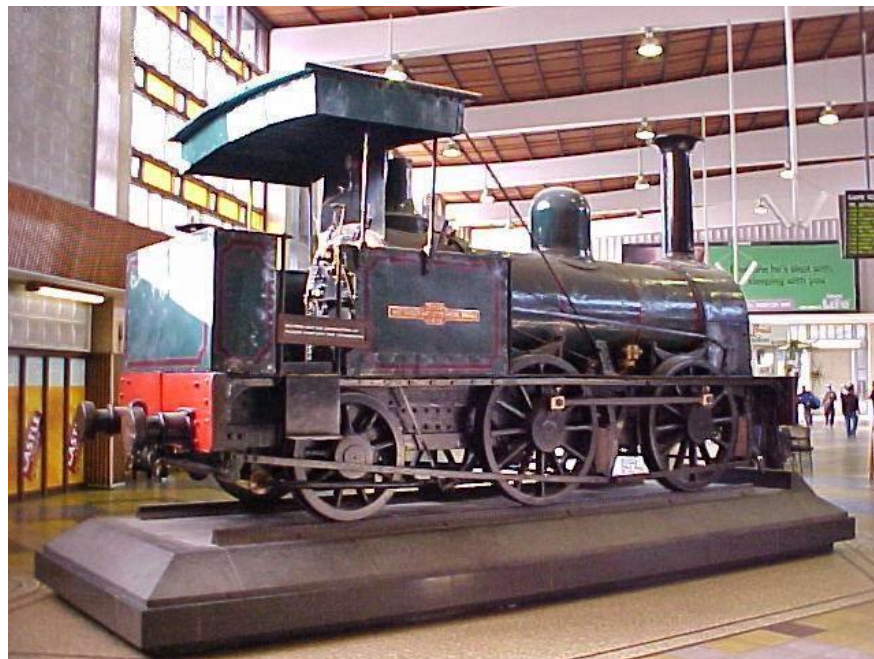
#### 11.2.2.1. Option B1 – Old Position in Main Line Concourse

11.2.2.1.1. Position not acceptable to PRASA - Would interfere with pedestrian flow and access to retail food outlets.

11.2.2.1.2. Mosaic panel can remain in position and be repaired.

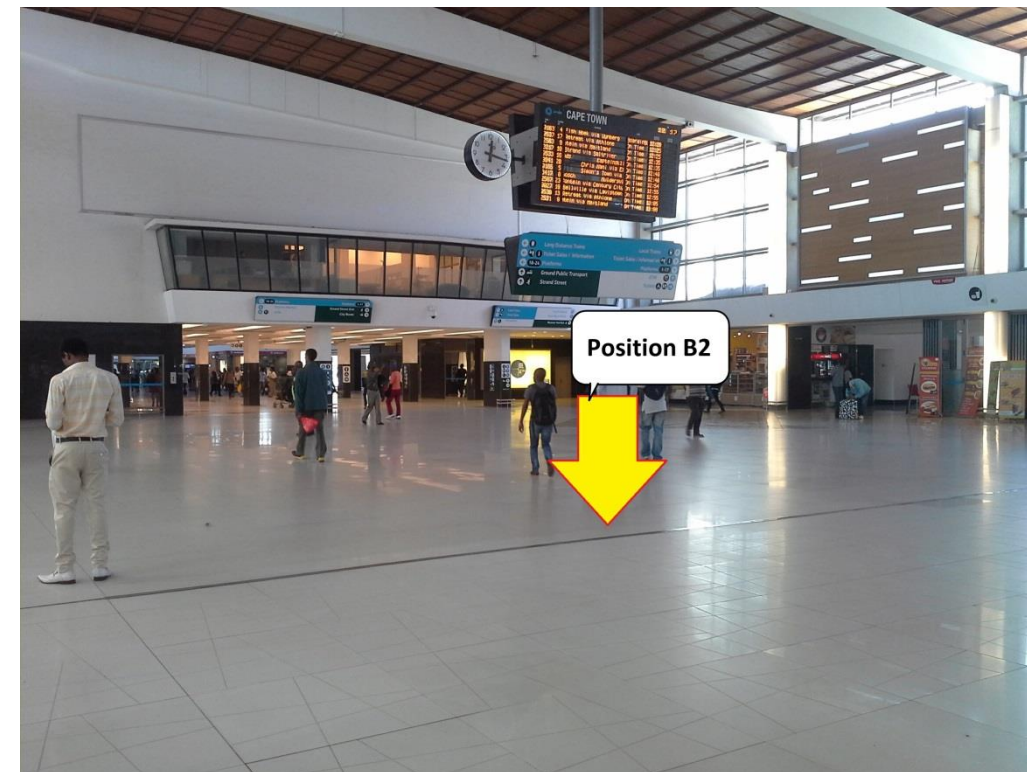
### 11.2.2.2. Option B2 – Central Position in Main Line Concourse

- 11.2.2.2.1. Mosaic panel will have to be uplifted and relocated.
- 11.2.2.2.2. Readily visible from all sides.
- 11.2.2.2.3. Will have some interference with pedestrian traffic flow in the Concourse but pedestrians can flow around display.
- 11.2.2.2.4. Will interfere with the overhead information boards in the middle of the concourse.
- 11.2.2.2.5. Would NOT be a recommended option.

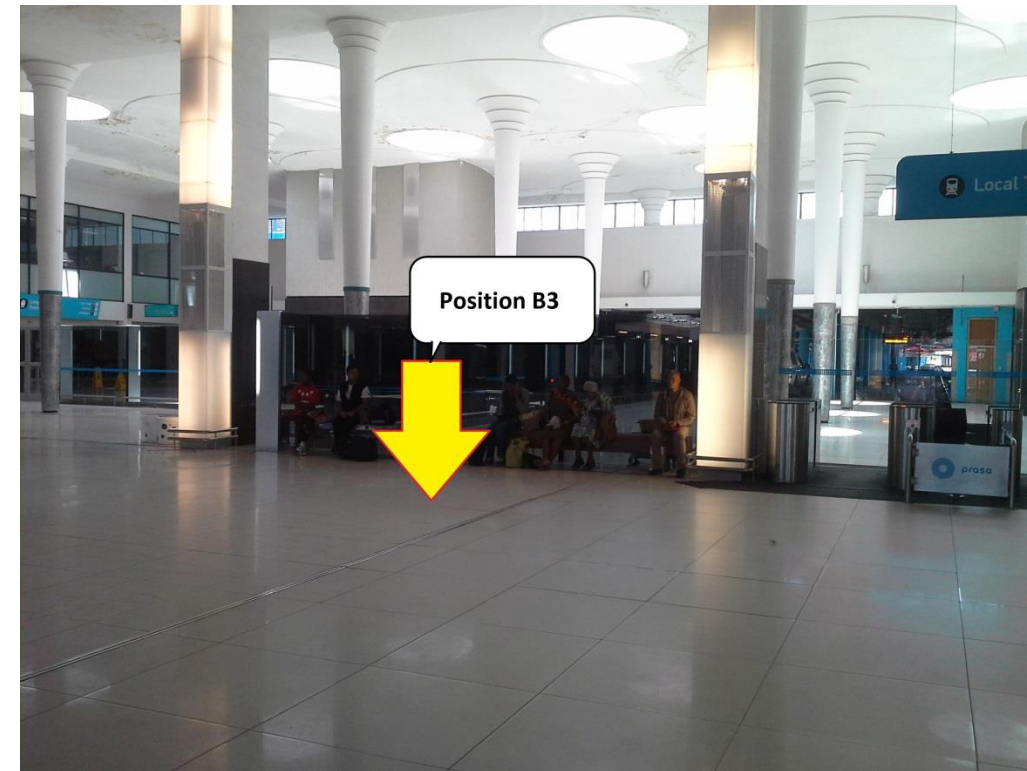
### 11.2.2.3. Option B3 – Offset towards Main Line platforms in Concourse

- 11.2.2.3.1. Mosaic panel will have to be uplifted and relocated.
- 11.2.2.3.2. Visible from all sides.
- 11.2.2.3.3. Will have minimal interference with pedestrian traffic flow in the Concourse
- 11.2.2.3.4. Position probably acceptable to PRASA.
- 11.2.2.3.5. Not preferred option.
- 11.2.2.3.6. Could be an acceptable option.
