FINAL BASIC ASSESSMENT REPORT

BOKONI PLATINUM MINES: RAPHOLO RIVER REHABILITATION AND WATER TREATMENT PLANT PROJECT

JULY 2021

BASIC ASSESSMENT REPORT and ENVIRONMENTAL MANAGEMENT PROGRAMME REPORT

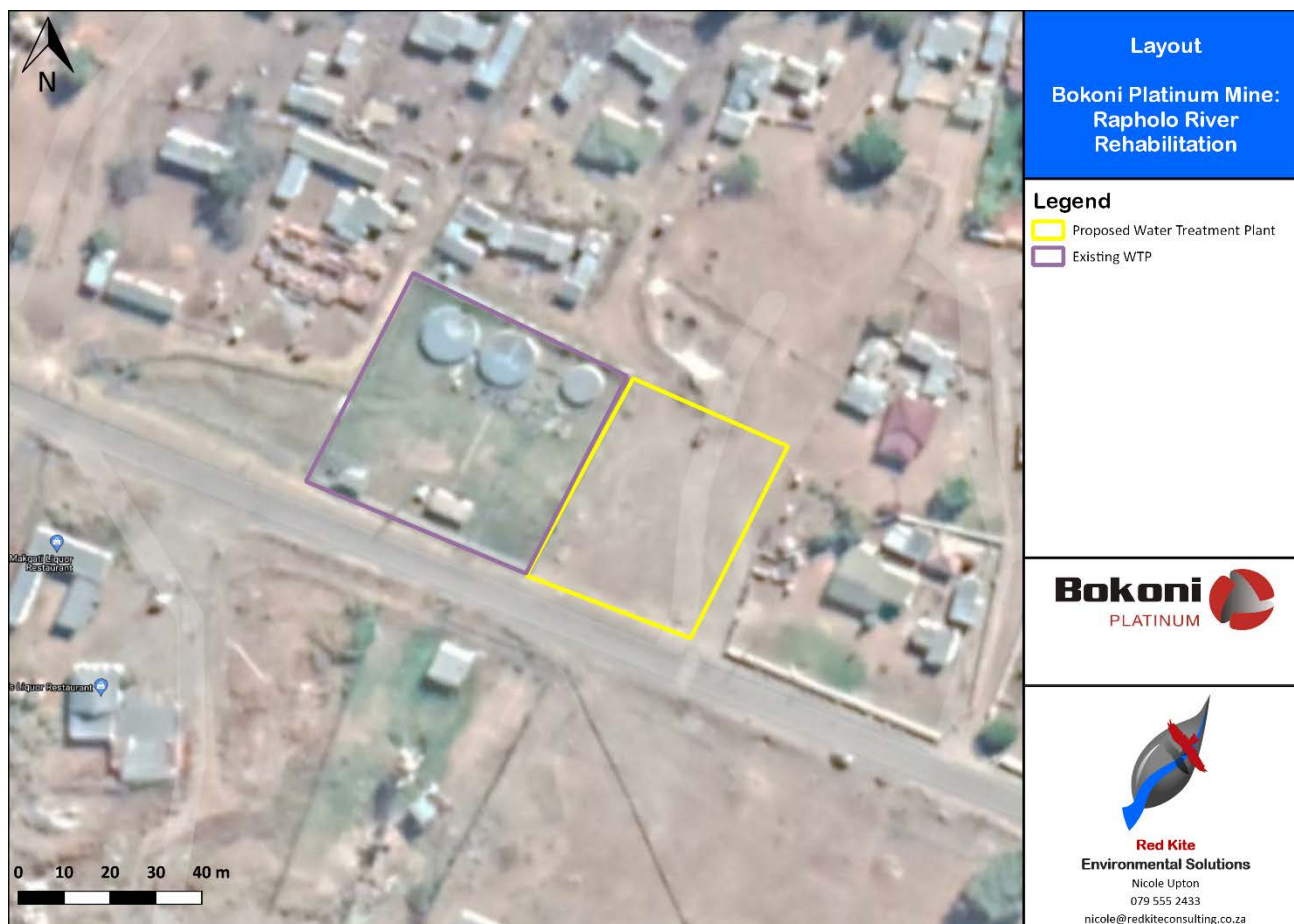
Figure 4: Layout of proposed and existing Water Treatment Plant

The new WTP will be constructed adjacent to the existing Bokoni Platinum Mines Merensky WTP. The proposed WTP site has been transformed by adjacent community activities and currently consists of bare soil with no indigenous vegetation remaining on the proposed WTP footprint. Refer to Figure 4.

The new WTP will be constructed adjacent to the existing Bokoni Platinum Mines Merensky WTP, thereby connecting and utilising the existing infrastructure. The proposed WTP site has been transformed by adjacent community activities and currently consists of bare soil with no indigenous vegetation remaining on the proposed WTP footprint. Thus, no additional ecological disturbances will take place. Refer to Figure 4 and photos below.

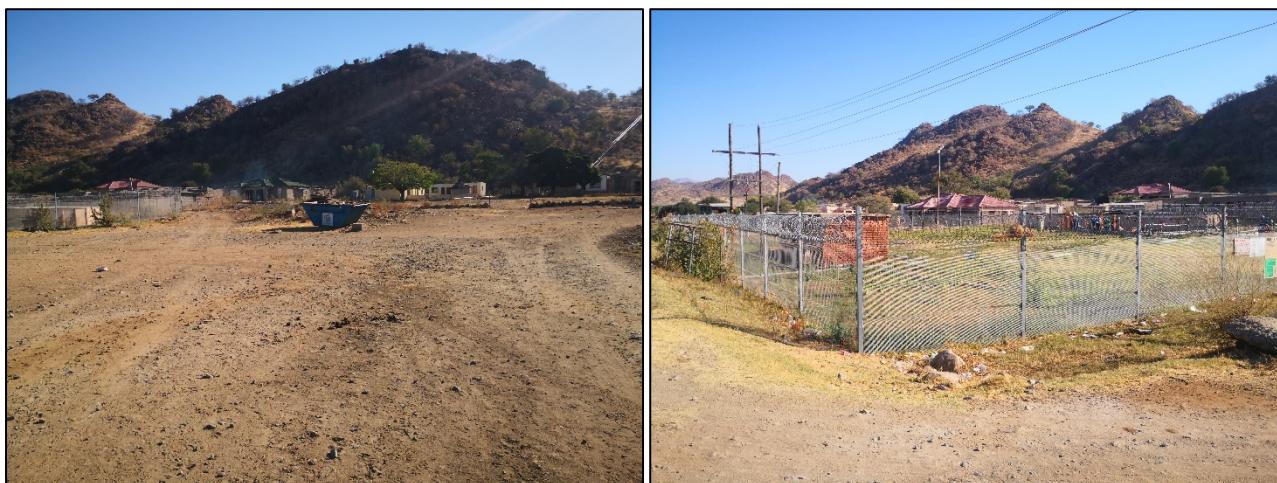
Figure 6: (left) proposed site for new WTP; (right) existing WTP adjacent to new WTP site

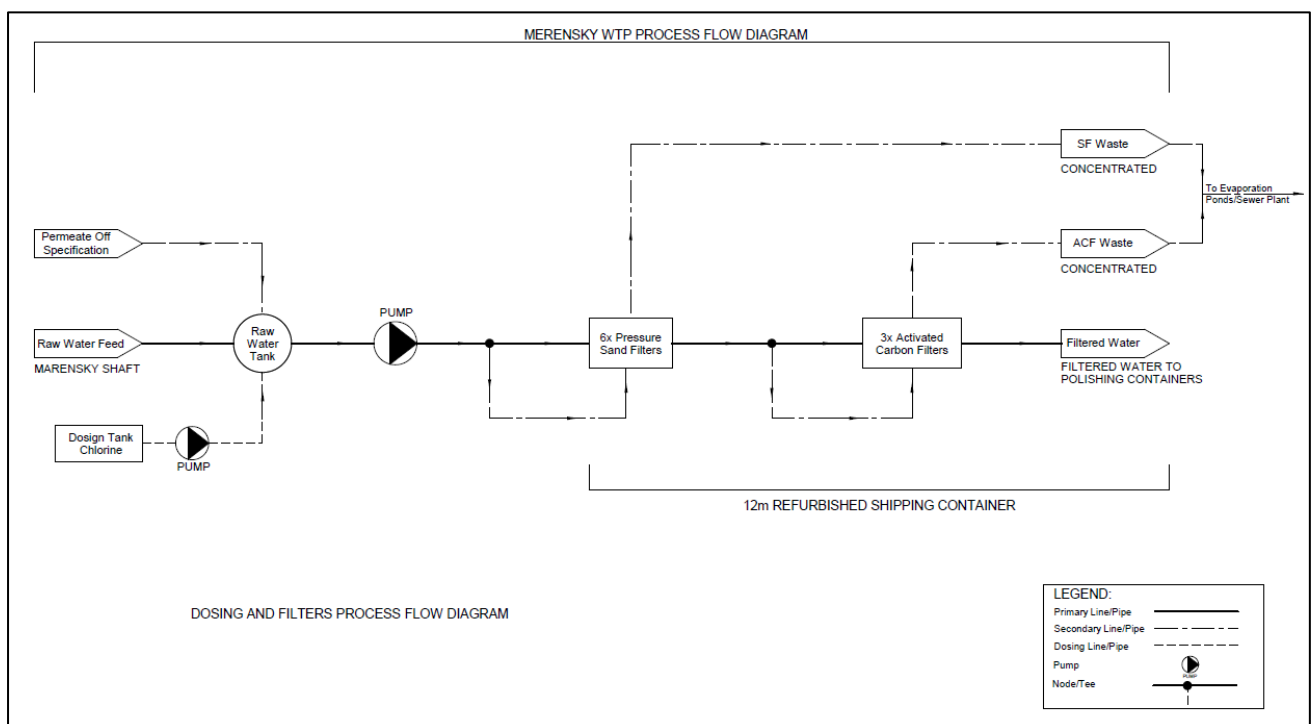
Figure 8: Proposed Water Treatment Plant design diagram (2)

Refer to Appendix 7 for the design report of the proposed WTP.

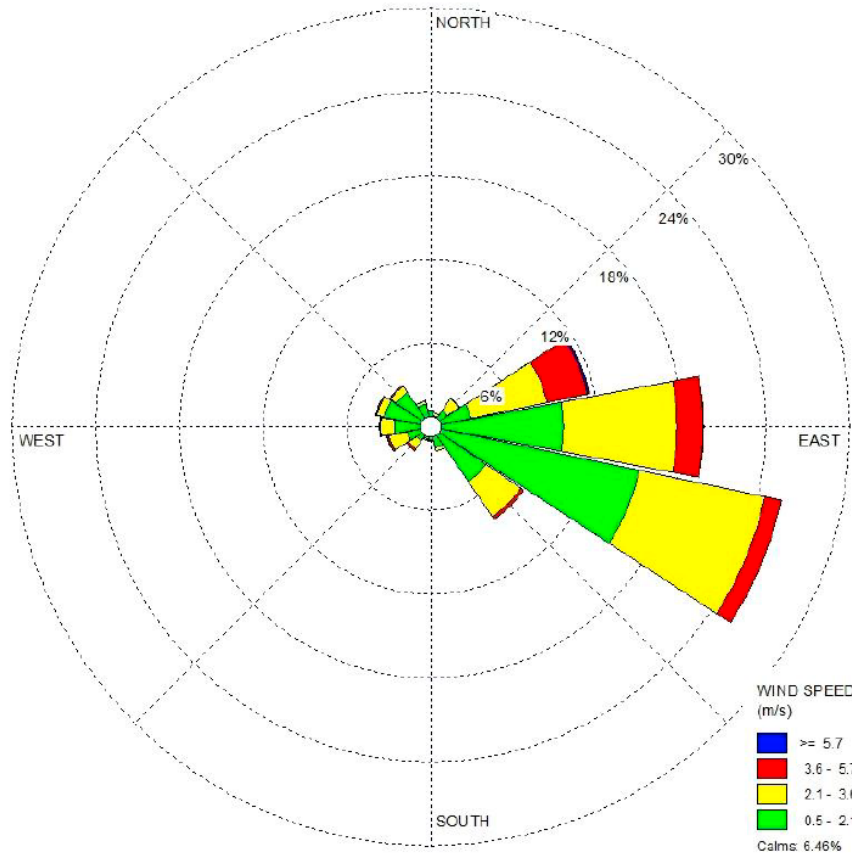
Regionally the daytime winds are normally south-westerly, changing to northerly between the hours of 00:00 and 06:00. Distinct seasonal patterns are observed with northerly winds prevailing in winter, and south-westerly and westerly winds in the summer months. Wind speeds decrease from 3.7 m.s⁻¹ in summer to 3.3 m. s⁻¹ in winter, and are generally light to moderate, annually averaging below 3.5 m.s⁻¹.

Figure 9: BPM wind rose

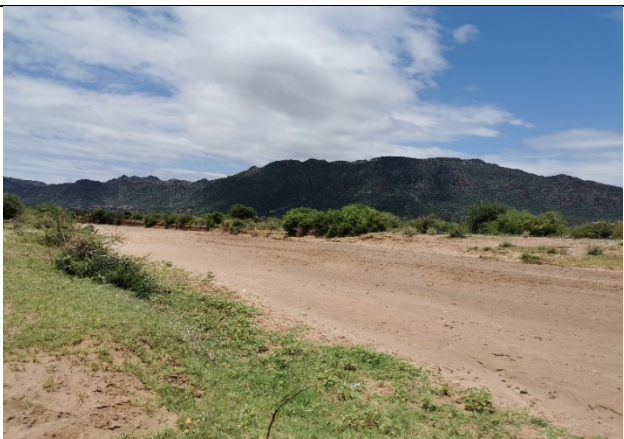
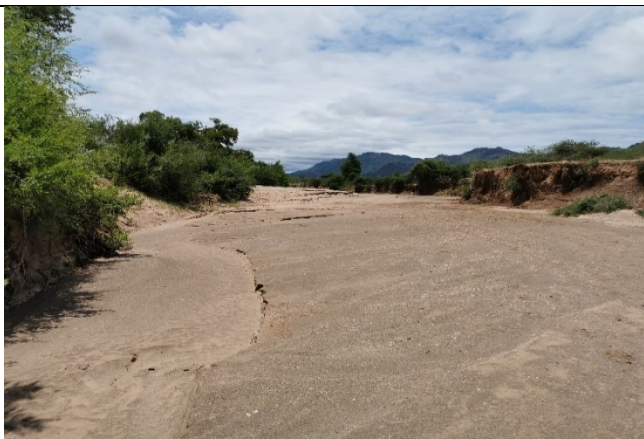
Upstream Point US located in the Rapholo River

<i>Upstream photograph at sampling point</i>		<i>Downstream photograph of sampling point</i>	
Site Description		Most upstream point in tributary. Flow was absent, no water visible although recent rains had occurred. Erosion prevalent River well incised.	
Impacts on the water environment observed		Anthropogenic disturbances associated with easy access.	
GPS		24°18'30.11"S 29°53'26.20"E	
Reference PES as per SQR		Class E: Severely Modified	
RQOs to be achieved		Class C: Moderately Modified (2016 /2017 DHSWS Gazetted)	
High Flow 2020	SASS Score	No of Taxa	ASPT
SASS 5 Results	N/A	N/A	N/A

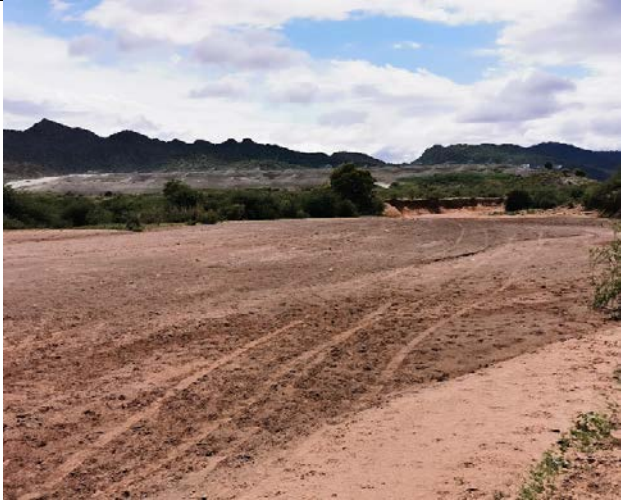
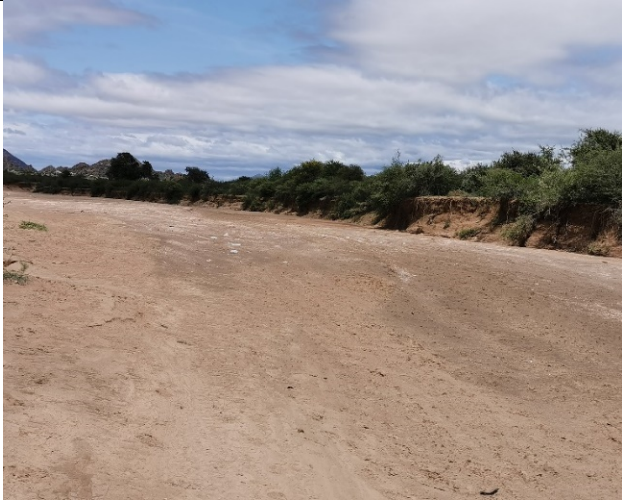
Mid-Stream (MS) located in the Rapholo River

<i>Upstream photograph at sampling point</i>		<i>Downstream photograph of sampling point</i>	
Site Description		Middle section of the area assessed. Flow was absent, no water visible although recent rains had occurred. Erosion prevalent and clear movement within the river based on the tracks and vehicle tracks present in the riverbed. River well incised.	
Impacts on the water environment observed		Anthropogenic disturbances associated with easy access.	
GPS		24°18'13.42"S 29°52'48.73"E	
Reference PES as per SQR		Class E: Severely Modified	
RQOs to be achieved		Class C: Moderately Modified (2016 /2017 DHSWS Gazetted)	
High Flow 2020	SASS Score	No of Taxa	ASPT
SASS 5 Results	N/A	N/A	N/A

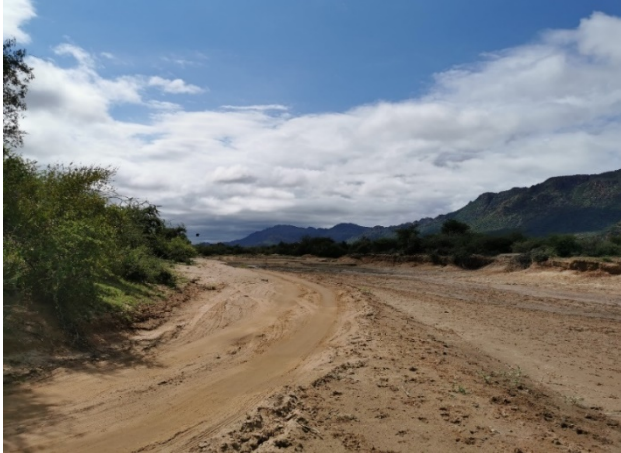
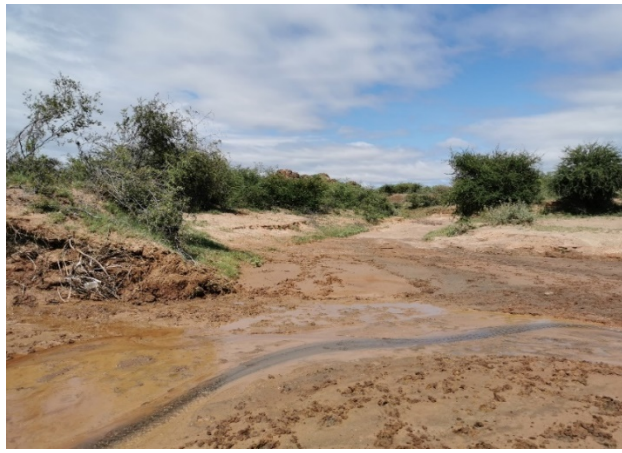
Downstream Points - DS

<i>Upstream photograph at sampling point</i>		<i>Downstream photograph of sampling point</i>	
Site Description		Site consisted of area which showed recent flow since a small very shallow section of flow (almost similar to sheet flow) was present.	
Impacts on the water environment observed		Motor vehicle waste related substances and spills. Anthropogenic disturbances, litter and waste since vehicles were found to drive inside the riverbed.	
GPS		24°17'45.71"S 29°51'49.91"E	
Reference PES as per SQR		Class E: Severely Modified	
RQOs to be achieved		Class C: Moderately Modified (2016 /2017 DHSWS Gazetted)	
High Flow 2020	SASS Score	No of Taxa	ASPT
SASS 5 Results	N/A	N/A	N/A
