*Geotechnical Investigation Report – Onkweni Filling Station
ULundi Local Municipality Zululand District Municipality, KwaZulu Natal*

oNkweni Filling Station

Geotechnical Investigation Report
December 2018

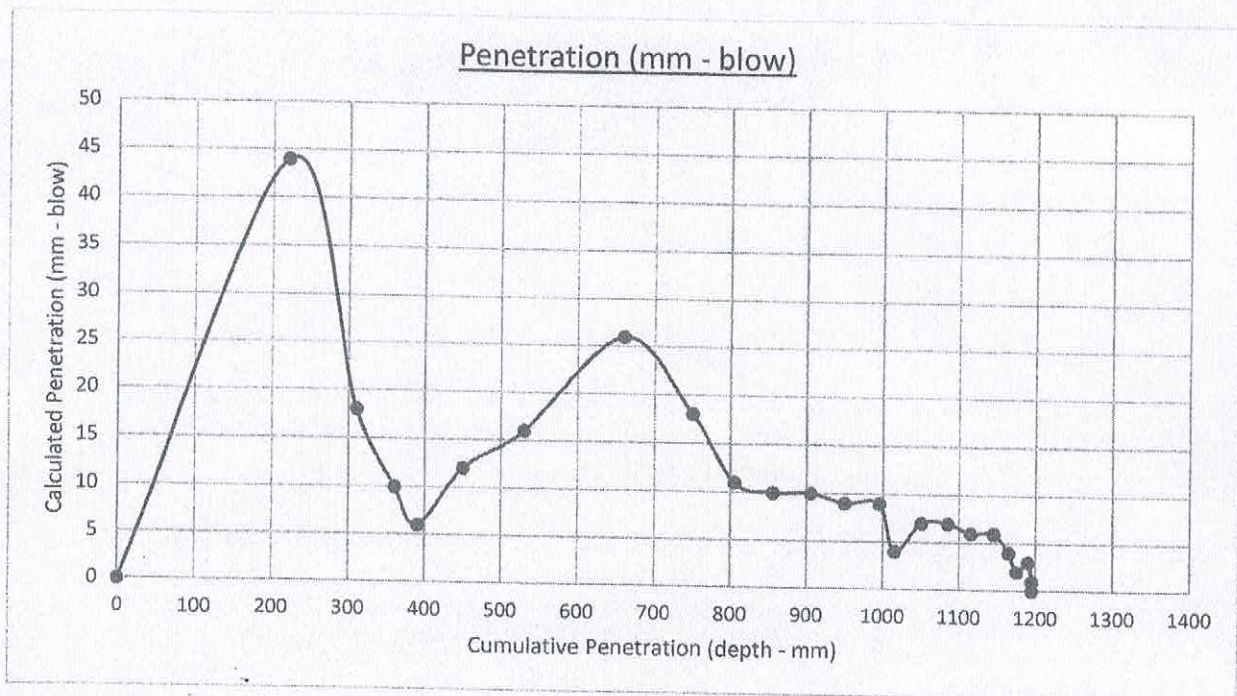
Client : Sphamandla Zulu
 Project : Onkweni Filling Station
 Position/ Km: TP1

Remarks: The above DCP test shows that the DCP had no difficulty when penetrating through the top layers. Between the depth of 0 - 995mm the layers are soft and this is indicated by the averagely high penetration (depth-mm) readings obtained. Between the depth of 995mm - 1195mm the layer is slightly compact and this is indicated by the averagely low penetration (depth-mm) readings obtained. At the depth of 1195mm the DCP refused to penetrate any further due to hard material encountered.

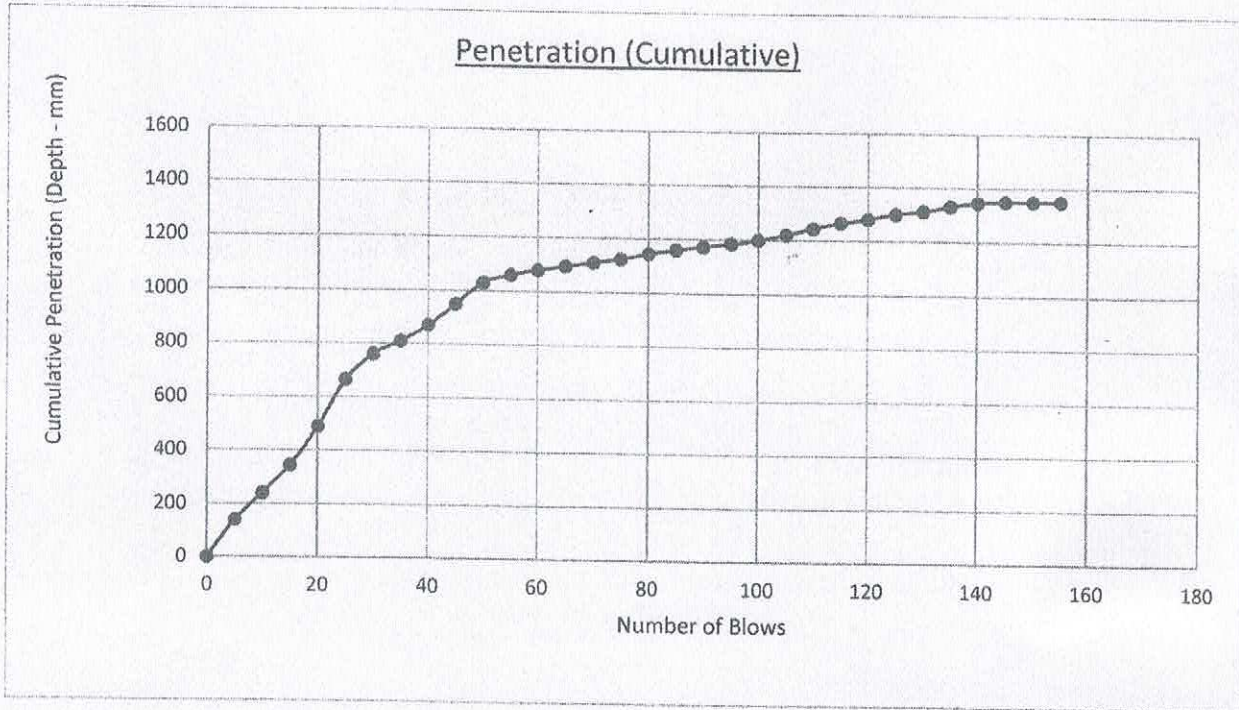
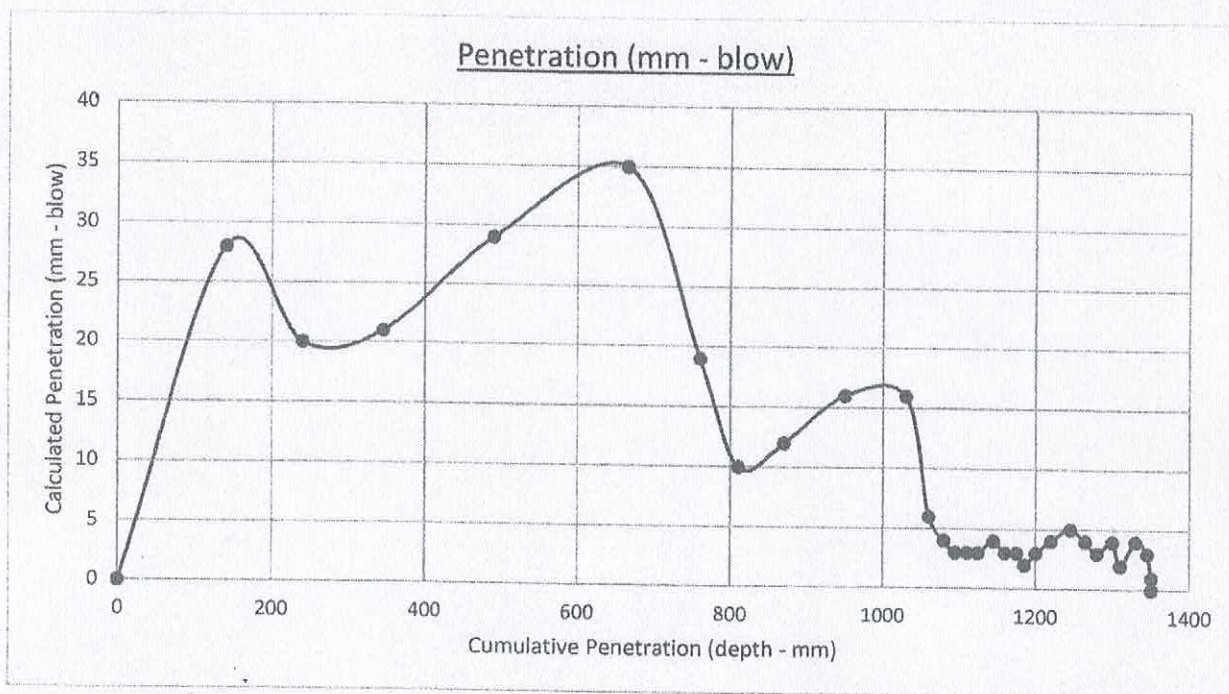
Client : Sphamandla Zulu
 Project : Onkwini Filling Station
 Position/ Km: TP2

Remarks: The above DCP test shows that the DCP had no difficulty when penetrating through the top layers. Between the depth of 0 - 1030mm the layers are soft and this is indicated by the high penetration (depth-mm) readings obtained. Between the depth of 1030mm - 1350mm the layers are somewhat compact and this is indicated by the low penetration (depth-mm) readings obtained. At the depth of 1350mm the DCP refused to penetrate any further due to hard material encountered.

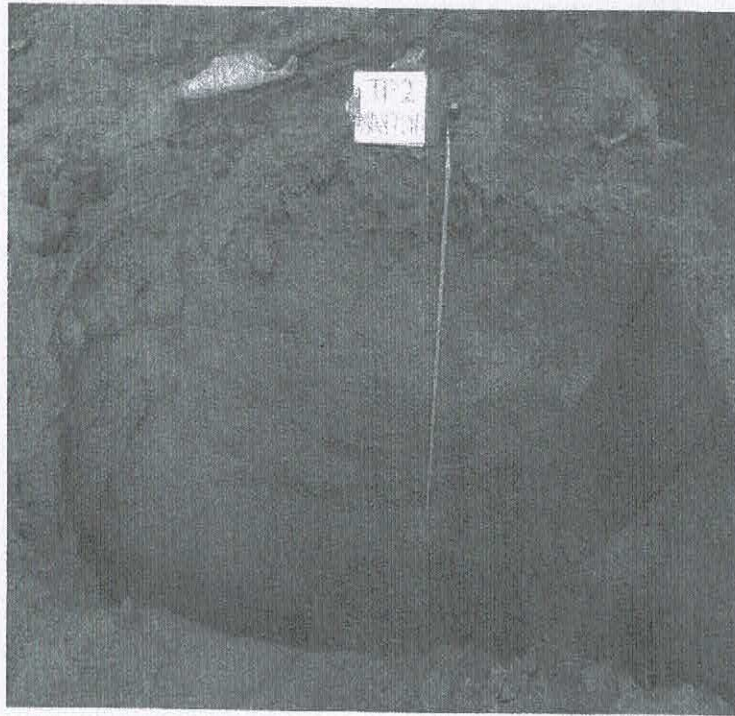
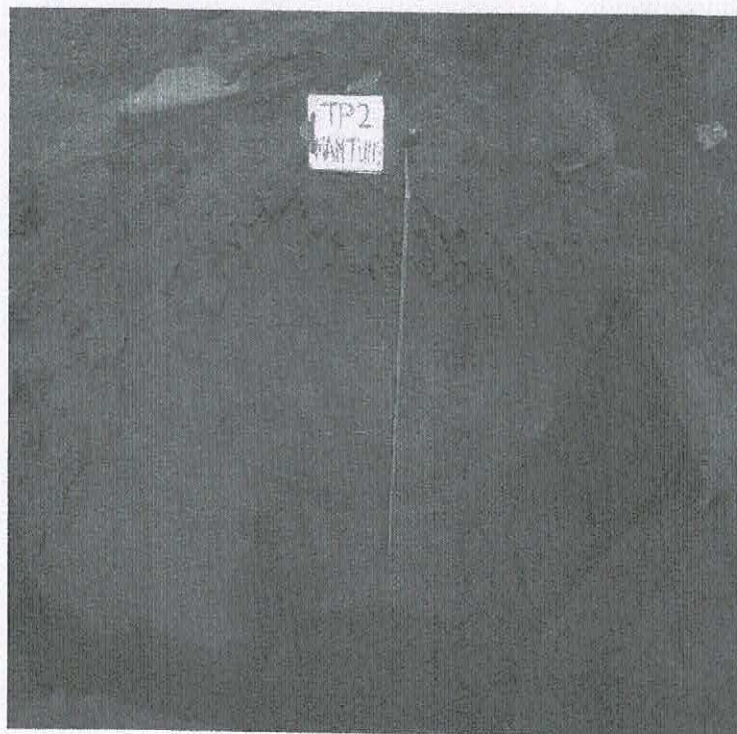
TRIAL PIT 2

At the time of the investigation, subsurface water seepage was not encountered in any of the Trial Pits. Moist conditions were prevalent on the two trial pits. (Refer to Annexure A & D)

Soil Legend	Depth (mm)	Description	Origin (Residual & Transported)
		Moisture, Colour, Consistency, Structure, Soil Type (MCCSSO)	
V V	0 - 400	Moist, Dark Grey, Firm, Soft, Top Soil	Residual
⊙ ⊙ ⊙ ⊙ ⊙ ⊙ ~~~~~ ⊙ ⊙ ⊙ ⊙ ⊙ ⊙ ~~~~~ ⊙ ⊙ ⊙ ⊙ ⊙ ⊙ ~~~~~	400 - 900	Moist, Light Grey, Firm, Soft, Sandy Gravel	Residual
XXXXXXXXXXXXX XXXXXXXXXXXXX XXXXXXXXXXXXX XXXXXXXXXXXXX XXXXXXXXXXXXX XXXXXXXXXXXXX XXXXXXXXXXXXX XXXXXXXXXXXXX XXXXXXXXXXXXX XXXXXXXXXXXXX XXXXXXXXXXXXX XXXXXXXXXXXXX XXXXXXXXXXXXX XXXXXXXXXXXXX XXXXXXXXXXXXX XXXXXXXXXXXXX	900 - 1600	Moist, Dark Grey Red, Firm, Hard, Laterite	Residual
¥ ¥ ¥ ¥ ¥ ¥ ¥ ¥ ¥ ¥ ¥ ¥	1600 - 1700	Moist, Dark Brown, Firm, Hard, Shale	Residual
¥ ¥ ¥ ¥ ¥ ¥ ¥ ¥ ¥ ¥ ¥ ¥	1700>	Hard, Shale	Residual

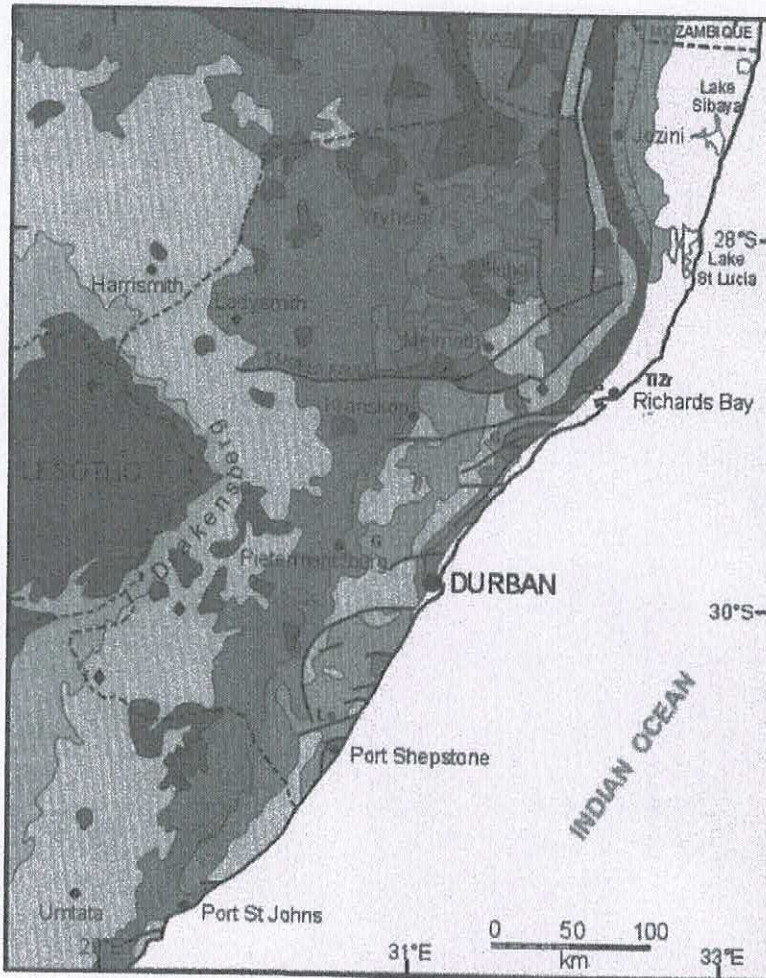
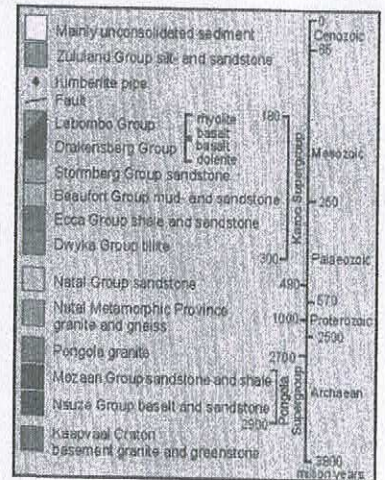
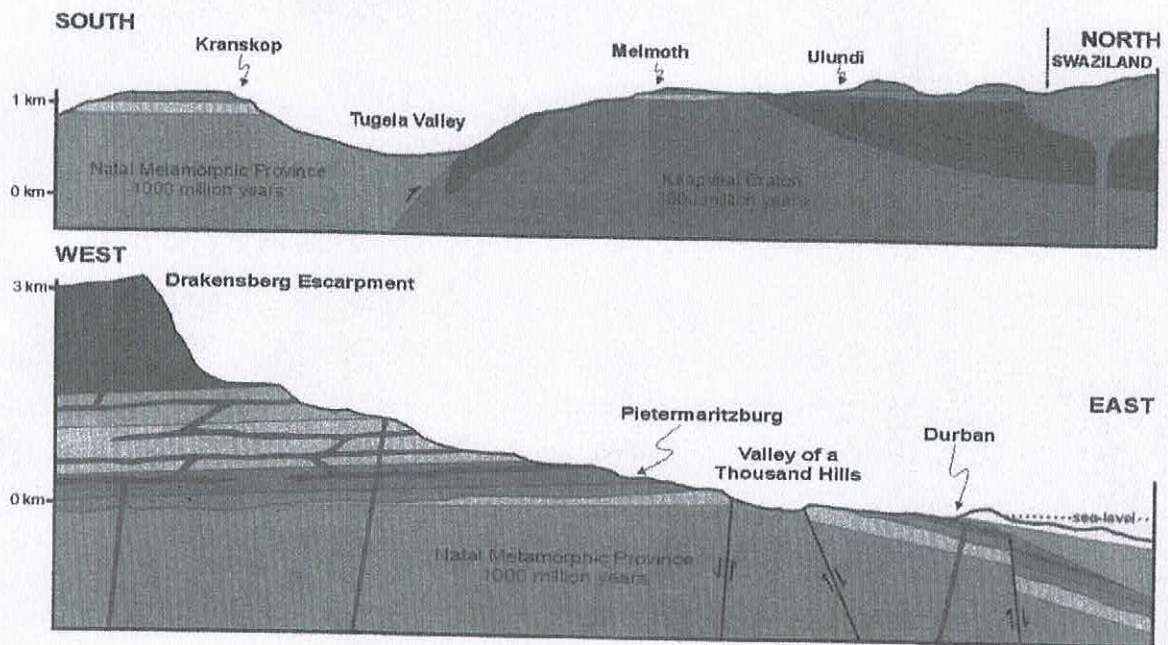
ANNEXURE F
GEOLOGICAL MAP

According to the 2731 CD St. Lucia, 1:250 000 Geological Map Series, the general area within which the site is located is underlain by sandstone, shale, siltstone and dolerite sediments. From the available literature as well as the observations during the site investigation, it is apparent that the area is underlain by sandstone, shale and siltstone that belong to the Karoo Supergroup that is estimated to be 180 – 300 million years.

Traces of sandy laterite were also found during the investigation. Laterites are formed from the leaching of parent sedimentary rock sandstones. A simplified geological map has been attached as Annexure F.
