DE CASTRO & BRITS
ECOLOGICAL CONSULTANTS

**Watercourse Delineation and Assessment Study for Proposed New
Mining Infrastructure on the Farms Frischgewaagd and Mimosa,
North West Province**

March 2016

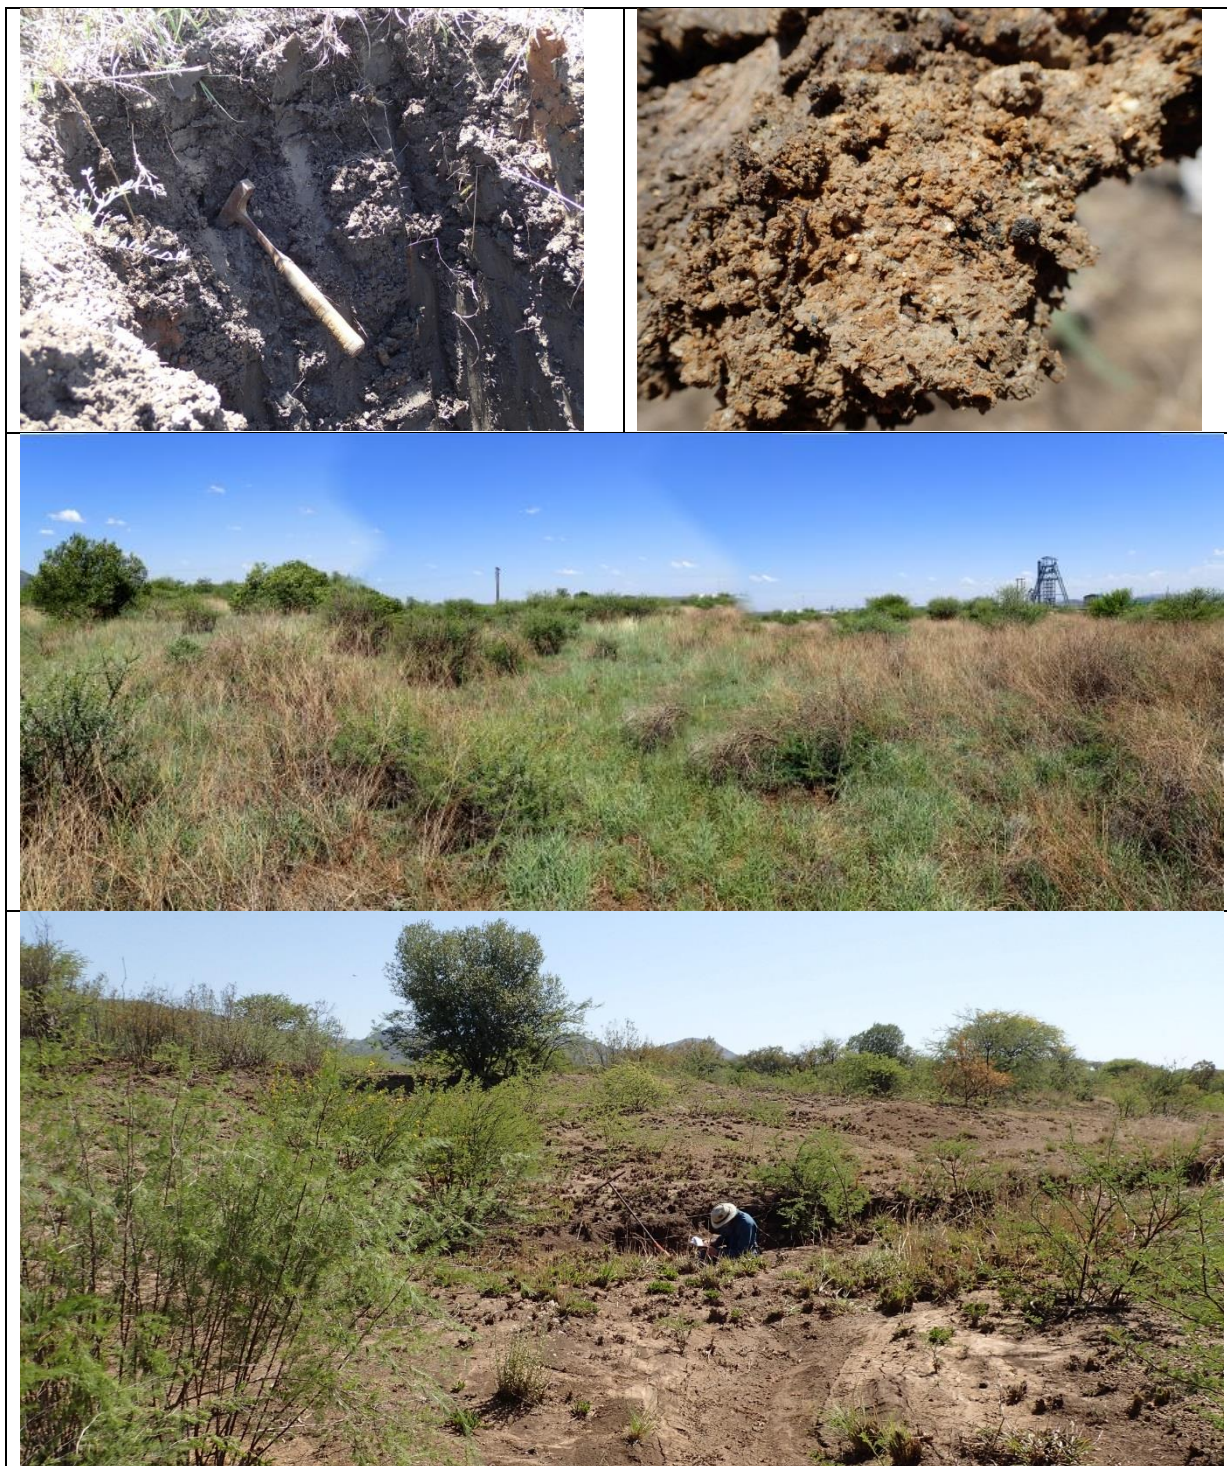
Figure 6: Illustrates the following features in the unchannelled valley bottom wetland: An Arcadia soil form with localised gleying (top left); more pronounced signs of hydromorphism in the wetland in the form of mottling and more extensive gleying (top right); The wetland as it appears in its upstream section with visibly greener vegetation (centre row); & A headcut and discontinuous channel in the downstream portion of the wetland (bottom row).

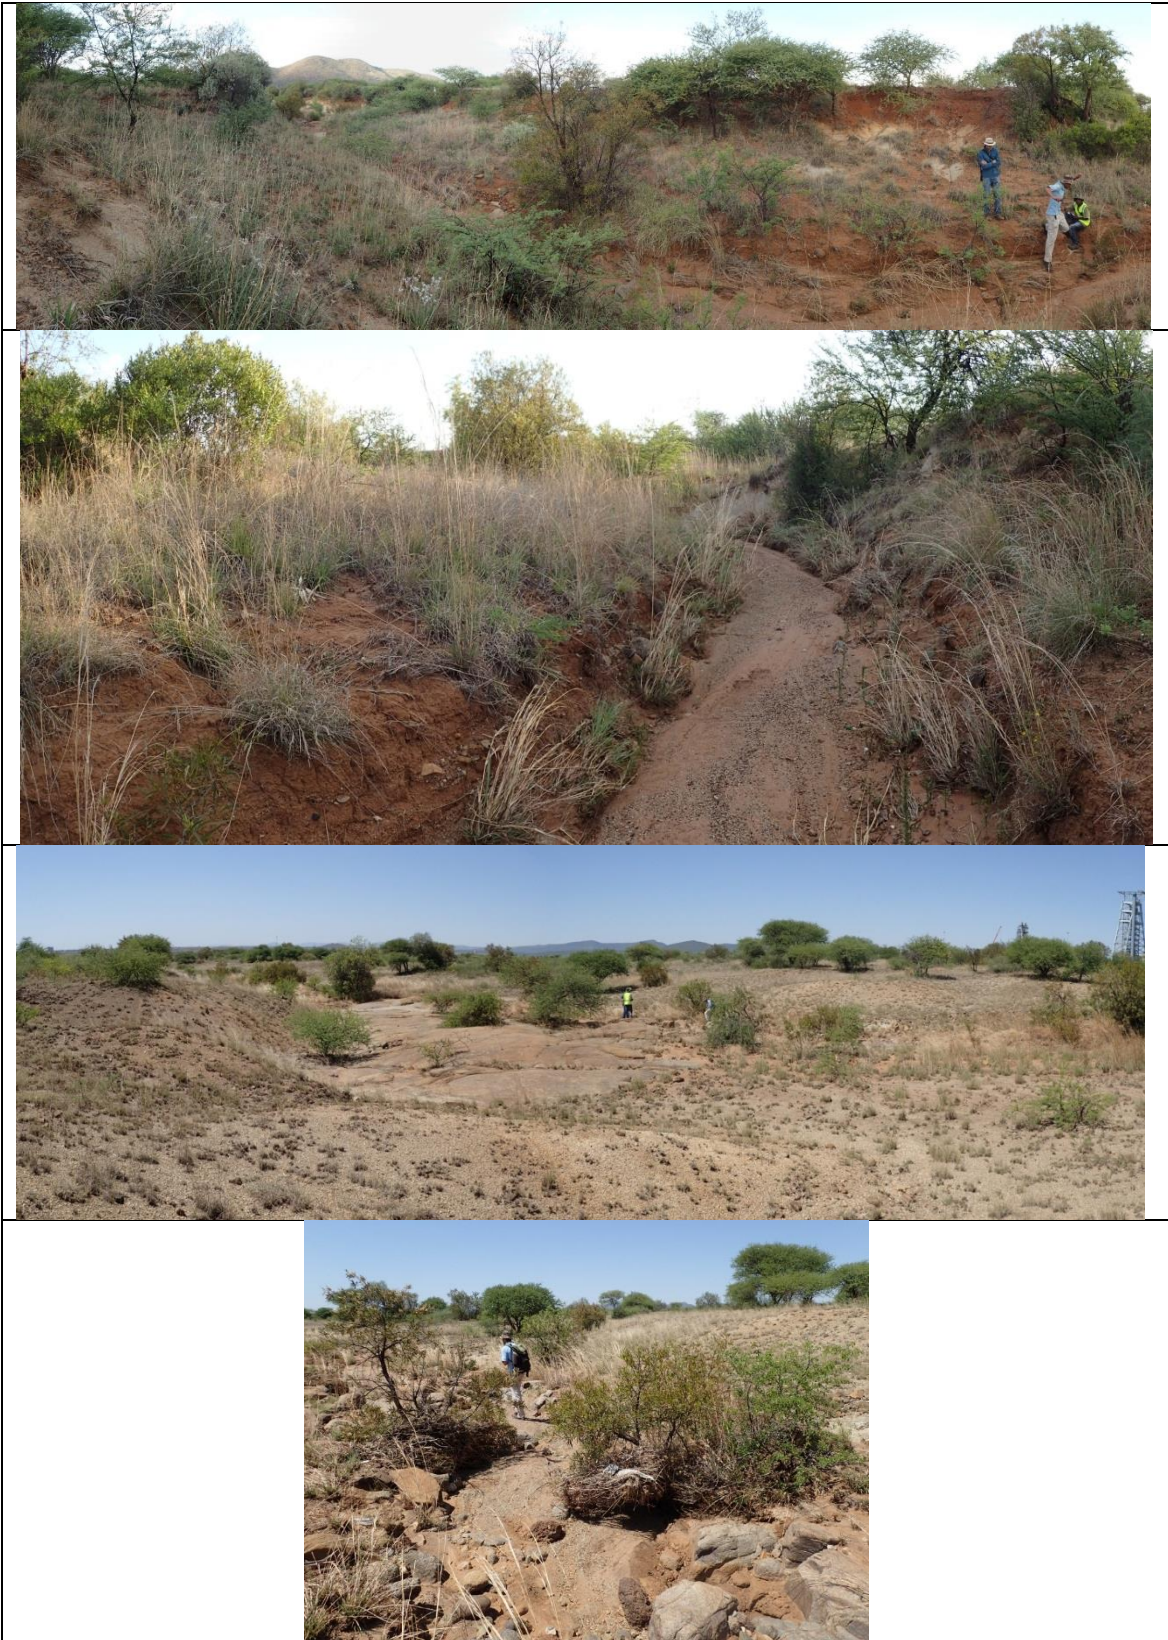
Figure 7: Illustrates the incised and eroded macro channel of Ephemeral channel 2 near the location of the proposed bridge (top) and its active channel with alluvial sands on the surface (second row). Ephemeral channel 2 becomes less incised with gentler sloped channel banks further downstream (third row). Recorded flow features included debris and deposited sand (bottom row).

- Ephemeral channels represent watercourses that contain a natural channel with regular or intermittent flow, based on the definition by the NWA, but generally lack signs of hydromorphism. All delineated ephemeral channel watercourses are illustrated in Figures 3 & 4.
- Alluvial sediment depositions are typically present in the channel bed, which implies that these watercourses are more consistent with the interpretation of riparian systems, even though typical woody riparian species are often present at low densities. The presence of channel banks and bed features along with features that indicate surface flow, such as debris, scour holes and headcut erosion features are regarded as important indicators for ephemeral channels (Figure 7).

- Several of the ephemeral channels are narrow with swale-like to well-defined channels. Ephemeral channel 2 is particularly well-developed with a macro channel that ranges between 30–90m wide and a channel depth of approximately 7–3m (Figures 7 & 8).

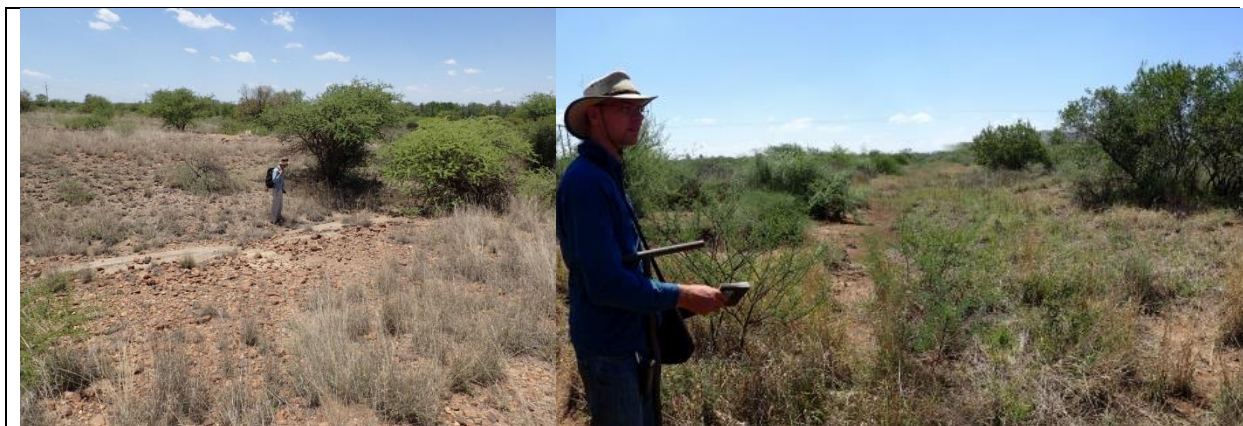
Figure 8: Illustrates other Ephemeral channels with narrow and well defined channels, such as Ephemeral channel 9 (left), while other channels represent broad swales, such as ephemeral channel 3 (right).

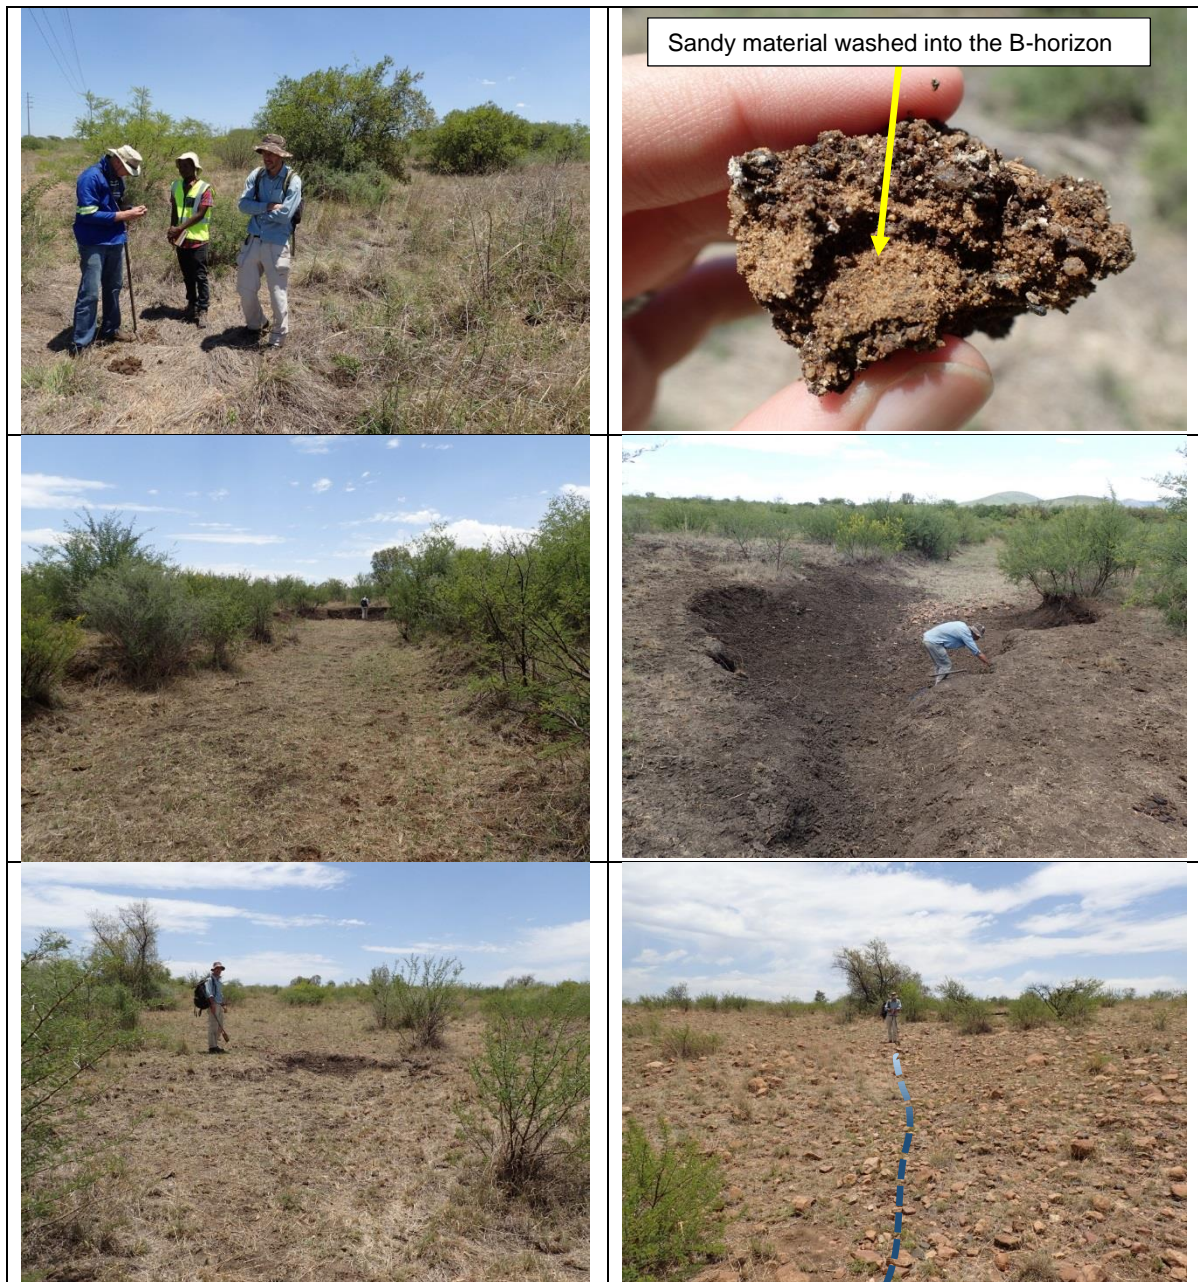
Figure 9: Illustrates Ephemeral drainage line features recorded within the study area: A swale-like channel along Ephemeral drainage line 7 (top left); Alluvial material that has been washed over the underlying Valsrivier soil form in Ephemeral drainage line 7 (top right; De Castro & Brits, 2016b); Distinct headcut and channel features in Ephemeral drainage line 13 (left and right images in the centre row); A smaller headcut in the upper reach of Ephemeral drainage line 13 (bottom left); & An indistinct swale-like channel on a rocky area at the origin of the western arm of Ephemeral channel 13.

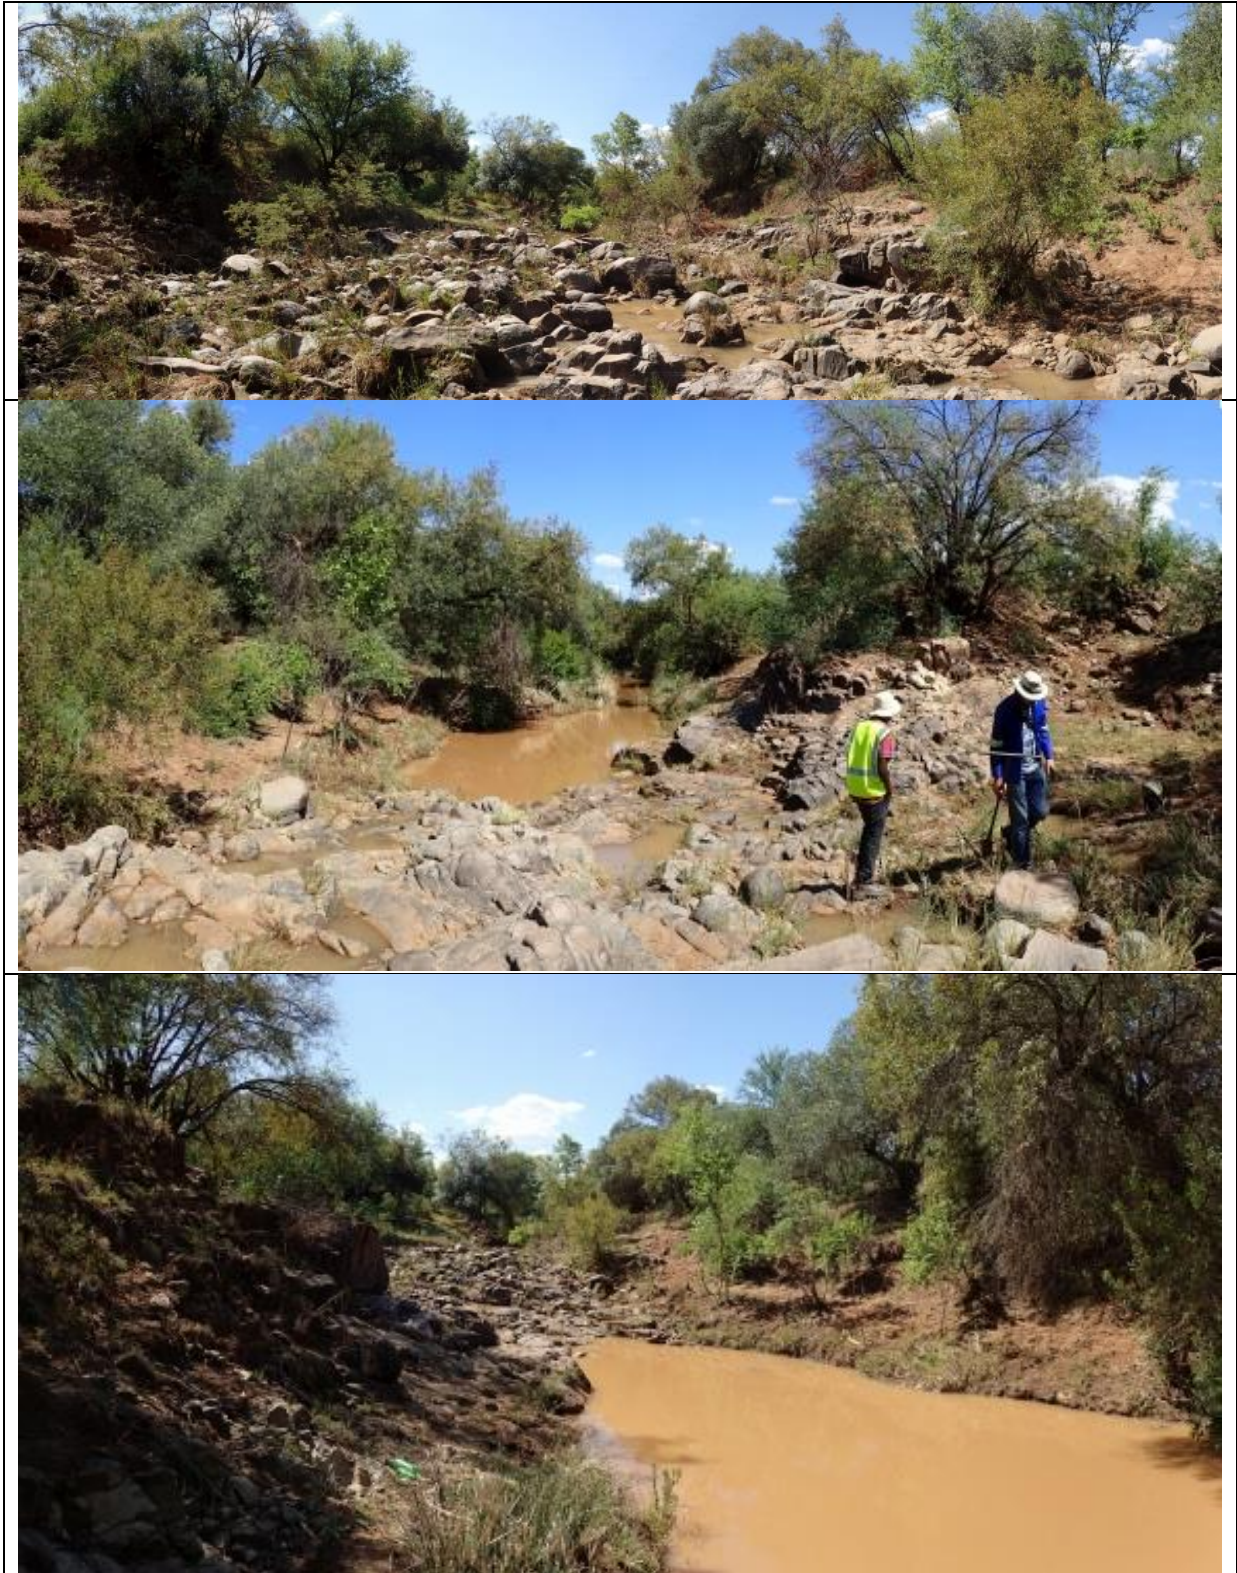
Figure 10: Illustrates different cross sections of the Sandspruit River along the first proposed pipeline alignment (November 2015; Figure 3). Important features include the macro channel with riparian habitat, a narrow strip of the marginal zone on the banks of the active channel, and the active channel. Pools, alluvially transported boulders and bedrock associated with a dolerite dyke across the macro channel are also visible.

The exposed macro-channel bed (between pools) comprises alluvial sands and gravel with scattered to dense alluvial rock cover on the surface (Figure 10). The vegetation comprises herbaceous plant communities dominated by hygrophytic grasses and sedges, which include many alien weeds. Frequent flooding by fast flowing waters largely precludes the establishment of mature trees, but rheophytic shrubs occur scattered on the macro-channel bed. Common shrubs include the rheophytes *Gomphostigma virgatum*, *Salix mucronata*, and the alien *Sesbania punicea*. Dominant grasses and rushes include *Cynodon dactylon* and *Juncus excertus*. Common grasses and sedges include *Agrostis lachnantha*, *Hemarthria altissima*, *Paspalum distichum*, *Cyperus sexangularis* and the alien *Cyperus eragrostis*. Common forbs include *Lobelia thermalis*, and *Pulicaria scabra*, as well as the aliens *Aster squamatus* and *Xanthium strumarium*.

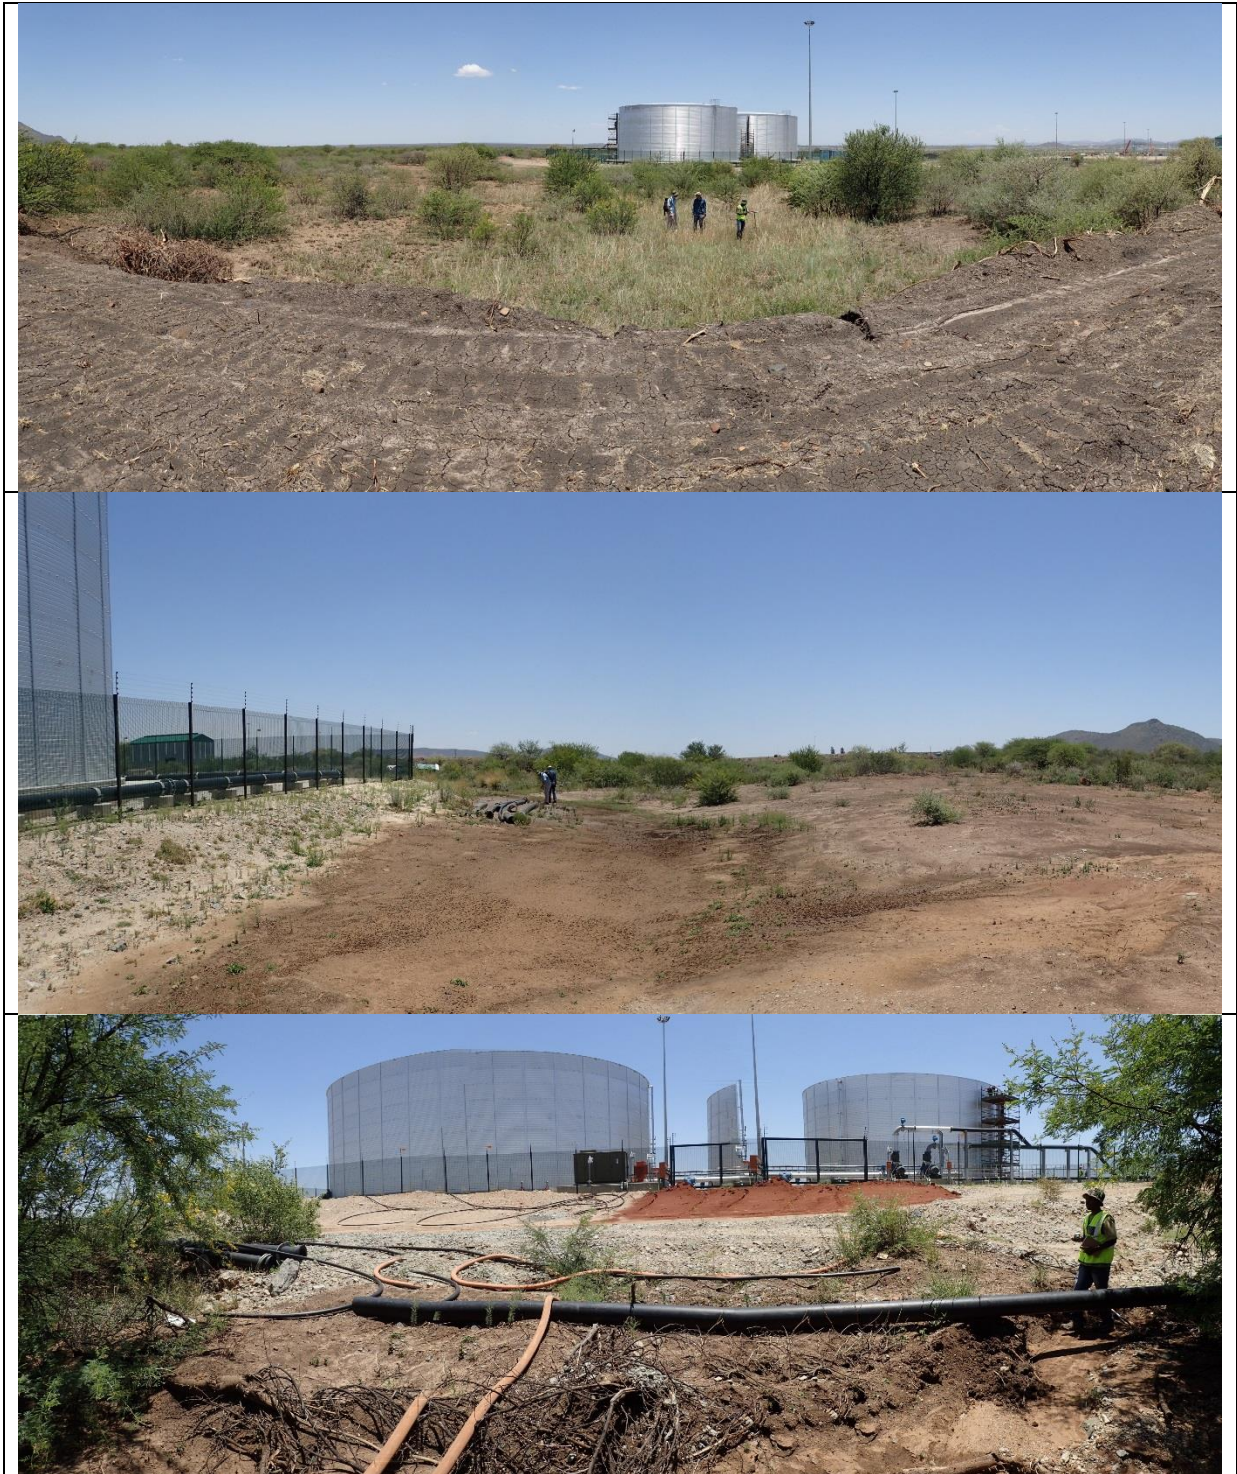
Figure 12: Illustrates existing impacts within Unchannelled valley bottom wetland 1 associated with existing mining infrastructure: A newly created 'noise berm' that bisects the wetland and prevents surface flow (top) (also refer to Figure 3 regarding existing infrastructure in the wetland); A diversion of the flow path of the wetland around steel tower infrastructure (centre) (also refer to Figure 3); & Channel development in the wetland downstream of the flow path diversion (bottom).
