**ECOLOGICAL ASSESSMENT OF THE AQUATIC  
RESOURCES IN THE VICINITY OF THE PROPOSED  
TAILINGS PIPELINE, ROAD CROSSING AND BERM  
CONSTRUCTION FOR THE BAKUBUNG PLATINUM MINE**

**SLR Consulting**

**Prepared by:** Scientific Aquatic Services  
**Report author:** L. Jonker  
**Report reviewer:** S. van Staden (Pr. Sci. Nat.)  
**Report Reference:** SAS 215322  
**Date:** December 2015

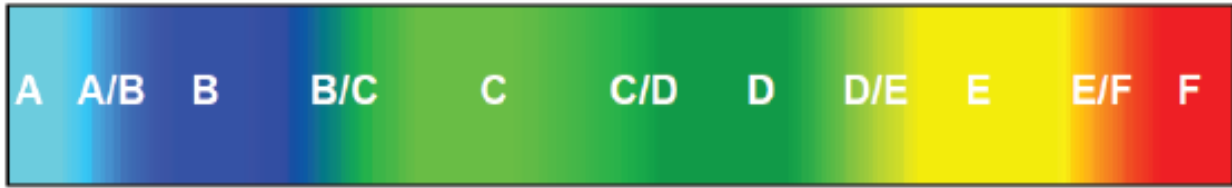
**Figure 2: Ecological Categories (ECat) eco-status A to F continuum approach employed (Kleynhans and Louw 2007)**

The Ecological Category (ECat) classification for each aspect of ecology and habitat analysis will be employed using the eco-status A to F continuum approach (Kleynhans and Louw 2007) where applicable. This approach allows for boundary categories denoted as B/C, C/D etc., as illustrated in Figure 2.

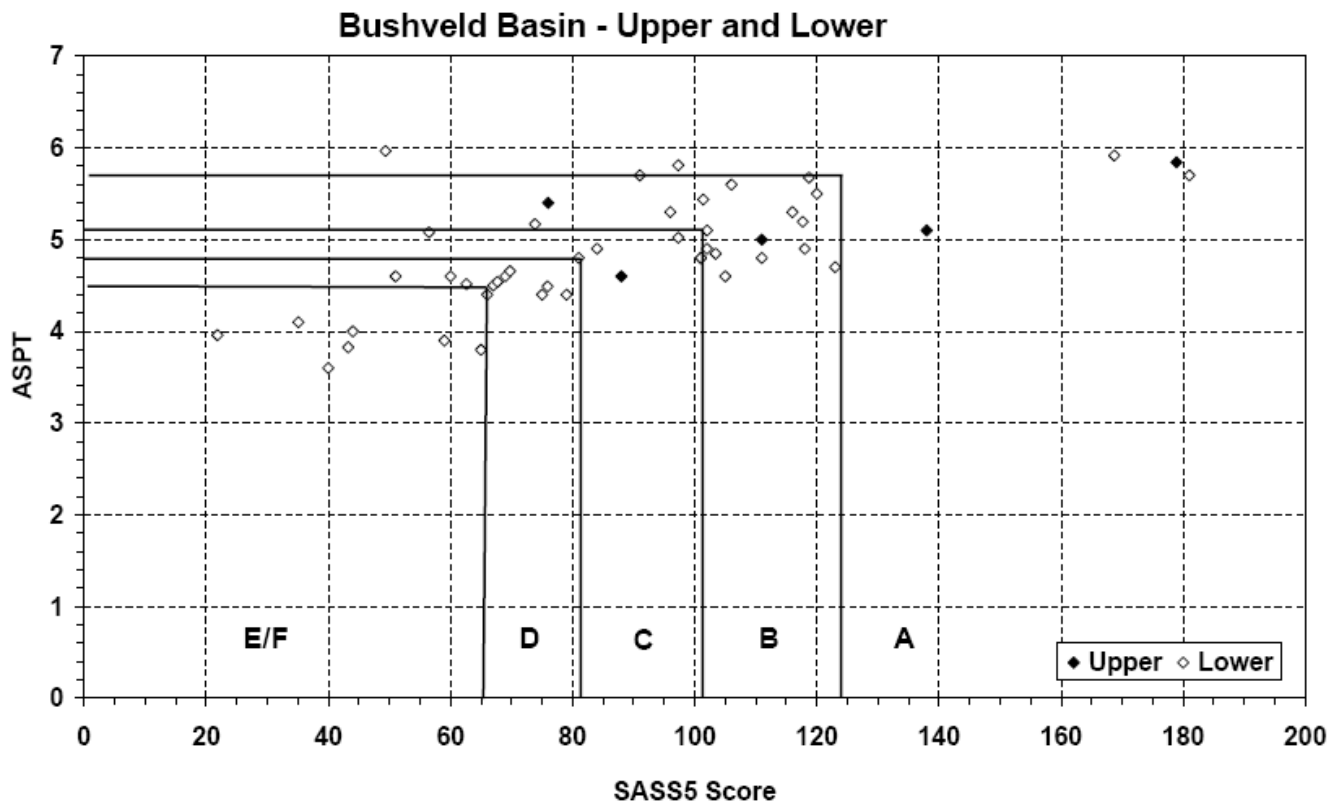
Figure 3: Biological Bands for the Bushveld basin – Upper and Lower zones, calculated using percentiles

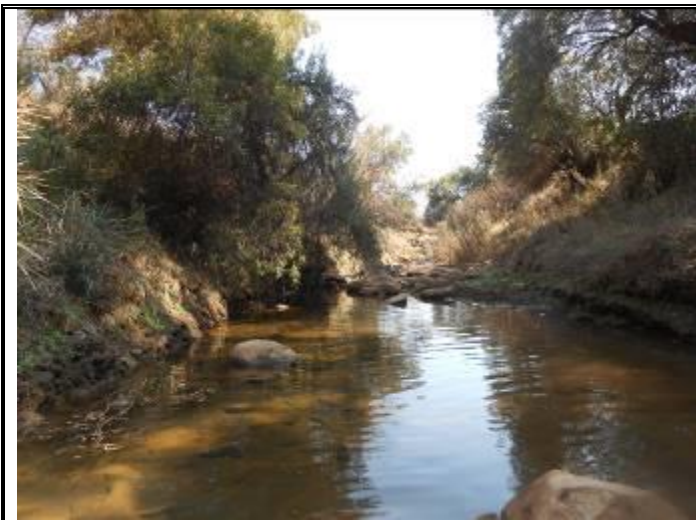
Figure 5: Upstream view of the Bak1 site on the Sandspruit.

- Habitat conditions at both sites of the Sandspruit (Bak1 and Bak2) can be regarded as inadequate for supporting a diverse and sensitive aquatic macro-invertebrate community. This is due to the lack of strong flowing water and the absence of marginal vegetation due to the incised nature of the stream;

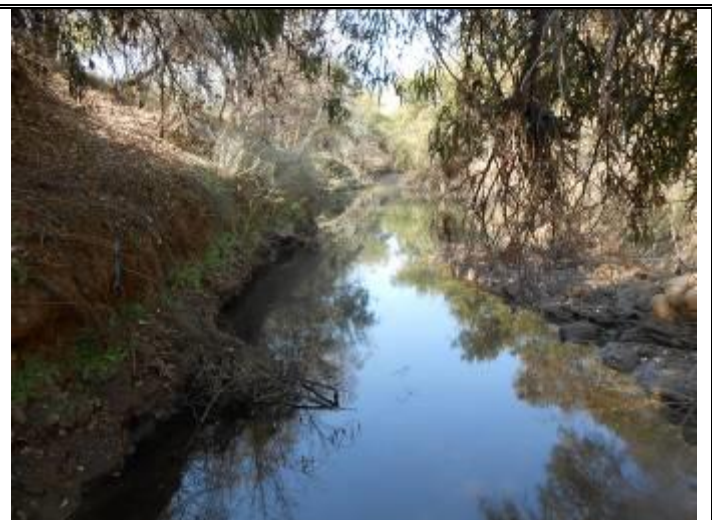
Figure 6: Downstream view of the Bak1 site on the Sandspruit.

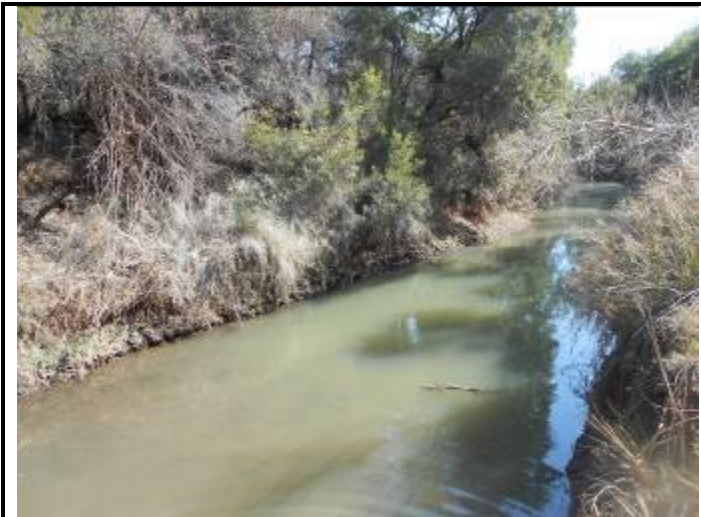
**Figure 7: Upstream view of the Bak2 site on the Sandspruit.**

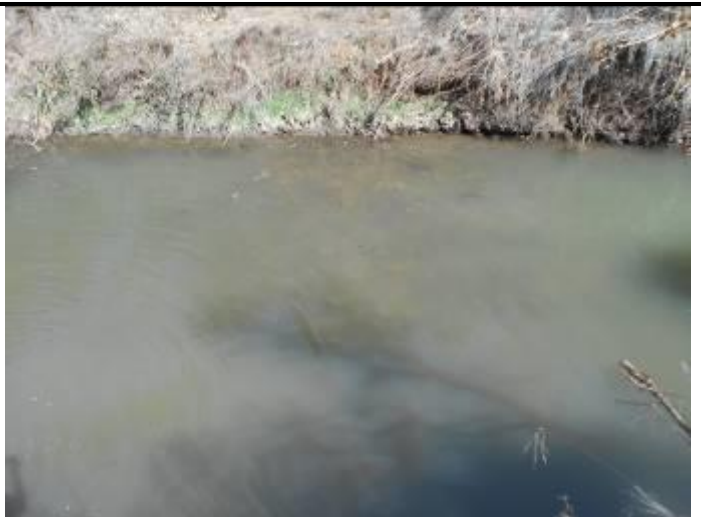
**Figure 8: Local view of the Bak2 site on the Sandspruit.**

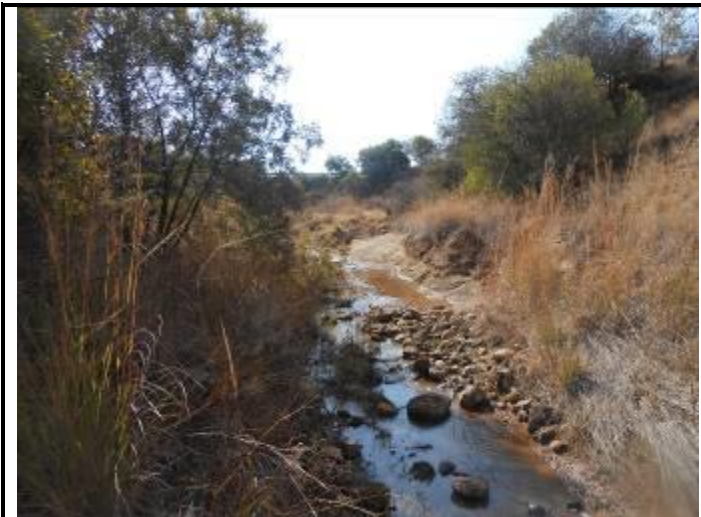
**Figure 9: Upstream view of the Bak3 site on the unnamed tributary.**

- Habitat conditions at the upstream site (Bak3) of the unnamed tributary can be regarded as inadequate for supporting a diverse and sensitive aquatic macro-invertebrate community while the downstream site (Bak4) can be regarded as adequate. The inadequate IHAS score at site Bak3 is due to the sedimentation present at the site as a result of the collapsed road crossing further upstream in the system;

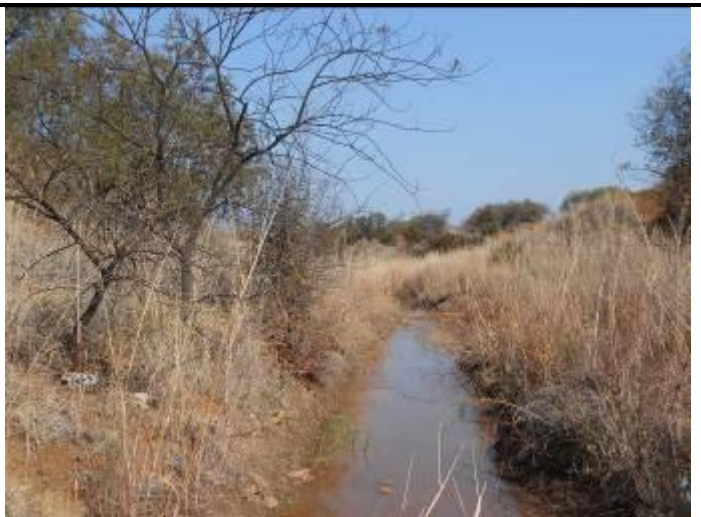
**Figure 10: Downstream view of the Bak3 site on the unnamed tributary.**

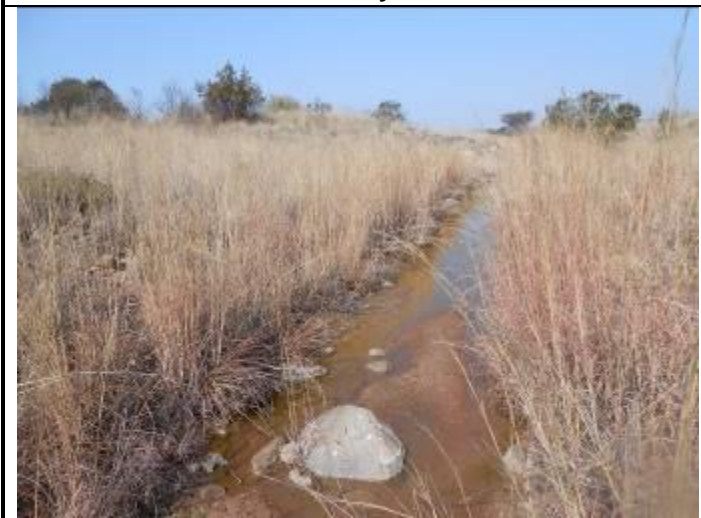
**Figure 11: Upstream view of the Bak4 site on the unnamed tributary.**

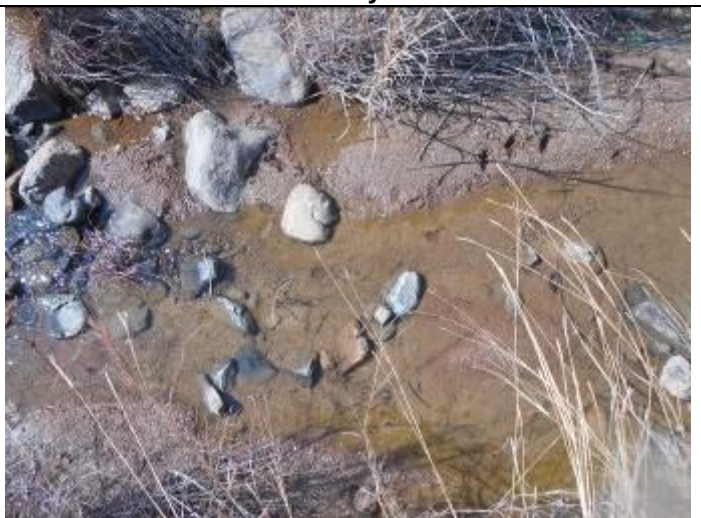
**Figure 12: Local view of the Bak4 site on the unnamed tributary.**

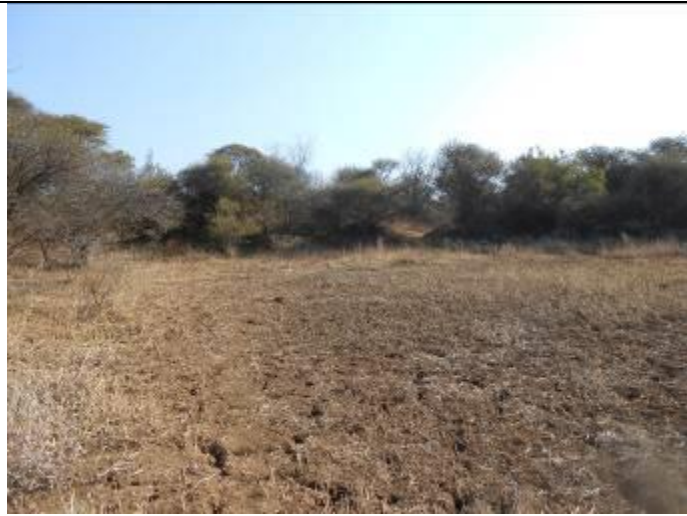
Figure 13: Local view of the pan (Bak5) at the time of the assessment.

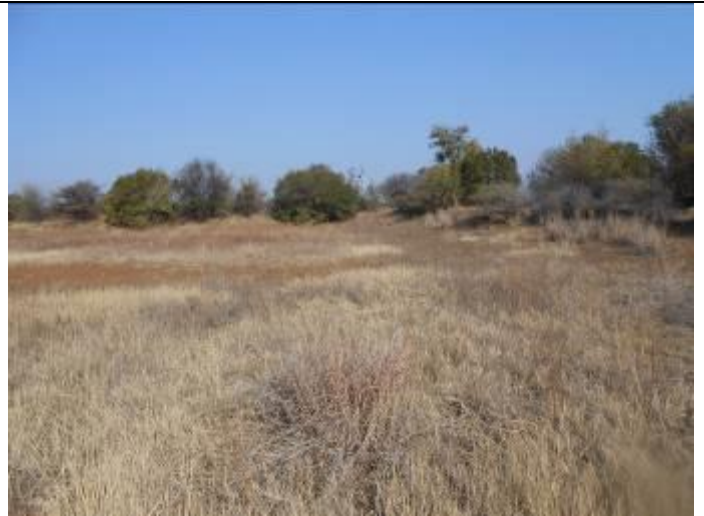
Figure 14: Local view of the pan (Bak5) at the time of the assessment.

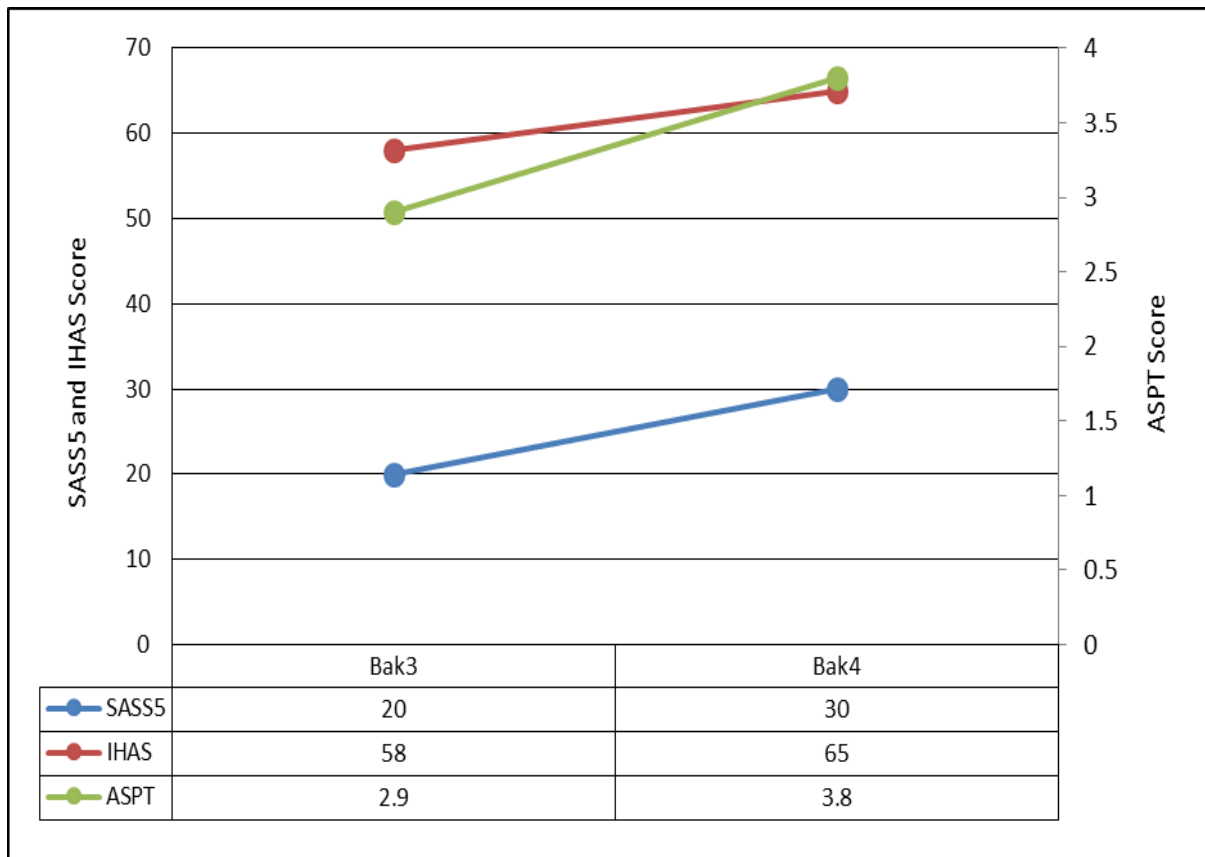
Figure 19: SASS and IHAS score variation between the upstream and downstream sites located on the unnamed tributary of the Elands River.

- Spatially, the SASS5 score of the unnamed tributary increases significantly in a downstream direction between the Bak3 and Bak4 sites by 50.0%, while the ASPT score increased by 12.1%. This is likely as a result of the improved habitat conditions and the slight decrease of EC at the downstream Bak4 site; and

Parameter	The Sandspruit (Bak1 and Bak2)	The Unnamed Tributary (Bak3 and Bak4)
SASS5 Score	+2.6%	+50.0%
ASPT Score	-7.7%	+12.1%
IHAS Score	-8.3%	+31.0%
