BASIC ASSESSMENT REPORT

DEPARTMENT OF ECONOMIC AFFAIRS, ENVIRONMENT AND TOURISM, PROVINCE OF THE EASTERN CAPE

D1: GEOLOGICAL, HYDROLOGICAL & GEOHYDROLOGICAL ASSESSMENT

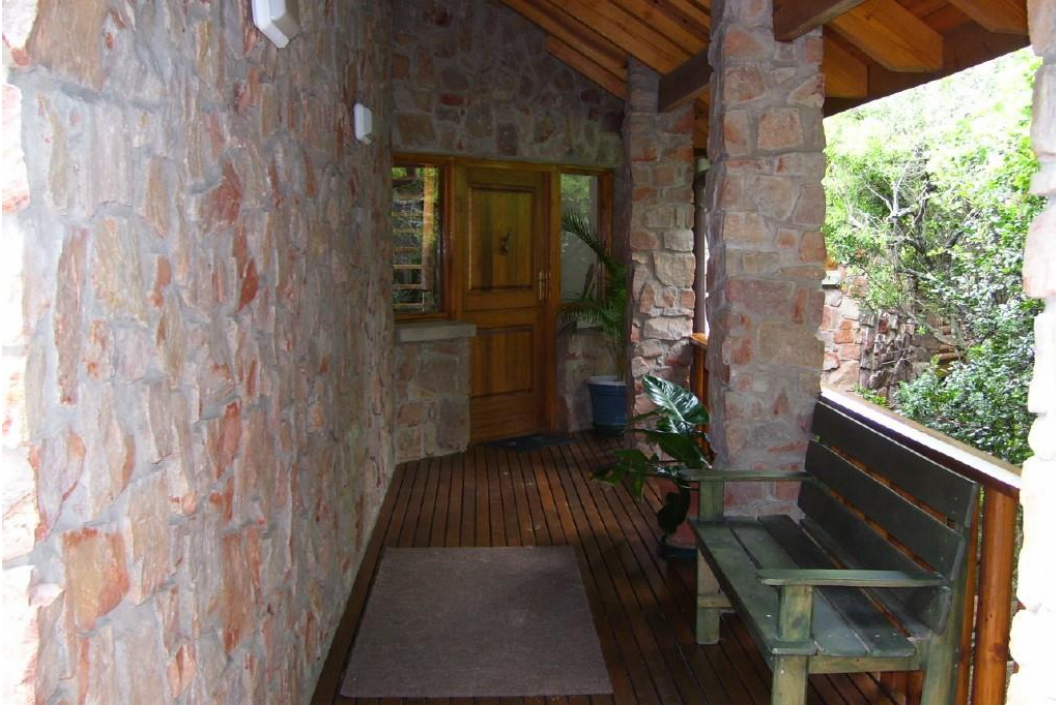
Plate 25: Verandas provide shade as well as insulating the house

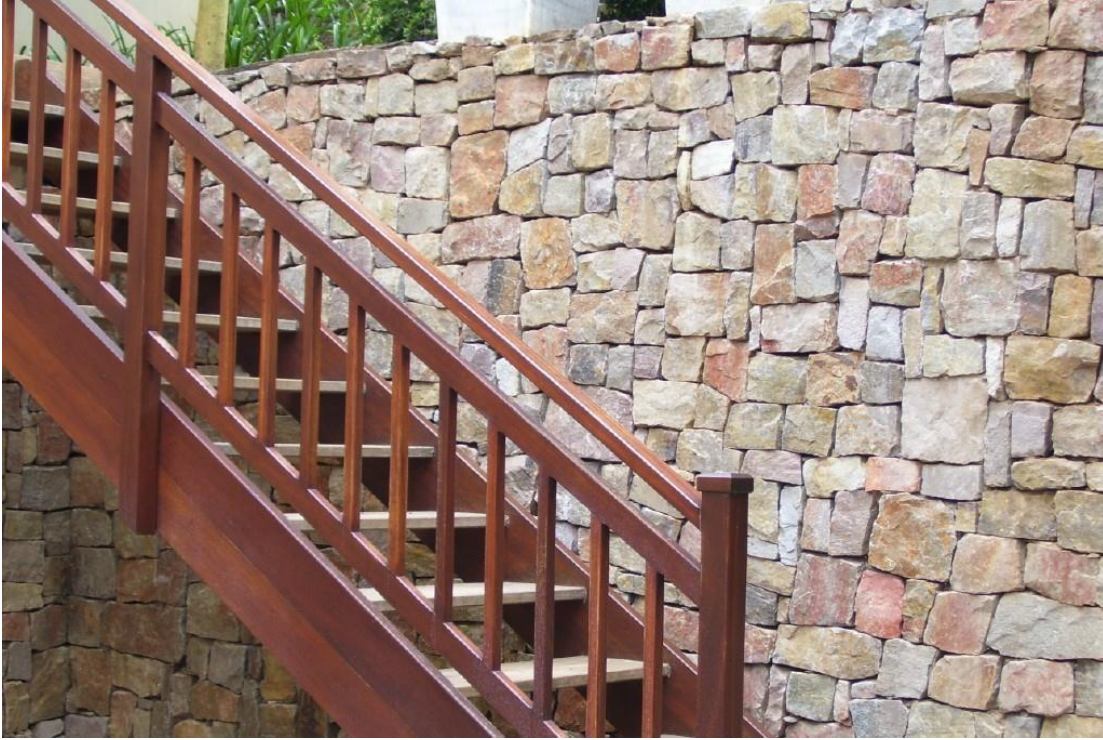
Plate 29: Wood and stone are used harmoniously in the design
