## **Ecological and Wetland Assessment for sand mining operations on a Portion of Portion 5 of the Farm Bezemfontein 213 near Laingsburg, Western Cape Province.**

November 2019

### **Darius van Rensburg**

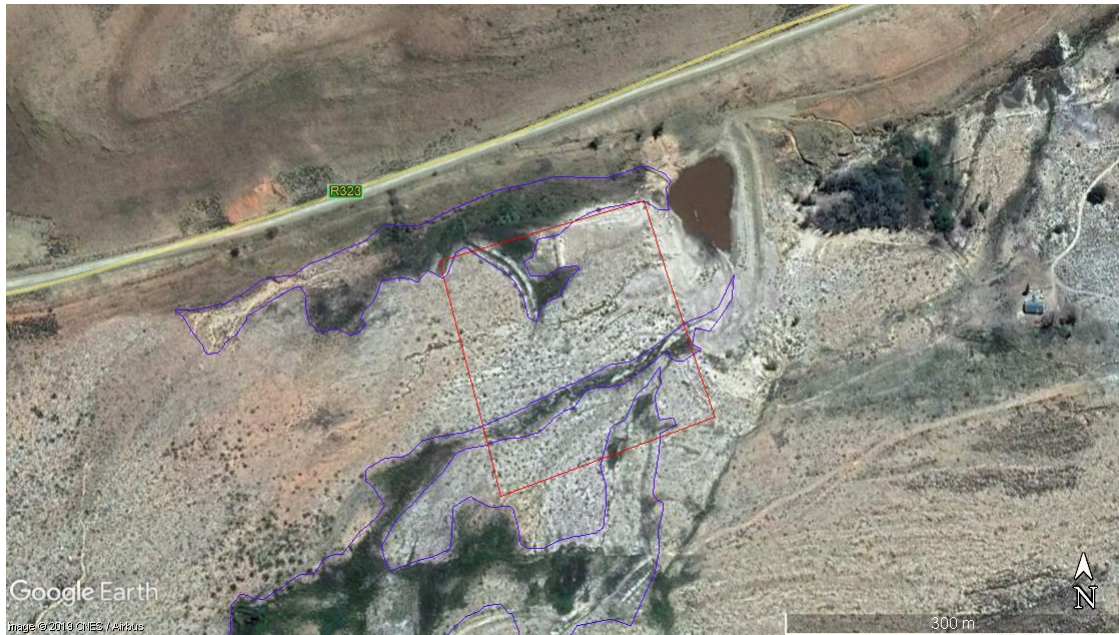
Figure 4: Aerial view of the site showing the site, the delineated borders of the two streams and the artificial impoundment (Google Earth 2018). Note that the border of the streams are much more easily discernible here and that the vegetation cover is considerably lower after the recent fire, circa 2016.

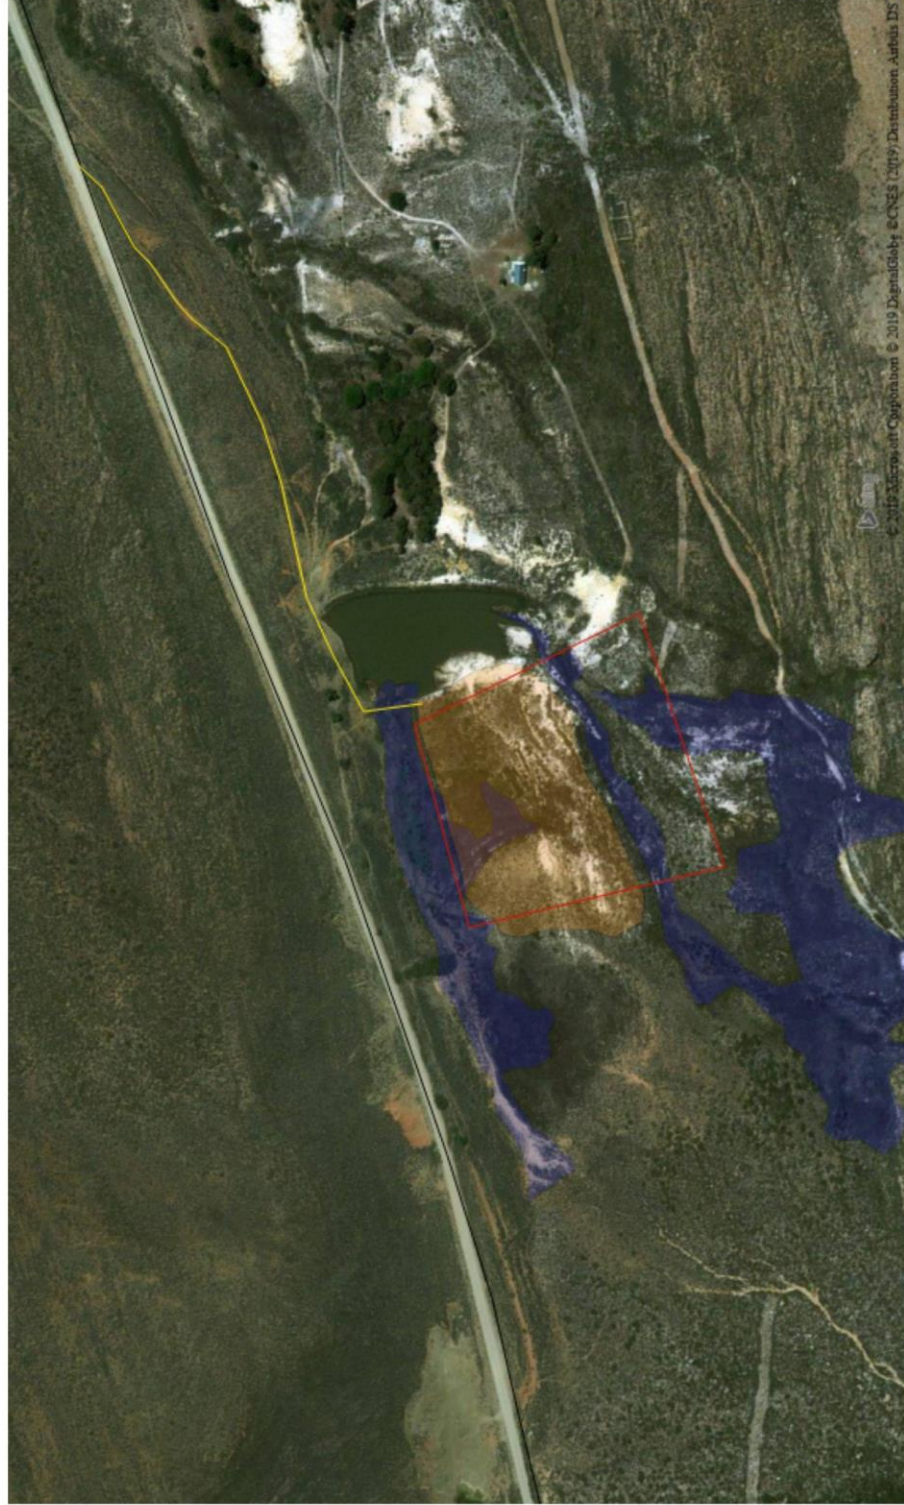
## Wetland delineation map for sand mining operations on a Portion 5 of the Farm Bezemfontein 213 near Laingsburg, Western Cape Province.

Map 1: Wetland delineation map of the proposed sand mining on the Farm Bezemfontein 213. The mining area boundary is indicated, as well as the alluvial sand embankment to which mining operations should be confined. The proposed access road follows an existing dirt track. The two stream systems, associated wetland conditions and the artificial impoundment are all visible.

be easily utilised to provide an accurate border of wetland conditions. Obligate wetland species are only able to inhabit wetland areas and as a result where they occur wetland conditions can be assumed to occur. The obligate wetland cape reed (*Elegia capensis*), riparian grass (*Pennisetum macrourum*) and geophyte (*Watsonia angusta*) was utilised to provide a quite accurate boundary of wetland conditions and the floodplain of these streams (Map 1).

Along the northern stream system there is also an artificial crescent shaped channel and berm (Map 1). This furrow or channel diverts a portion of the flow in the stream although its intended function is unclear. It has however also manifested some wetland conditions due to continued inundation and saturated soil conditions. These wetland conditions are however artificial and do not perform any function which is important to the continued natural functioning of the stream. This channel and berm can therefore be included in the sand excavation operations without having a large impact on the functioning of the stream.

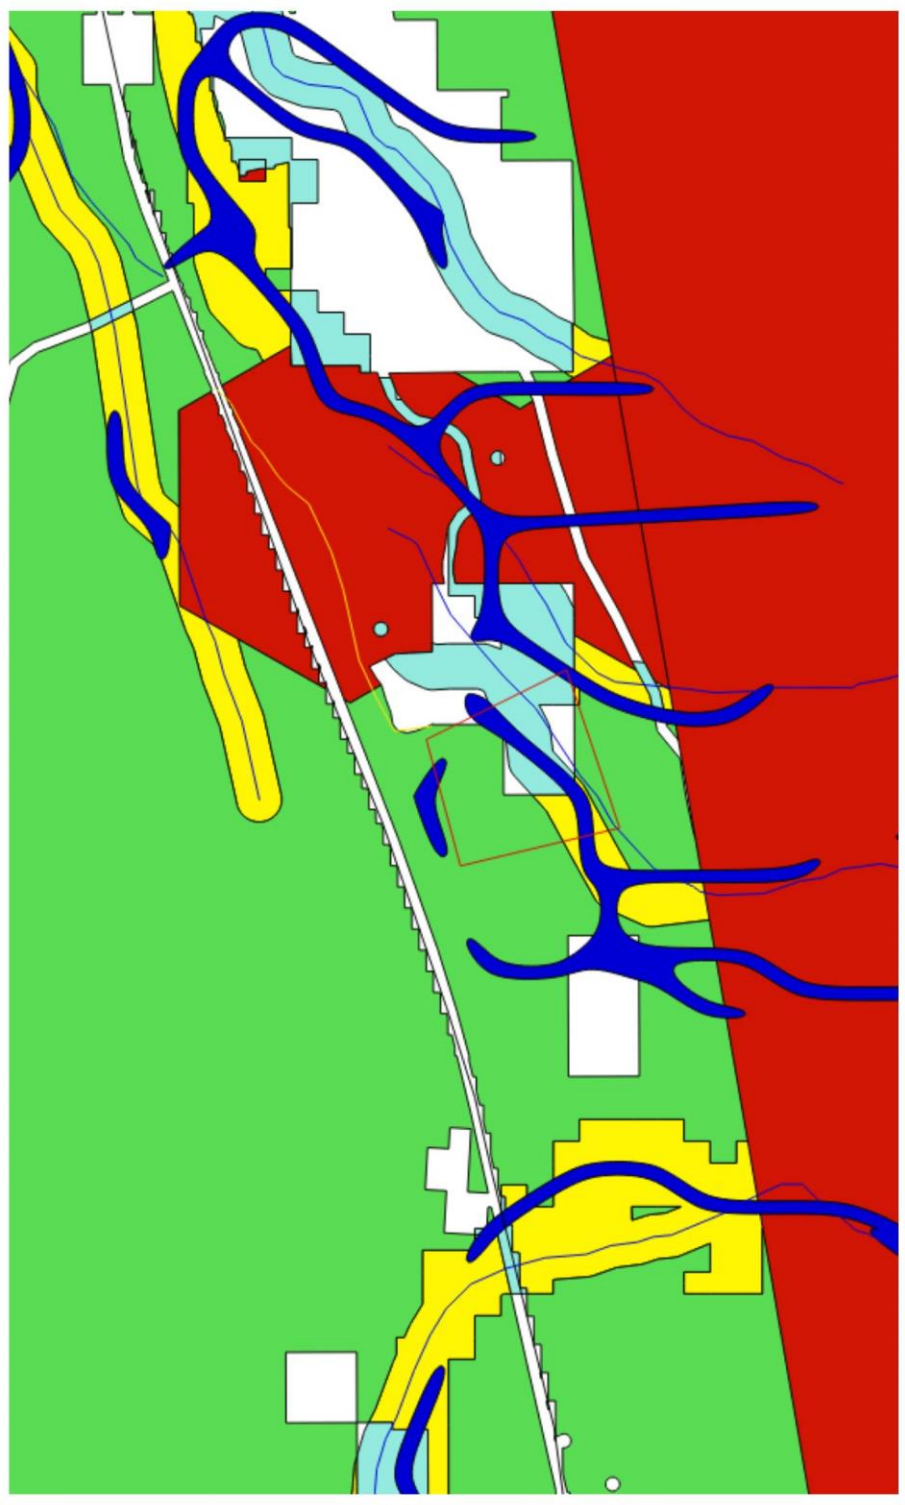
**Western Cape Biodiversity Plan map for sand mining operations on a Portion of Portion 5 of the Farm Bezemfontein 213 near Laingsburg, Western Cape Province.**

Map 3: Biodiversity plan map of the proposed sand mining on the Farm Bezemfontein 213. Note that the majority of the site is considered an Other Natural Area with the southern stream system considered an Ecological Support Area 1 and 2. The Towerkop Nature Reserve to the south of the site is also visible.

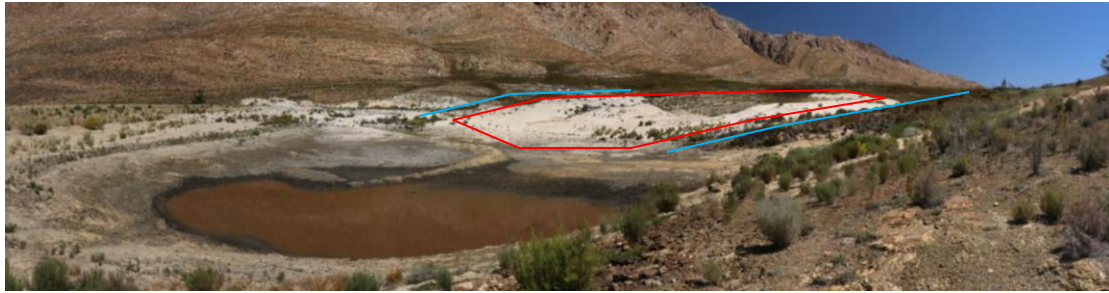
Figure 1: Panorama of the site at the foot of the Klein Swartberg (background). Note the large artificial impoundment with two stream (blue) flowing into it. The alluvial sand embankment proposed for sand excavation is also indicated (red).

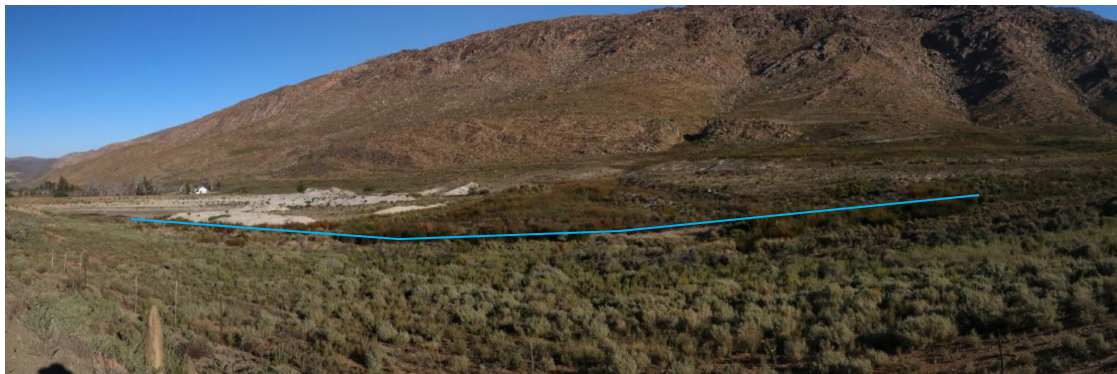
Figure 2: Another panorama of the site with the northern stream indicated (blue).

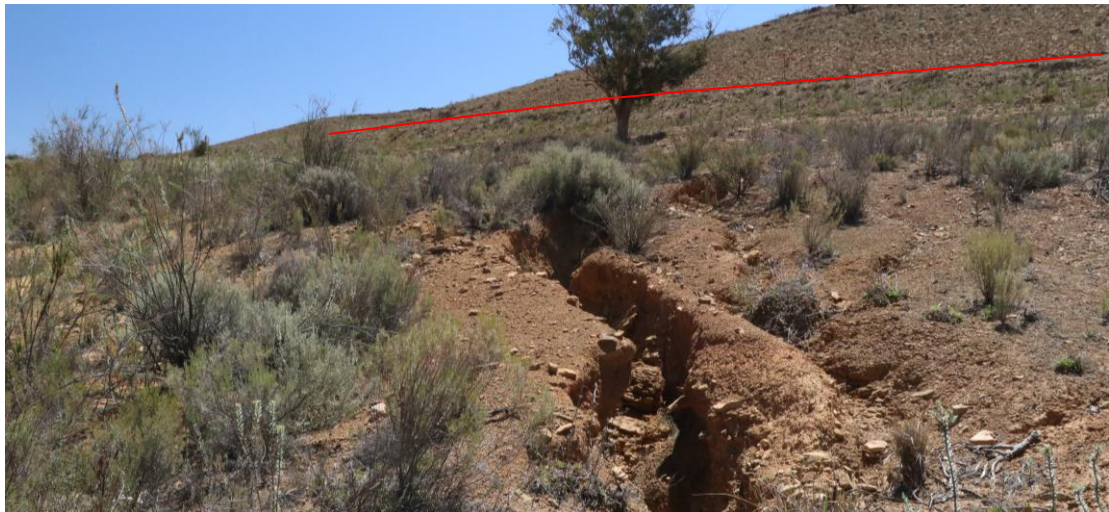
Figure 3: Storm water from the adjacent gravel road (red) does contribute to significant erosion on the site.

The excavated sand will have to be transported from the site by trucks and heavy vehicles and will require an adequate access road which may affect the two stream systems. Crossing of these streams by such a road will have a significant impact on them and should be avoided. This can be achieved by utilising an existing small dirt track which can be upgraded and accessing the site via the dam shore which is already an artificial and degraded area and will prevent impacting on the stream systems (Map 1). Should this route be used the risk should remain low. It is however also subject to the upgrading of the existing track minimising erosion and its design allowing for adequate drainage of surface runoff without exacerbating erosion.

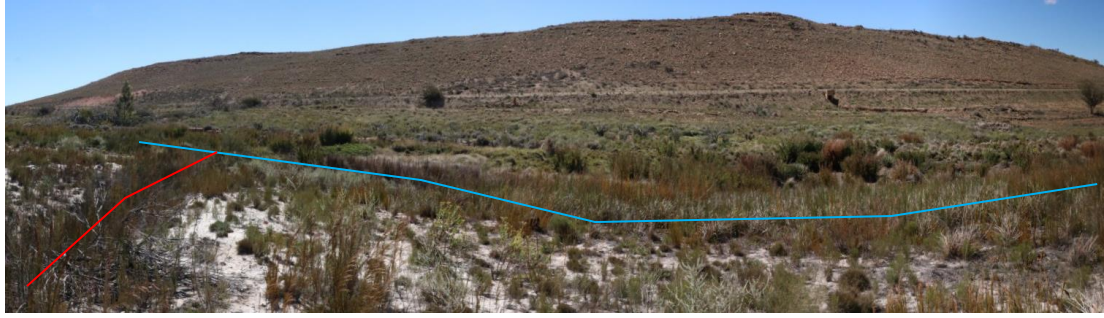
Figure 5: Panorama of the northern stream (blue) also showing the small artificial channel (red).

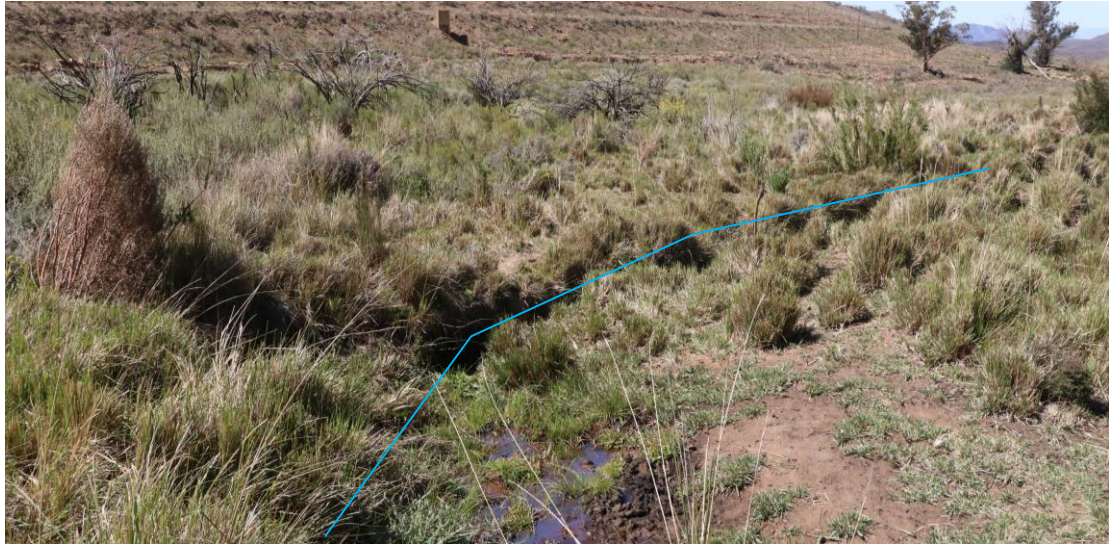
Figure 6: View of a portion of the main channel of the northern stream (blue).

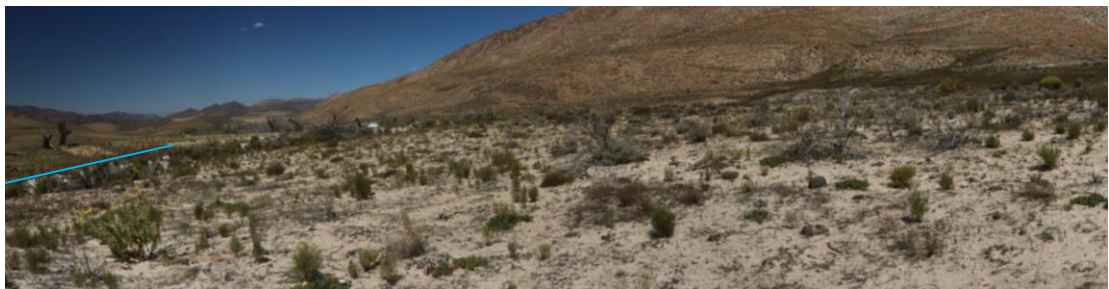
Figure 7: Panorama of the alluvial sand embankment which will be the focus of mining operations. Note that it is elevated above the surrounding stream systems (blue). Note also sparse vegetation cover.

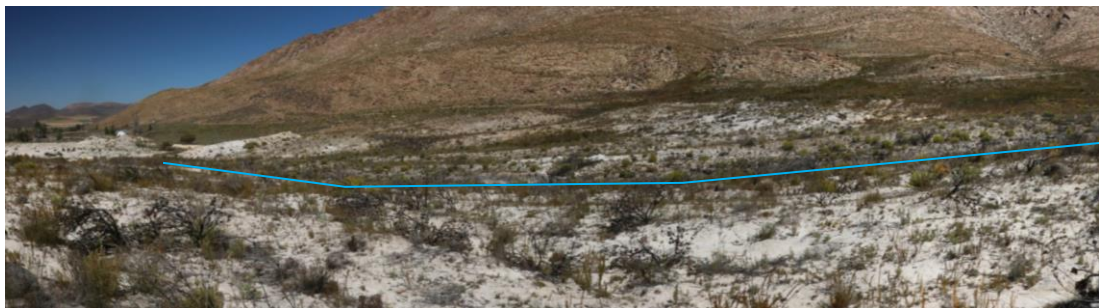
Figure 8: Another panorama of the alluvial sand embankment with the southern stream in the background (blue).

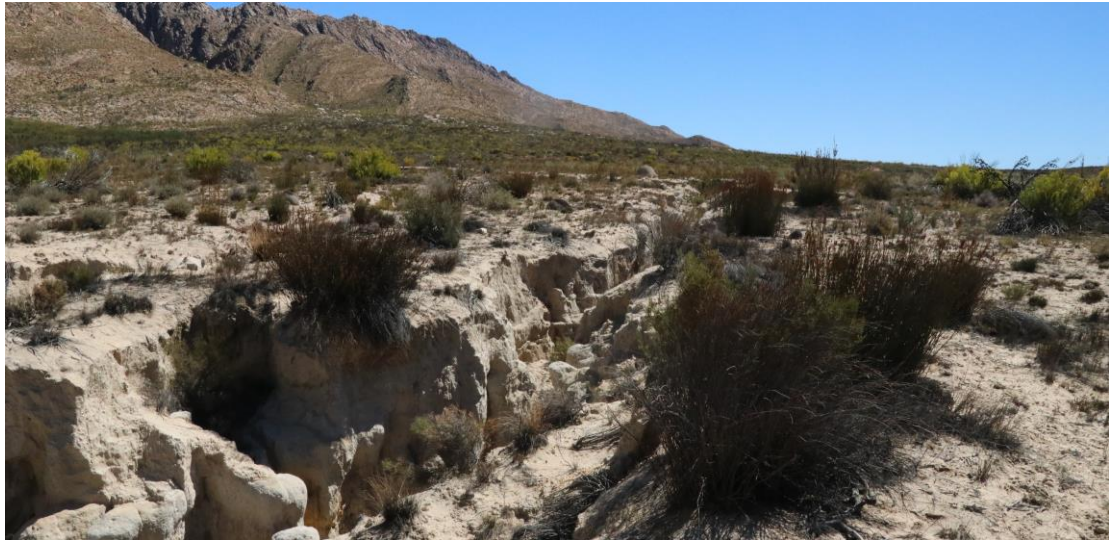
Figure 9: Substantial erosion is also evident on the alluvial plain.

The alluvial plain on the site is highly conducive to erosion and even when comprehensive erosion management measures are implemented it remains likely that sand mining will considerably increase the sediment load in downstream sections. However, the artificial impoundment essentially acts as a sediment trap and will prevent any mobilised sediments from entering the downstream sections. This will effectively contain impacts associated with sand mining in the immediate area.

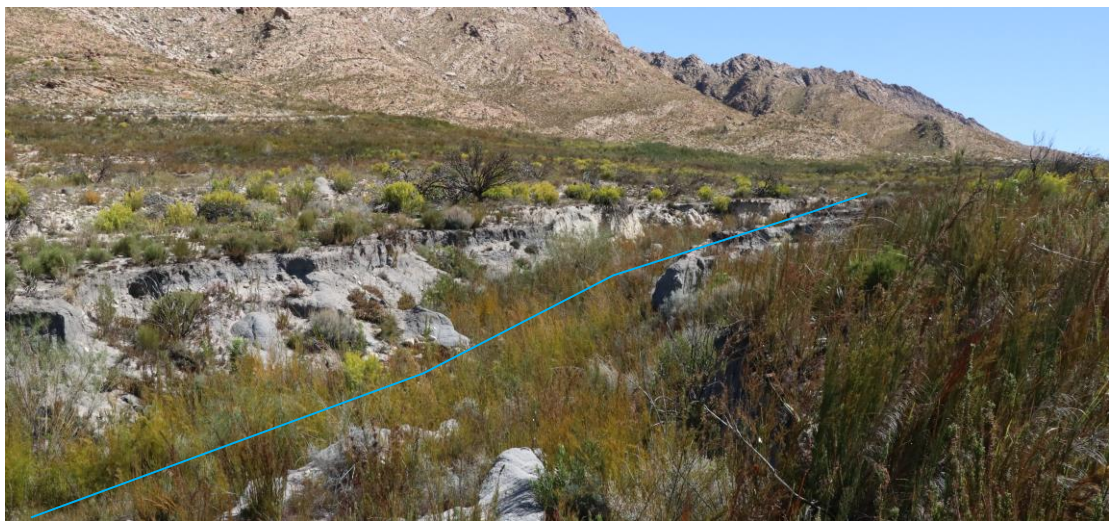
Figure 10: View of the southern stream (blue). Note also significant erosion, though considered to be largely natural.

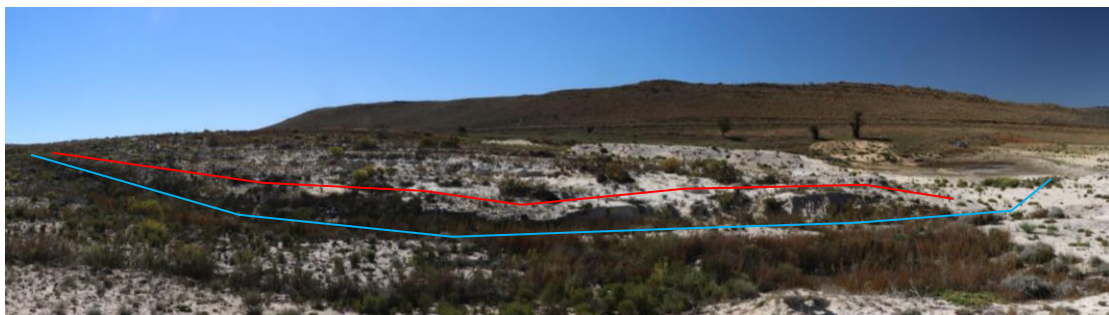
Figure 11: Panorama of the central alluvial sand embankment with the southern stream (blue) visible in the foreground. It should be quite evident that the sand embankment is elevated above the stream and sand excavation will be possible without impacting the hydrology of the streams as long as the depth of excavation does not exceed the level of the stream banks (red).

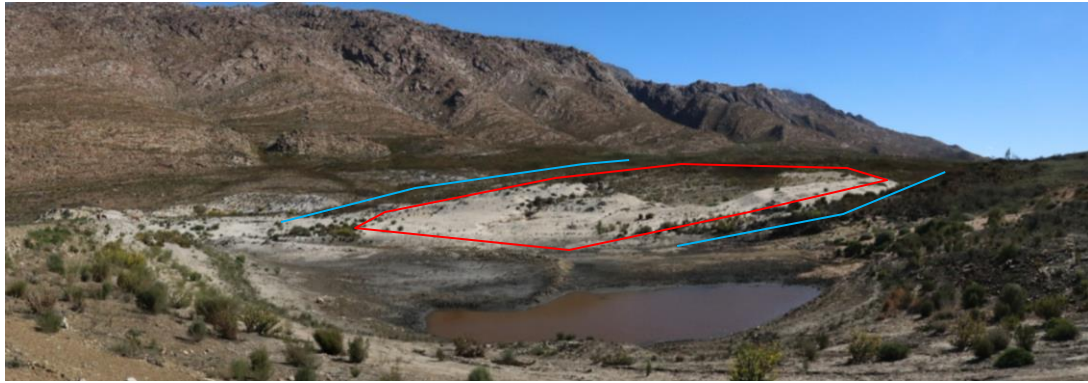
Figure 12: Another panorama from the artificial impoundment toward the site clearly indicated the alluvial sand embankment (red) surrounded by the two stream systems (blue).
