Clover Hill Club Access Road and Bridge

BIODIVERSITY ASSESSMENT

**Ecological Assessment and Aquatic (Wetland) Assessment for the
Proposed Upgrading of the Access Roads and Bridge leading to Clover
Hill Club, Gauteng Province**

REPORT NUMBER: CH/AR_01

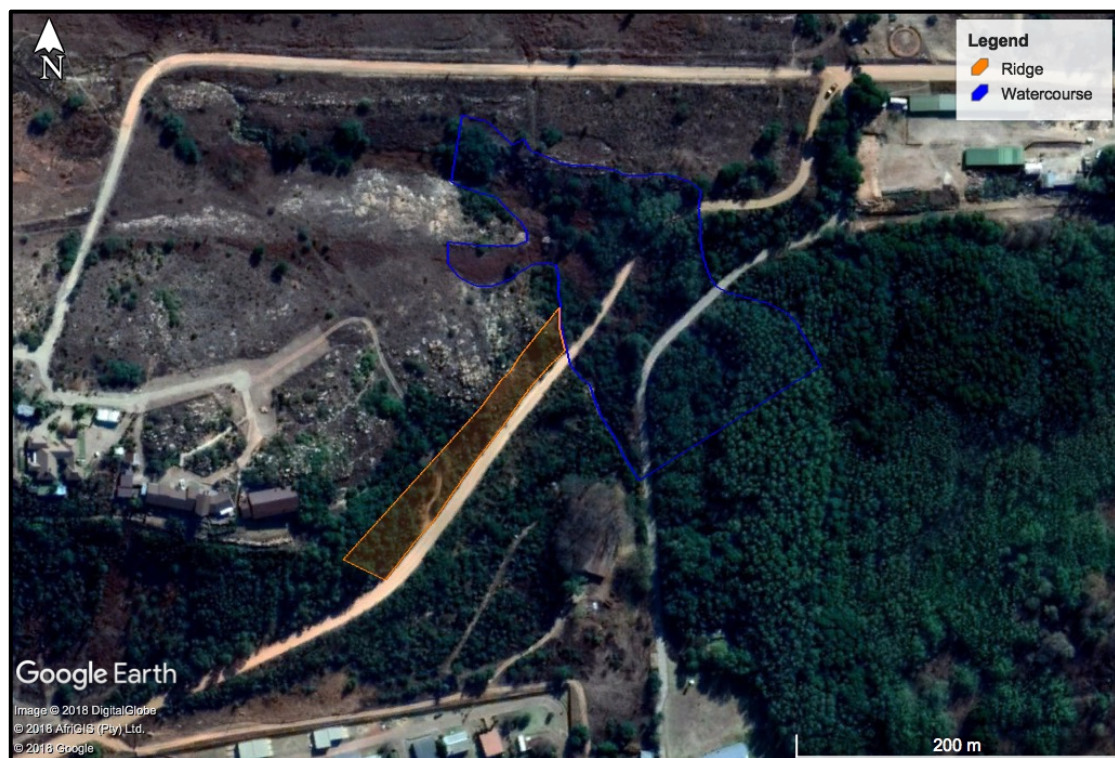
Sensitivity map of the study site

The entire study site is seen as having a sensitivity rating of 'Low', except for the demarcated watercourse and ridge areas (figure below) that are demarcated as 'High'.

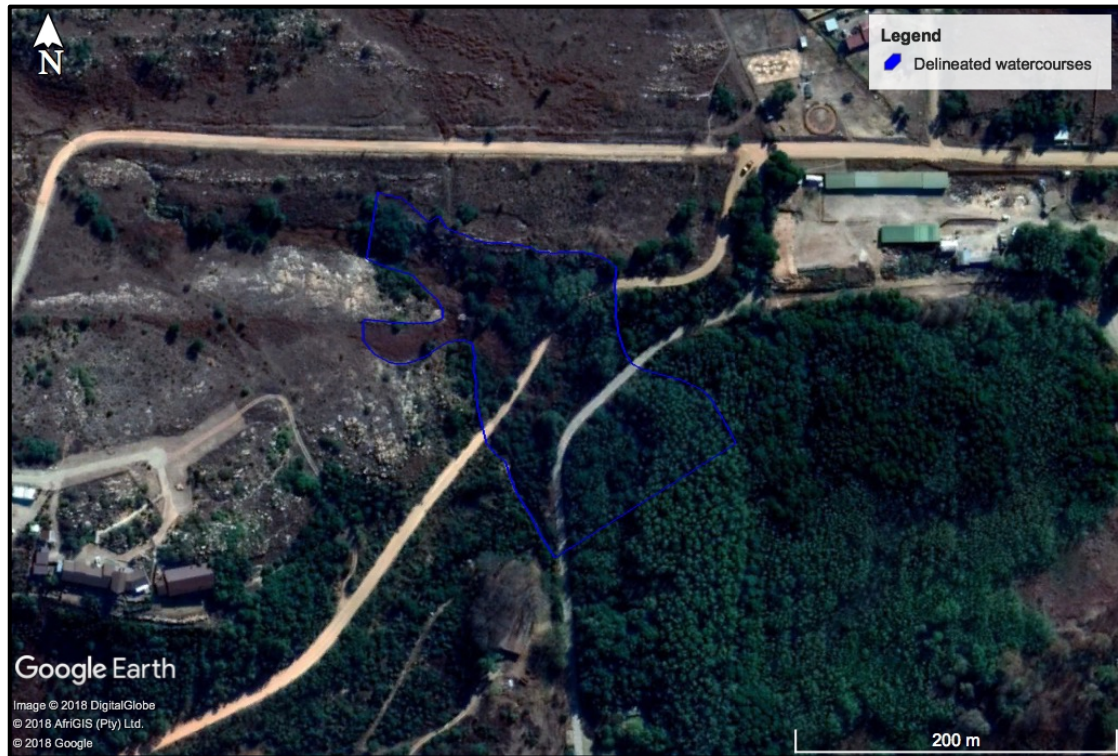
Figure 16: Delineated watercourse

The only watercourse in the study area is a small semi-perennial stream that flows in a fairly deep and steep ravine (kloof) at the foothills of the higher ridges. The stream was delineated as shown below (Figure 16). The entire stream, riparian area and ravine were delineated as they holistically form the watercourse. Due to the extreme high levels of encroachment on the system by alien trees it is very difficult to delineate the watercourse 100% accurately.

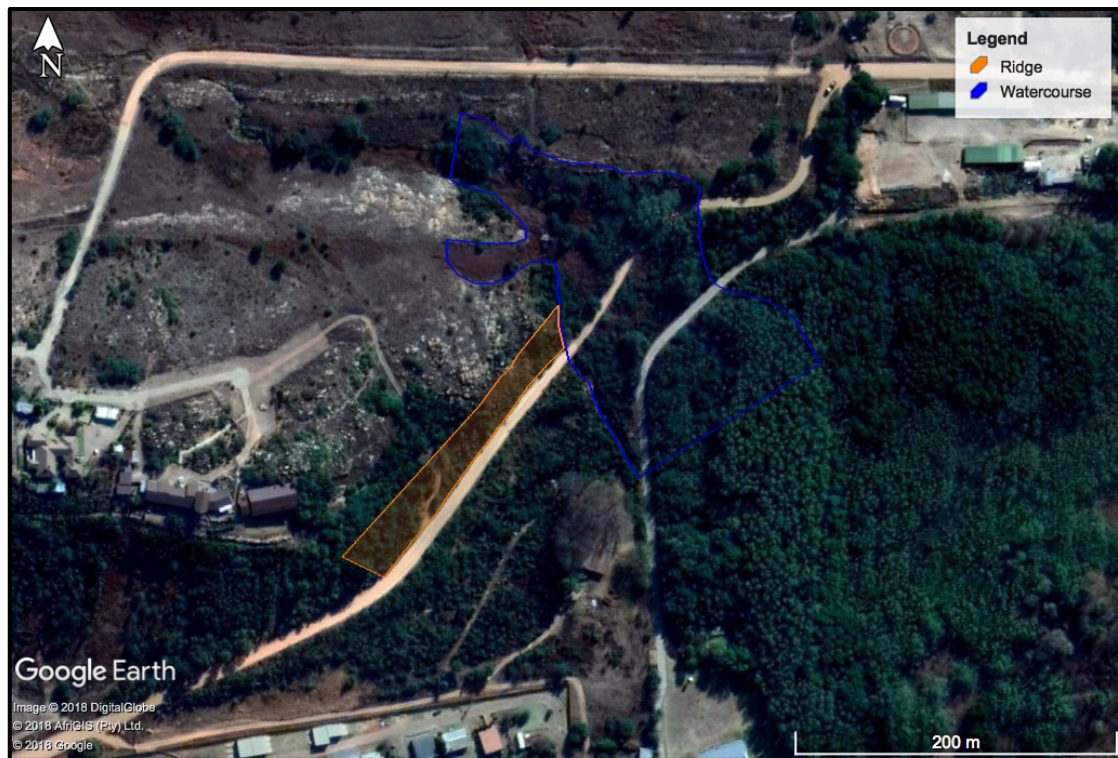
Figure 26: Sensitivity map of the study area

The road itself is not a sensitive area because it has been totally transformed and is an existing gravel road. This is also relevant to the bridge. The southern section of the study site, which is situated in the original extent of grassland, but that has all but been totally transformed or highly degraded is also not a sensitive area in terms of the ecological assessment. The ridge and watercourse areas are however sensitive. The northern section of the road and bridge are within demarcated ridges. The ridge is especially prominent on the western side of the road. The ridge and watercourse

have therefore been demarcated as sensitive, even though they are seriously degraded in the area of the road and road reserve. This degradation is almost entirely due to excessive invasion and encroachment by alien tree species. Along the ridge / rocky area the alien species is almost entirely the highly invasive Australian blackwattle (*Acacia mearnsii*), while the watercourse and kloof (ravine) is a mix of pine, poplar, syringa and blackwattle on the edges. The entire study site is seen as having a sensitivity rating of 'Low', except for the demarcated watercourse and ridge areas (Figure 26, below) that are demarcated as 'High'.

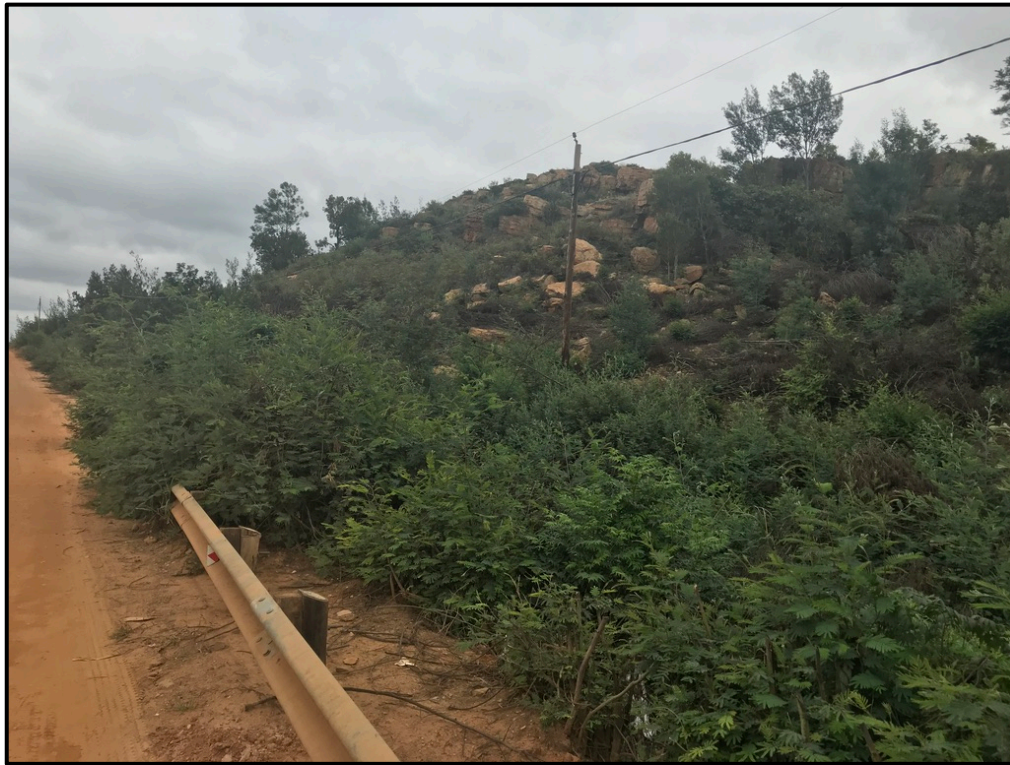
Photo 3: Ridge (rocky area) right of road and just south of bridge.

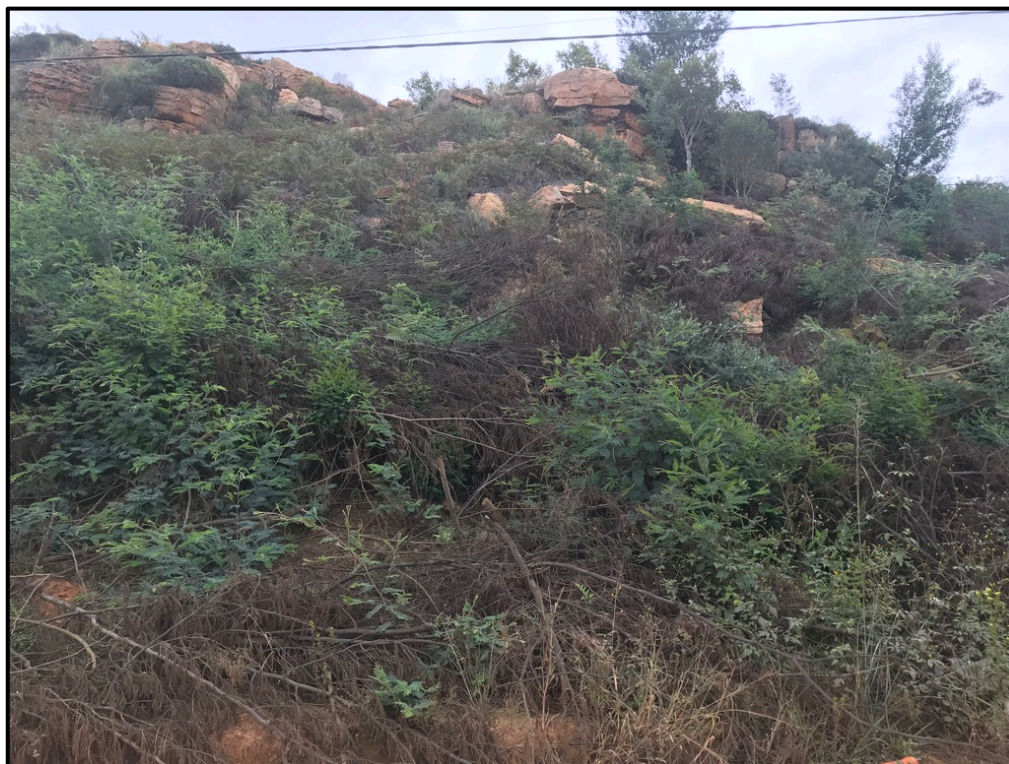
Photo 5: Ridge area west of road. All green trees in photo are felled alien invasive blackwattle that have invaded the ridge and watercourse

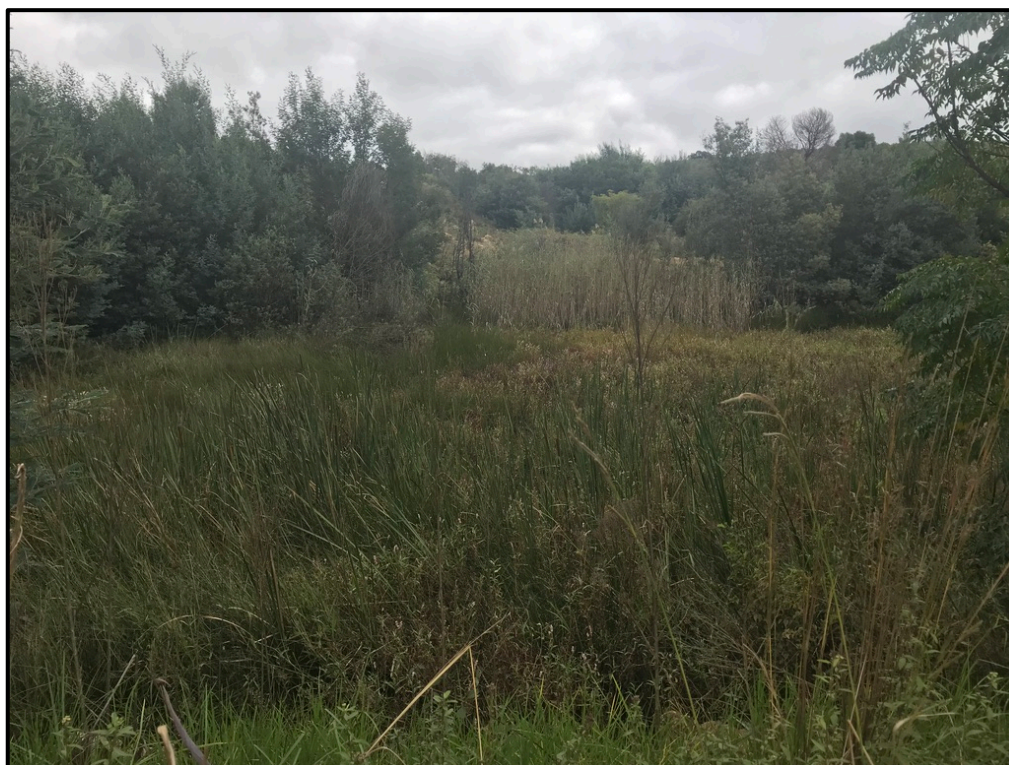
Photo 6: Watercourse and kloof upstream (west) of the bridge. Trees in the photo are predominantly invasive weeds species of blackwattle and syringa

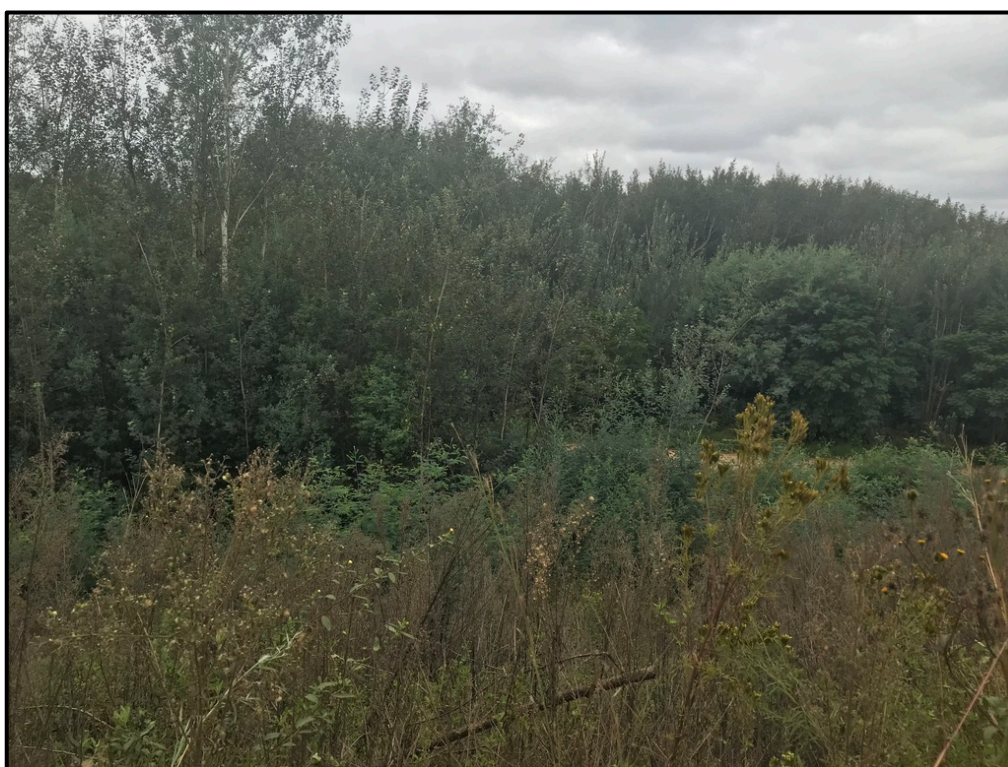
Photo 8: Watercourse downstream (east) of bridge. All trees in photo are invasive alien trees of poplar and blackwattle, invading and choking the watercourse

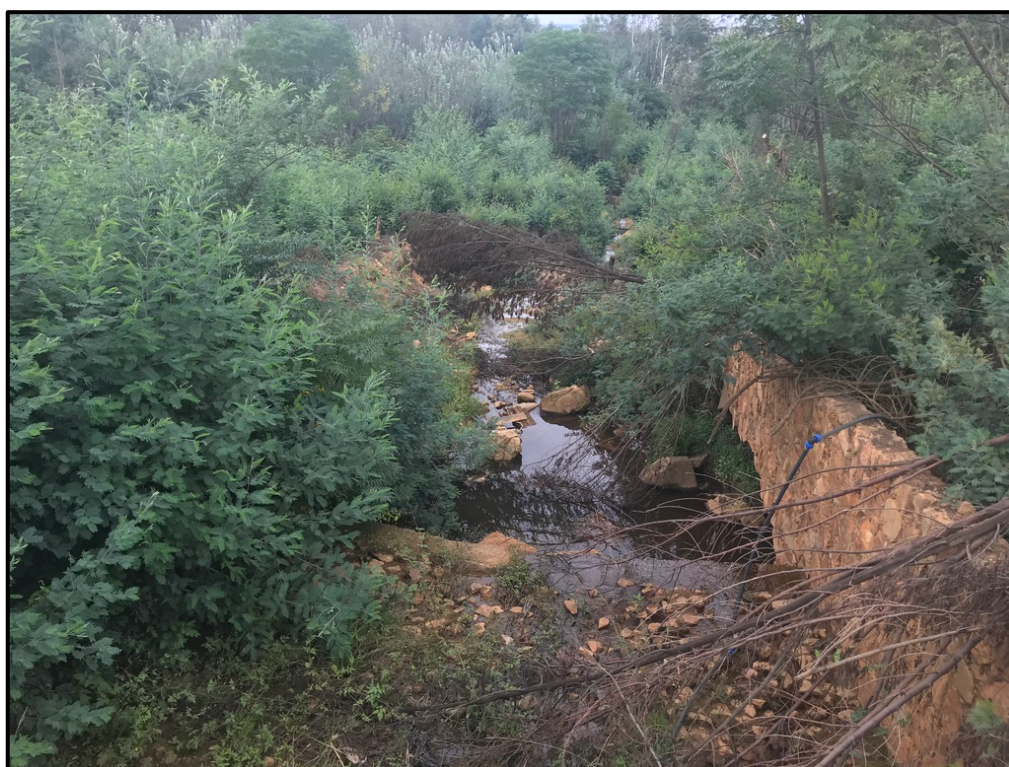
Photo 10: Stream immediately east of bridge (downstream). All trees in picture are invasive alien species (mainly blackwattle)

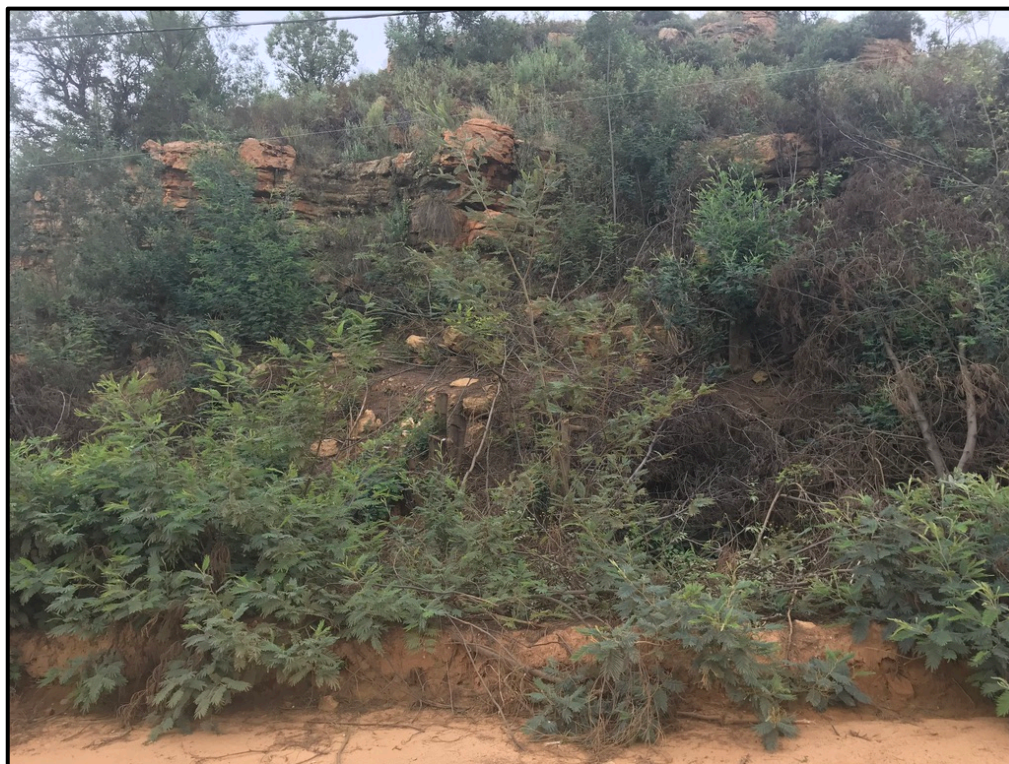
Photo 11: Edge of ridge next to road. This ridge along the western side of the road is seriously degraded and over run by invasive alien trees (blackwattle) all the trees in the photo are alien.
