**The Upgrade of the Provincial Routes D620 and D621
from Gravel to Surfaced Roads in the Winterveld Area,
Gauteng Province**

BIODIVERSITY ASSESSMENT

**Ecological Assessment and Wetland Assessment
for the Provincial Routes D620 & D621**

**Compiled by
Flori Scientific Services
Johannes Maree**

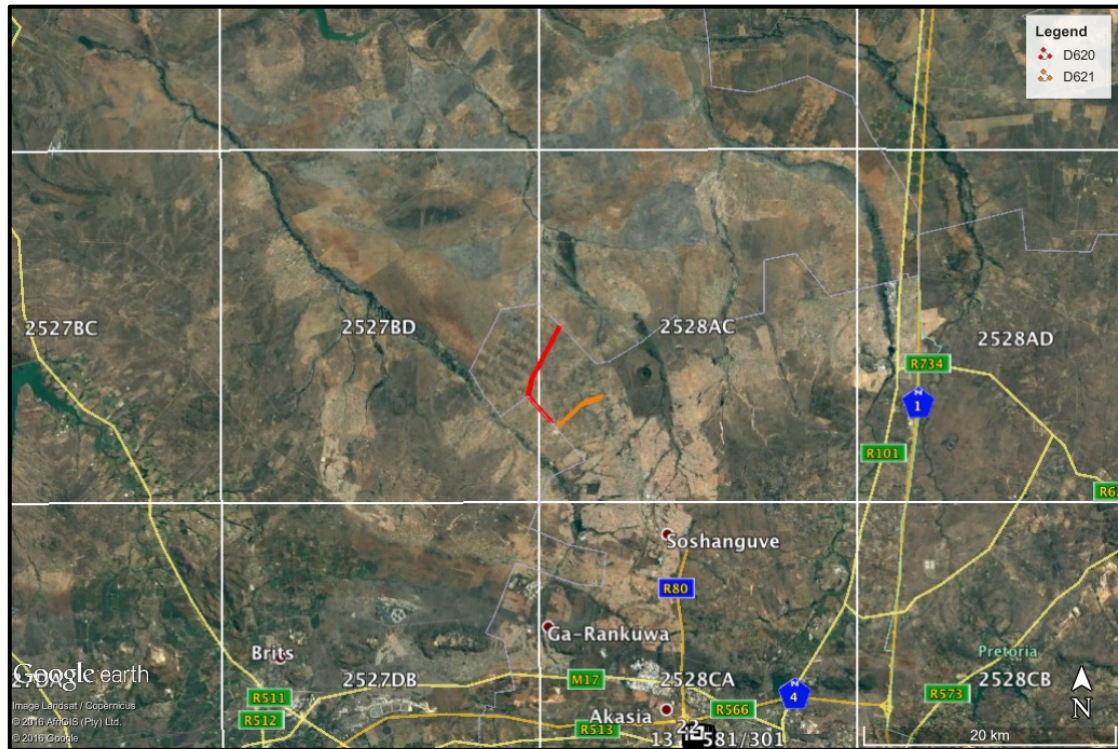
Figure 7: QDS for the study area

No Red Data species (endangered, threatened or vulnerable) were observed during field investigations. According to the SANBI database (www.posa.sanbi.org) no Red Data species have been recorded in the area of the QDS quadrants in which the study site is situated (Table 4), with the exception of *Brachystelma discoideum* in QDS 2528AC (Table 4). It is fairly unlikely that any Red Data species occur in the study area, but it is not impossible. The summaries of priority floral species per grid reference are tabled below (Table 4). Figure 7 below shows the extent of the roads (study area) within the relevant Quaternary Degree Square (QDS).

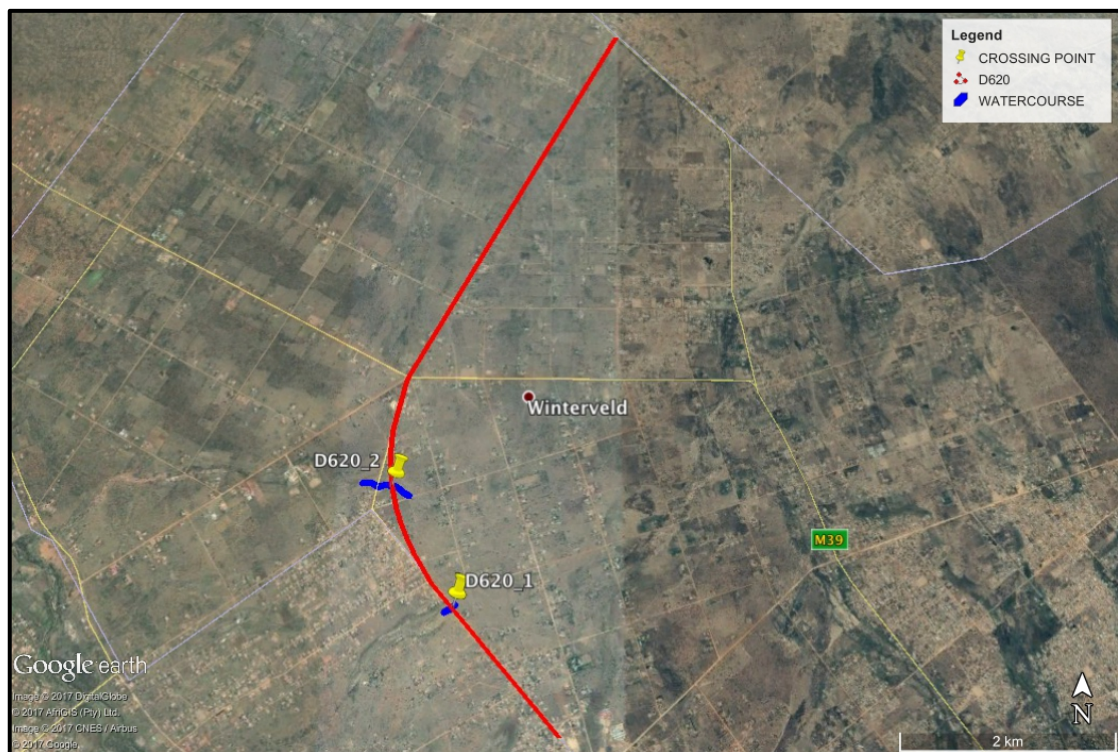
Figure 15: Watercourse crossings along Route D620

Route D620 only crosses over two small seasonal drainage lines and no streams or rivers (Figure 15). Route D621 crosses over two watercourses, the one being a seasonal drainage line and the other one a larger seasonal drainage line or small seasonal stream (Figure 16). The two watercourses along Route D621 are part of the same, larger drainage system, as is evident from the satellite Google Earth image below (Figure 16). The watercourses in the study area are moderately to highly impacted on by years of urbanisation, cultivation, general movement of people through the area and the over utilisation of resources. The watercourses present are small, highly seasonal and insignificant, with little to no significant riparian zones or vegetation. Many of the channels have been altered over the years, which makes it difficult to accurately delineate.

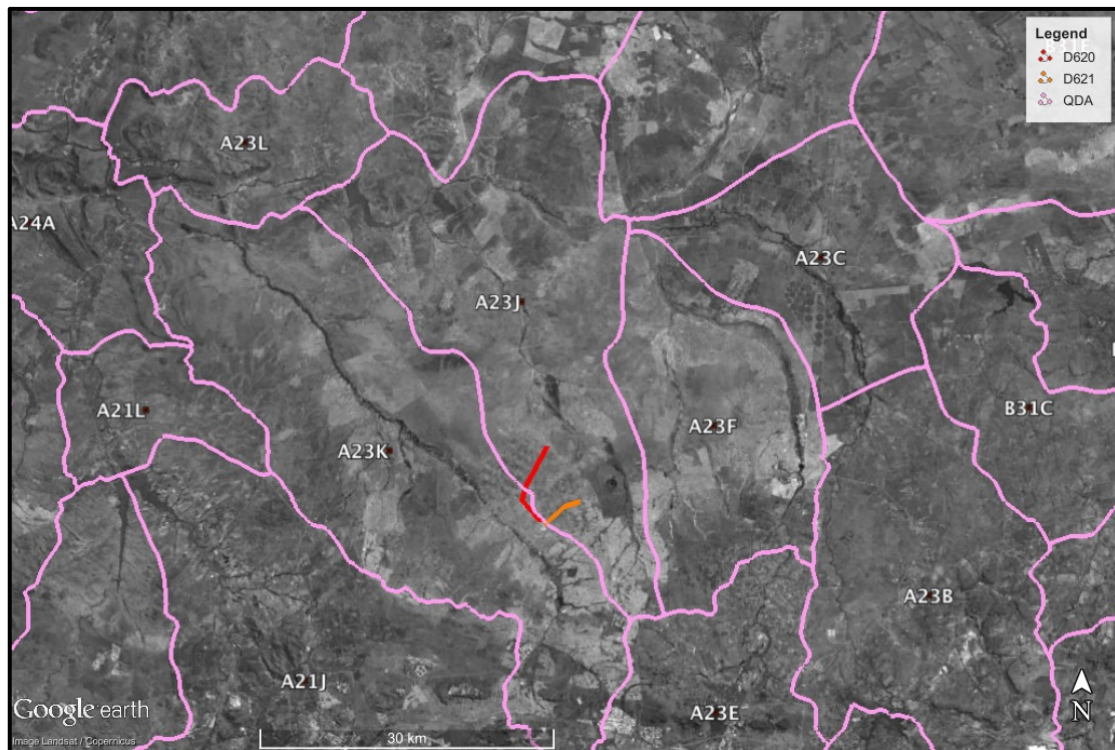
Figure 25: Quaternary drainage areas (QDA)

The study area is situated within the Primary Drainage Area (PDA) of A and the Quaternary Drainage Areas (QDAs) of A23J and A23K (Figure 25).

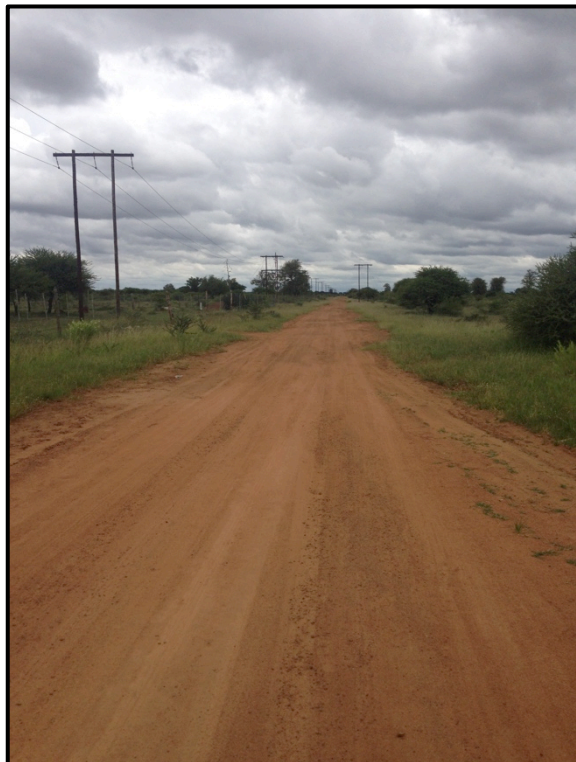
Photo 1: Route D620 in area of M39 looking south

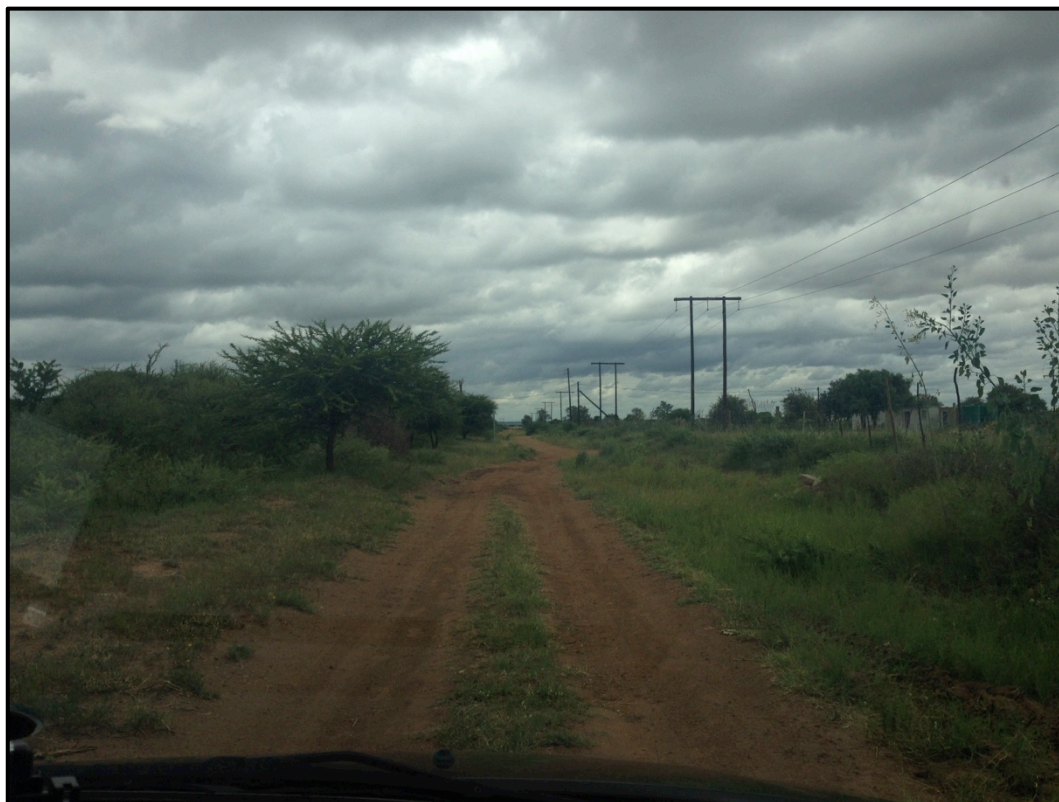
Photo 3: Gravel road (D620) at about 7km looking north

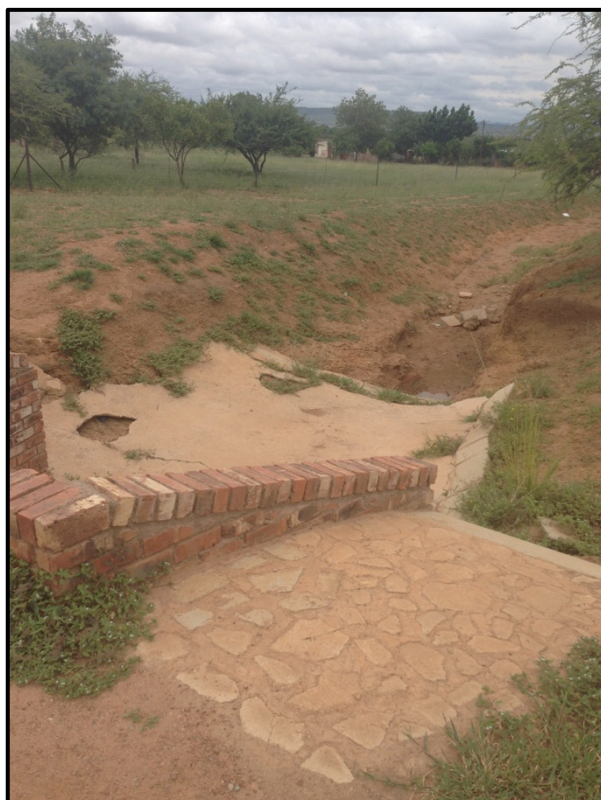
Photo 4: Stormwater drain along D620 route

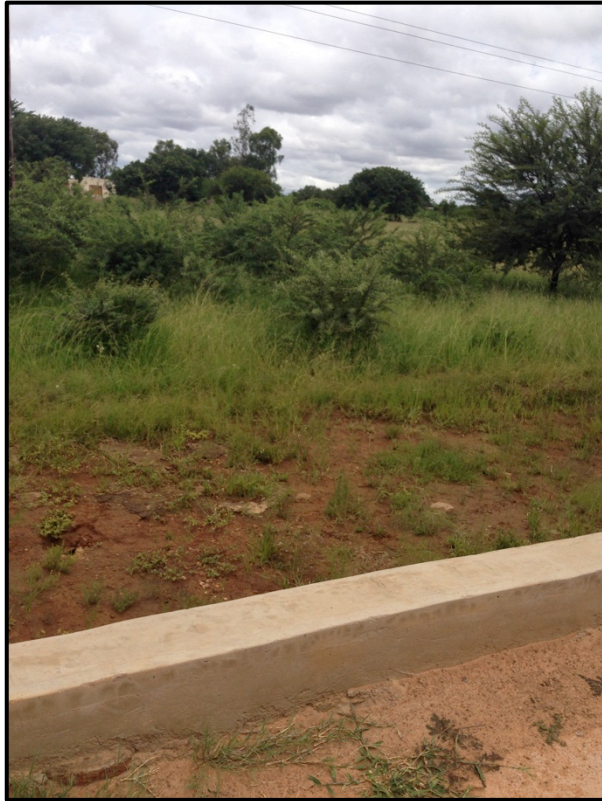
Photo 11: Culverts / stormwater drains over stream at 3,3km. This is the largest watercourse crossing in the study area

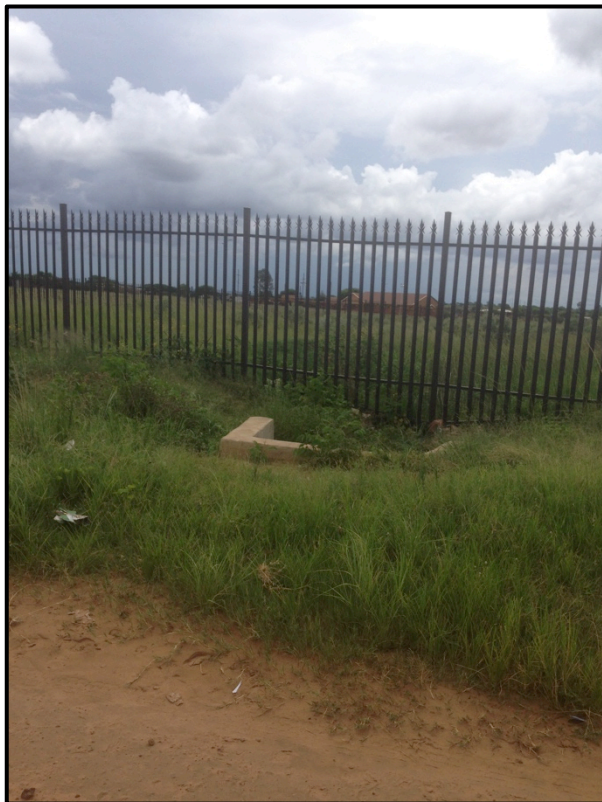
Photo 12: Small stormwater drain in area of 3,3km near east end of route
