BOLOBEDU POLICE STATION, GA-KGAPANE.

The National Department of Public works appointed SSA Consulting Engineers as architects and project managers for the Repair & Renovation, Conversion and Construction of the new Bolobedu Police Station (WCS 039808)

HERITAGE ASSESSMENT OF BUILDINGS AT BOLOBEDU POLICE STATION (BOLOBEDU, TZANEEN)

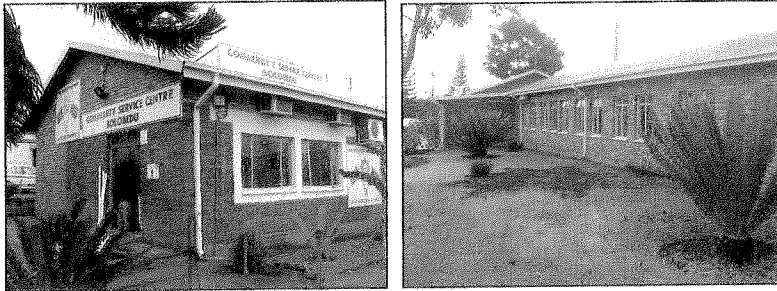
1.	<p><i>Are any of the buildings or structures important examples of a building type.</i></p> <p>1. <u>Main building</u>: the building reflects the architectural style of official buildings designed by the Department of Public</p>	<p><i>Rating</i></p> <p>Low</p>
----	---	--

Works during the period 1975-1989. They were designed to be clinical, functional, low-maintenance buildings with little or no embellishment. The same style and architectural vocabulary was used for the magistrates offices and police stations elsewhere in the Limpopo Province and this style has become a common tradition.

1. Main building: Be retained and used as core building for the complex but allowed to be extensively redesigned to accommodate current and future spatial needs

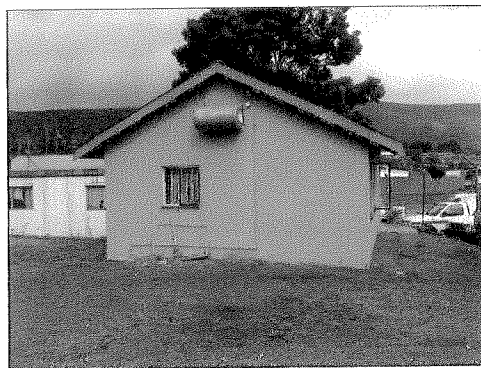
This building has been erected in the period 2000 to 2008 and has no architectural relationship with the original main building in terms of architectural vocabulary, style and use of materials.

5. Office annex (green building): this function needs to be incorporated into a master plan for the site and altered design for the complex, allowed to be demolished and redesigned.

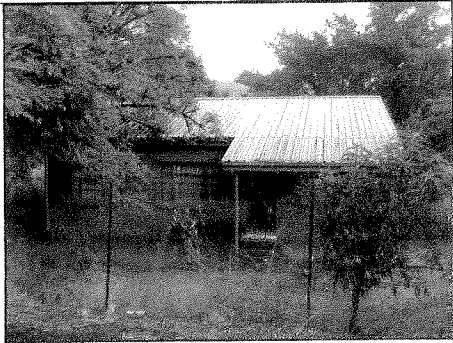
Dwelling across the street from the police station. It is a smaller type of staff housing as the one adjacent to the site but reflects exactly the same architectural vocabulary in terms of style, and use of materials.

7. Dwelling 1: be upgraded and renovated and included in a new site development plan.
8. Dwelling 2: be upgraded and renovated and included into the new site development plan.
