Mitigation based on the Phase 1 Heritage Impact Assessment for the proposed Photo Voltic (PV) plant installation at Boshoff Floors for Ekapa Minerals (Pty) Ltd, Northern Cape dated February 2023 refers.

The Phase 1 Heritage Impact Assessment (HIA) was conducted for the proposed establishment of a Photo Voltic (PV) plant installation at Boshoff Floors for Ekapa Minerals (PTY) Ltd outside Kimberley in the Northern Cape.

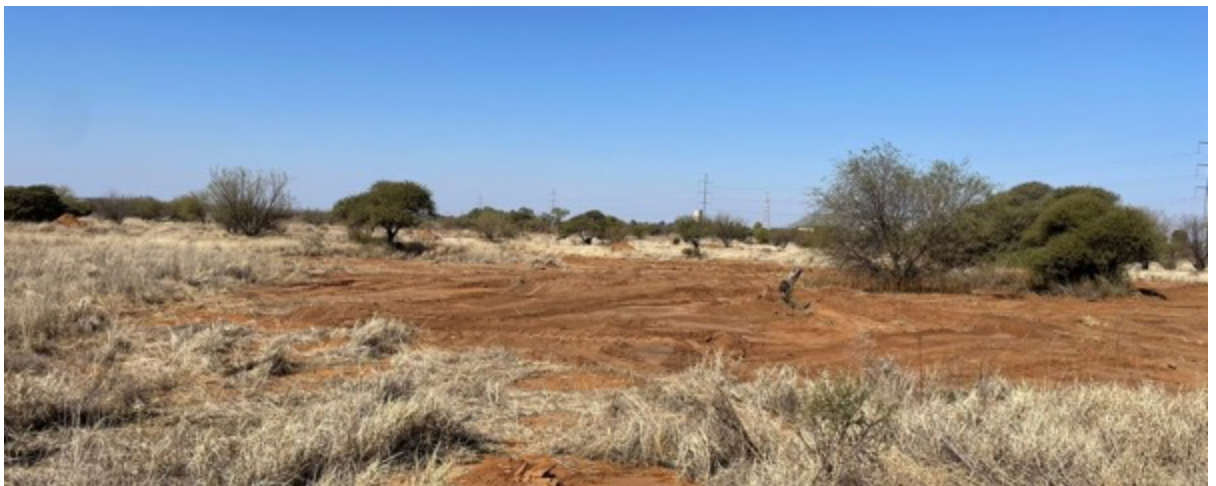
1. *Figure 1. Covering of the exposed subsurface deposit with topsoil complete*

1. Protect the sites in situ and design the development footprint so that it will not negatively impact resource.
2. To protect the integrity of each site the extent of individual site was established and staked out to allow surveying by a professional surveyor.
3. Each site was then backfilled and covered with 250-300mm of sandy topsoil to protect the integrity of the deposit.

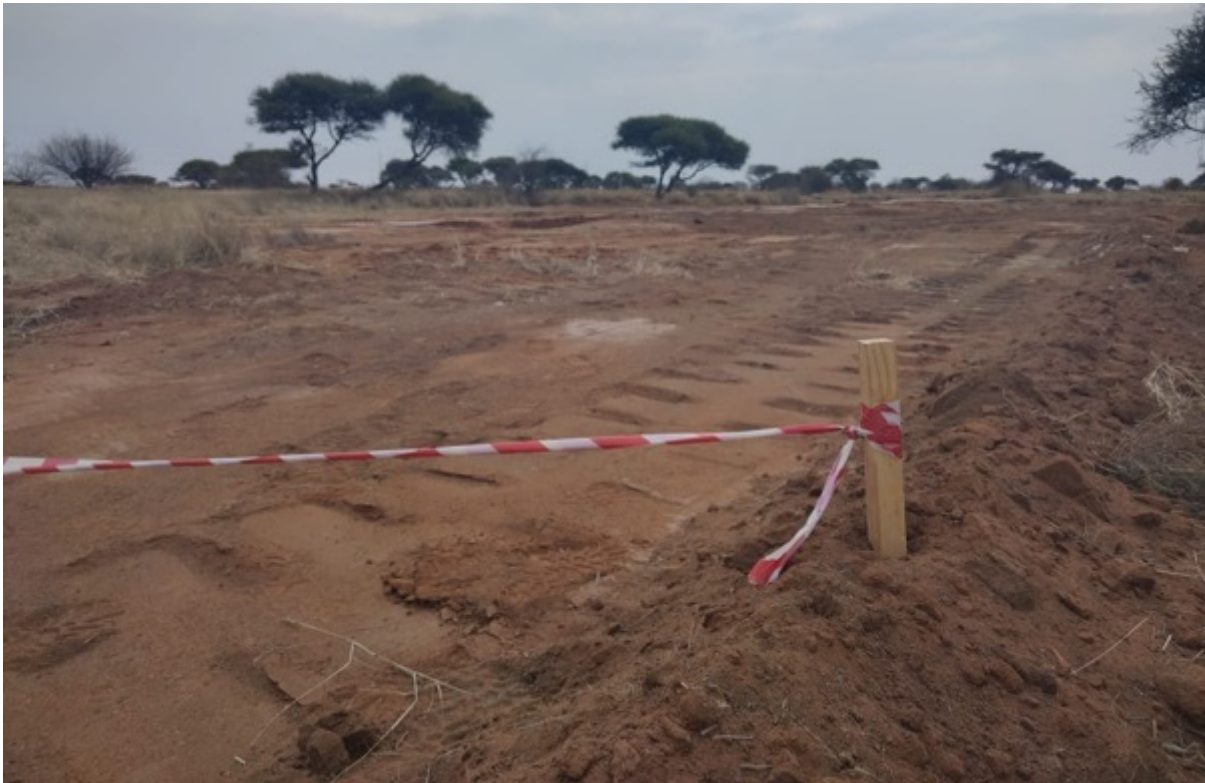
Figure 2. Staking / marking of the sensitive area.

- 2.
4. Following the covering of the deposits each locality was staked out on site.
