**RE: BOTANICAL REVIEW OF THREE SECTIONS OF THE ARIADNE EROS  
2 400KV LINE**

The following comments and findings pertain to the proposed Ariadne Eros 2 400 kV line, specifically three sections in the hinterland of the KZN South Coast (Fig 1). SDP cc undertook an extensive site visit on the 13<sup>th</sup> of August 2015. Line routes were inspected by vehicle and on foot. Relevant points were marked using a hand held GPS. Kml files of the affected structures and line routes were provided.

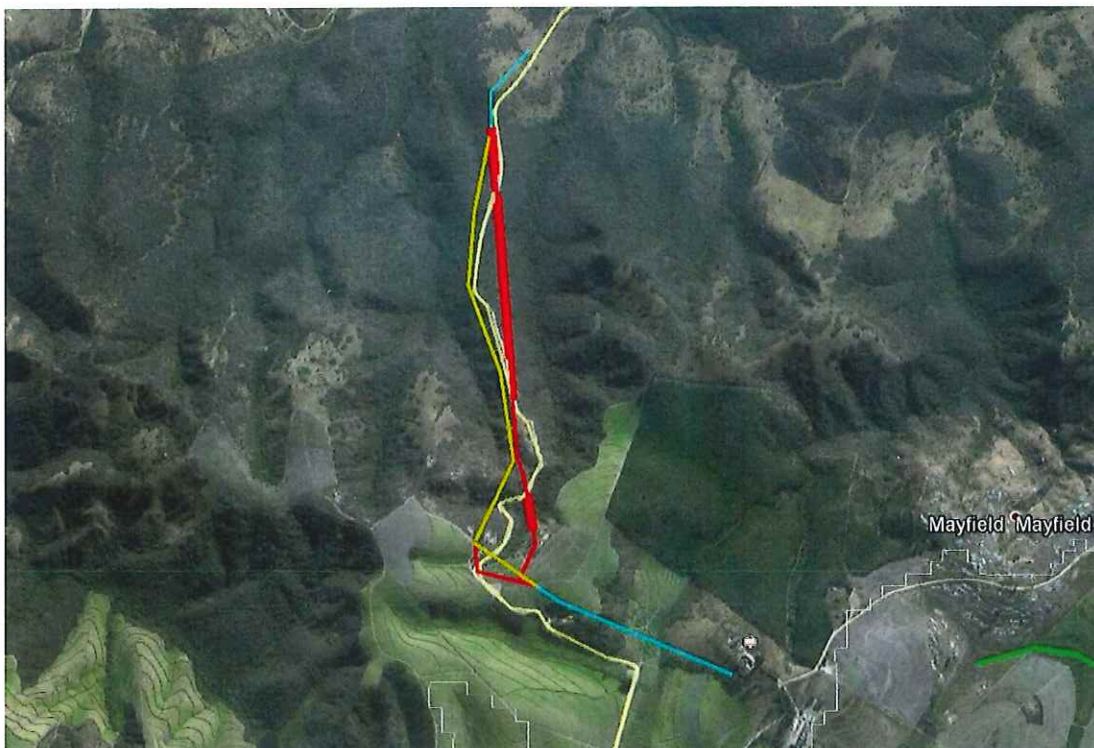
Fig 2. The two areas where bush clearing is likely are indicated in the thicker red line.

Fig 2 below shows the new section of the line (red) and the affected areas of vegetation (thicker red line). The initial portion of the line passes through a sugar cane plantation which is of little concern. The intention is to then span a narrow but steep valley, pass over a ridge, close to the existing line and then continue to the right of the dirt road. The area of concern from a botanical perspective are the narrows valley and the area to the right of the dirt road. The former consists of dense woody vegetation consisting of *Trema orientalis*, *Ficus sur*, *Apodytes dimidiata*, *Celtis africana* and *Protorhus longifolia*. The area shows signs of disturbance, but is generally intact and representative of a natural forest community (Fig 3). Due to the steepness of the valley, the line will span the valley and it is possible that no bush clearing will be required. Stringing this section without extensive bush clearing would be preferable.

It is expected that significant bush clearing will be required along this particular portion due to the dense nature of the vegetation. Due to the natural forest character of the vegetation in the narrow valley and dense nature of the vegetation within the bushveld component, it is recommended that a license for the disturbance of Natural Forest be applied for.

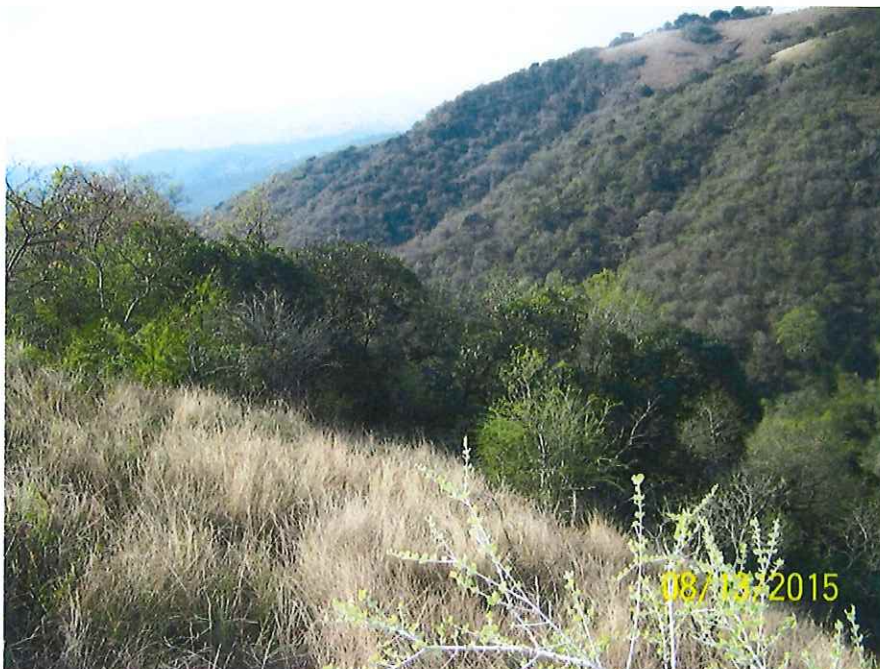
Fig 4. Dense bushveld vegetation to the right of the dirt road.

The latter consists mainly of dense Eastern Valley Bushveld vegetation, (Fig 4). The nature of the vegetation along this portion of the line route section was diverse and consisted of the following species:

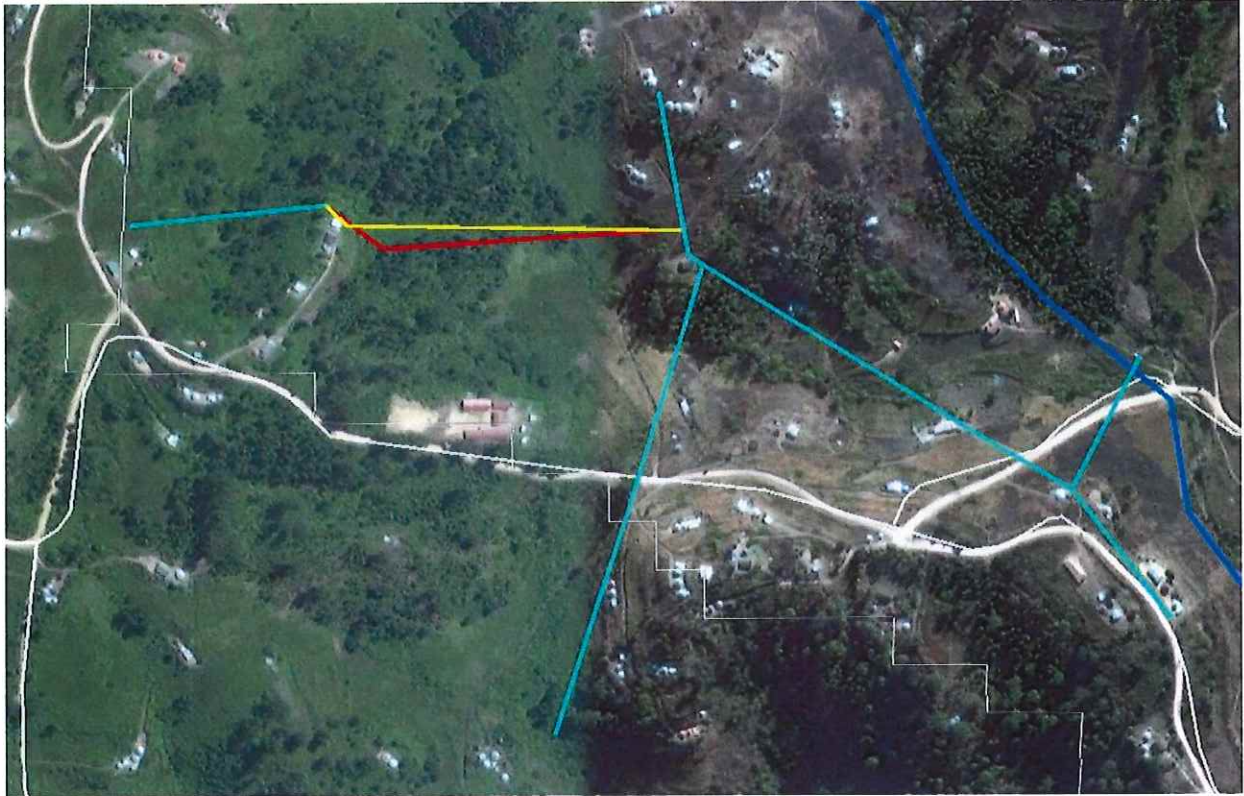
Fig 5. Position of the proposed line route through the *E. grandis* “plantation”.

agricultural activities and exotics plant species having transformed the surrounding landscape. The red line (Fig 5 below) indicates the proposed route. The vegetation present is dominated by *Eucalyptus grandis*, an exotic tree species (Fig 6). Clearing will be required, however no license is required due to the trees being exotic.

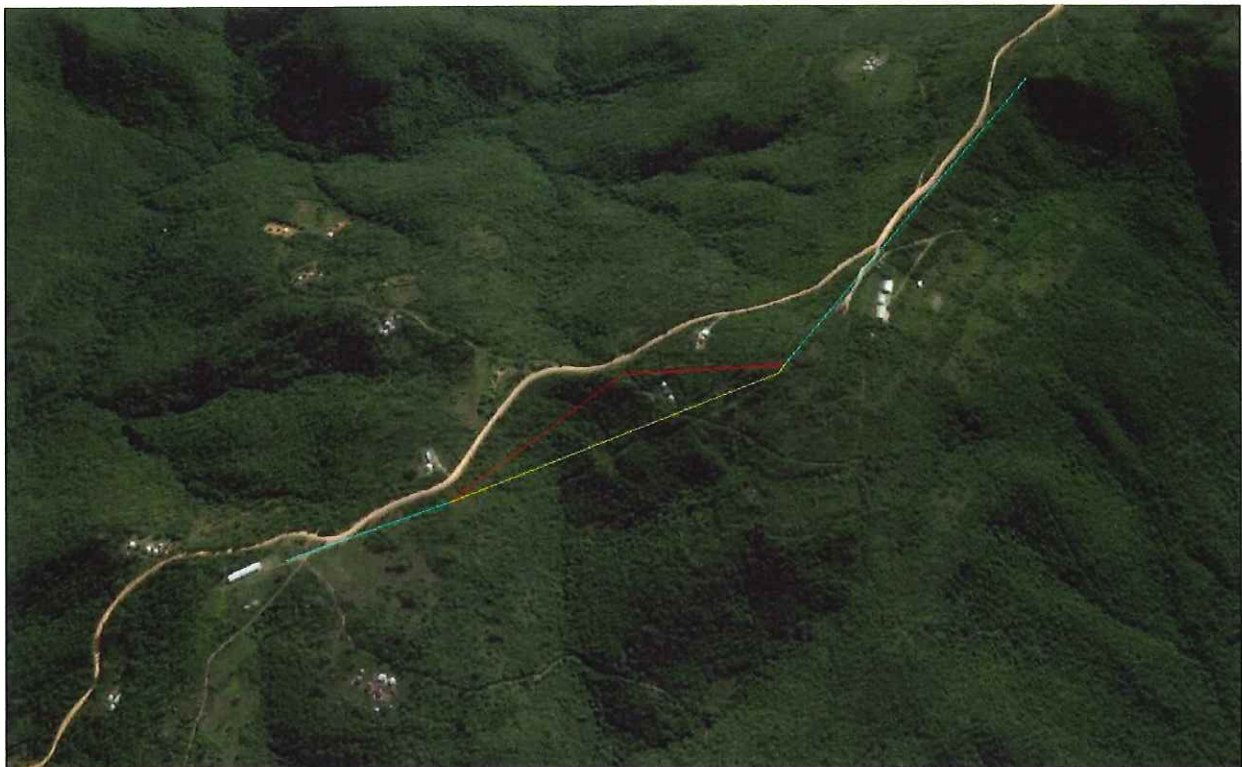
Fig 7. The proposed route (red) situated closer to the road. The vegetation nearer the road is more invaded by *L. camara* and more disturbed relative the lower portions of the valley.

This section of line is situated inland of Port Shepstone, north of the Umzimkulu River, near St Faiths (GPS: 30°36'23.64"S 30°11'10.11"E) (Fig 7). According to Mucina and Rutherford (2006) the site falls within the Kwazulu-Natal Coastal Belt vegetation type. The vegetation on site however resembles disturbed Eastern Valley Bushveld. *Acacia* species (*A. natalita*, *A. tortillis* and *A. robusta*) and *D. cinerea* were dominant and the vegetation was generally of low diversity (Fig 8 and 9). Invasion by *Lantana camara* was widespread. The vegetation was generally short (2 to 3 m) with no "canopy" evident. No protected tree species were noted on site. Significant bush clearing will be required, however no license is required.

The proposed route indicated in read below is favourable as it is situated closer to the road at the valley head and situated within the more invaded portion of the vegetation present.
