AN AQUATIC ASSESSMENT OF THE LOCAL RIVER SYSTEMS OF THE BRAKFORTEIN MINING OPERATION

UNIVERSAL COAL

SEPTEMBER 2012

Project Number: UNI1292

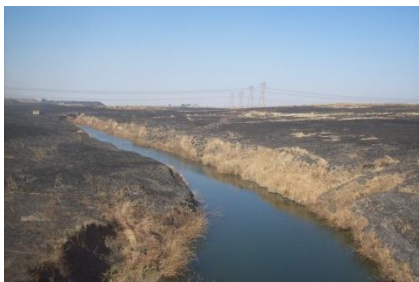
Site Name	Coordinate	Description	Photograph
Site 1	26 13 39.56 S 28 51 22.65 E	This site is located just off the R50 road. The site is located upstream the mining operation on a tributary of the Wilge River. The site is described as approximately 5m wide with the water surface being about 2m below that of the river banks. The flow type was characterised by slow flow (>0.1m/s) It must be noted that this site had excessive siltation and thus had a sandy substrate. The site's riparian vegetation was composed predominantly by grasses with a lack of large trees.

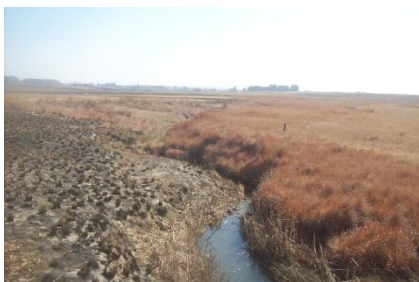
Site 2	26 14 05.42 S 28 53 07.66 E	This site is located near to the R50 road above the mining operation. This stream forms a tributary of the Wilge River and is known as the Kromdraaispruit. The stream was approximately 2m wide and had a water surface about 1m away from the riverbanks top. The flow type would be described as slow (>0.1m/s) The stream is located near to agricultural activities and its dominant riparian vegetation was grasses and various aquatic macrophytes such as Bulrushes (<i>Taphia capensis</i>).

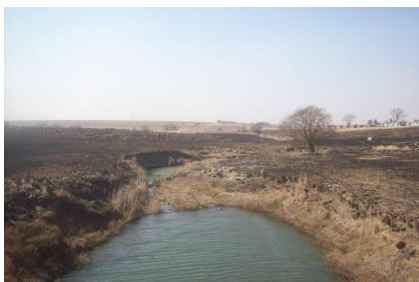
Site 3	26 12 34.40 S 28 52 38.37 E	This site is located on the Wilge River immediately downstream mining operations. The river was approximately 3m wide and there were signs of erosion on the outer banks cutting a depth into the riverbanks of approximately 2m. The flow type of the river at the time sampled was slow (>0.1m/s). Riparian vegetation was dominated by grasses and aquatic macrophytes.

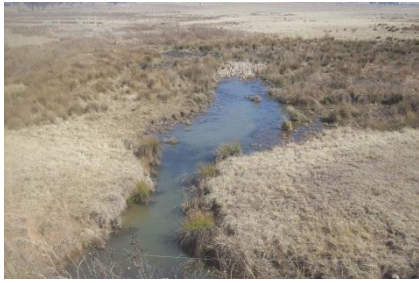
Site Name	Coordinate	Description	Photograph
Site 4	26 11 52.71 S 28 51 56.27 E	This site forms a tributary of the Wilge River and is located within the mine operation area. At the time of sampling there was no flow observed and the predominant vegetation was wetland type species.

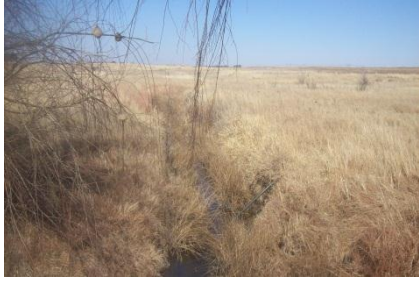
Site 5	26 12 50.4 S 28 53 21.2 E	This site is located on a tributary of the Wilge River and is located approximately 1.34km up stream of the Wilge River confluence. The site is located downstream the Kromdraai Dam. The stream is approximately 1m wide with banks about ½m high. At the point of sampling there was no discernible flow with the formation of pools. Riparian vegetation was dominated by grasses.

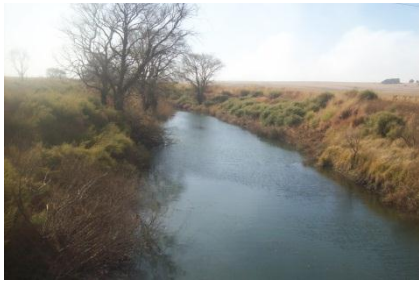
Site 6	26 08 30.0 S 28 52 38.6 E	This site is found on the Wilge River downstream of the Brakfontein mining operation as well as a variety of other mining operations. The river is about 8m wide and has riverbanks ±2m from the water surface. The flow type with identified to be slow (>0.1m/s).
