River Index of Habitat Integrity (IHI) and riparian vegetation assessment for the proposed establishment of a measuring weir within the Caledon (Mohokare) River (Quaternary Drainage Region: D22D)

November 2012

Prepared for:
Department of Water Affairs
P.O. Box 528
Bloemfontein
9300

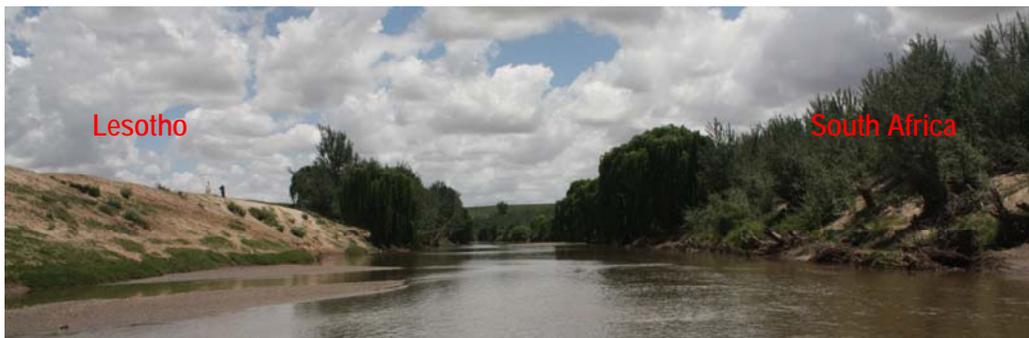
It must be stated that all of the riparian zones on the Lesotho side of the river are severely degraded and although the different zones are present the riparian vegetation itself are severely transformed, unnatural and absent in many areas (Figure 1). The discussion as follows is based on the riparian communities on the South African side of the river.

Figure 1: Panorama of the Caledon River. Note the absence of vegetation on the Lesotho side of the river, some exotic weeds, grasses and isolated trees remain. Vegetation on the South African side contains grasses, herbs and a multitude of exotic trees.

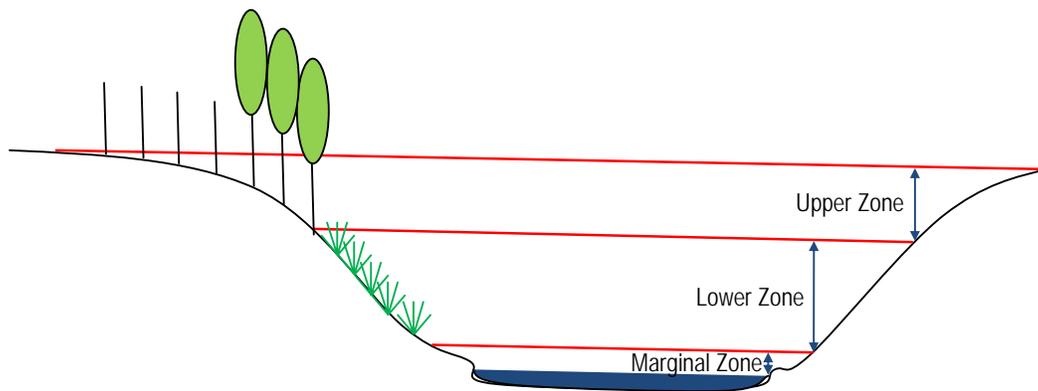
All river systems contain three distinct, lateral riparian zones, namely marginal, lower and upper zones (Figure 2). The zones are identified by a combination of the periodicity of the hydrological influence, marked changes in lateral elevation or moisture gradients, changes in geomorphic structure and changes in plant species distribution or community composition along lateral gradients.

The marginal zone is the lowest zone and is always present in river systems while the other two zones may not always be present. The zone is situated from the water level at low flow, if present, up to the features that are hydrologically activated for the most of the year (Figure 2). The marginal zone along this section of the river is relatively small and rarely extends for more than one meter from the waters edge. The marginal zone in this section does not contain a large amount of vegetation. This is primarily due to the sandy sediment and the constant

The lower zone is characterised by seasonal features and extends from the marginal zone up to an area of marked elevation. This area may be accompanied by a change in species distribution patterns. The lower zone consists of geomorphic features that are activated on a seasonal basis (Figure 2). The lower zone along this section of the river contains a steep slope but is subjected to annual flooding. The riparian vegetation in this zone consists primarily of grasses and herbs. The lower zone is also encroached by exotic Poplar Trees (*Populus x canescens*) although these trees are annually removed by floods. Isolated specimens of exotic Weeping Willow (*Salix babylonica*) are also present in the lower zone though they do not invade and are adapted to the high moisture regime and annual floods. The lower zone is degraded to some extent and exotic species are common.

The upper zone is characterised by ephemeral features as well as the presence of both riparian and terrestrial species. The zone extends from the lower zone to the riparian corridor. The upper zone contains geomorphic features that are hydrologically activated on an ephemeral basis (Figure 2). The upper zone along this section of the river contains a steep slope that contains a marked decrease in lateral slope. The upper zone is dominated by exotic Poplar Trees (*Populus x canescens*). These trees form dense stands and exclude most other vegetation. The species has transformed the upper zone riparian vegetation. This zone is considered severely degraded.

Figure 2: Illustration showing the different riparian zones of this section of the Caledon River.

The riparian zones on the Lesotho side of the river is severely degraded, transformed and the riparian vegetation is absent in many areas. The riparian zones on the South African side of the river are intact but degraded.

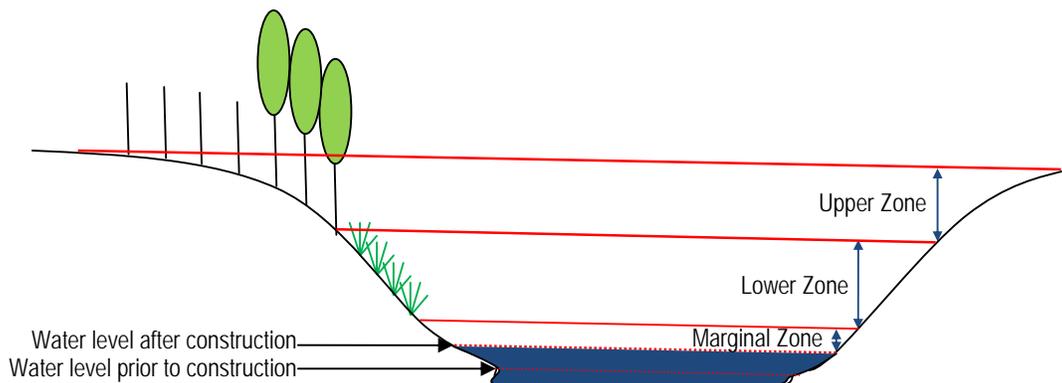
Although the river is in a degraded state it still constitutes a sensitive environment as it provides vital ecological services. Therefore any alteration in the hydrology and functioning of the river must be carefully assessed. The height of the obstruction formed by the weir is approximately 0.5m from the river bed. Due to the low height of the weir the effect of damming will not be significant but will still have a low effect on the riparian zones. As the weir causes an increase in low flow height the riparian zones will be shifted upwards as illustrated by Figure 3.

Figure 3: Illustration showing the effect that the weir will have on the riparian zones. Note that the water level will rise slightly as a result of the weir, this will result in an upward shift of the marginal zone, a small portion of the lower zone will be lost as the marginal zone moves upward and the upper zone will remain intact.

Due to the low height of the weir and the already degraded condition of the riparian zones this impact cannot be regarded as significant.

The obstruction formed by the weir would not be substantial since the height of the weir is relatively low. Therefore the impact of the weir on the riparian communities of the river would be relatively low. The increase in height of the low level water flow would lead to an upward

movement of the marginal zone. This would be a slight change in the riparian zones and is not regarded as a major impact on the riparian zone of the river.
