# **Aquatic Biodiversity Compliance Statement – Carolus Solar Photo- Voltaic (PV) Solar Energy Facility and associated Grid Connection Infrastructure**

**Pixley ka Seme District Municipality,  
Northern Cape Province**

Report Date: September 2022

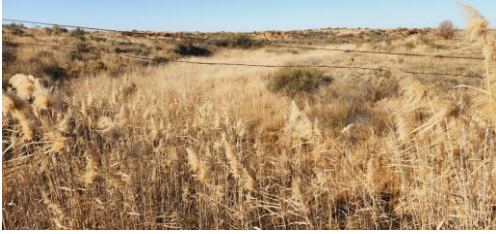
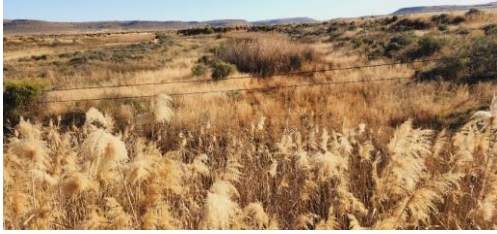
<b>Comments</b>	Upstream Brak River site, upstream and east of proposed infrastructure. The watercourse presented wetland habitat and was dry.	
<b>GPS-coordinates</b>	30°40'42.52"S 24°10'45.43"E	
<b>Brak Down</b>

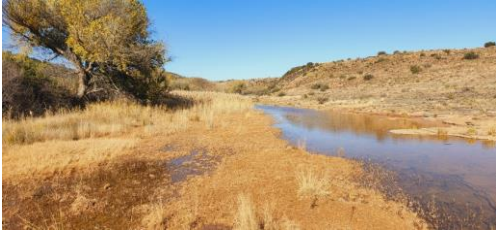
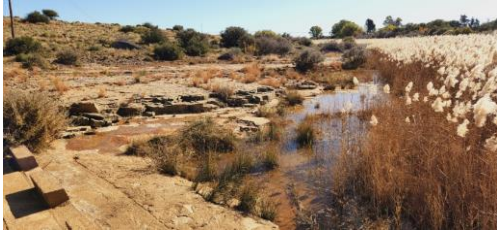
<b>Comments</b>	Downstream Brak River site, downstream of proposed infrastructure and downstream of Brak Mid. The site presented wetland habitat. The site was deemed too shallow and unsuitable for standard aquatic sampling methods and was limited to <i>in situ</i> water quality analysis only.	
<b>GPS-coordinates</b>	30°38'18.43"S 24° 8'12.64"E	
<b>Brak River tributaries</b>		
<b>East Trib Dam</b>

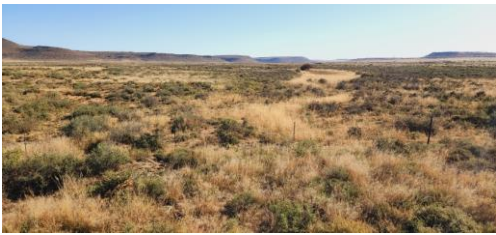
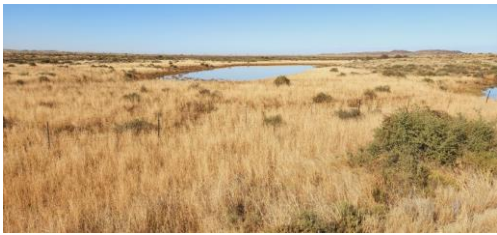
<b>Comments</b>	Located at a Dam on a Brak River tributary to the east of the project area (Eastern tributary). The site is downstream of the Carolus Solar PV1 Footprint and would drain into the Brak River upstream of Brak Mid. The dam had surface water and water quality analysis was conducted at this site.

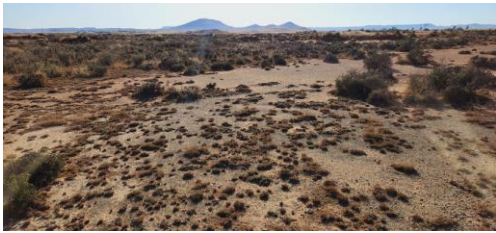
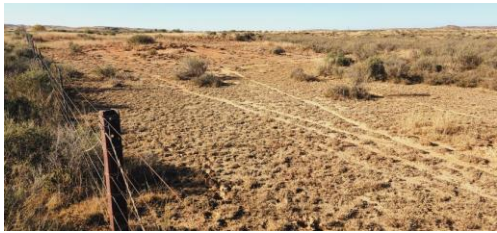
Site	Upstream	Downstream
<b>Comments</b>	Located on the major Brak River tributary within the western portion of the project area. The site assessed the upper portion of this tributary (Western Tributary) that will be traversed by the proposed linear infrastructure (powerlines and roads). This site was presented by a wide drainage area (alluvial floodplain) with an inconspicuous channel, which was dry at the time of the survey.	
<b>GPS-coordinates</b>	30°42'39.68"S 24° 6'36.75"E	
<b>West Trib 3</b>

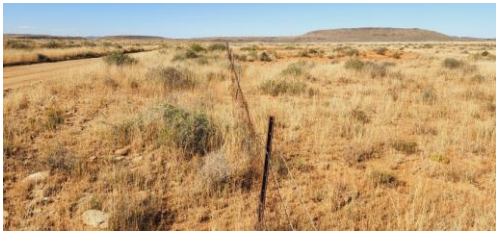
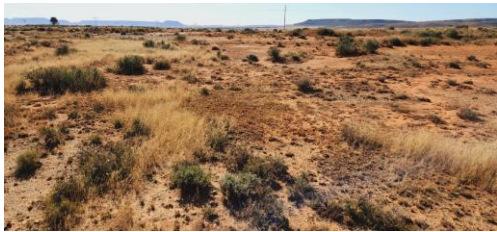
<b>Comments</b>	Located on the Western Tributary in the lower portion of this tributary that will be traversed by the proposed linear infrastructure (powerlines and roads). This site was presented by a wide drainage area (alluvial floodplain) with an inconspicuous channel, which was dry at the time of the survey.	
<b>GPS-coordinates</b>	30°38'50.53"S 24° 6'0.03"E	
<b>Artificial Dam</b>

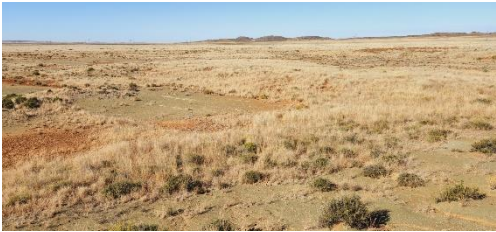
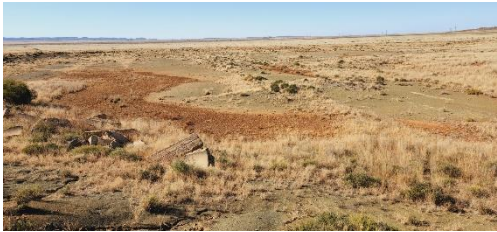
<b>Comments</b>	A dam located along a public road with no clear drainage lines. The dam is located adjacent to the BESS area of the PV area. The dam is considered artificial and a result of the presence of the road. The site was dry and considered to have low aquatic ecology importance or sensitivity due to its artificial nature.	
<b>GPS-coordinates</b>	30°41'20.69"S 24° 8'52.01"E

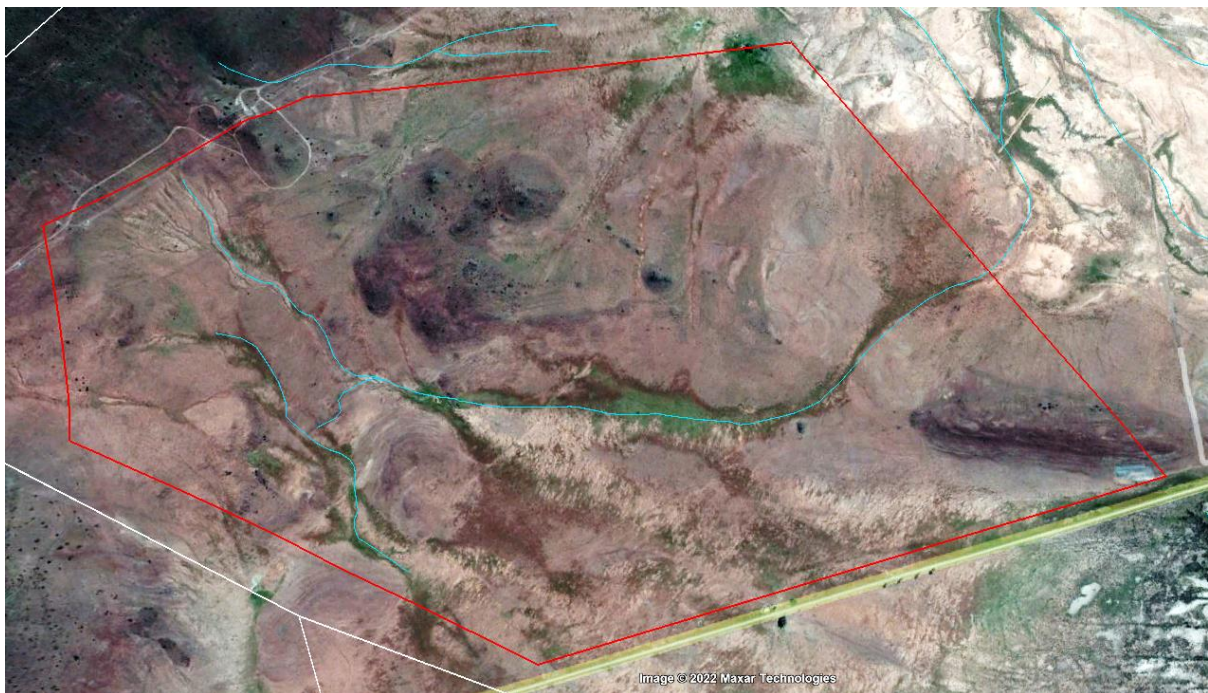
Figure 5-3 Illustration of the alluvial fans (green areas) in wet periods (Google Earth 3/2017)

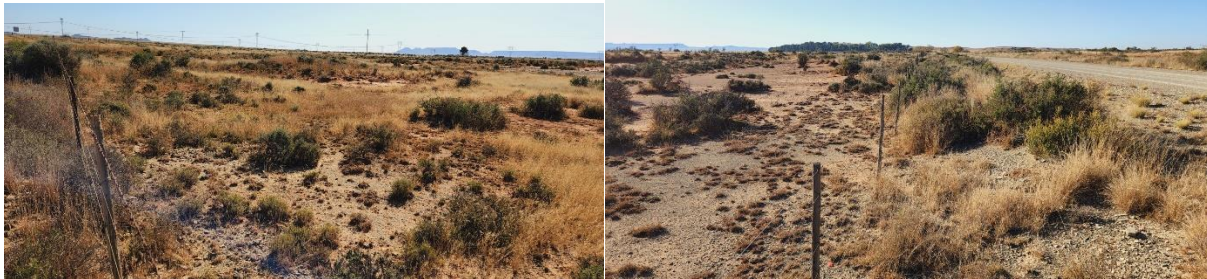
*Figure 5-4 Illustration of the ephemeral habitat features of the Western tributary (June 2022)*

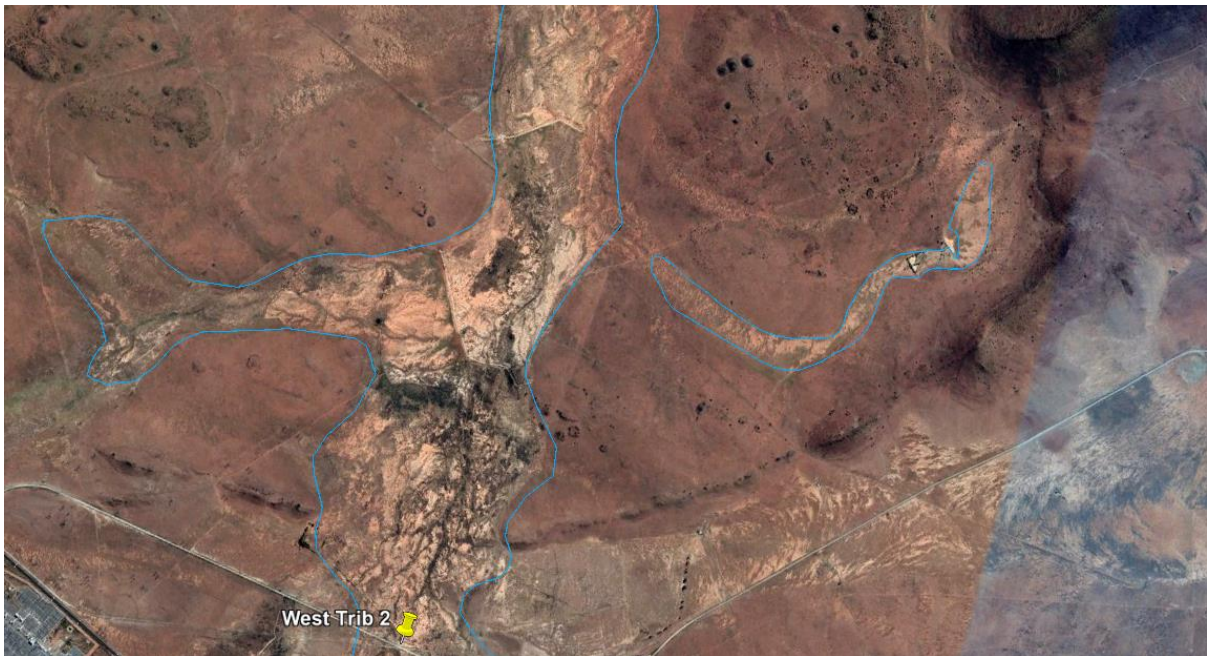
*Figure 5-5 Illustration of the catchment condition of the Western tributary (Google Earth)*

The on-site assessment of the watercourses presented largely dry conditions, with the ephemeral systems presenting no clear banks or riparian features which is typical for watercourses in an arid region (Figure 5-5 and Figure 5-4). Many of the drainage features presented as alluvial fans that have formed in the low laying areas below mountain slopes or gorges due to the flat topography and low water energy that has resulted in the accumulation of alluvial sediment. These areas are broad presenting as wide floodplain-like features which are difficult to observe in-field and are best seen from satellite imagery (Figure 5-2, Figure 5-5 and Figure 5-4). These drainage areas are highlighted in times of good rainfall when the vegetation cover is greatest from inundated soils, with an example from March 2017 imagery highlighting the extent of these areas (Figure 5-3). The areas are prone to flooding during large storm events and may remain saturated for several days to weeks, depending on the permeability of the soils and climate conditions. These areas are important for groundwater recharge.

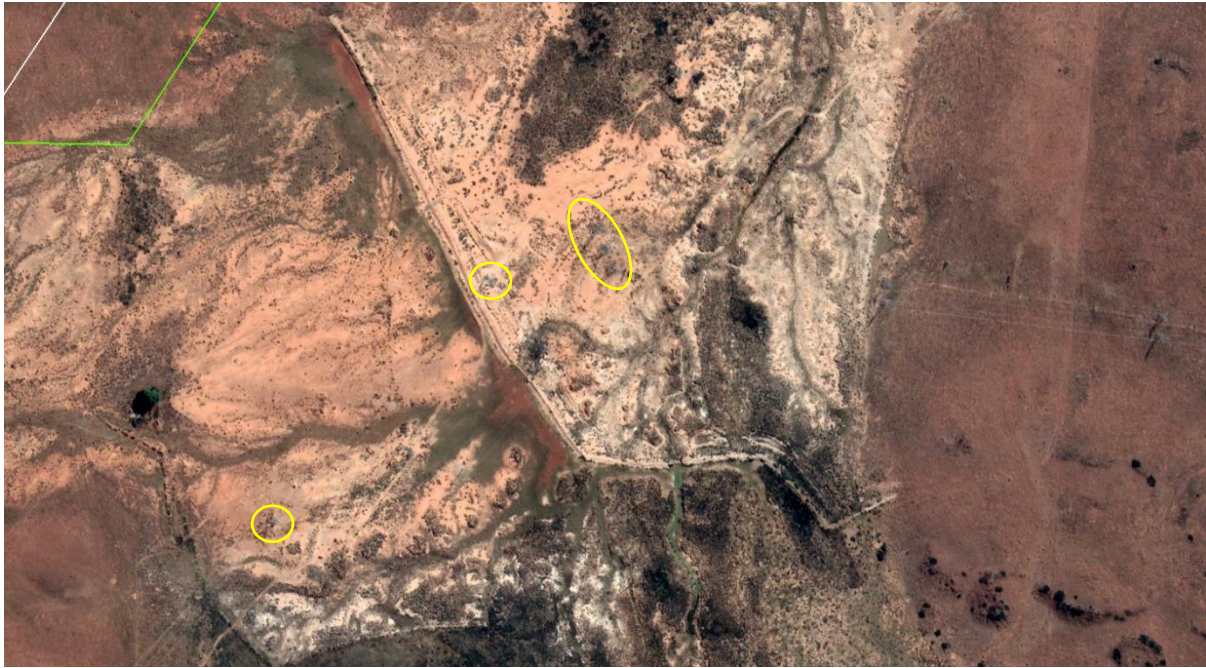
Figure 5-6 Illustration of existing in-stream weirs structures and powerline pylons (yellow circles) within the drainage features (Google Earth)

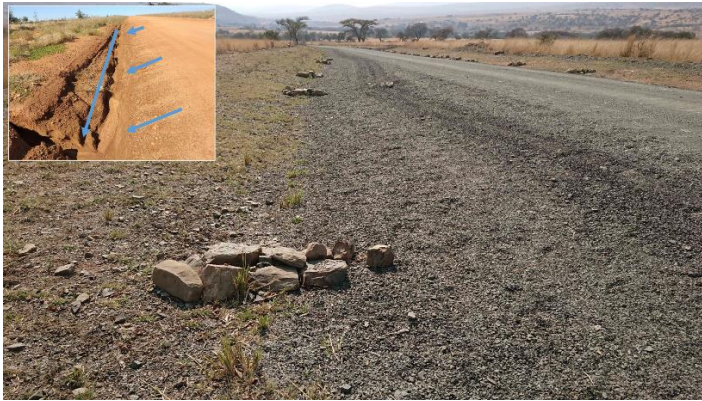
Figure 6-3 Example of road margin erosion prevention

- Energy dissipation, such as stone berms or blocks must be strategically placed along the road margins for the entire road network as surface runoff leaves the roads and enters the surrounding environment with the potential for severe erosion. The steeper the slope of the road, the more regular the berms should be spaced and can be as close as one meter apart where necessary;

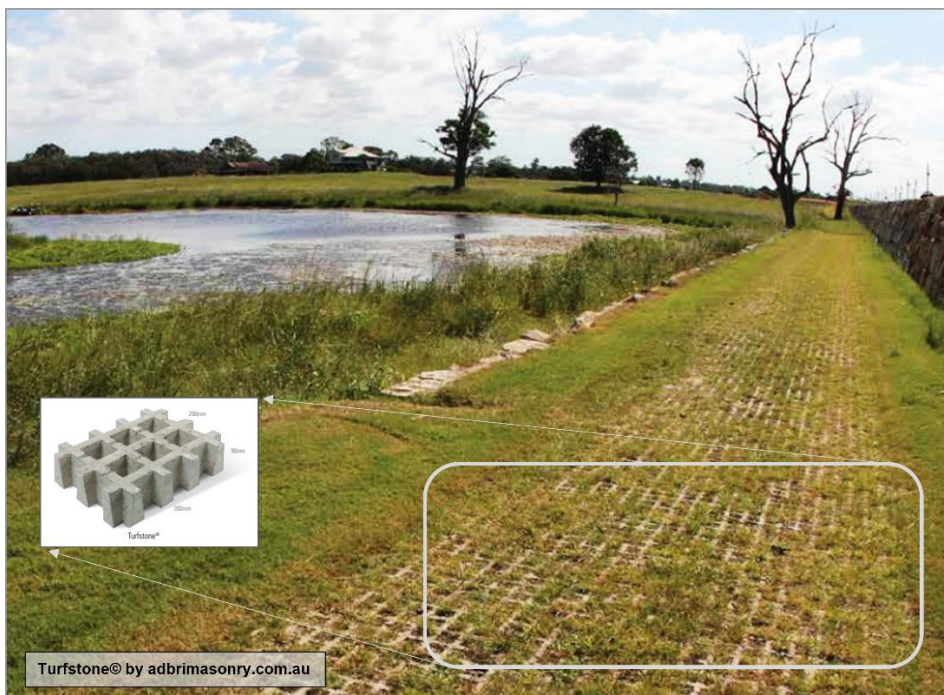
Figure 6-4 Example of permeable paving for roads and habitat maintenance

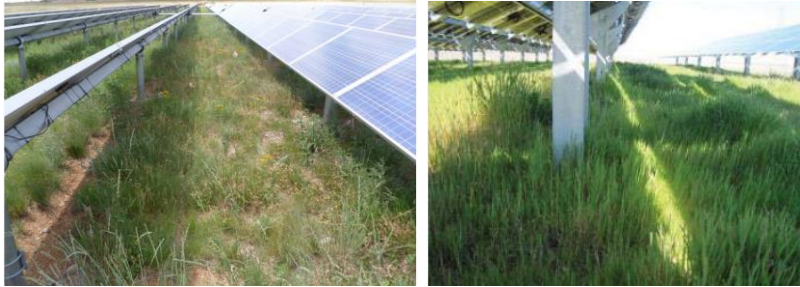
- Indigenous vegetation must be maintained under the solar panels to ensure biodiversity is maintained and to prevent soil erosion (Beatty *et al*, 2017; Sinha *et al*, 2018). This vegetation cover will maintain surface roughness which will assist in maintaining hydrological connectivity through infiltration and subsurface interflow. The photographs below are sourced from these documents;
