SUMMARY OF BORROW PIT RESULTS - REP COM 8

Client:	Aurecon	BP No:	4	GPS (X):	6514518.39
Project Name:	R27 W/Cape Border to Calvinia	TP No:	1	GPS (Y):	34J 361775.39
Project No:	106547	Section:	Section 8	Date:	
Job No:		Chainage:	Km 45.0	Test Methods:	TMH1 A1-A5 / A7 / A8
		Position:	RHS

PART C: INDIVIDUAL BORROWPITS

ENVIRONMENTAL MANAGEMENT PROGRAMME

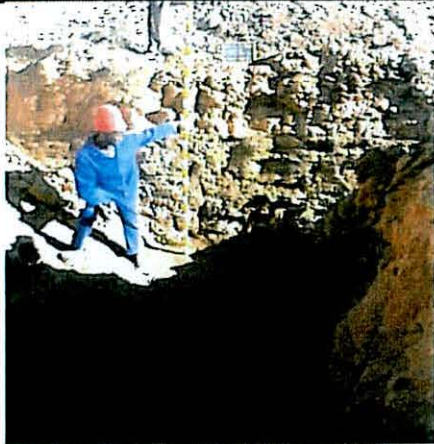
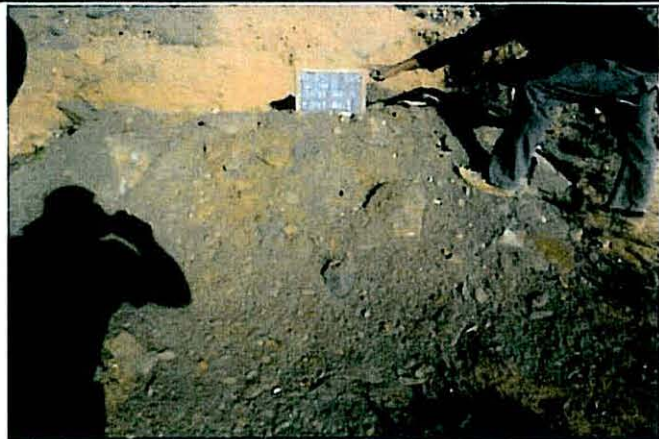
SAMPLE DESCRIPTION	Layer 1	Layer 2	Layer 3	Layer 4	Layer 5	Layer 6
Depth (mm)	0 - 600	600 - 1900				
		1900 > Refusal				
Lab No		1/327

DESCRIPTIONS	
Layer 1	TOPSOIL
Layer 2	Br weath. Fine med dense to v dense Dolorite gravel
Layer 3	
Layer 4	
Layer 5	
Layer 6

GRADING ANALYSIS						
% Passing Sieve	63.0 mm	No Sample				
	53.0 mm		100			
	37.5 mm		93			
	26.5 mm		84			
	19.0 mm		84			
	13.2 mm		80			
	4.75 mm		67			
	2.00 mm		47			
	0.425 mm		16			
0.075 mm	5

MDD / OMC & CBR ANALYSIS	
Maximum Dry Density	2249
Optimum Moisture Content	6.5
In-situ Moisture Content	
In-situ Density (%)	
CBR @ 90%	36
CBR @ 93%	57
CBR @ 95%	76
CBR @ 98%	101
CBR @ 100%	122
% Swell (Max)	0.0

MATERIAL CLASSIFICATION	
COLTO Classification	G5

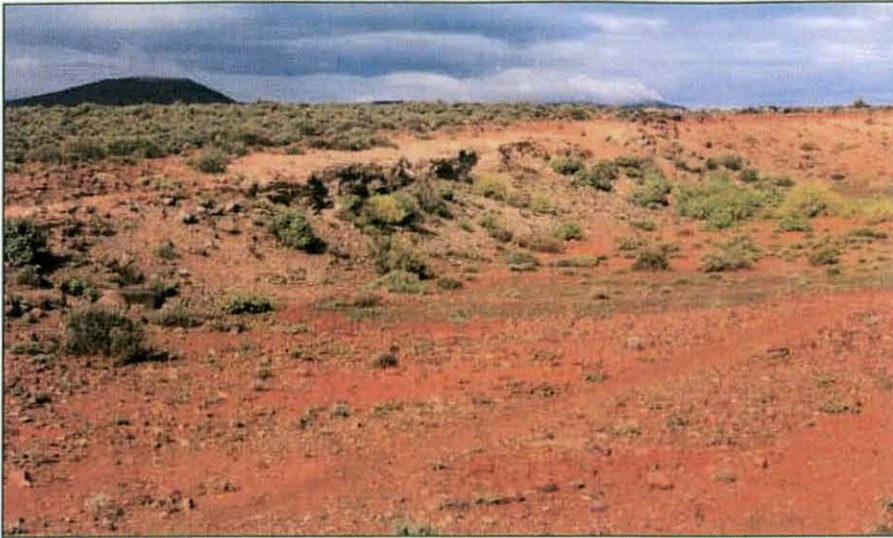
Figure C3.4: BP R27-8 KM 61.6 RHS 1.0: View of existing disturbed area (facing south-east)
(photo provided by Dr D MacDonald)

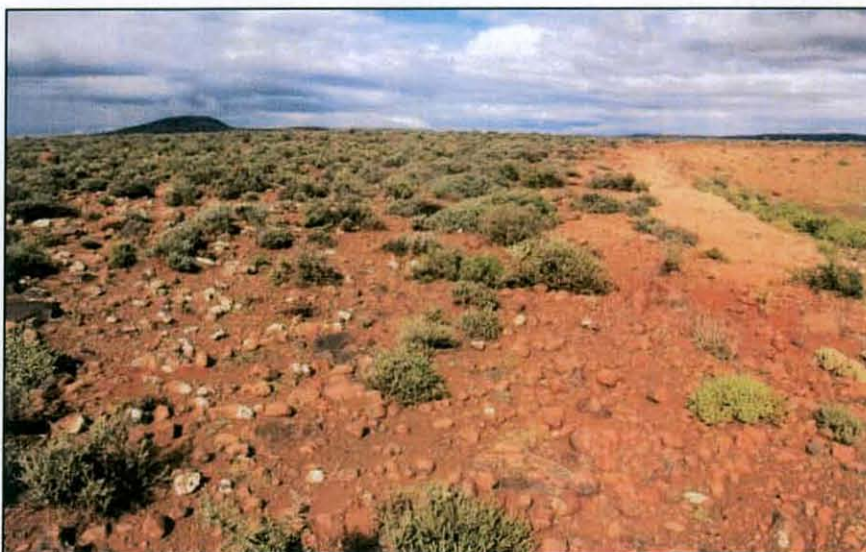
Figure C3.6: BP R27-8 KM 61.6 RHS 1.0: View of eastern edge of the existing borrow area (facing south-east)
(photo provided by Dr D MacDonald)
